**Manly Fire Station –
Whangaporoa Road, Manly:
Condition Assessment Report
& Forward Maintenance Plan**

REVISED March 2013

Manly Fire Station : Forward Maintenance Plan

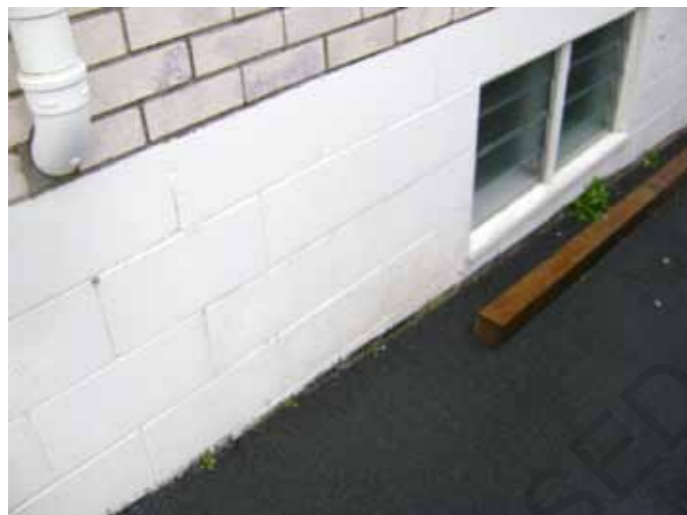
Photo 7

1.2.3	Painted concrete Block foundation walls	In a serviceable condition.	3	Re-finish in line with routine maintenance schedule.	7	3		\$ 1,200														\$ 1,200

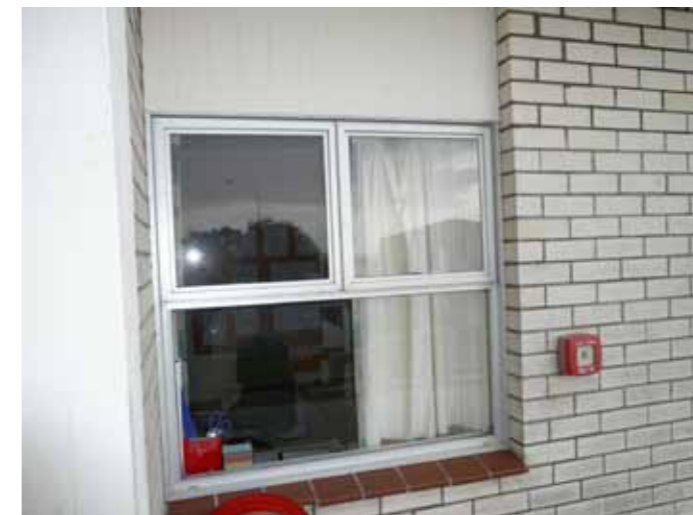
Photo 9

1.2.5	All aluminium framed windows and ranchsliders	Anodised aluminium frames in a serviceable condition, all glazing undamaged.	3	Replace window seals at end of serviceable life.	9	2		\$ 1,350														\$ 1,350

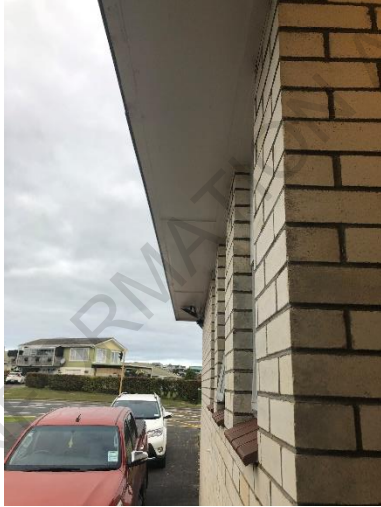
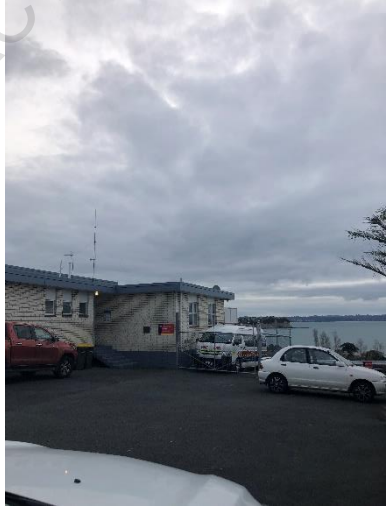
Reference Number	RV379478	Extent	40 m ²

<p>Perspective Image</p>
Date Identified	05 Mar 2020	Condition	Low damage		
How Identified	Sampled	Friability	Non-friable		
Surveyor Name	Ronaldo Vollenhoven	Accessibility	Accessible		
Survey Address	960 Whangaparaoa Road, Manly, Te Hiku	Surface Treatment	Sealed		
Building	Manly Fire Station	Laboratory	Analytica Laboratories		
Room	Exterior soffits	Lab Test ID	RV379478		
Floor	Ground floor	Test Result	Confirmed Asbestos RV379478		
Item Location	Exterior	Asbestos Type	Chrysotile Organic fibres		
Product Type	Cement products	Risk Assessment	9 - Medium risk ACM

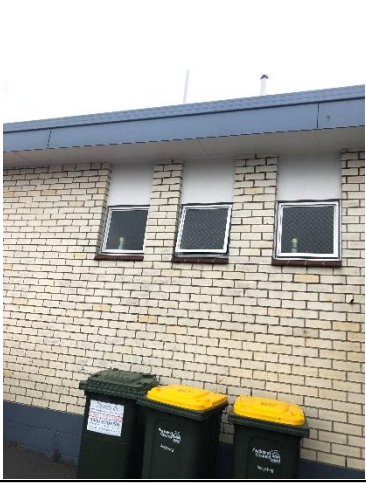
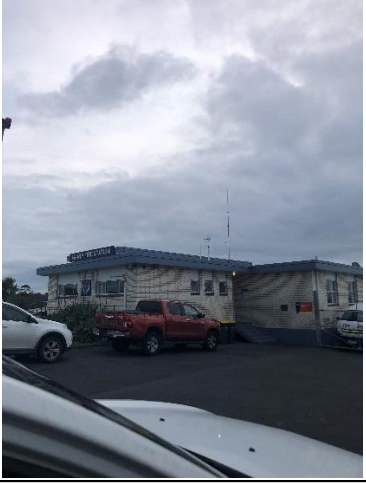
Reference Number	RV379478	Extent	20 m ²

<p>Perspective Image</p>
Date Identified	05 Mar 2020	Condition	Low damage		
How Identified	Sampled	Friability	Non-friable		
Surveyor Name	Ronaldo Vollenhoven	Accessibility	Accessible		
Survey Address	960 Whangaparaoa Road, Manly, Te Hiku	Surface Treatment	Sealed		
Building	Manly Fire Station	Laboratory	M/A		
Room	Exterior fascia boards	Lab Test ID	Presumed		
Floor	Ground floor	Test Result	Presumed Asbestos RV379478		
Item Location	Exterior	Asbestos Type	Presumed asbestos		
Product Type	Cement products	Risk Assessment	9 - Medium risk ACM

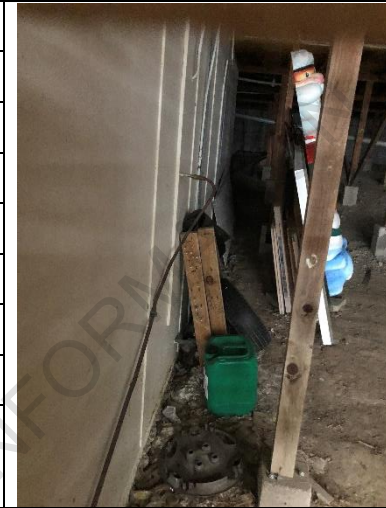
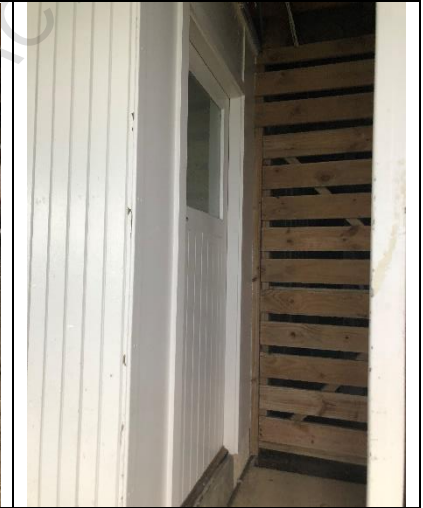
Reference Number	RV379955	Extent	40 m ²
Date Identified	05 Mar 2020	Condition	Low damage
How Identified	Sampled	Friability	Non-friable
Surveyor Name	Ronaldo Vollenhoven	Accessibility	Accessible
Survey Address	960 Whangaparaoa Road, Manly, Te Hiku	Surface Treatment	Sealed
Building	Manly Fire Station	Laboratory	Analytica Laboratories
Room	Baseboard cladding	Lab Test ID	RV379955
Floor	Ground floor	Test Result	Confirmed Asbestos RV379955
Item Location	Baseboard cladding	Asbestos Type	Amosite Chrysotile Organic fibres
Product Type	Cement products	Risk Assessment	9 - Medium risk ACM

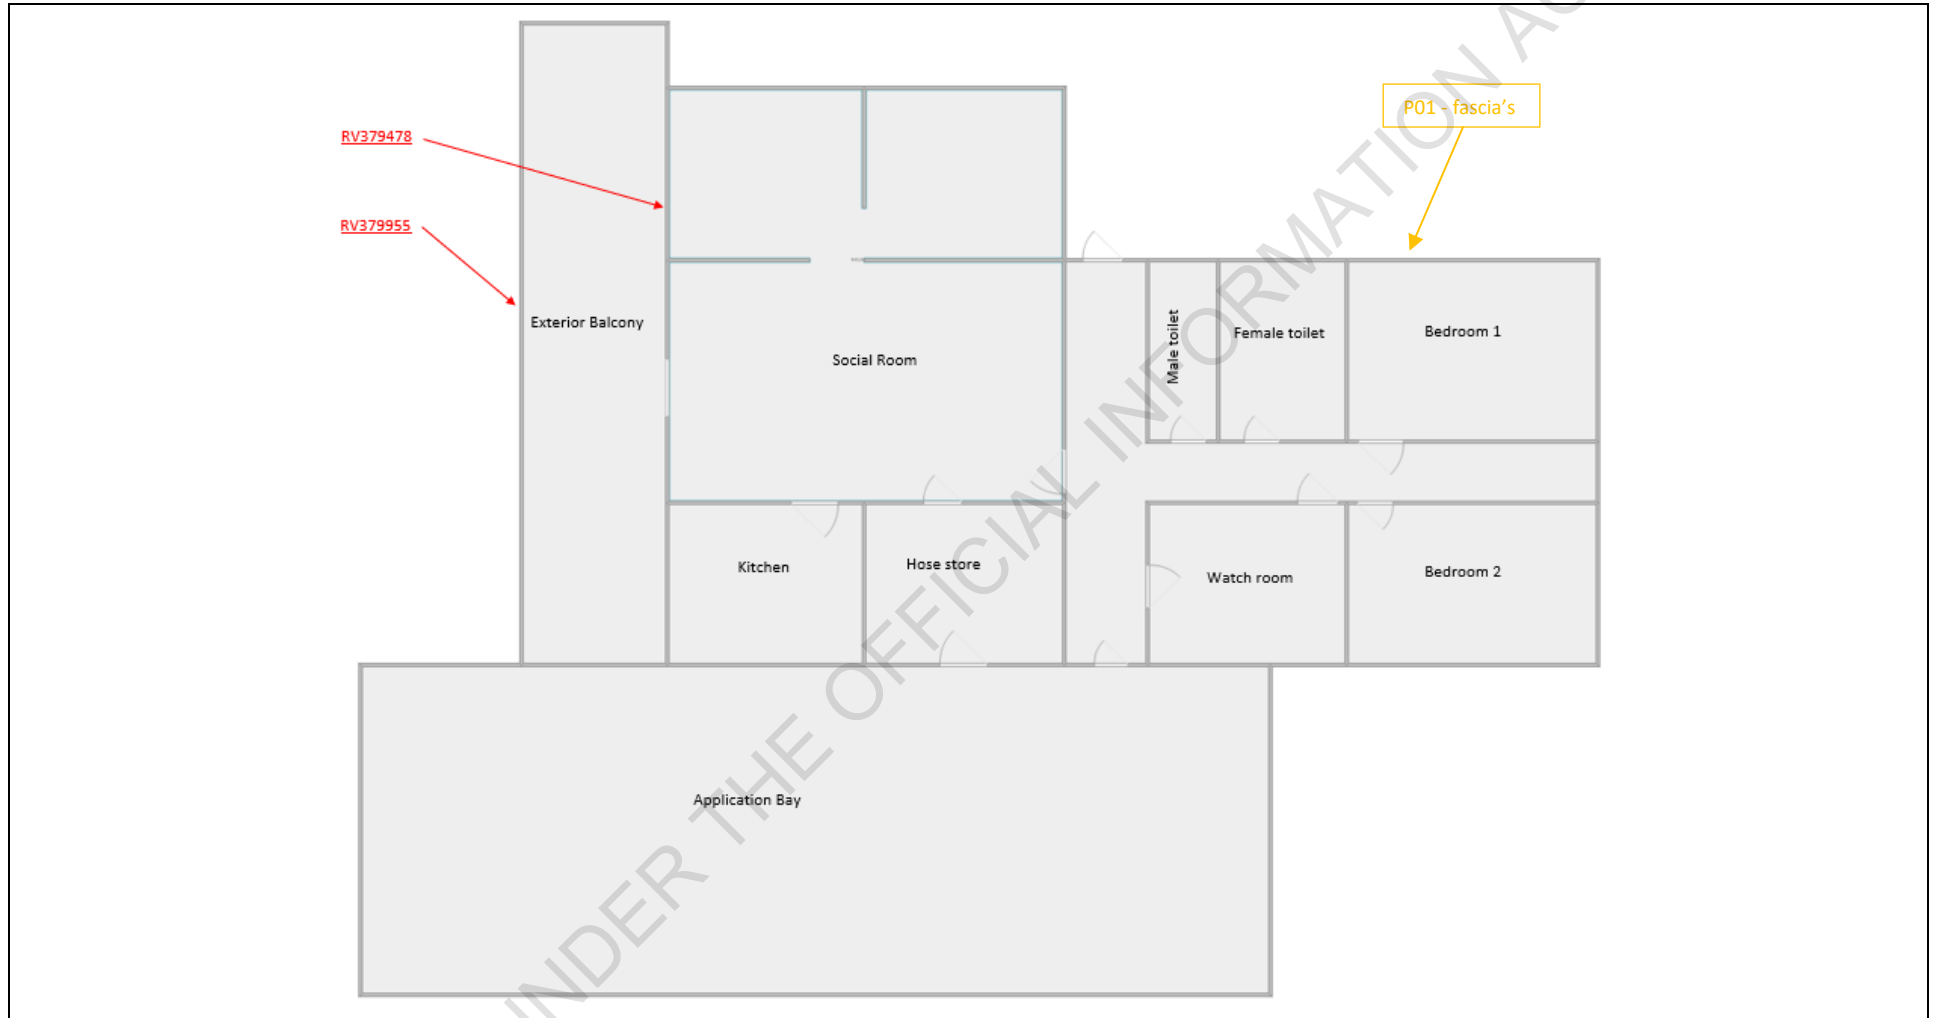
Appendix C – Marked Up Asbestos Diagrams

Manly Fire Station Ground Floor	<div style="background-color: red; color: white; padding: 2px; text-align: center;">Asbestos Detected</div> <div style="background-color: green; color: white; padding: 2px; text-align: center;">No Asbestos Detected</div> <div style="background-color: yellow; color: black; padding: 2px; text-align: center;">Presumed Asbestos</div>	 
---	---	--	---	---
