# STRUCTURAL ASSESSMENT OF

# OPERATIONAL SUPPORT BUILDING AT CHARTWELL FIRE STATION

70 Crosby Road, Hamilton

Structural Assessment incorporating Detailed Seismic Assessment (DSA), Wind Loading Assessment (WLA), Snow Loading Assessment (SLA) & Visual Ground Assessment (VGA) prepared by Arnold & Johnstone 2015 Ltd for Fire and Emergency New Zealand (FENZ)

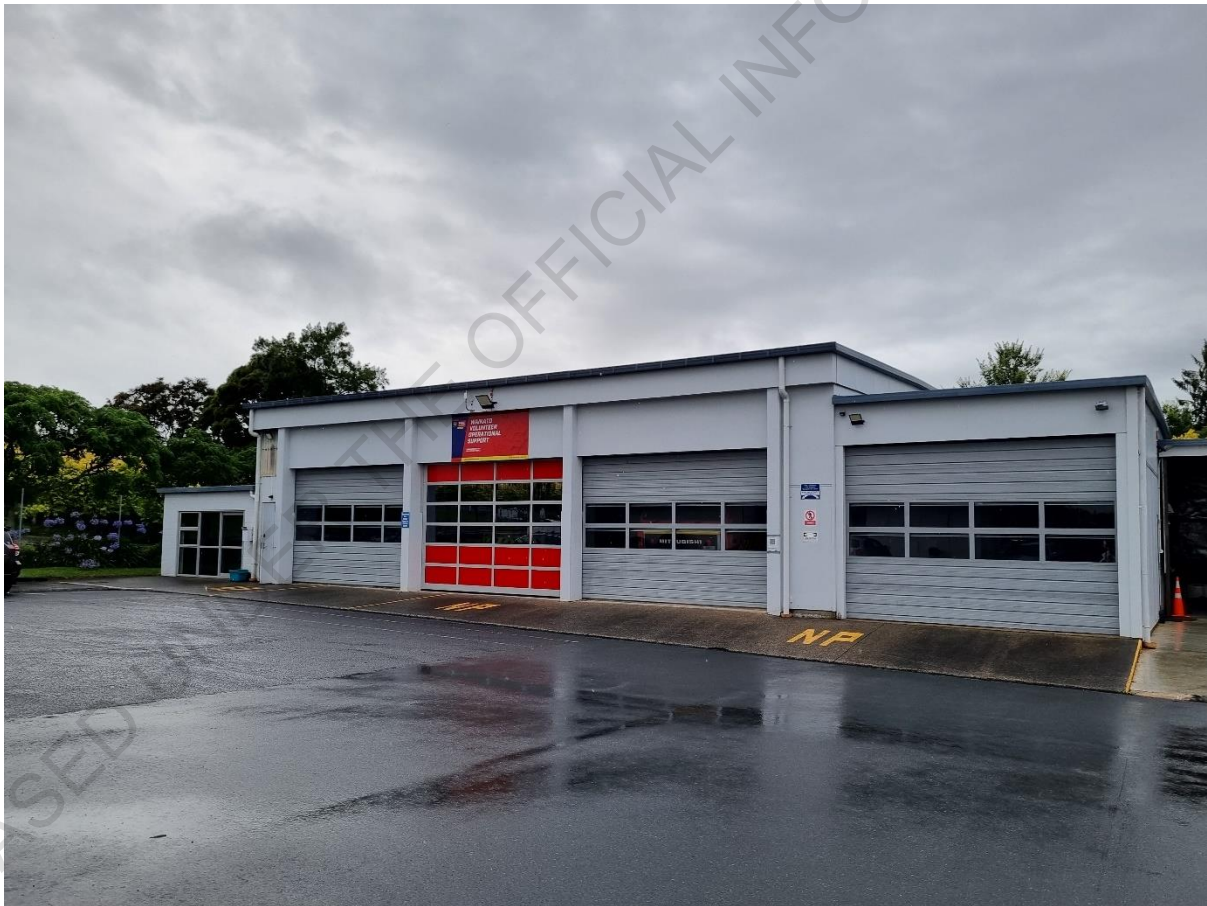
Figure 2: Photo of the Operational Support Building

- 1) The Operational Support Building is located generally on flat ground and surrounded by residential buildings. The rear (south) of the building backs onto the car park for Porritt Stadium.
- 2) A gully is located on the south western side of the site. Historically, gully areas have often been filled to allow further flat ground for development. No settlement or movement of the ground in the vicinity of the building was noted.
- 3) There is another building on the property (Chartwell Fire Station). The area surrounding the Operational Support Building is generally paved with concrete with some small grassed areas. No notable settlement was observed on site.
- 4) Storm water run-off appears to flow to catch pits in the paved area to the north of the building. No ponding issues were noted during our site visit.

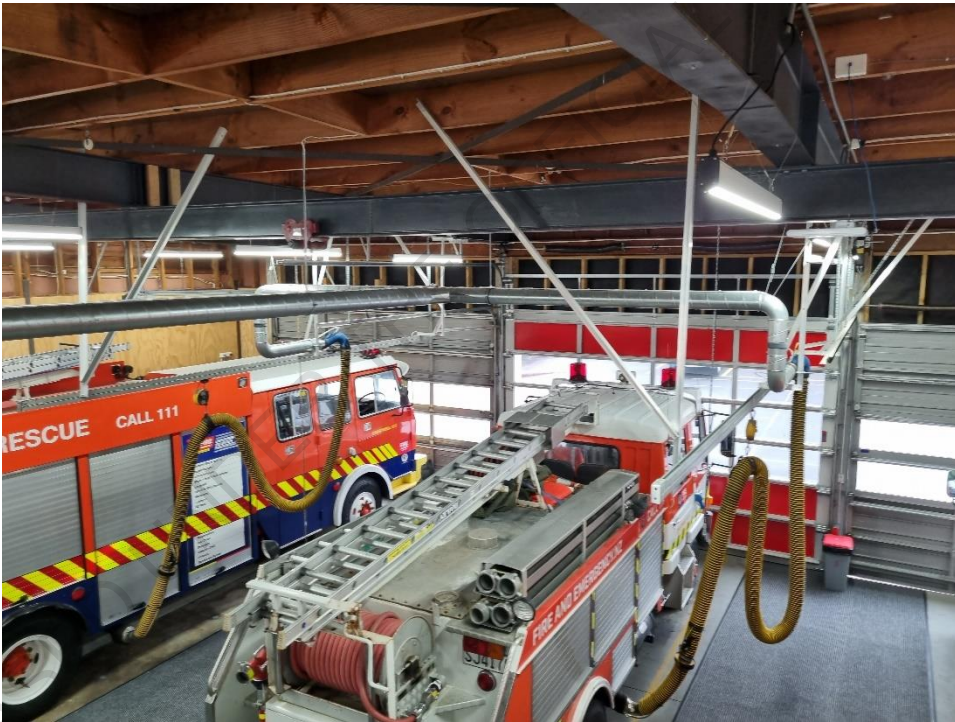
Photo 4 – Internal view of Appliance Bay 01

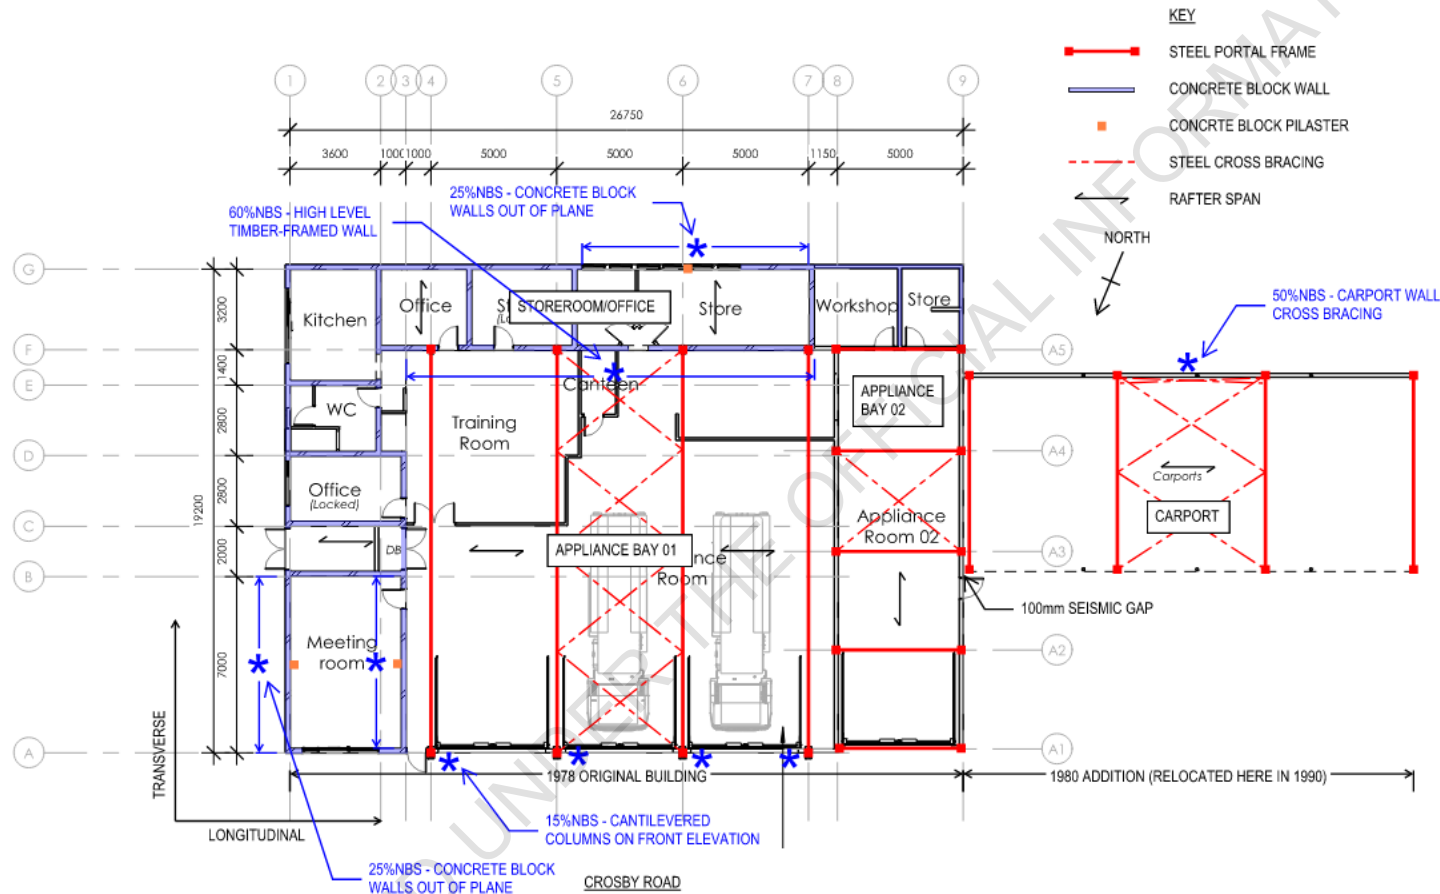
Figure 3: Floor plan showing IL4 seismic scores

Floor plan showing the locations of the primary lateral load resisting system and seismic scores for IL4 levels of shaking.

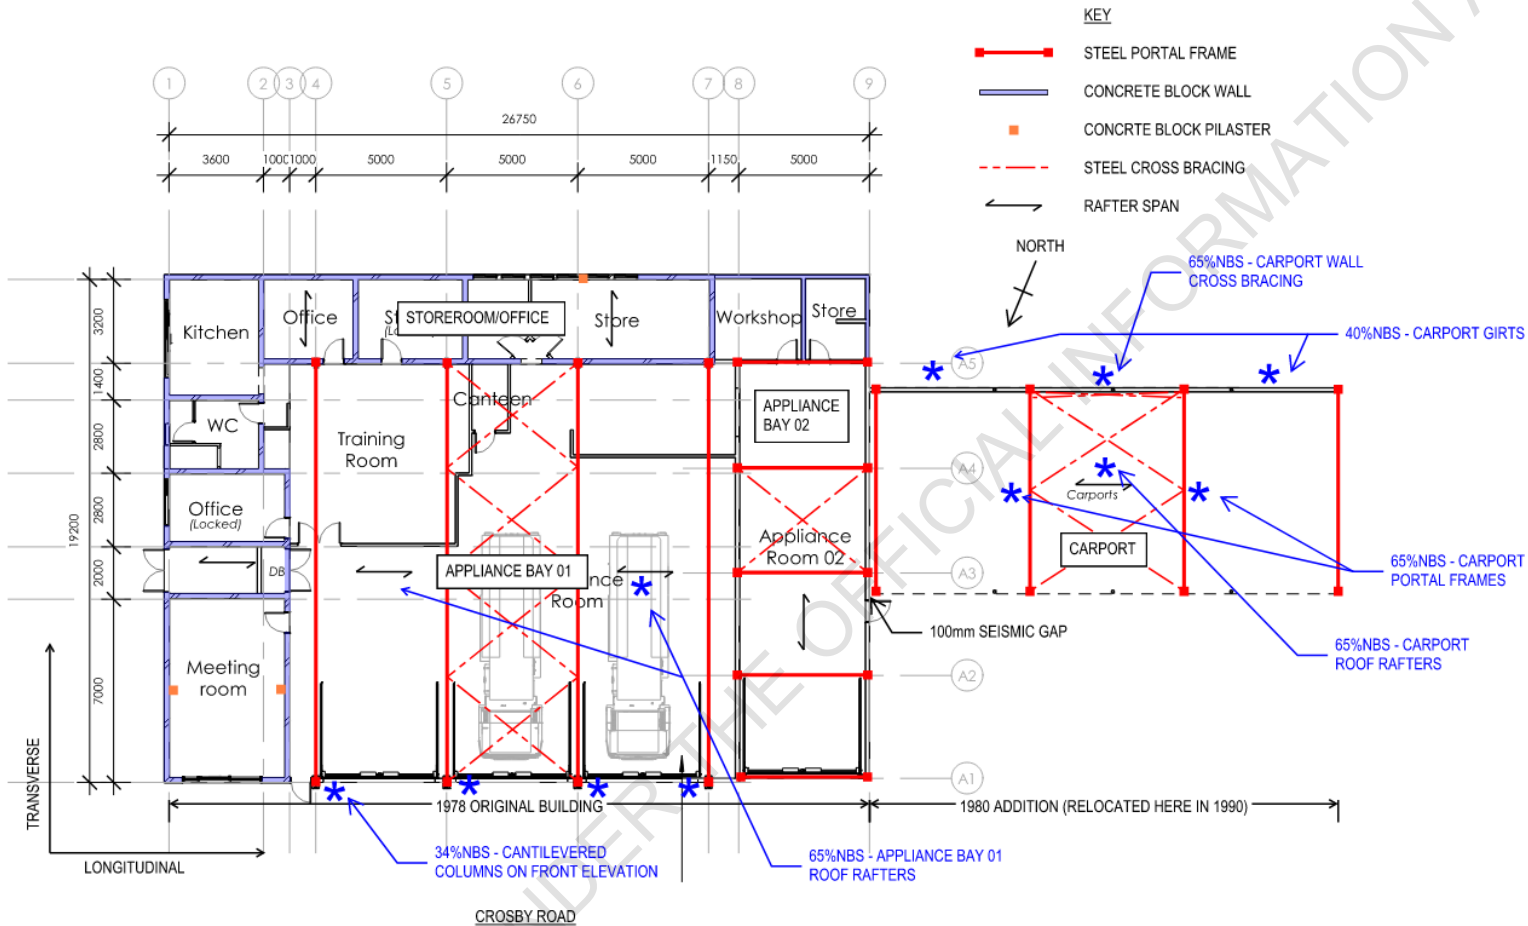
Figure 4: Floor plan showing IL4 wind scores

Floor plan showing the locations of the primary lateral load resisting system and wind scores for IL4 levels of shaking.

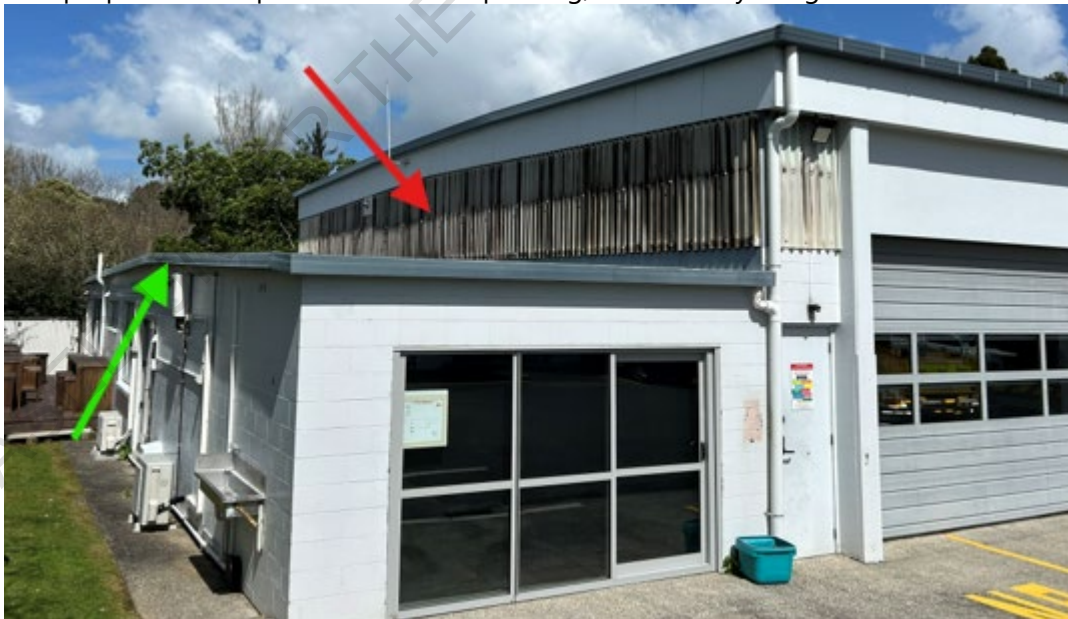
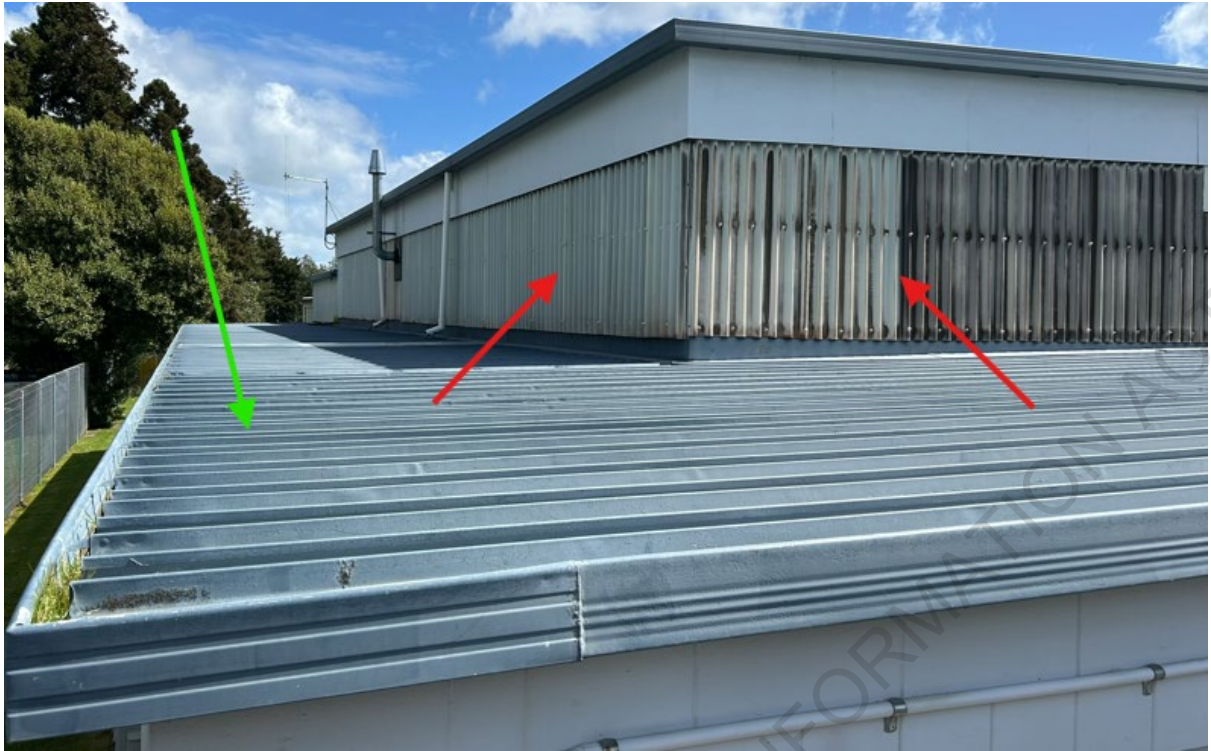
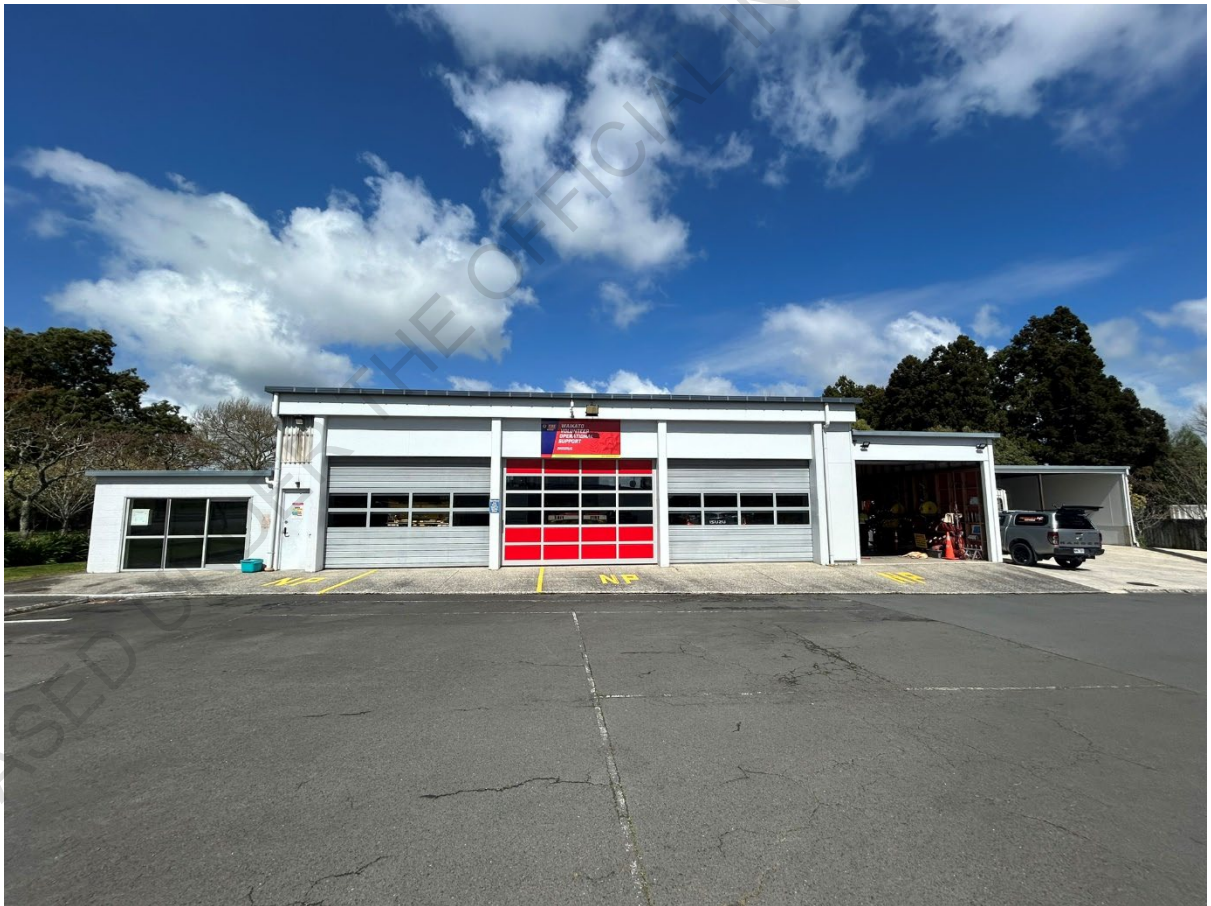
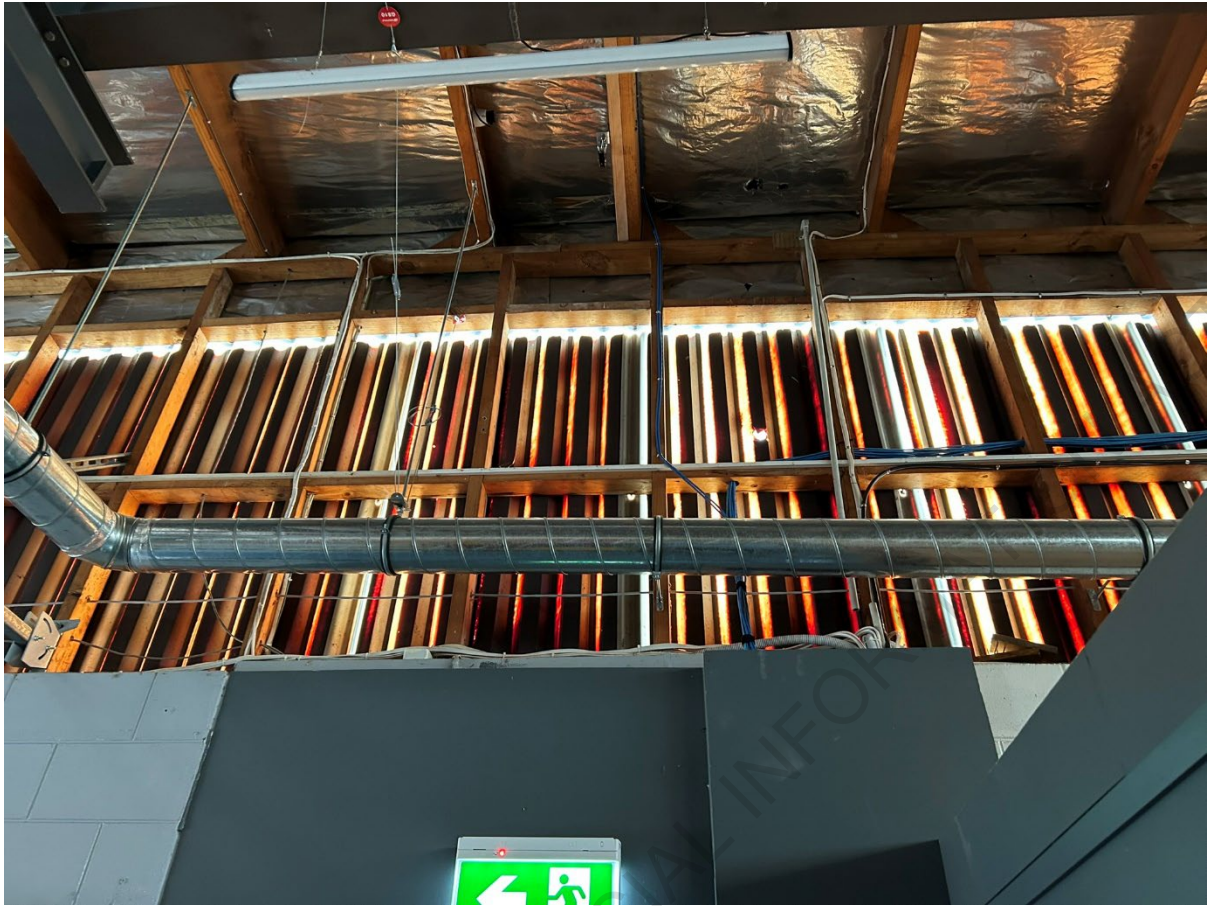
The photos below shows the cladding to be replaced, indicated by the red arrows, and the lower roof proposed for replacement and re-pitching, indicated by the green arrow.

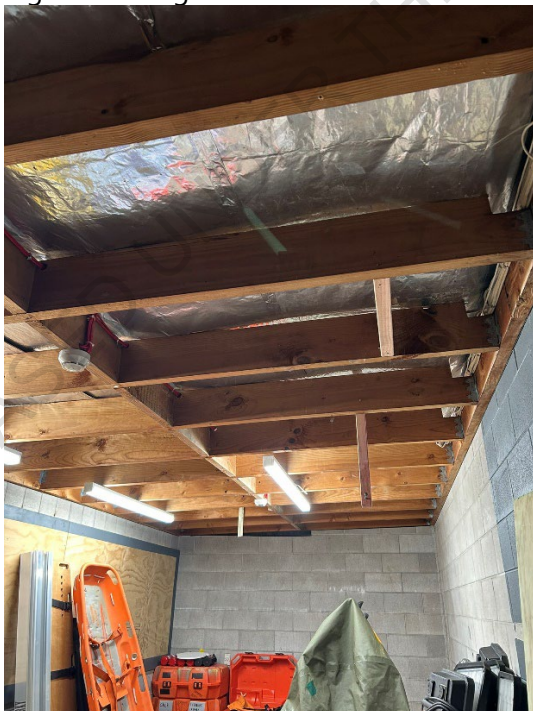
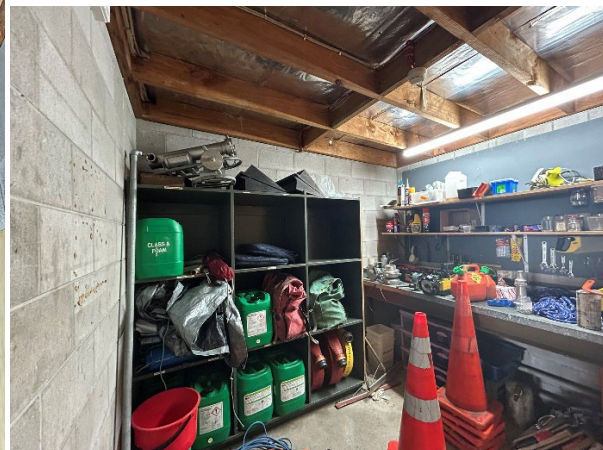
The photos below show examples of the existing roof framing in the areas proposed to be raised and re-pitched. These roofs are lightweight timber structures bolted between the block walls. The proposed solution will follow a similar construction method but at a higher level, with an increased pitch, and the roof structure extended over the external block walls to eliminated water ingress when gutters overflow.
