Project: Lincoln Fire Brigade
Detailed Seismic Assessment

Reference: 233791
Prepared for: New Zealand Fire Service
Revision: 1
19 June 2020

Document control							aurecon
Report Title		Detailed Seismic Assessment					
Document ID		Lincoln	Project Number		233791		
File Path		P:\233791 - DEE Fire Services Stations\3. Project Delivery\V02 Lincoln Update\233791-ST-REP-Lincoln Station Update 2020.docx					
Client		New Zealand Fire Service	Client Contact		NZFS		
Rev	Date	Revision Details/Status	Prepared by	Author	Verifier	Approver	
0	20 February 2013	Draft	T. McKee	T. McKee	E. Simeone	E. Simeone	
1	11 June 2020	Draft Update	G. Daly	G. Daly	M. Seifi	J. Finnegan	
Current Revision		1

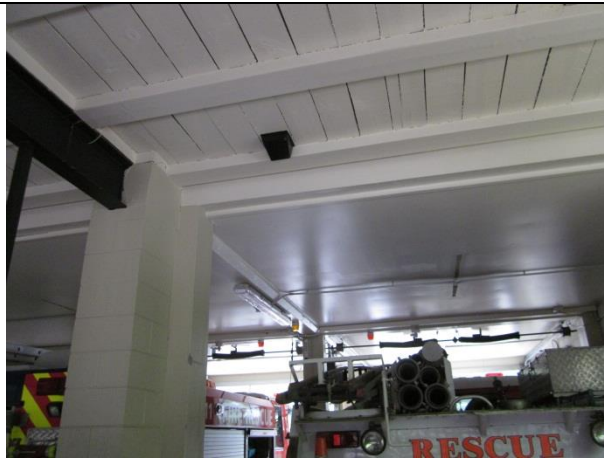
Internal Elevation
– appliance bay

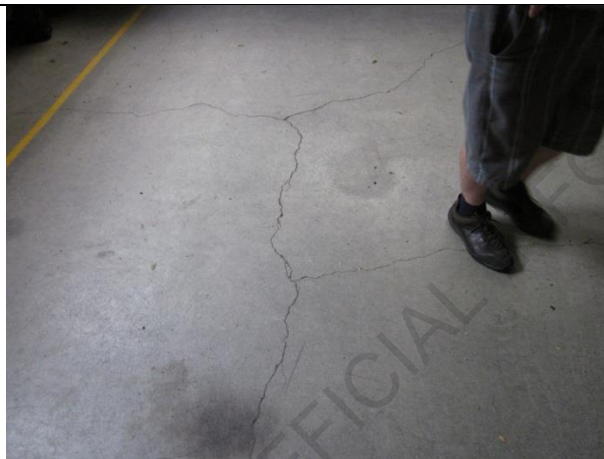
Cracking in floor
slab

It is recommended that the earthquake damage observed is repaired at the same time as carrying out the strengthening work.

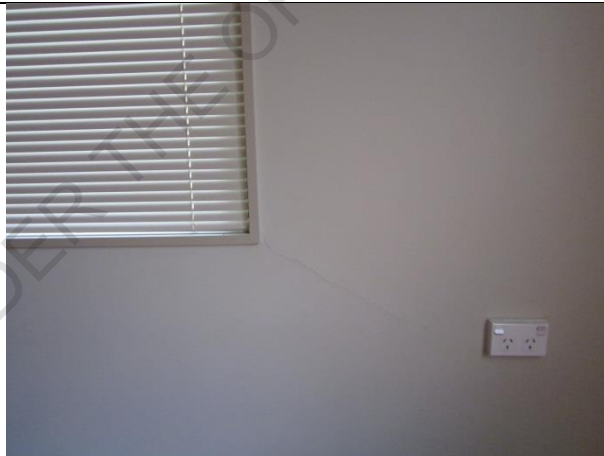
Internal Elevation
– cracking in
plasterboard
beside window
on first floor

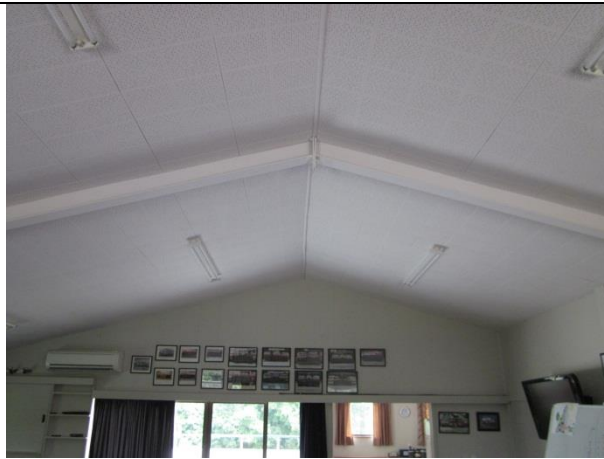
Internal Elevation
– social room on
first floor

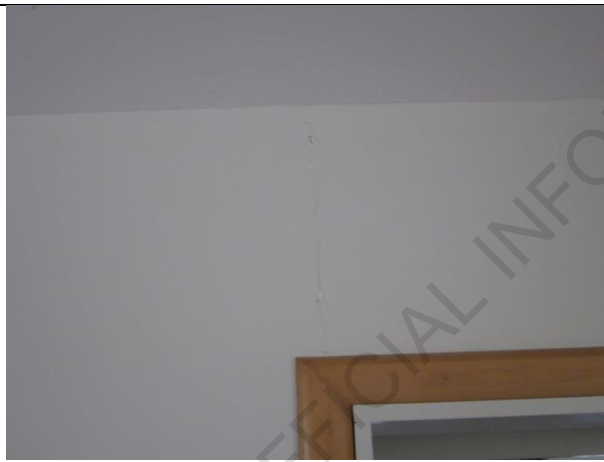
Internal Elevation
– cracking in
plasterboard
above door
opening on first
floor

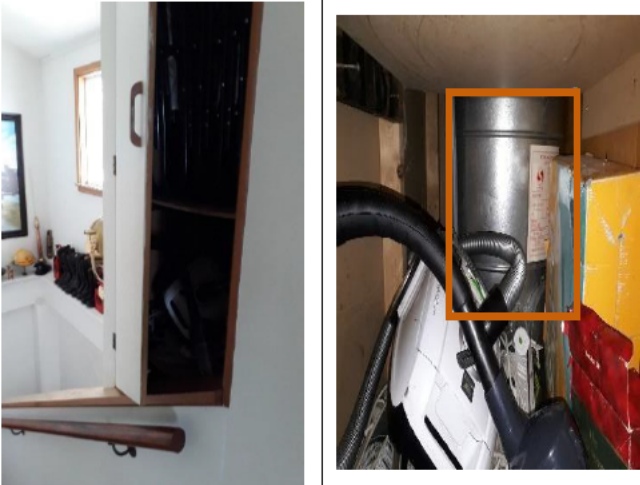
Lincoln Fire Station	1 st floor	Interior – 1 st floor hallway, cupboard Within hot water cylinder (Presumed)	9 – Medium risk ACM	<p><u>Manage & re-inspect periodically</u> Leave in place & manage. The condition of the HWC to be monitored.</p> <ul style="list-style-type: none"> Electricians (PCBUs) accessing/working on HWC electrical componentry should do so in accordance with Worksafe’s ‘ACOP for the Management & Removal of Asbestos’. Consider replacement should internal repairs be required. Re-inspect condition 3-yearly. <p>This water cylinder should be left in place, and the metal casing should be monitored for damage which may expose a potential ACM enclosed within. No drilling or otherwise intrusive work should be undertaken on this product.</p>	3 yearly – September 2022	<p>HWC has low damage and material a low chance of disturbance. Older HWCs can contain asbestos in the insulation, insulating board (around the electrical componentry), gaskets & wiring. Because it is not usually possible to fully inspect the internals HWCs, where date of manufacture is not known, should be presumed to contain ACM.</p> <p>Presumed ACM is enclosed within the metal casing of the water cylinder. Exposure to potential ACM is not possible without opening the metal casing. Low priority to remediate.</p>
