EARTHQUAKE-PRONE BUILDING

STRUCTURAL ASSESSMENT OF

ROLLESTON FIRE STATION

Structural Assessment incorporating Detailed Seismic Assessment (DSA), Wind Assessment (WA), Snow Assessment (SA) & Visual Ground Assessment (VGA) prepared by Aurecon New Zealand Ltd for Fire and Emergency New Zealand (FENZ)

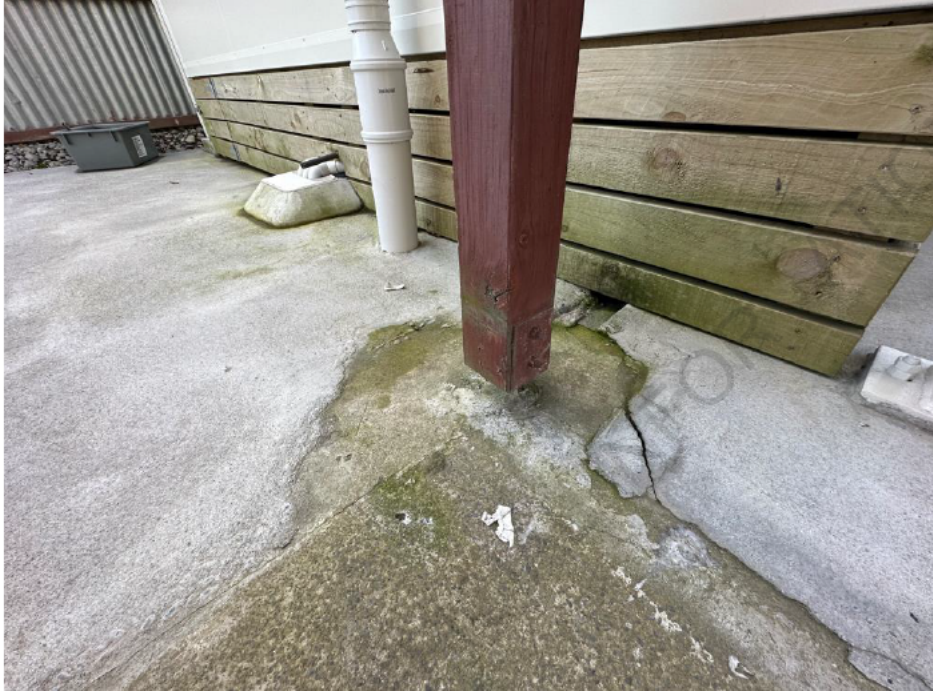
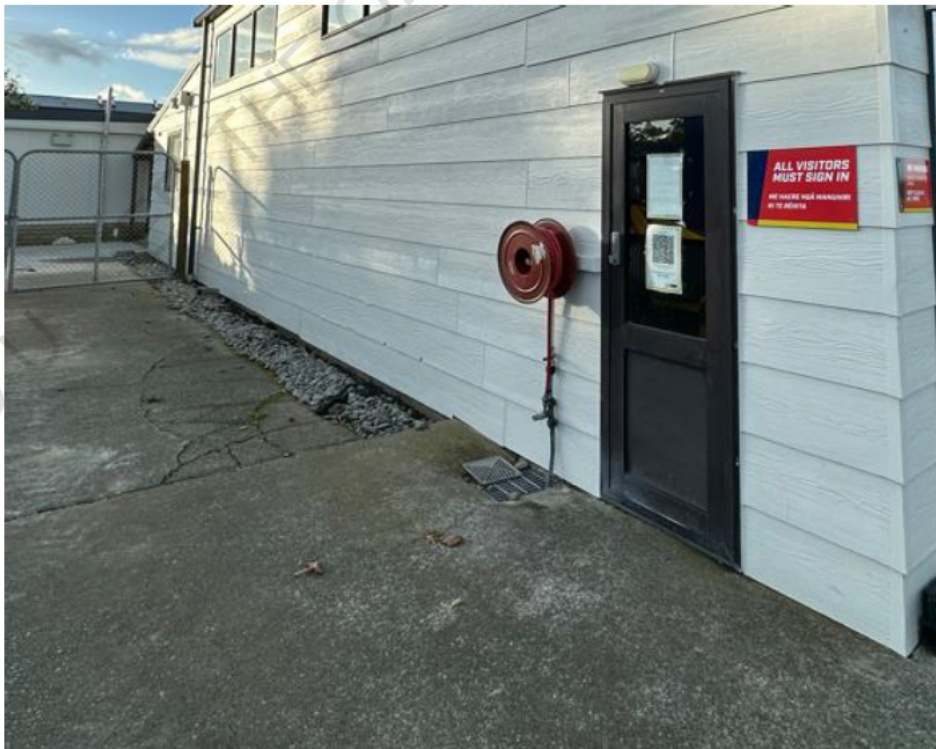
- 1) During the site investigation we noted no subsidence or settlement affected the building.

Photos showing typical ground conditions on site and foundation slab.

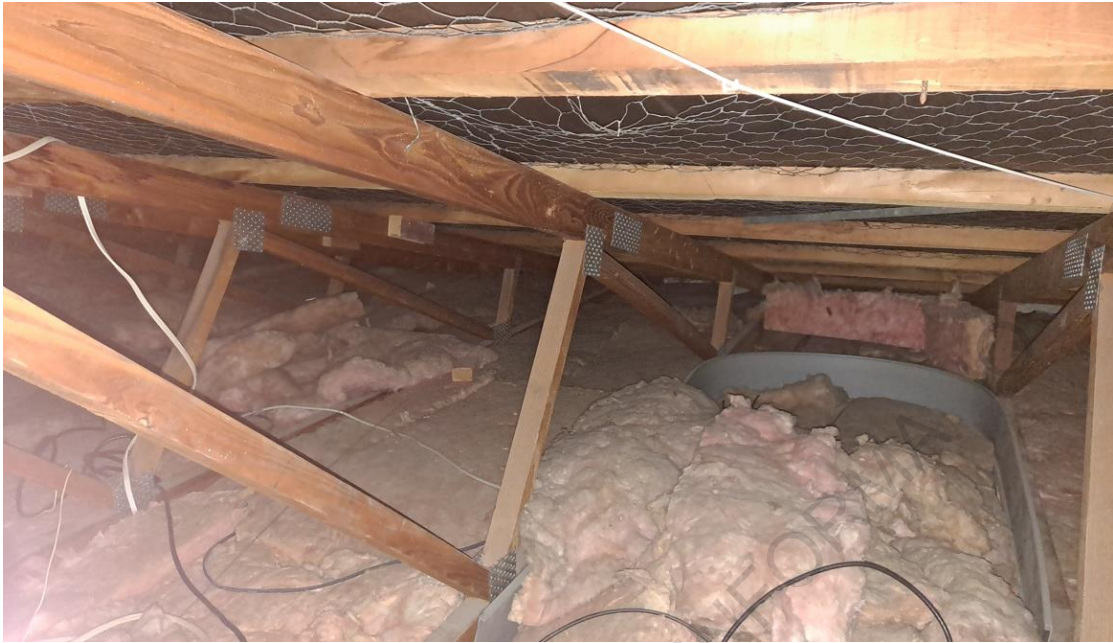
Lean-to roof truss system

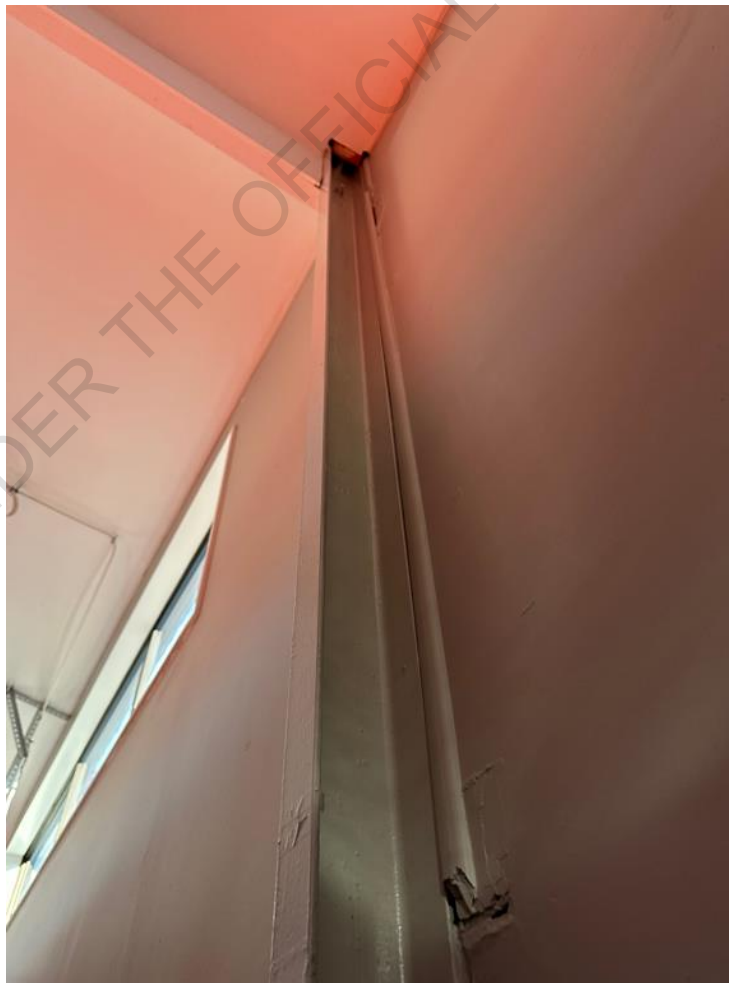
Appliance bay steel portal frame.

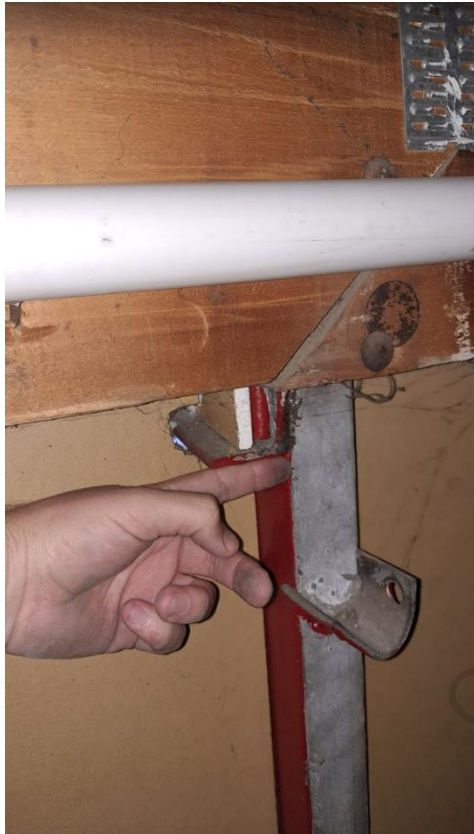
Bottom flange of appliance bay rafter connected to steel post.

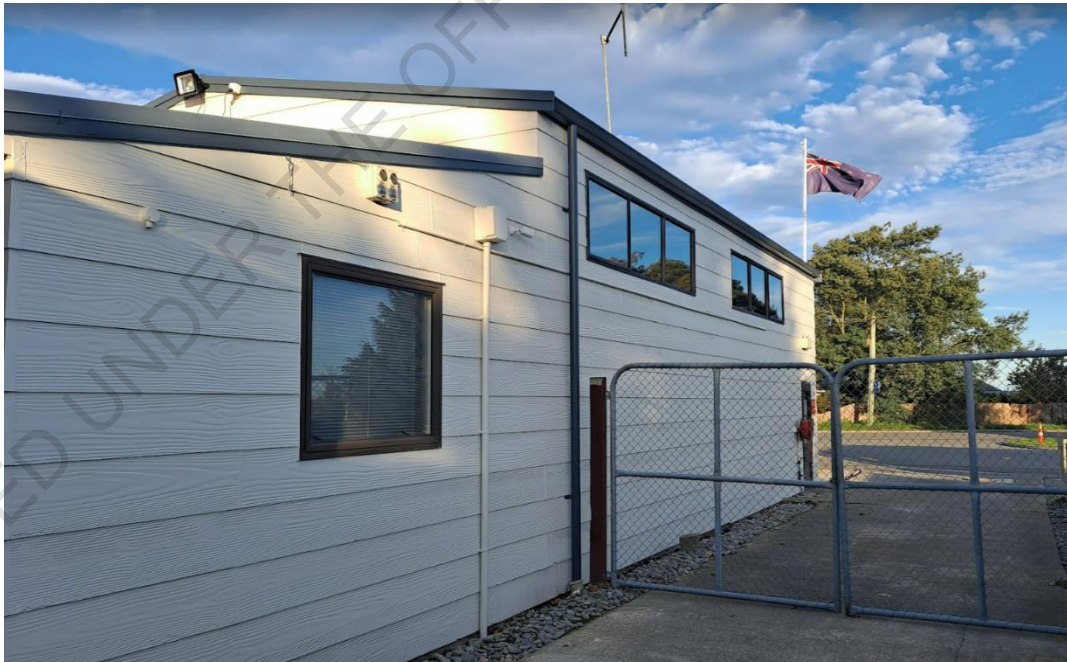
Exterior view of western elevation with high level windows in appliance bay.

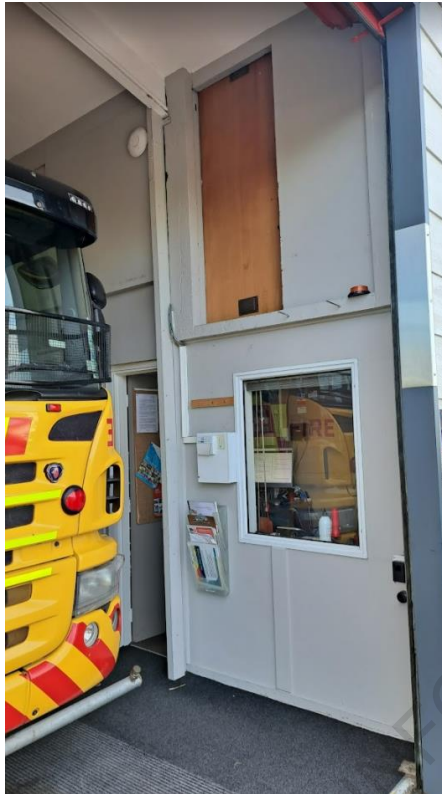
Penetrations in appliance bay side bracing walls. Steel roof rafter can be seen, boxed out in white plasterboard. The post can also be seen on the left high-level door.

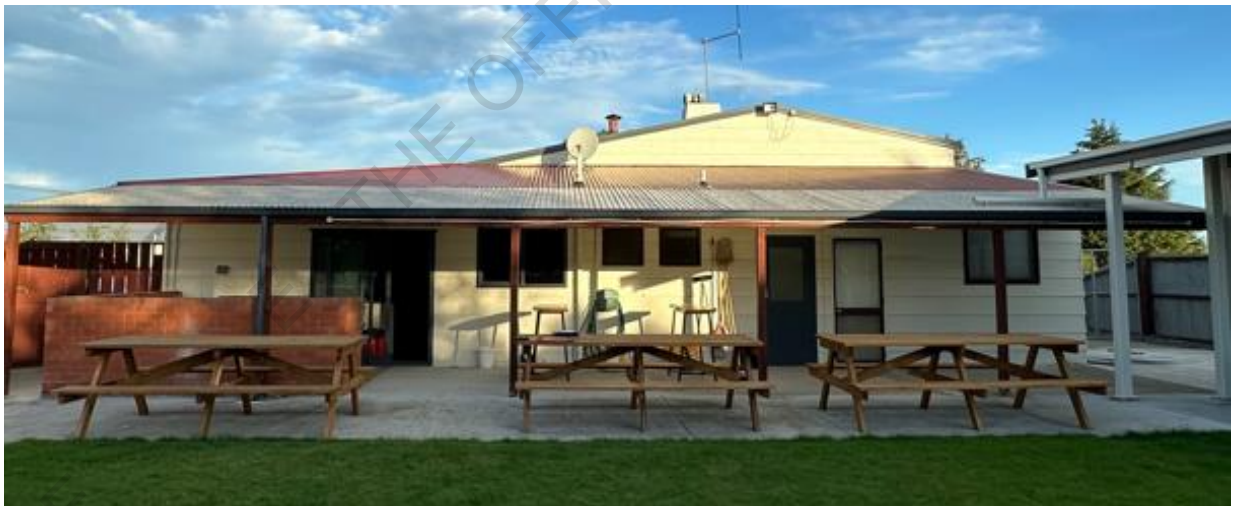
Exterior weatherboard and corrugated steel cladding.

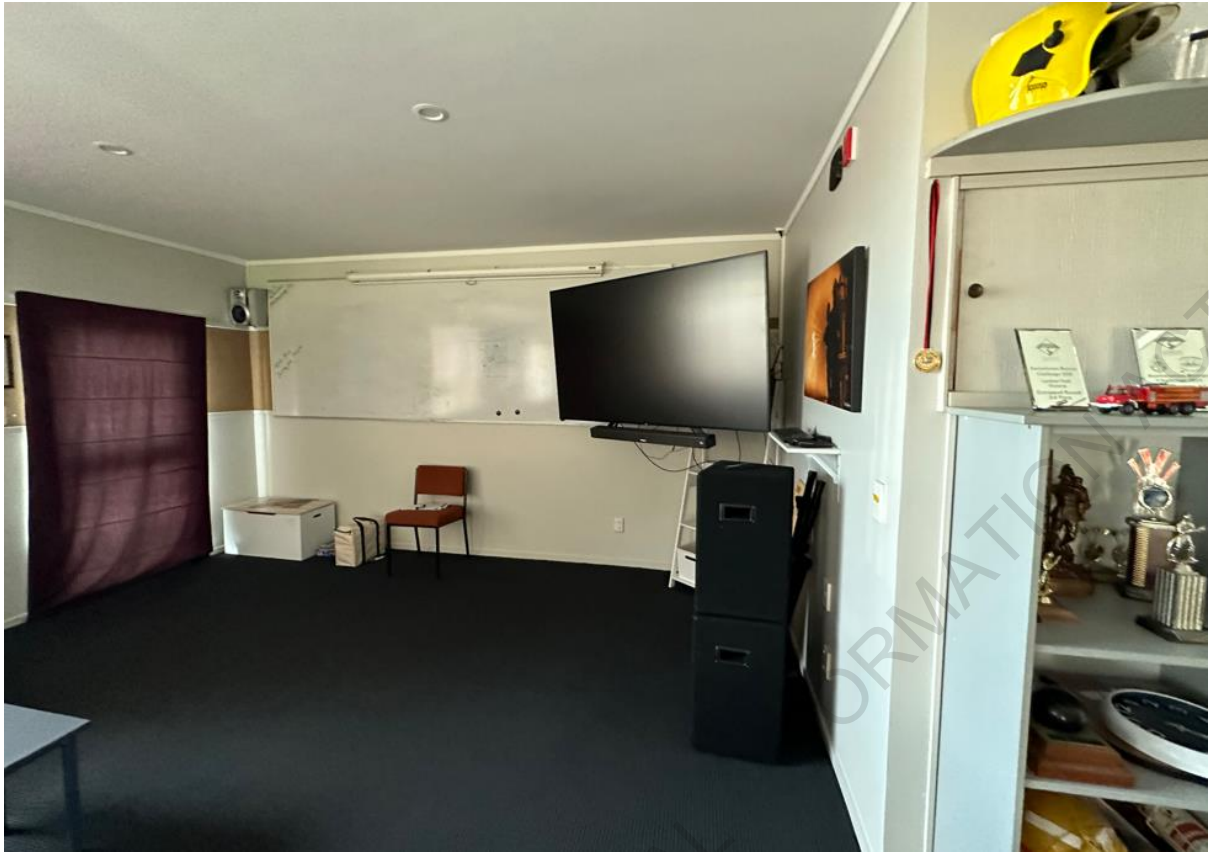
The CSW from the seismic assessment was the plasterboard lined timber-frame walls when loaded in the transverse direction. Due to the open plan area of in the appliance bay, large portions of the seismic load were concentrated along bracing lines where limited wall length was available. There were also large voids present in several load bearing walls which limited the capacity available on each bracing line. Therefore, there was insufficient bracing capacity provided against seismic loads.

Plasterboard lined timber-frame walls.

Recommendations (Optional for EPB purposes)	Adding new moment resisting portal frames and/or re-lining timber frame walls. Add load bearing walls to reduce area of diaphragm action required.

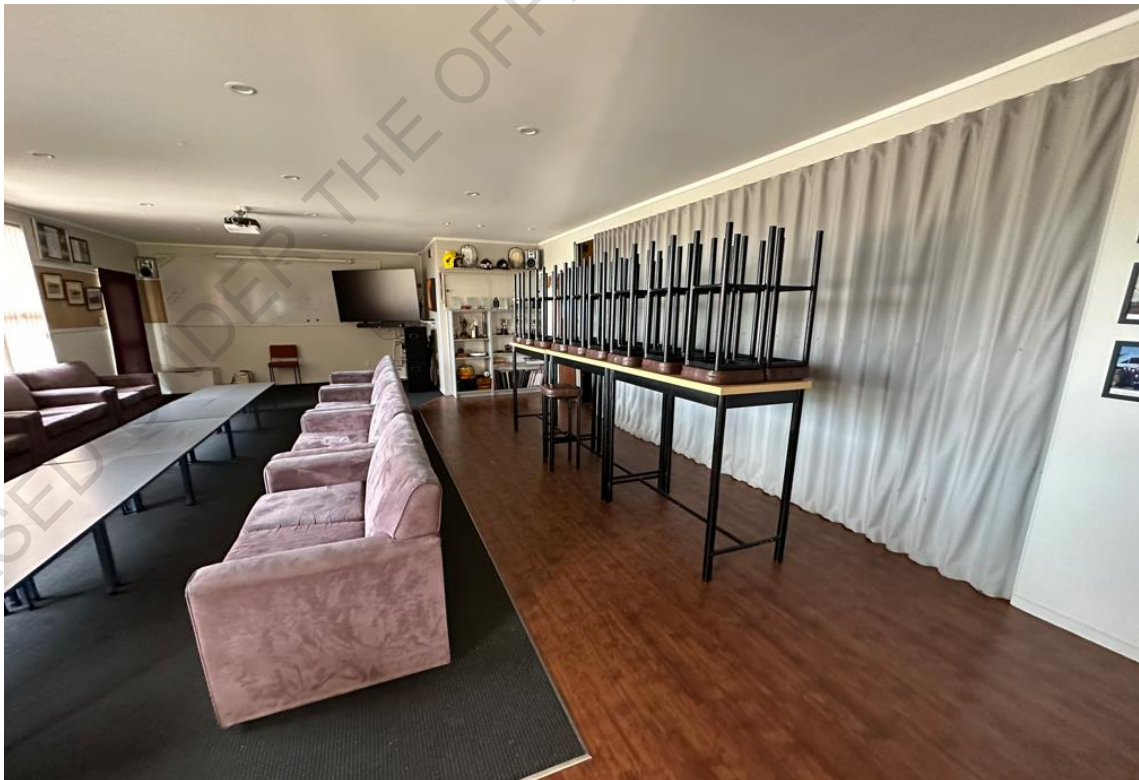
Large void behind curtain in social room to appliance bay wall.

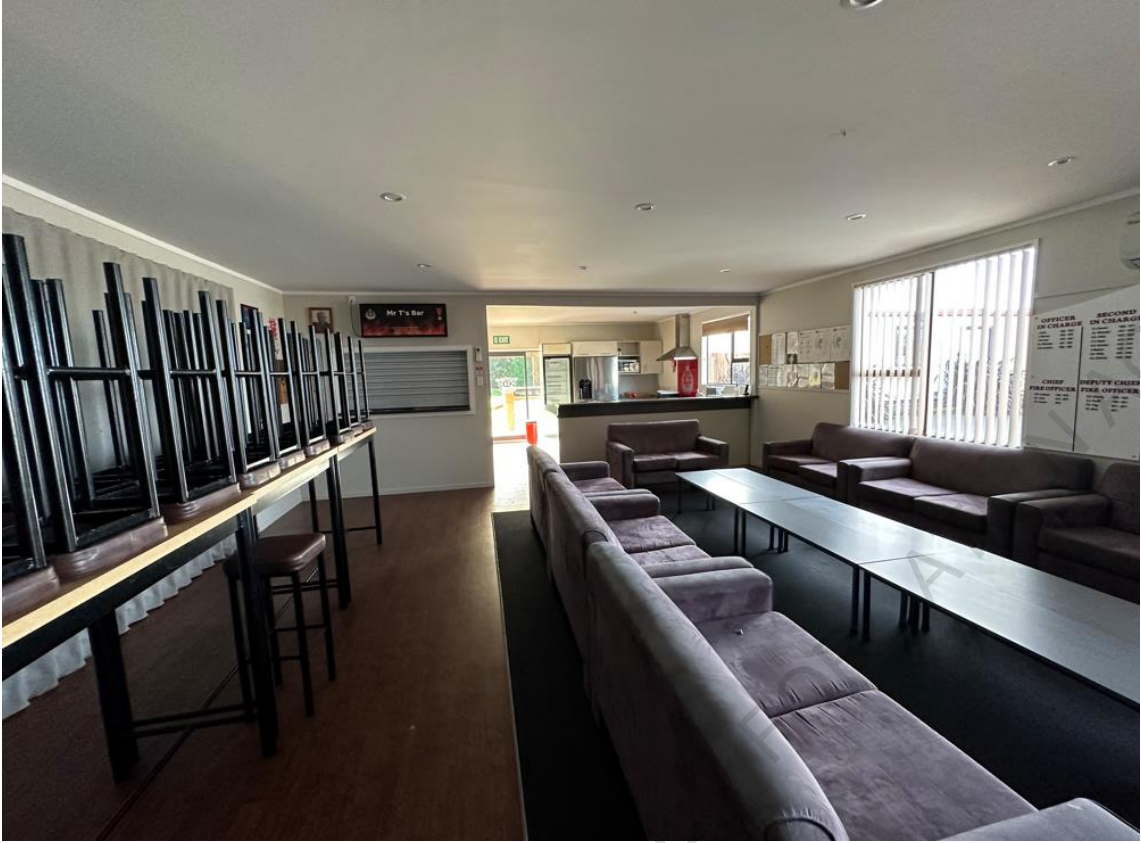
Large voids in kitchen area wall.

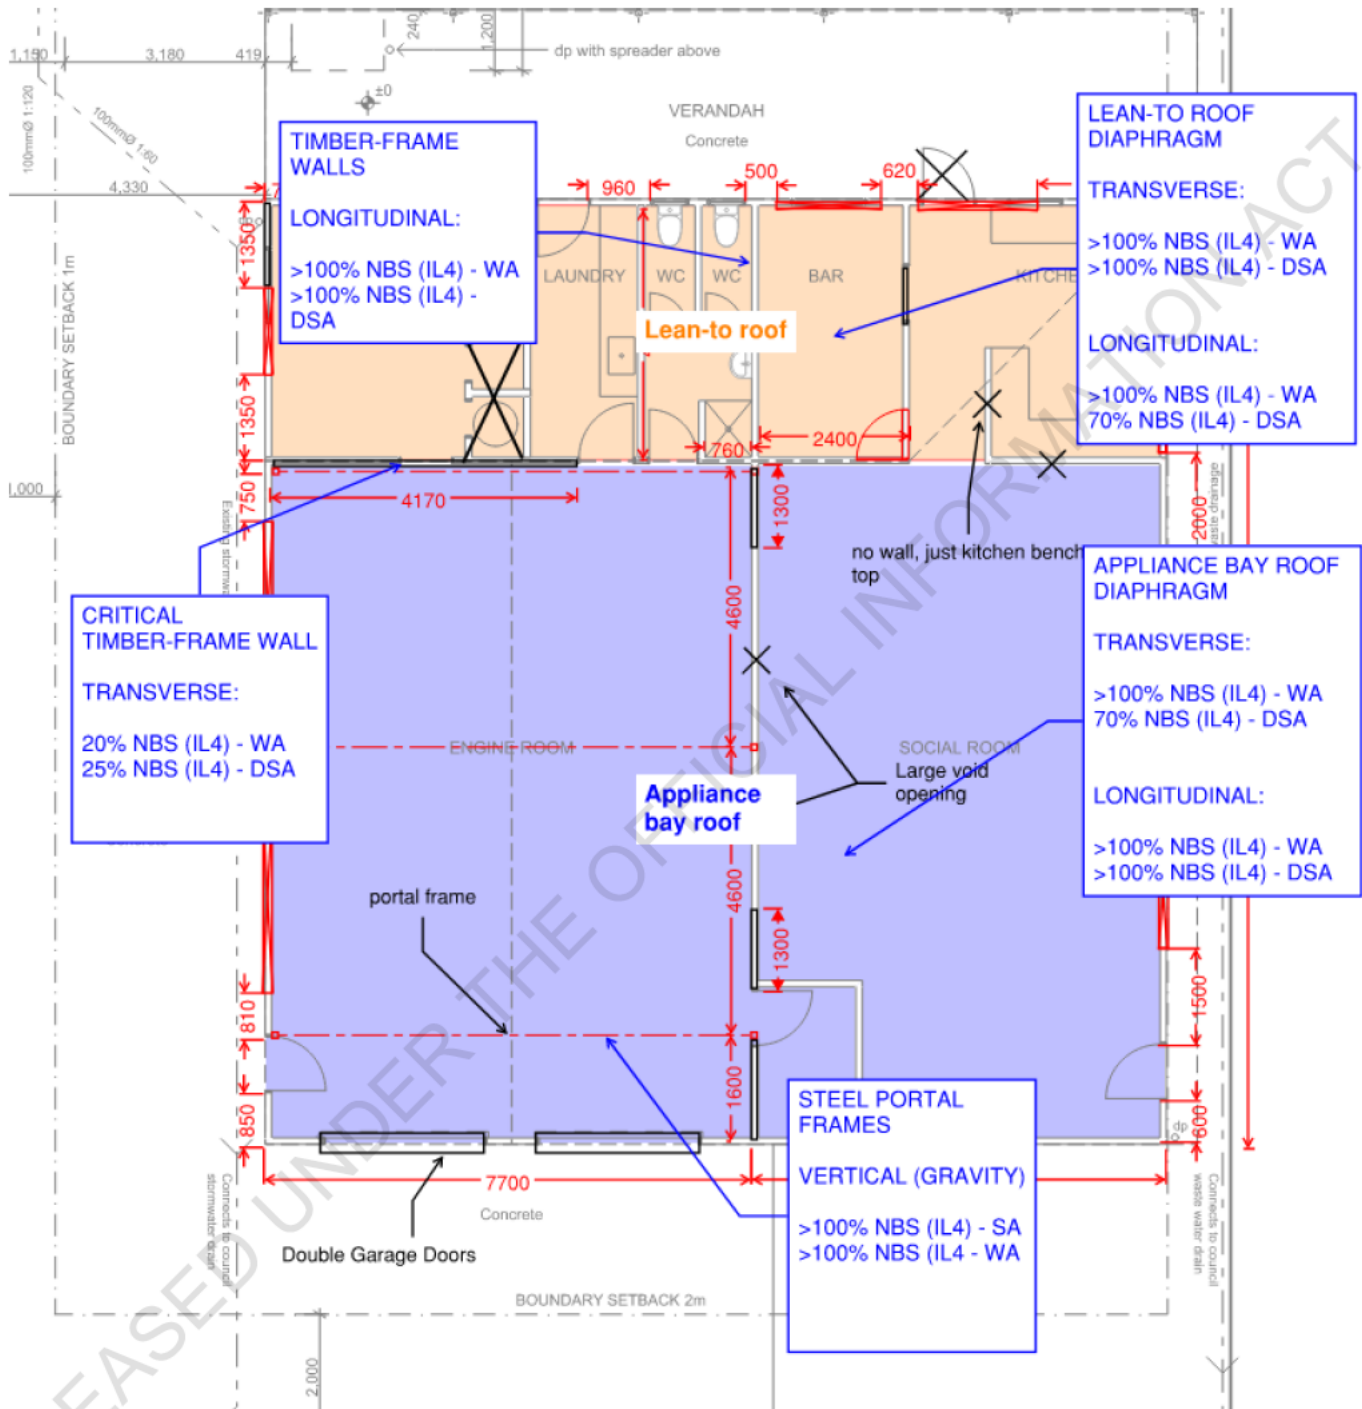
Appendix C – Mark-Up Drawing showing Assessment Scores

Refer to Appendix C for a mark-up drawing of the existing building showing assessment scores of all major structural elements which have been assessed.
