**OFFICIAL INFORMATION REQUEST: FIBRE OPTIC INSPECTION SYSTEM (REF: 3610)**

# Motueka Wastewater I&I Assessment Using Distributed Temperature Sensing

Goodman Park Pump Station Catchment  
Final Report

30<sup>th</sup> April 2024

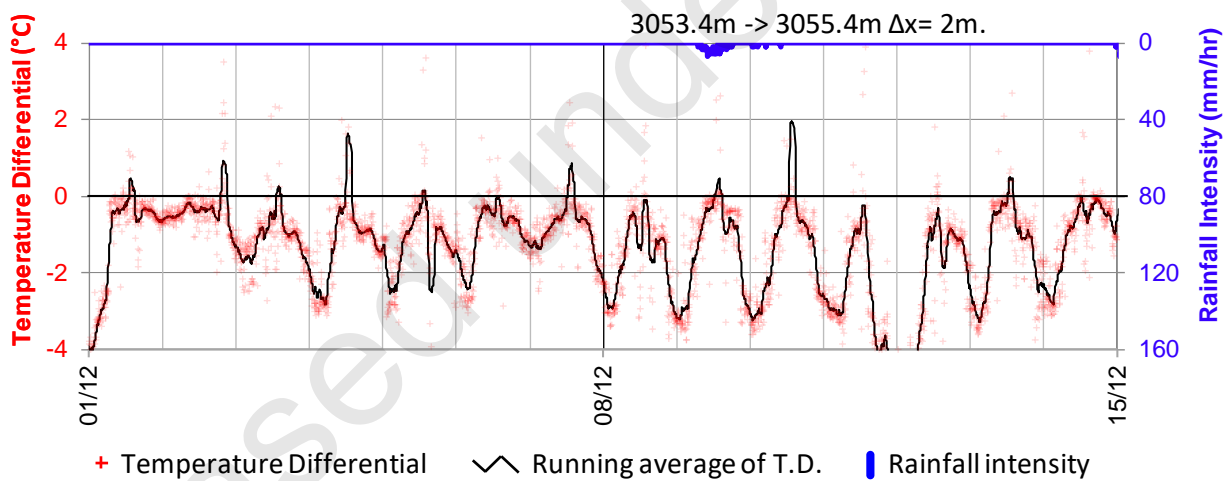
### Source Analysis Plot – Temperature Difference vs Time

Asset	Manhole 12354.
Address	218 High Street.
DTS signal	Strong, At manhole 12354.
Analysis	Temperature differential below 0°C during low wastewater flows in the early hours of the morning indicating ground water infiltration.
Recommendation	<p>Inspection of manhole 12354 checking for signs of deterioration and infiltration.</p> <p>The DTS I&amp;I signal was detected at a manhole connected to a section of the catchment that was not directly monitored using DTS.</p> <p>Inspection of the upstream catchment looking for signs of I&amp;I is also recommended.</p> <p>Inspections: Manholes 12354, 21918, 21919. Pipes 49924, 40923, 40922. Property 218 High Street)</p>

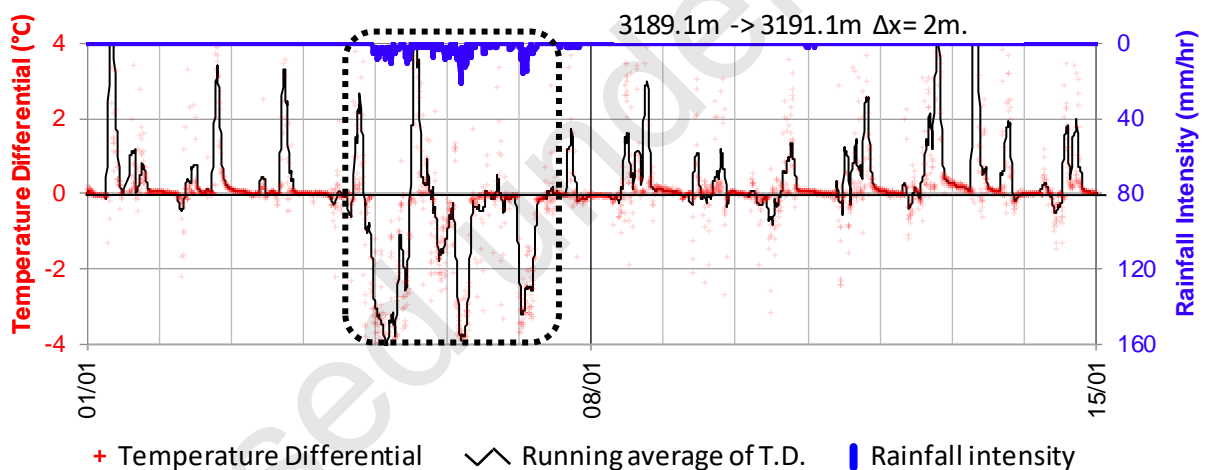
### Source Analysis Plot – Temperature Difference vs Time

Asset	Pipe 36282 DN150, 59m, Asbestos Cement, 1949.
Address	230 High Street.
DTS signal	Strong, 20m ±3m upstream of manhole 13482.
Analysis	Reduction in temperature during rainfall indicating stormwater inflow.
Recommendation	CCTV inspection of pipe 36282 to determine the connection point of laterals not shown on the GIS map (230 High St.). Inspection of nearby connected properties (230 High St.) looking for deterioration and inflow.
Note	Use the CCTV data to update the connection points for the laterals not shown in the GIS map. Include property inspections only if they are within five metres of the DTS signal.

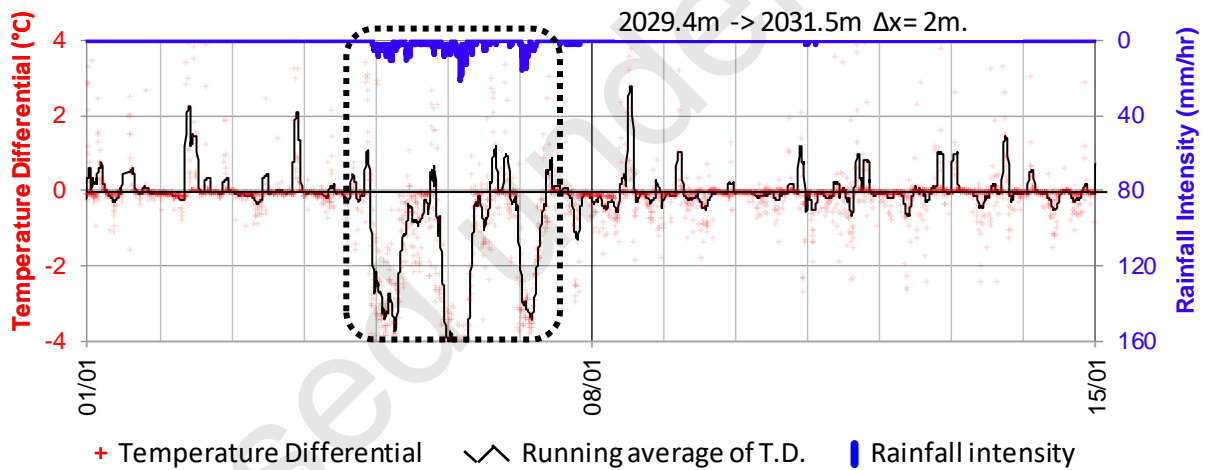
Source Analysis Plot – Temperature Difference vs Time

Asset	Pipe 29279 DN150, 89m, Concrete, 1949.
Address	157 High Street.
DTS signal	Strong, 10m ±3m upstream of manhole 16175.
Analysis	Reduction in temperature during rainfall indicating stormwater inflow.
Recommendation	CCTV inspection of pipe 29279 to determine the connection point of laterals not shown on the GIS map (157, 159, 161 High St.). Inspection of nearby connected properties (157, 159, 161 High St.) looking for deterioration and inflow.
Note	Use the CCTV data to update the connection points for the laterals not shown in the GIS map. Include property inspections only if they are within five metres of the DTS signal.

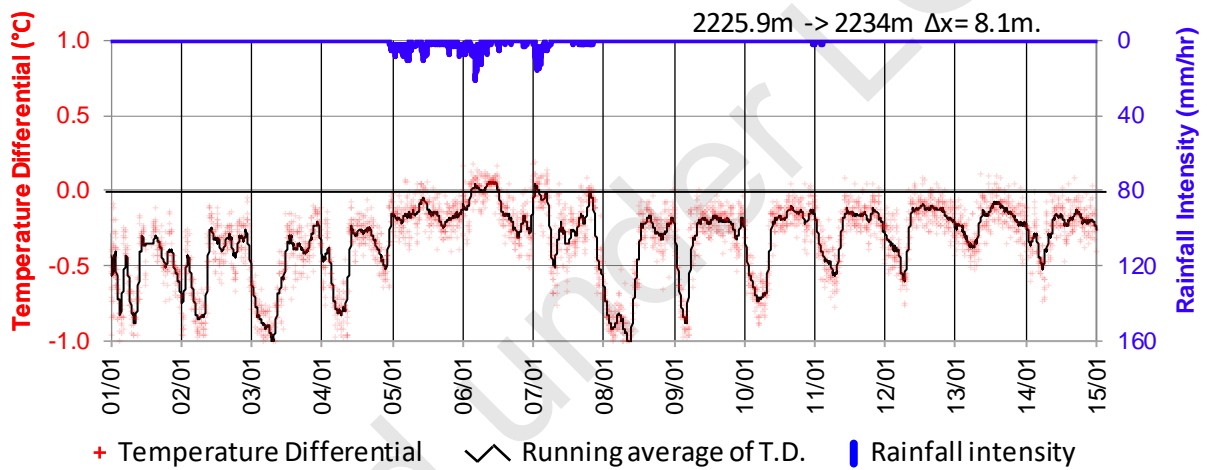
Source Analysis Plot – Temperature Difference vs Time

Asset	Pipe 36285	DN150, 103m, Concrete, 1949.
Address	219 High Street.	
DTS signal	Strong. 23m ±3m upstream of manhole 14925.	
Analysis	Reduction in temperature in the early hours of the morning indicating ground water infiltration.	
Recommendation	CCTV inspection of pipe 36285 checking for signs of deterioration and infiltration.

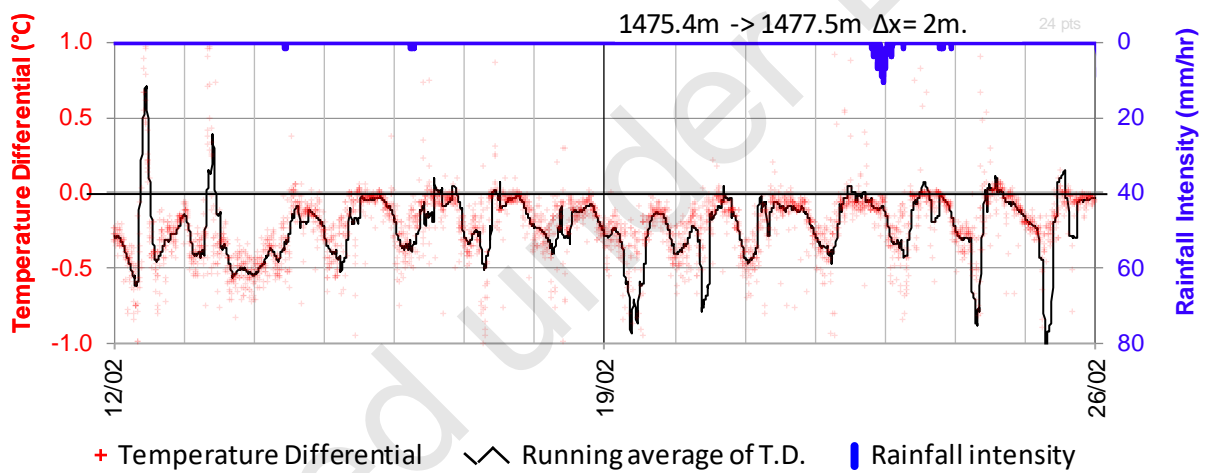
Source Analysis Plot – Temperature Difference vs Time

Asset	Pipe 36238	DN150, 122m, Concrete, 1996.
Address	14B Tudor Street.	
DTS signal	Strong, 32m ±3m upstream of manhole 12342.	
Analysis	Reduction in temperature in the early hours of the morning indicating ground water infiltration.	
Recommendation	CCTV inspection of pipe 36238 checking for signs of deterioration and infiltration. Inspection of nearby connected properties (14B Tudor St.) looking for deterioration and infiltration.

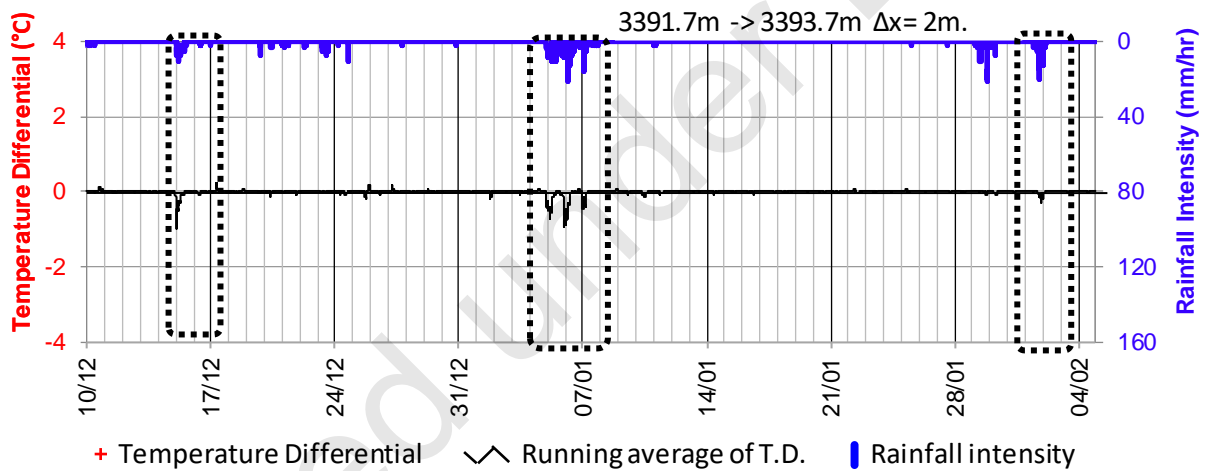
Source Analysis Plot – Temperature Difference vs Time

Asset	Pipe 38897	DN225, 102m, uPVC, 2008.
Address	18 Tudor Street.	
DTS signal	Strong, 45m ±3m upstream of manhole 12008.	
Analysis	Reduction in temperature during rainfall indicating stormwater inflow.	
Recommendation	Inspection of nearby connected properties (18, 20 Tudor St.) looking for deterioration and/or SW connections.

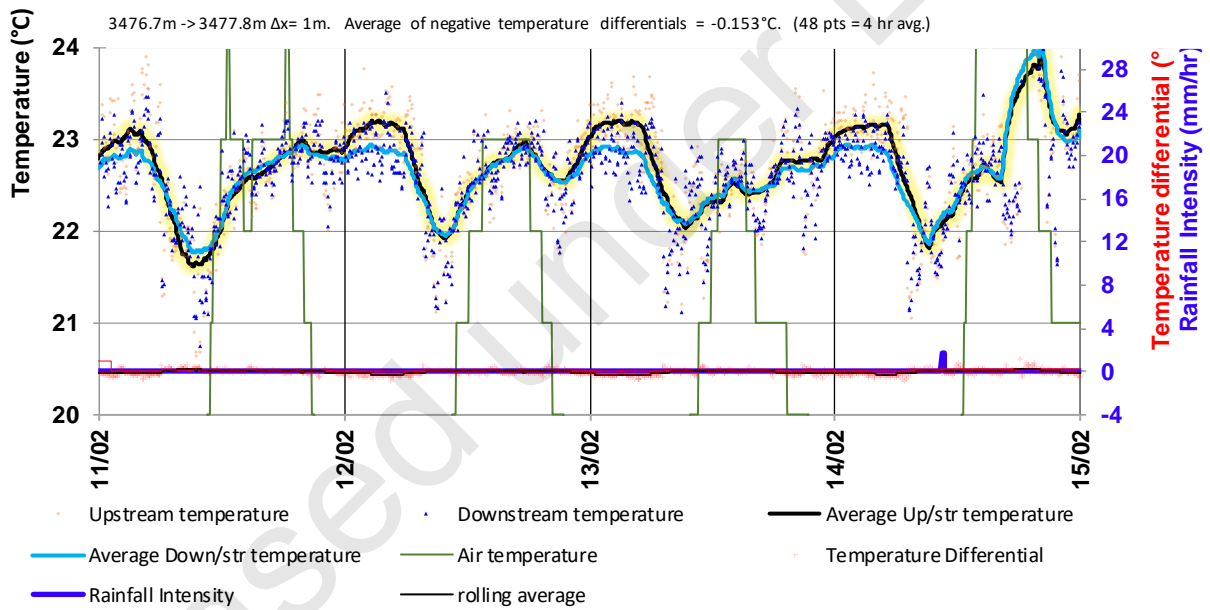
Source Analysis Plot – Temperature Difference vs Time

**This location was reported as a source of groundwater infiltration in the previous interim report. Further analysis has identified that the DTS data does not indicate a source of groundwater infiltration at this location.**

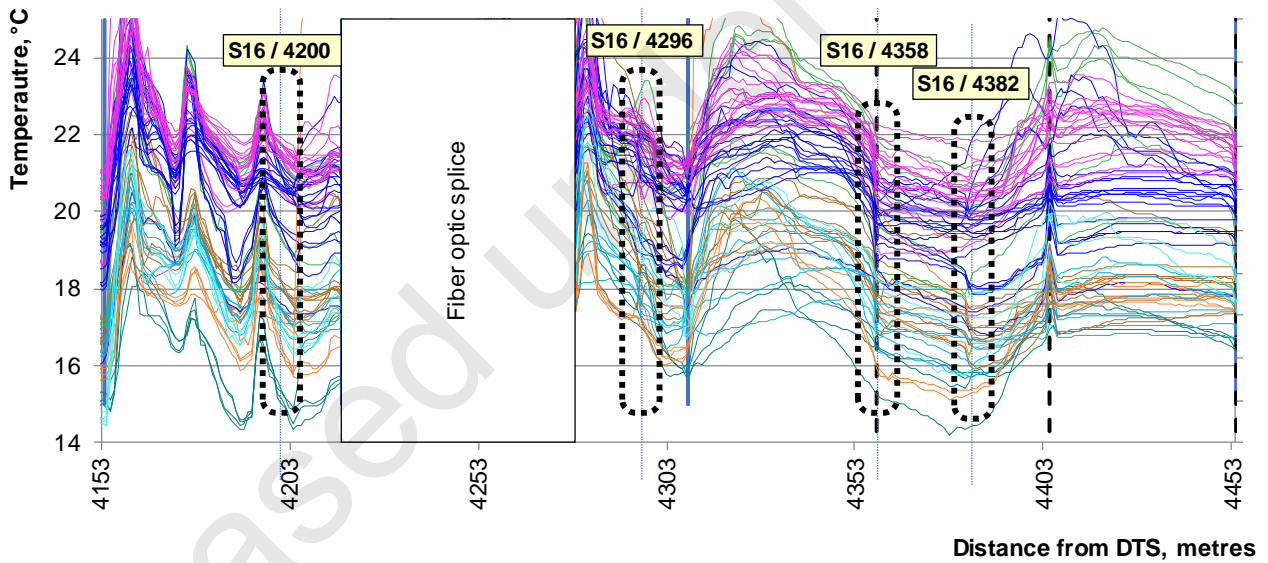
Source Identification Plot - Temperature vs Distance – Wet weather flow intervals

The temperature spikes between 4150 m and 4200 m are caused by solar heating of vehicle driveways transferring heat to the wastewater pipe. The cooler sections in-between have soil, grass, or vegetation above the wastewater pipe.

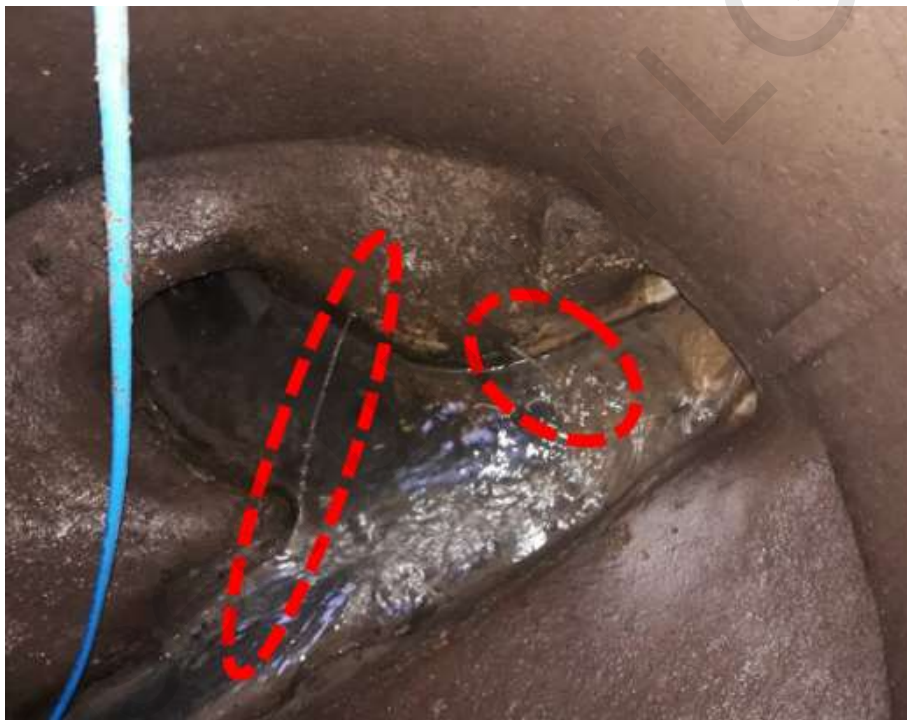
Photo of visible groundwater infiltration leaks
