BIRCHVILLE DAM

STABILITY REVIEW

STAGE 1

REF: 8925
JANUARY 1989

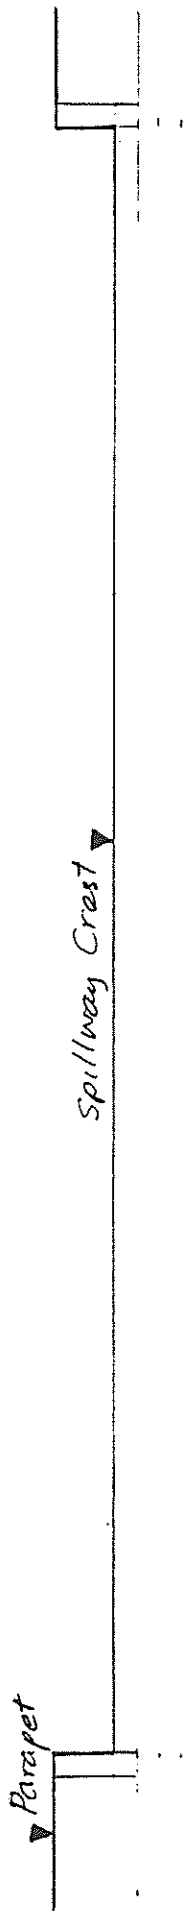
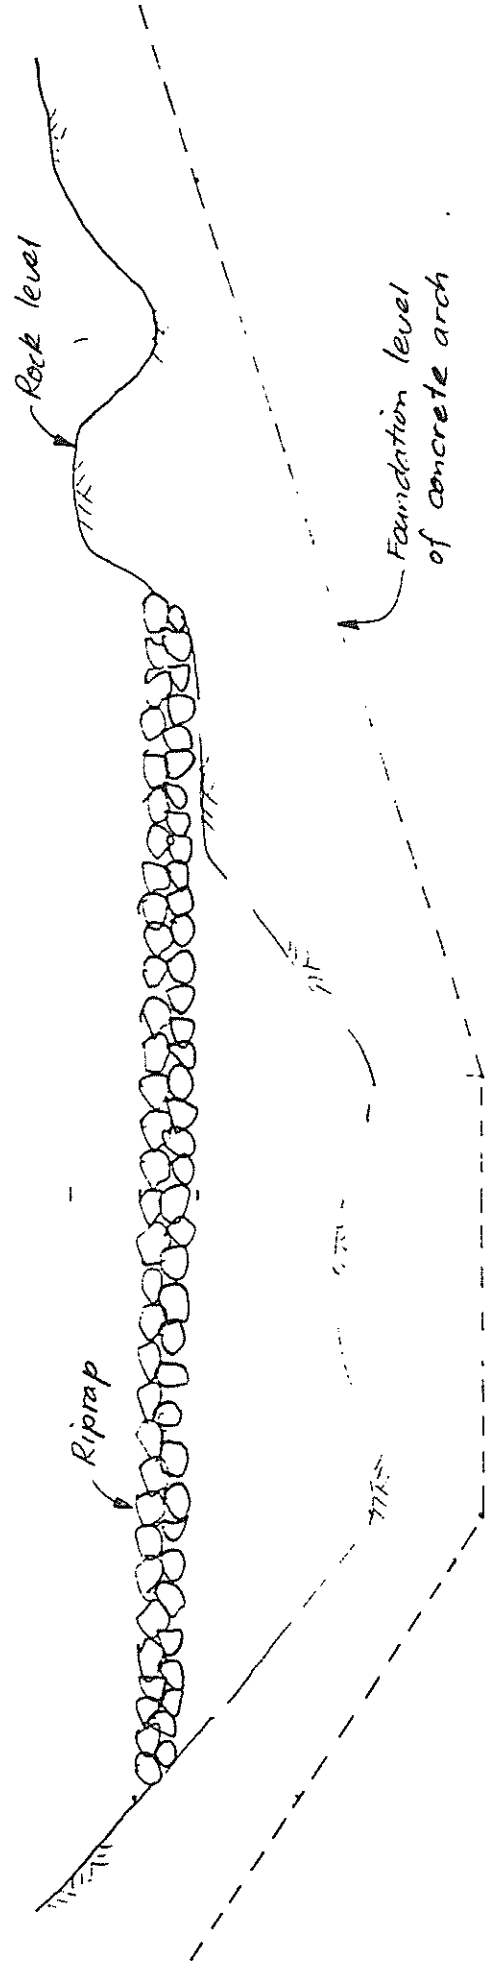
Following an initial inspection by senior engineers, Schmidt hammer tests and sonic velocity measurements were made on the dam with the water level drawn down approximately 2.6 m to permit velocity measurement through the dam. Figure 1 shows the sonic velocity test

positions. Direct transmission tests face to face were very time consuming because of access difficulties at the upstream face (an inflatable boat was carried in) and hence direct testing was limited to points 1 and 2. The other tests using indirect or transverse transmission indicate properties at shallow depth at the back face of the dam. Schmidt hammer readings were taken at the same locations as the sonic tests. As the results tabled below illustrate the concrete appears to be of consistent quality.

POINT	VELOCITY (km/s)	SCHMIDT READING (N)	
		Average	Std Deviation
1	3.95	24	6.3
2	2.45	23	3.7
3	3.0	27	5.2
4	2.94	22	5.6
5	2.94	17	5.4
6	2.52	21	5.6
7	2.46	19/17	5.3/3.4
8	3.03	-	-
9	2.97	22/20	4.3/4.3
10	2.92	21	4.7
11	1.97	22	5.2
12	2.78		
13	2.84		
14	2.41		
15	3.13		
16	2.90		
17	3.01		
18	2.34	18	4.6

Results indicate a modulus of 10-20 GPa which is consistent with concrete with strength in the range given by the Schmidt Hammer tests.

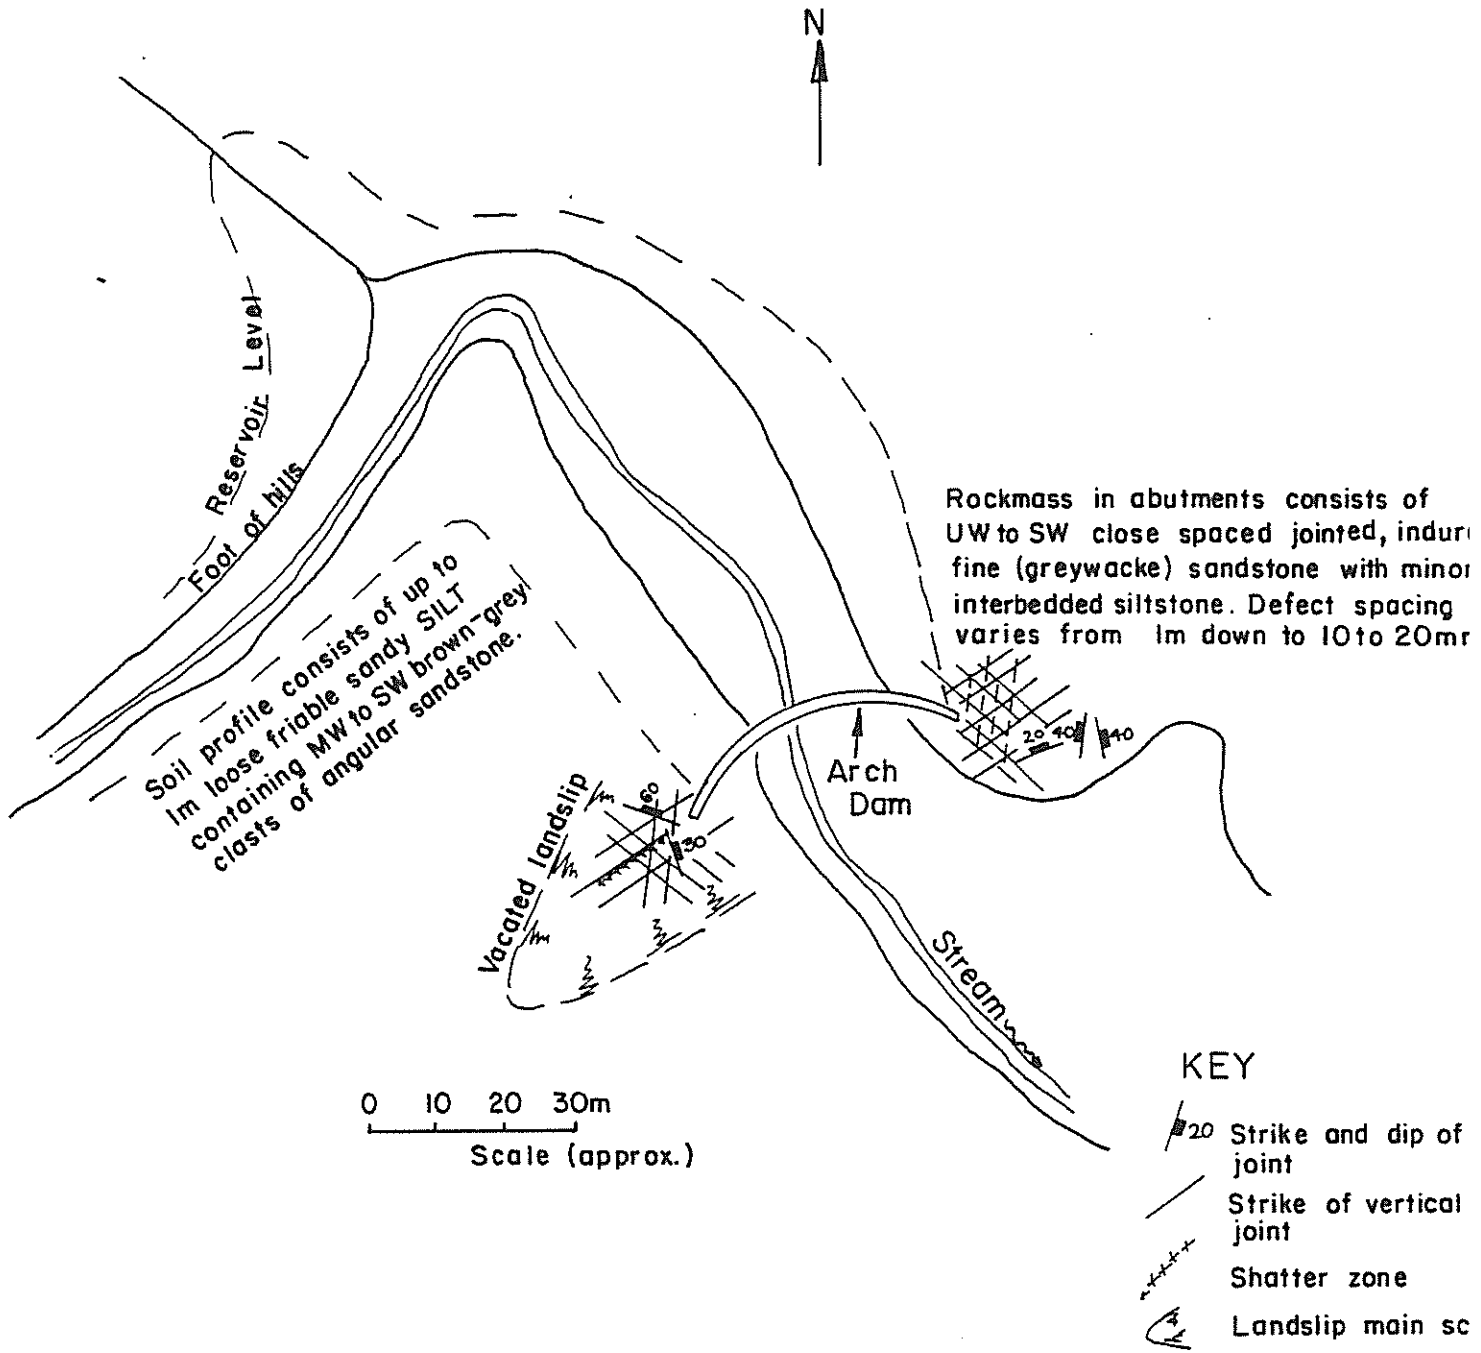
The rockmass exposed in the abutments consists of unweathered to slightly weathered close space jointed indurated hard strong fine sandstone (greywacke sandstone) with minor interbedded moderately hard to hard moderately strong to strong siltstone (argillite). Defects within the rock mass consist of a persistent, well-developed parting parallel to bedding which has a NE to SW trend and several joint sets also well developed, which have NW to SE, and N to S trends. Shattering of the siltstone rock mass is common.

The topography above the right abutment has the physical expression of a vacated landslide controlled by breakage and sliding along pre-existing defect surfaces. On the left abutment a steep sided re-entrant controlled by preferential erosion along close spaced defects occurs immediately downstream of the dam abutment. Defects exposed in the re-entrant are continuous with an open aperture and shattered appearance.

Figure 2 summarises these features.

From this stage 1 evaluation and taking into consideration the perceived low hazard potential of the dam, the only area that could warrant improvement is the left abutment. We expect that any improvement would take the form of stressed anchors installed at right angles to the defects at the left abutment to improve abutment security.
