# Old Mangere Bridge

## Review of Current Strategy

**November 2018**

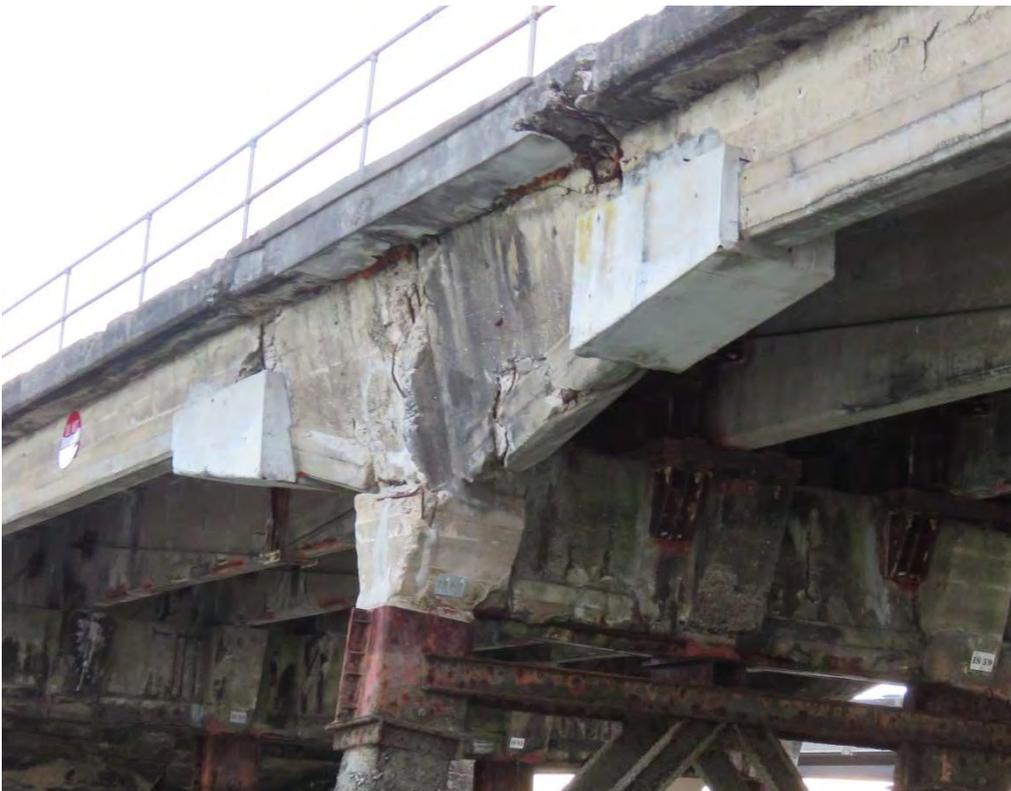
Impact damage on Column IS60 / Pier 15. Evident damage from a collision by a water-borne vehicle has caused significant damage to the edge girder haunches on the Western side of the bridge. The concrete haunches are contorted and cracked with exposed rebar visible. Repairs include a localised concrete encasing in the transition zone to the tapered section. At first glance, it is hard to see how this helps the damaged section. The concrete thickening would appear to want to attract load to this region of the structure in addition to the dead load from the additional concrete. Meanwhile the load transfer to column IS60 is compromised due to the distortion of the haunches. The area immediately above this is closed off to the public so any dead load failure in this region is unlikely to endanger life.

*Photo 1 – Pier 15 (Column IS60) impact damage and repairs*

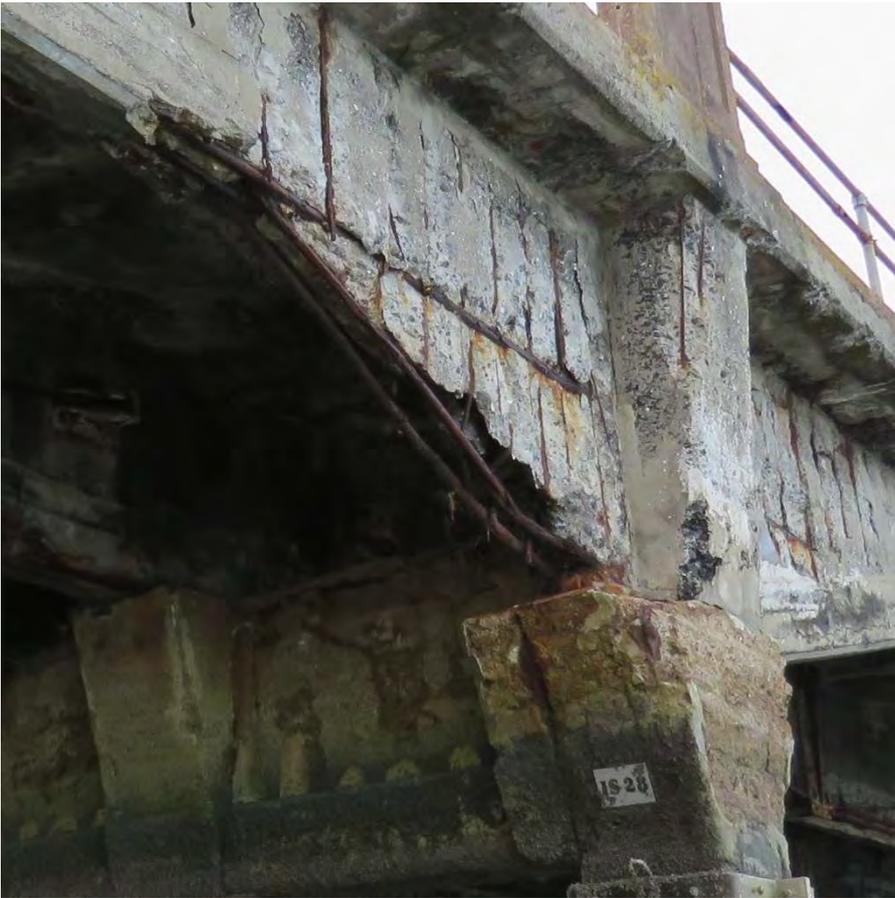
Pier 7, Column IS28: On the Span 8 side there is severe loss of section on the outer girder in the shear zone haunch. The exposed bottom steel is buckled and the stirrups have corroded away leaving a rough concrete surface with approximately 300mm loss of section. The full width of Span 8 is open to the public which could pose a risk should crowd loading ensue.

*Photo 2 – Pier 7 (Column IS28) loss of concrete and exposed, buckled reinforcing bars*

1. We would recommend initially load testing the bridge with operational monitoring in place. The phased approach would depend on the outcome of this. Assuming a structural failure does not occur, the monitoring information can be used to set trigger and alert levels for future events. We would suggest keeping the bridge open as it is for the first 12 months with monitoring and upgrades to the fencing including providing an adequate locking system. Fencing should also be reconfigured to restrict access to the edges of Span 8 due to the condition of the concrete edge girder at Pier 7.

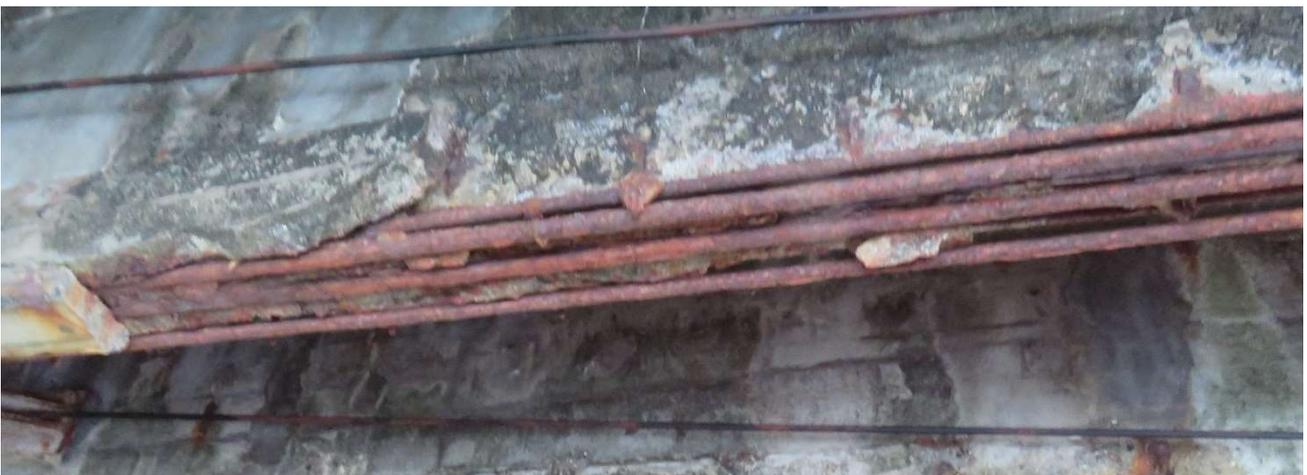
Spans 3, 4, 5 & 6 exhibit sufficient loss of concrete to reveal two layers of steel reinforcing bars on the soffit of some of the internal girders. Stirrups are also corroded through in the zones of maximum shear.

*Photo 3 – Beam soffit – Span 5*

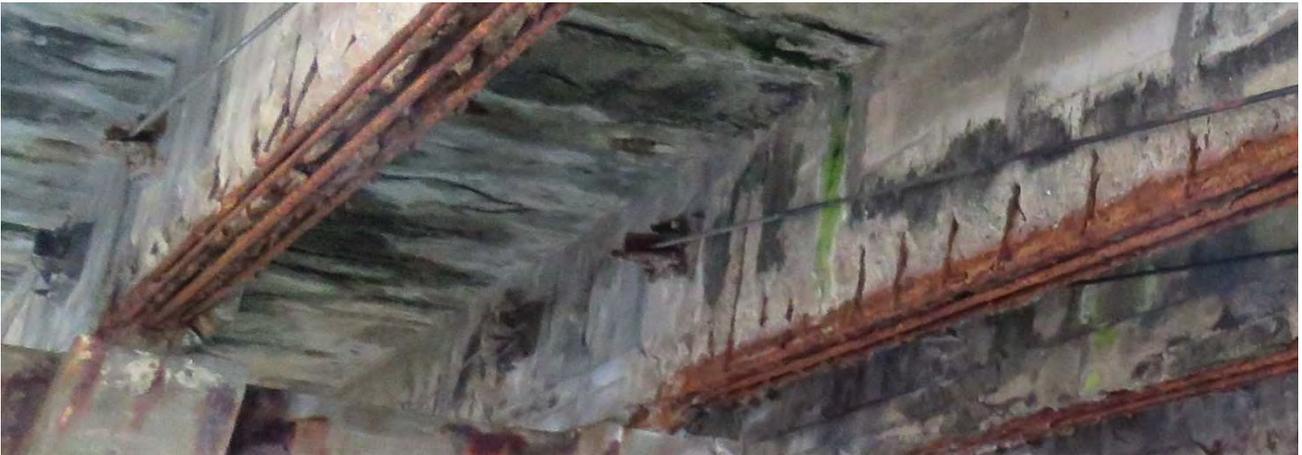
*Photo 4 – Beam soffits – Span 3*
