Response to official information request for Investigation Report on discharge from sewerage treatment plant

**FINAL REPORT for GRWC
REDACTED**

Porirua Wastewater Treatment Plant Incident: 6 October 2018

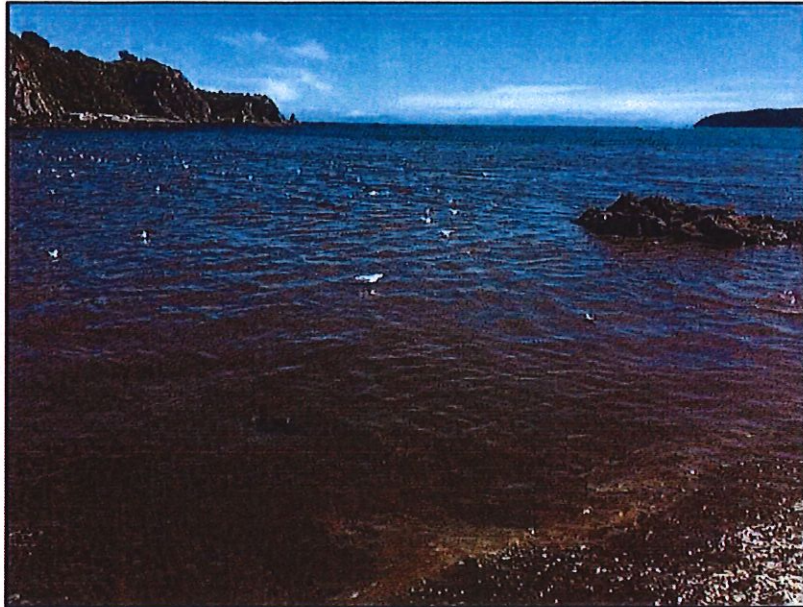
Photographs taken on the day of the incident show the plant breached conditions 13 (a) and 13(b) of the resource consent, with the plume clearly visible beyond a 200m radius of the Rukutane Point Outfall. This also breached condition 4, as the plant's maintenance was not to a standard that was adequate to meet the consent's conditions.

Figure 1: Close-up view of water at Rukutane Point, taken 6/10/2018. The plant's outfall is off-camera at the bottom right of the photo.

Visual observations and photographs taken on the day of the incident show that conditions 13 (a) and 13(b) were clearly breached. Condition 13 relates to effects on the receiving environment beyond a 200 metre radius (the mixing zone) of the Rukutane Point outfall. There was clearly a visible plume of suspended solids, which resulted in a conspicuous change in the colour of the water.

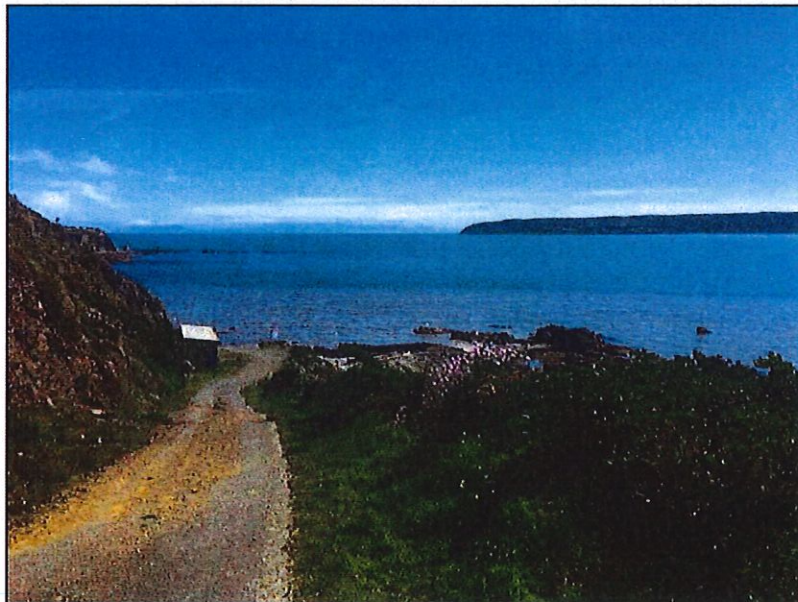
Figure 2: View of wastewater carryover at Rukutane Point, taken 6/10/2018.

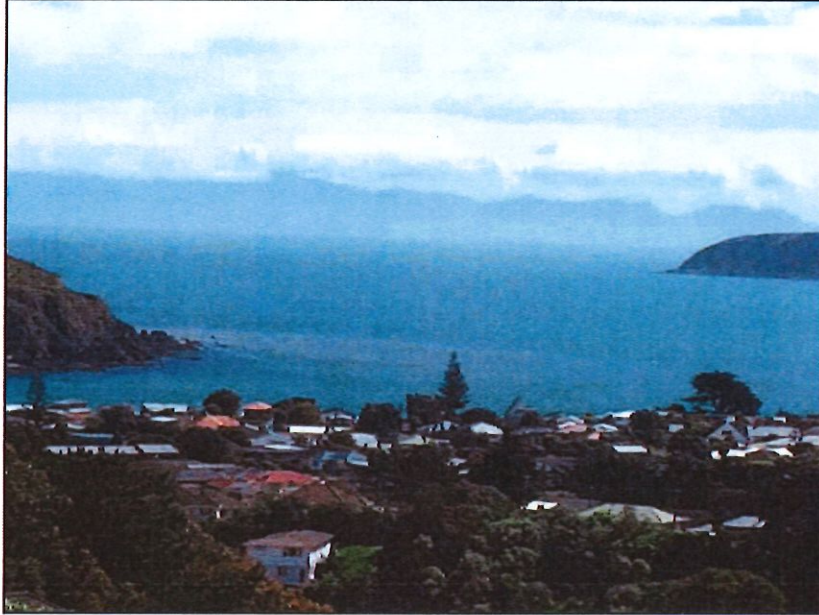
Figure 3: View of wastewater carryover off Titahi Bay, taken 6/10/2018.

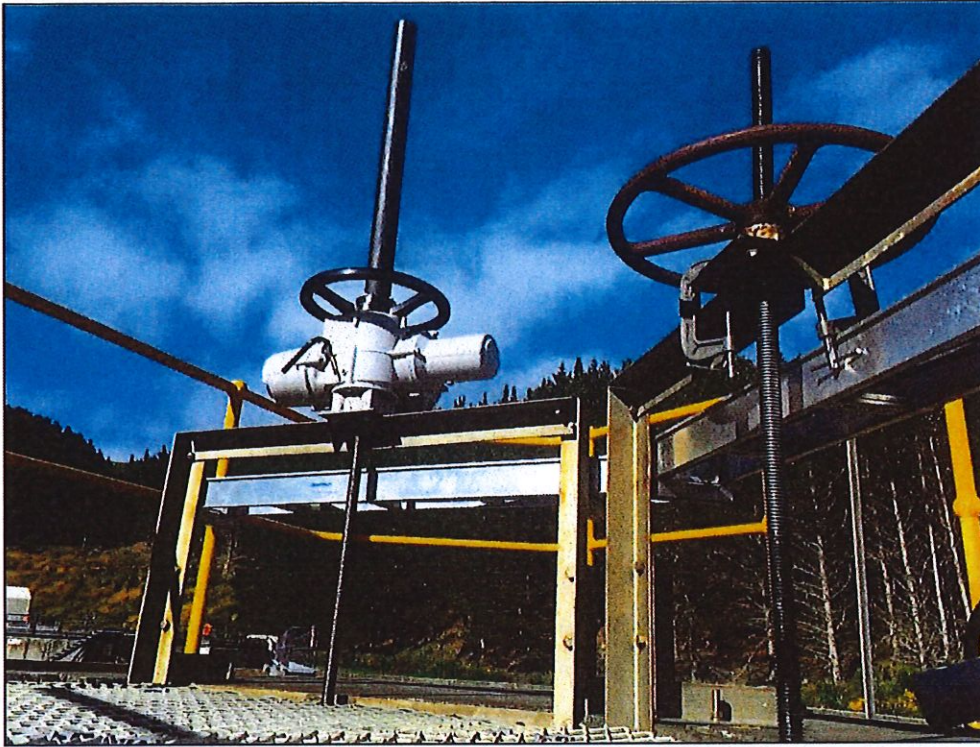
The penstock was left in the closed position, and the original manual control wheel was not reinstalled. This put Clarifier 2 was out of service. Clarifier 2 normally receives 30% of the flow from the aeration basin, but the RAS (Return Activated Sludge) pumps were not adjusted to compensate for Clarifier 2's isolation.

Figure 6: (L) Rotork-fitted penstock; (R) manual penstock attached to support frame with clamps.

The [redacted] fixed the manual flywheel to the penstock with clamps and opened the penstock to allow flow into Clarifier 2, reducing the loading to Clarifier 1 and stopping the carryover.
