**Technical Advice for Repairing and Reconstructing Houses Damaged in the Canterbury Earthquake**

## **Engineering Advisory Group on House Repairs and Reconstruction Following the Canterbury Earthquake**

# Local Land Damage Mapping

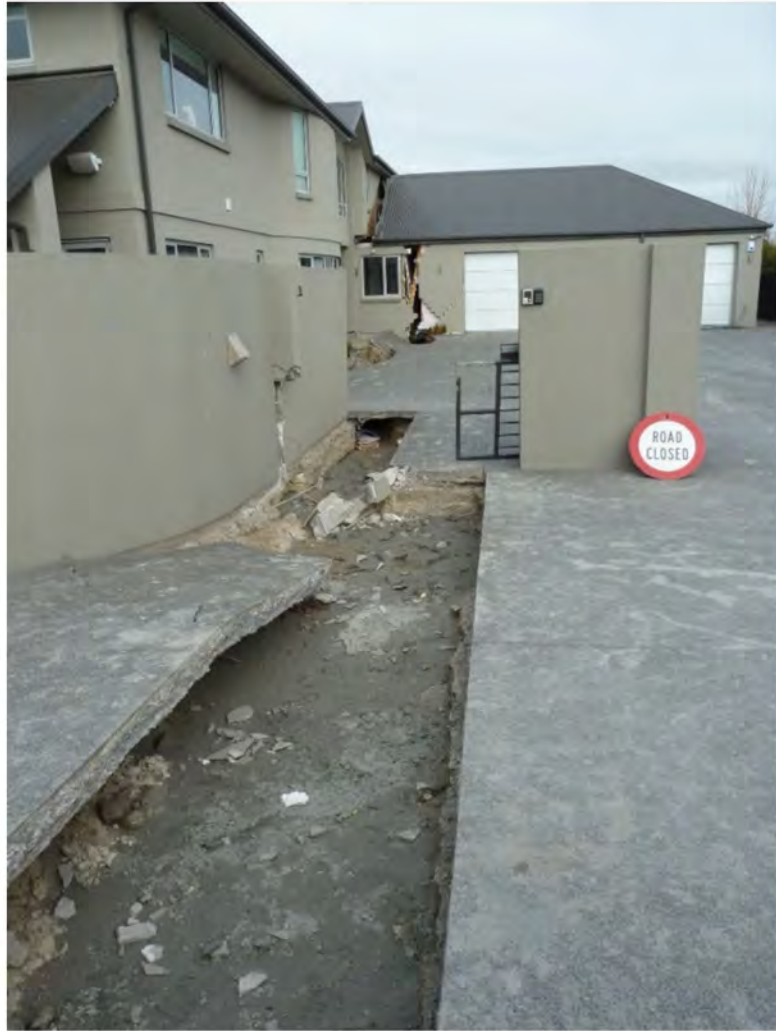
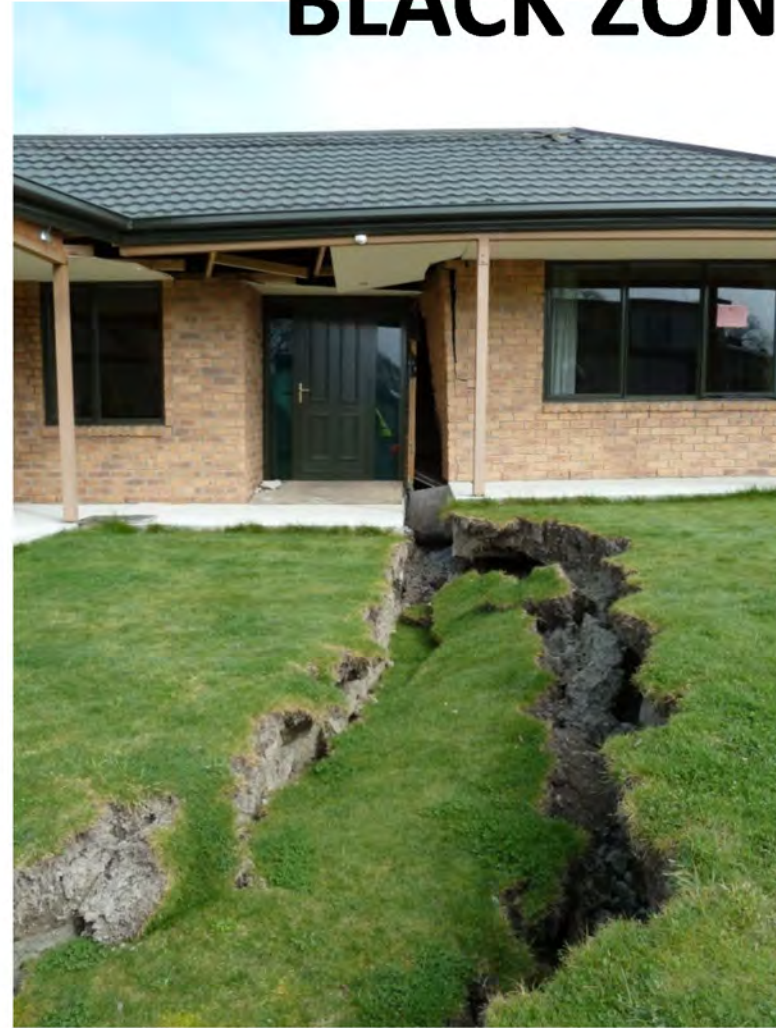
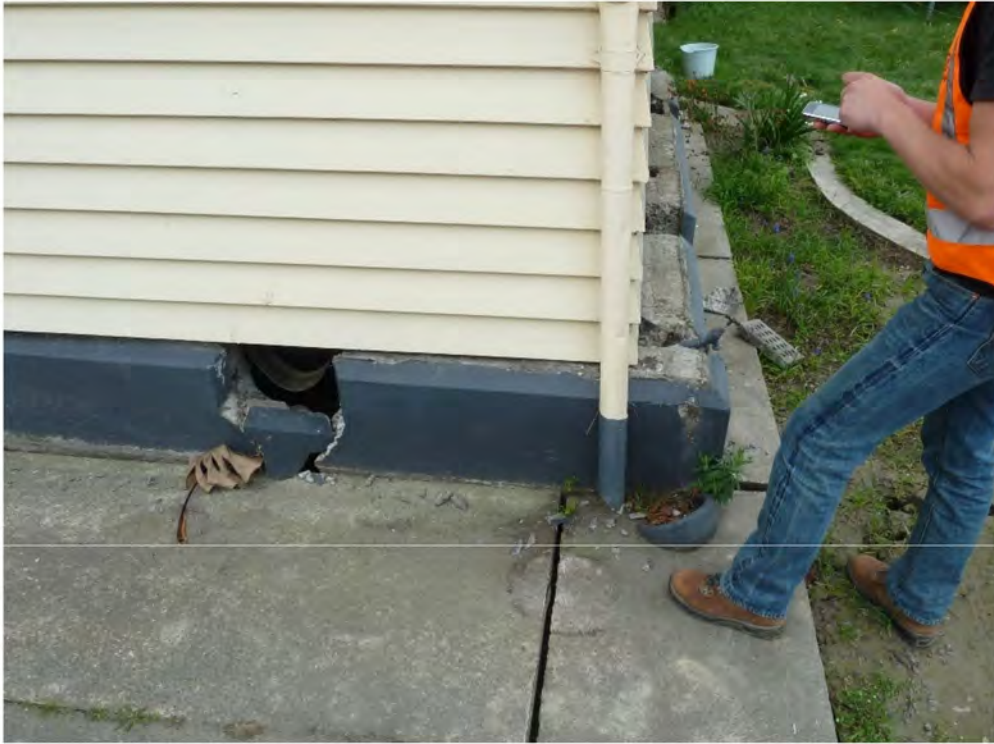
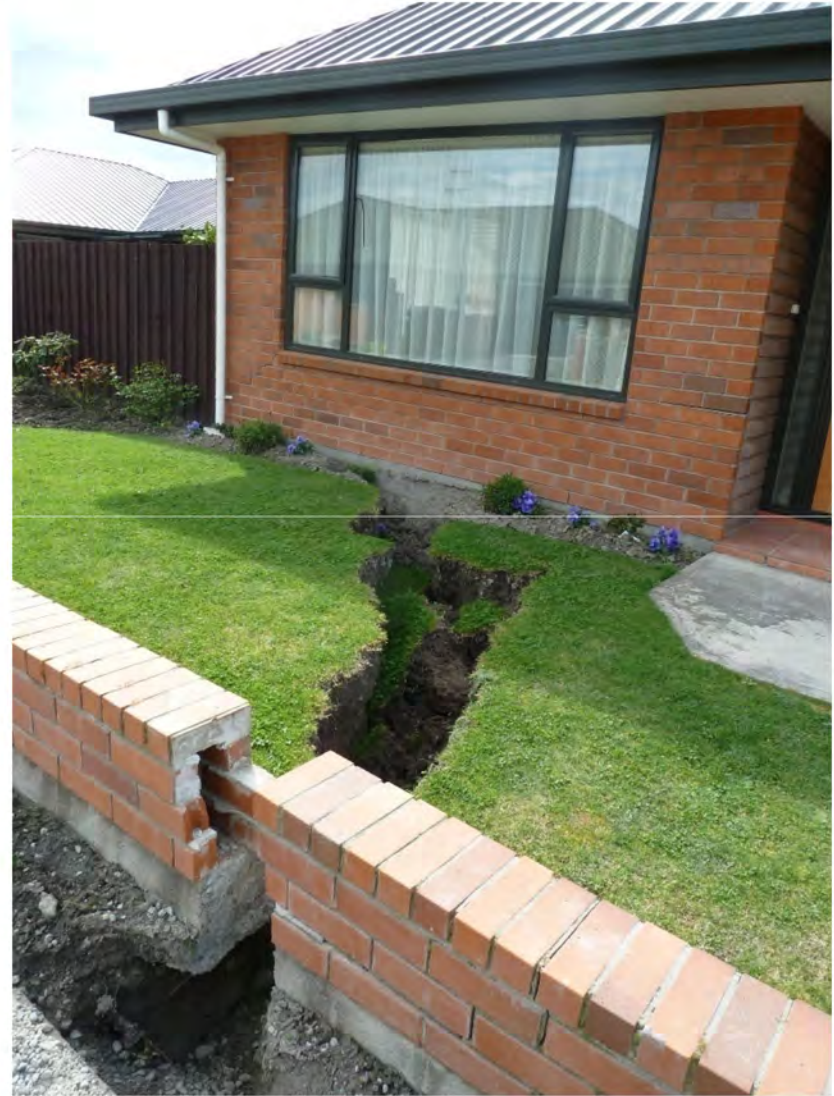
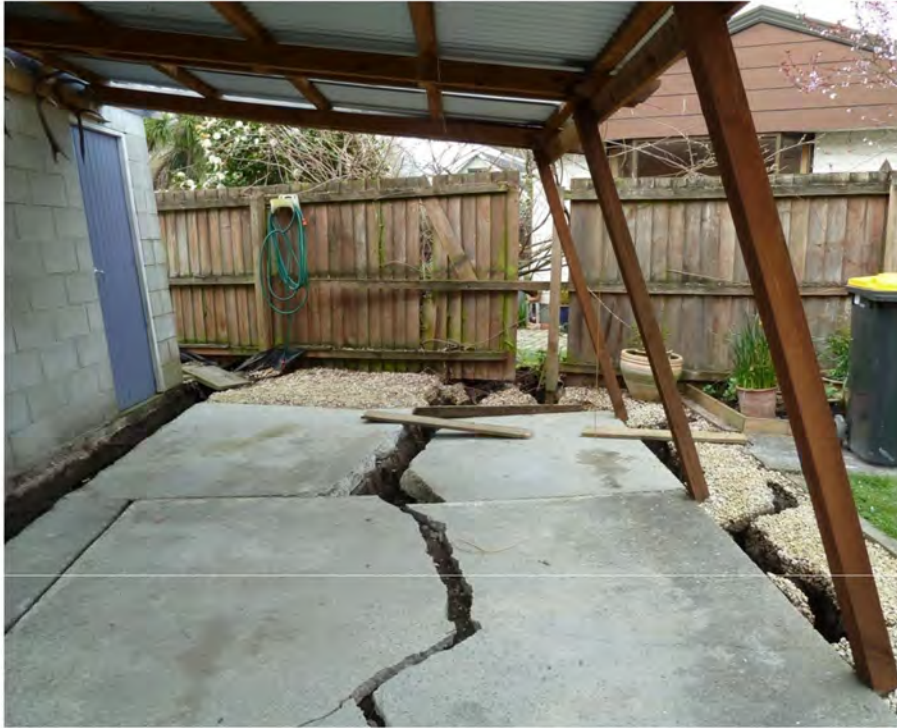
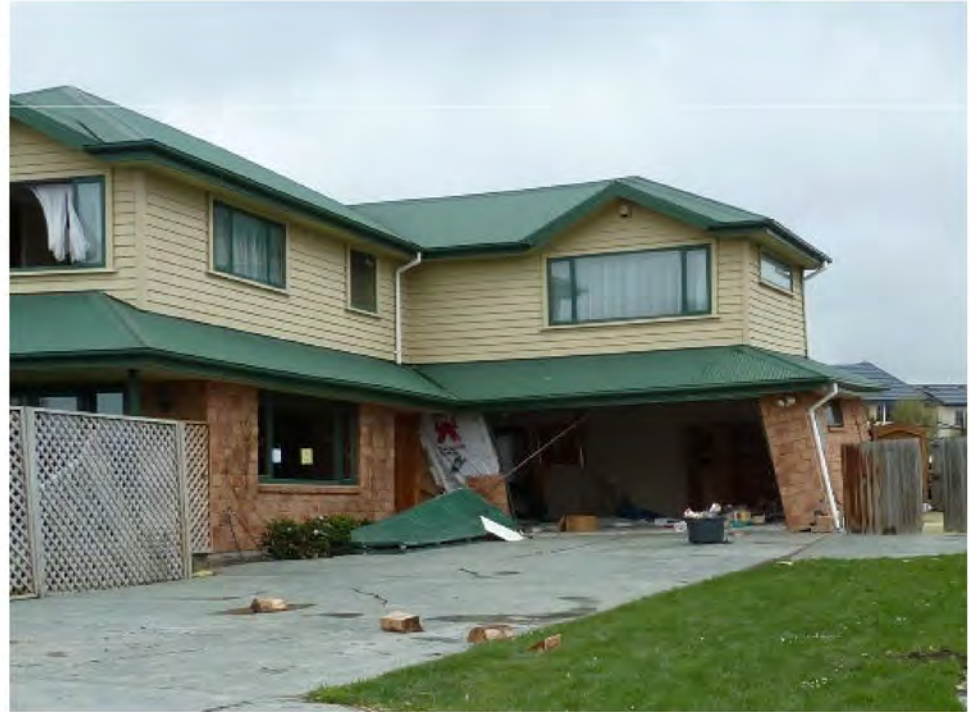
**BLACK ZONE**

- Extensive lateral spreading  $>1\text{m}$
- Surface rupture. Large open cracks  $>100\text{mm}$
- Extensive liquefaction (ejected sand)
- Significant horizontal and vertical displacement  $>500\text{mm}$
- Heavy structural damage to buildings
- Dislocation of roads/ services
- Dwellings most likely to be uninhabitable and beyond economic repair

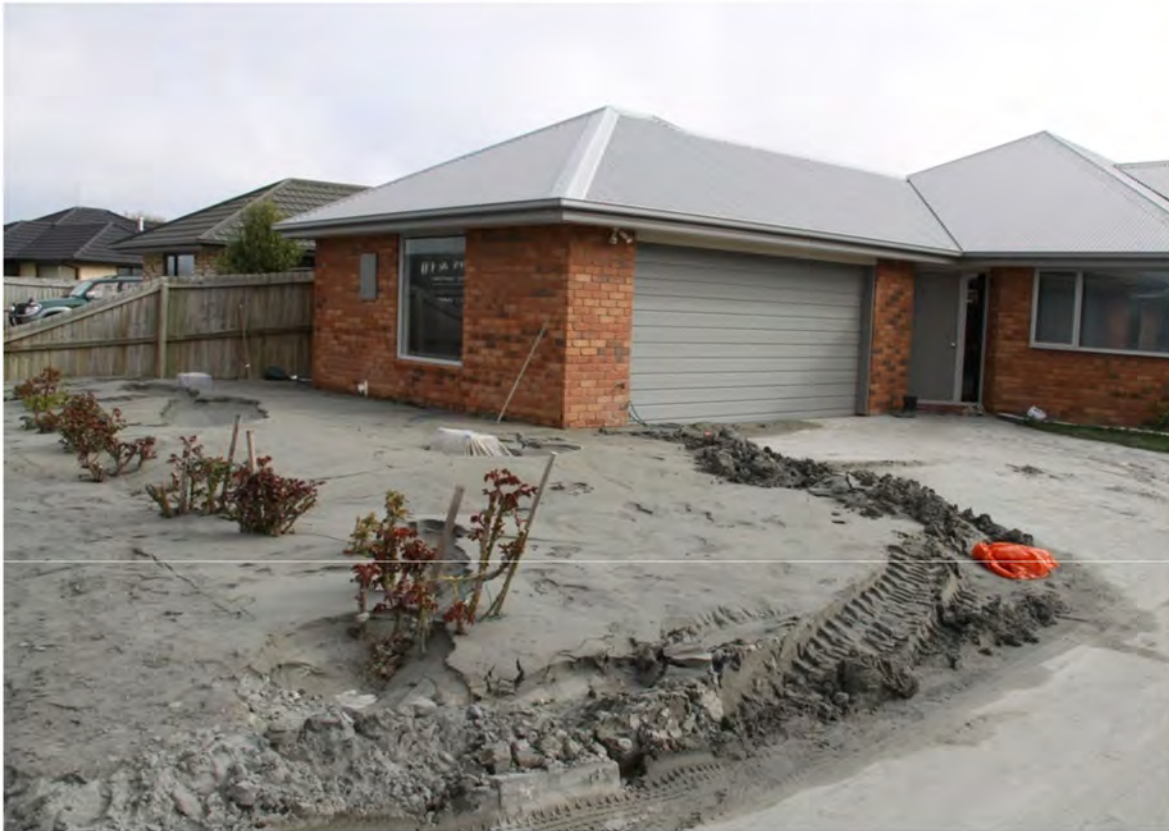
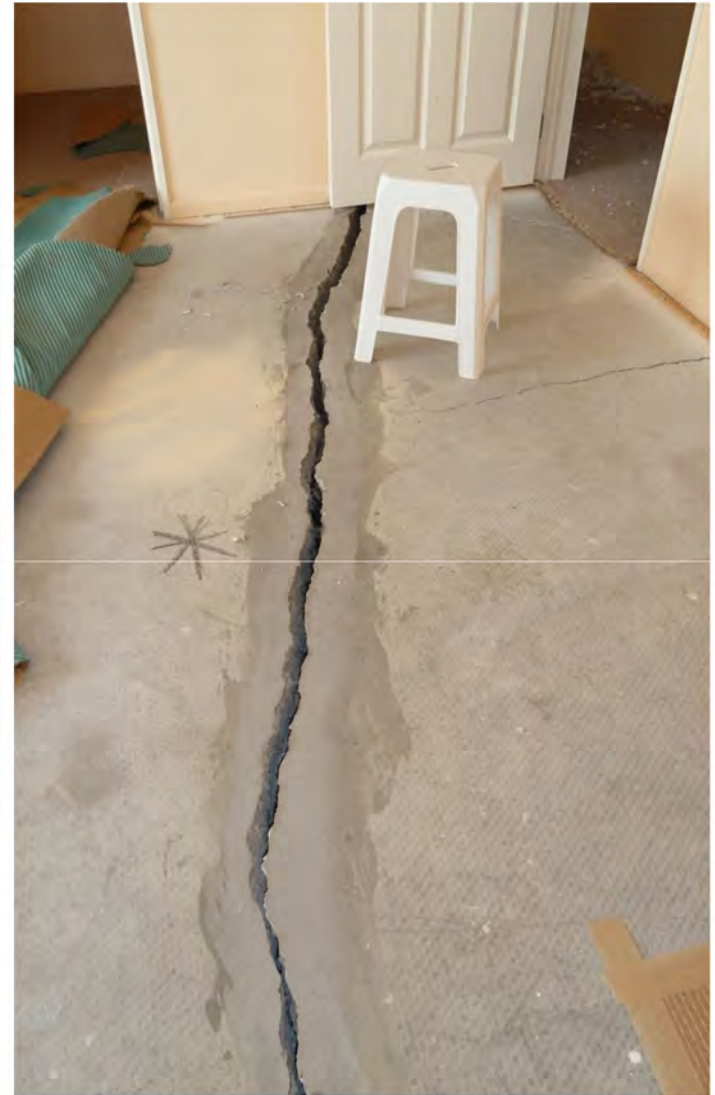
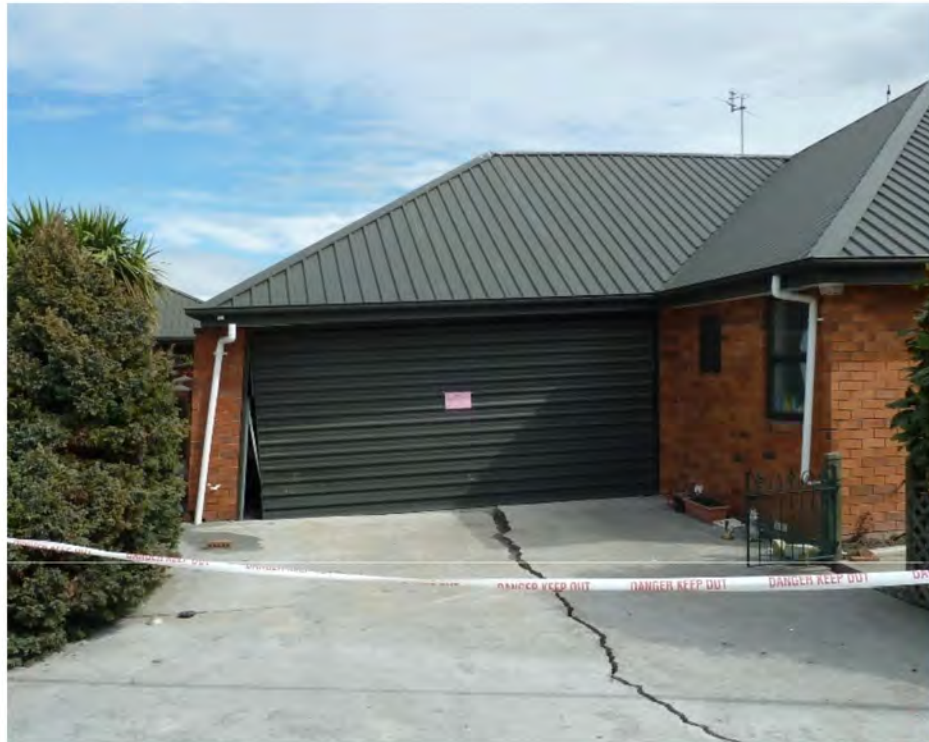
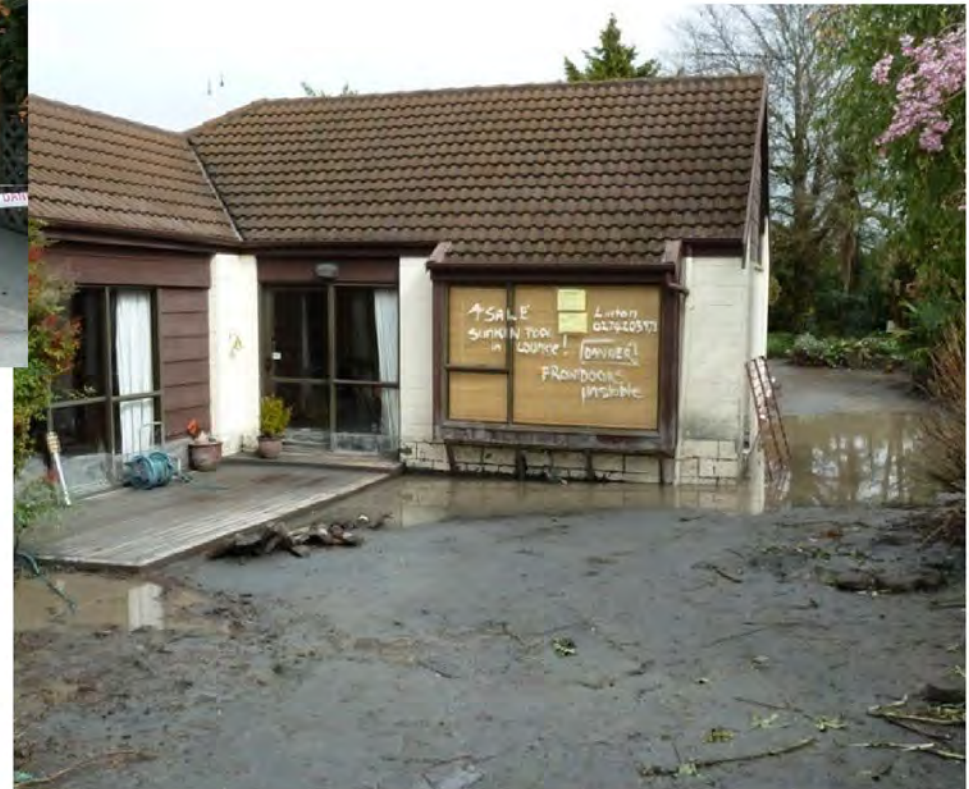
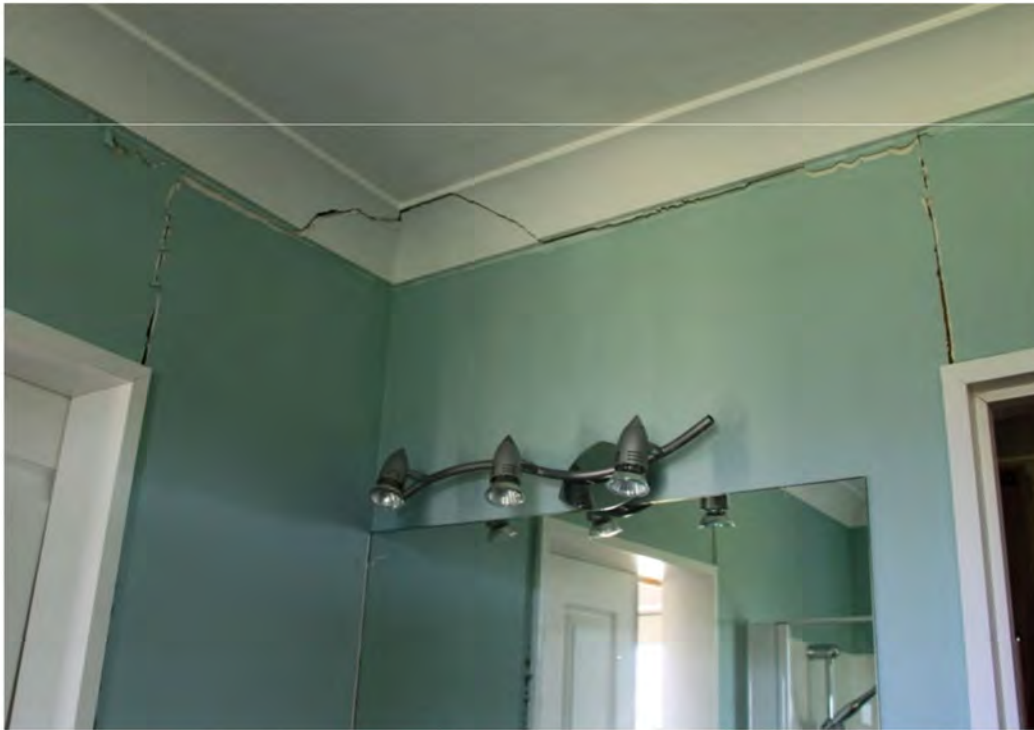
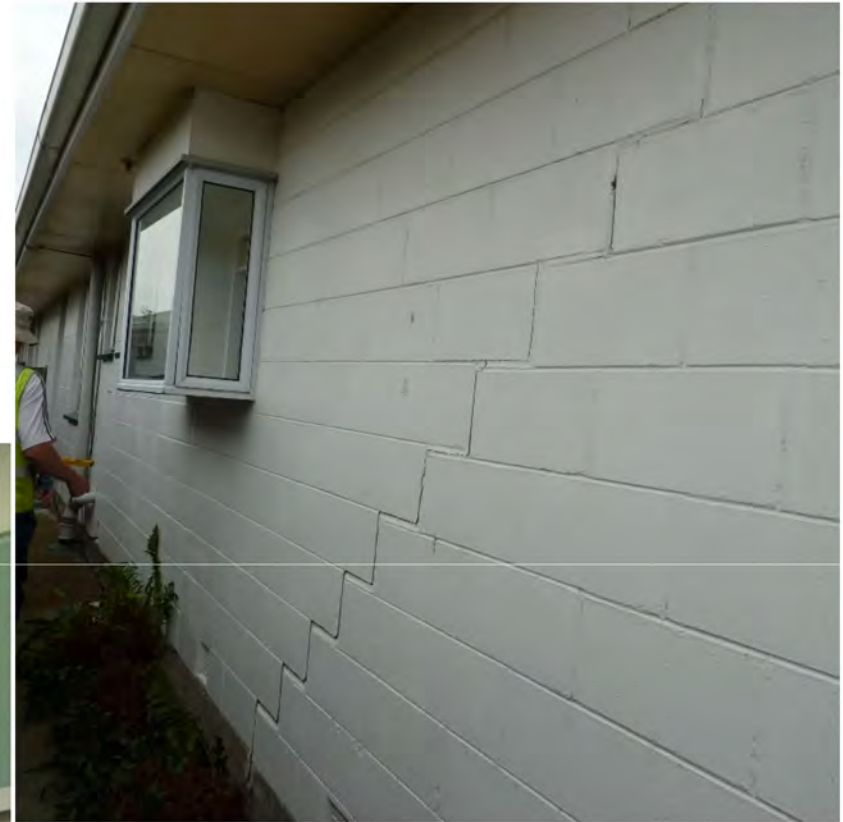
**RED ZONE**

- Extensive liquefaction (ejected sand)
- Large cracks from ground oscillations
- Horizontal and vertical displacement >50mm
- Structural damage to buildings
- Major differential settlement >1/100
- Damage to roads and failure of services
- Dwellings generally uninhabitable and beyond economic repair

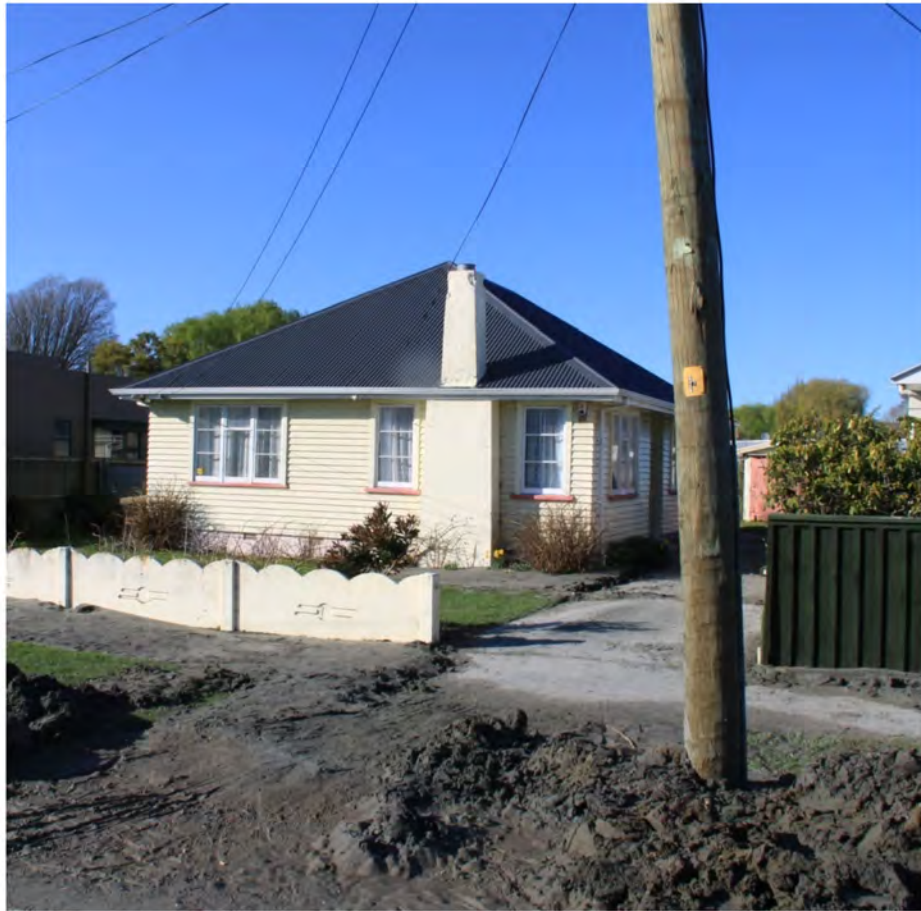
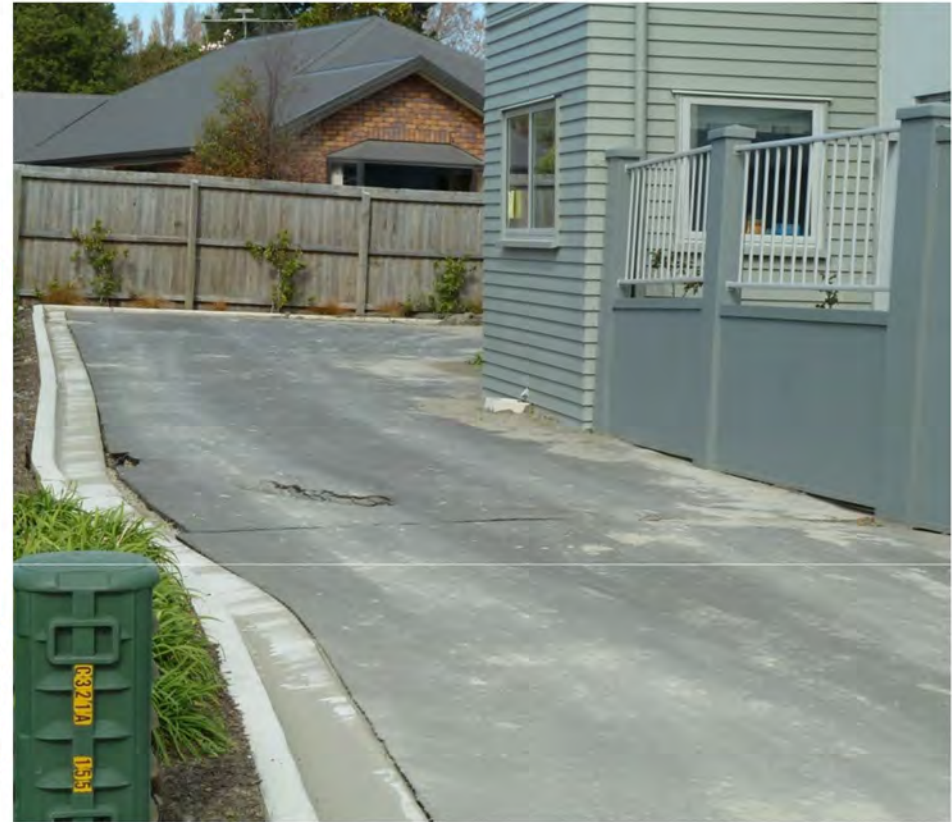
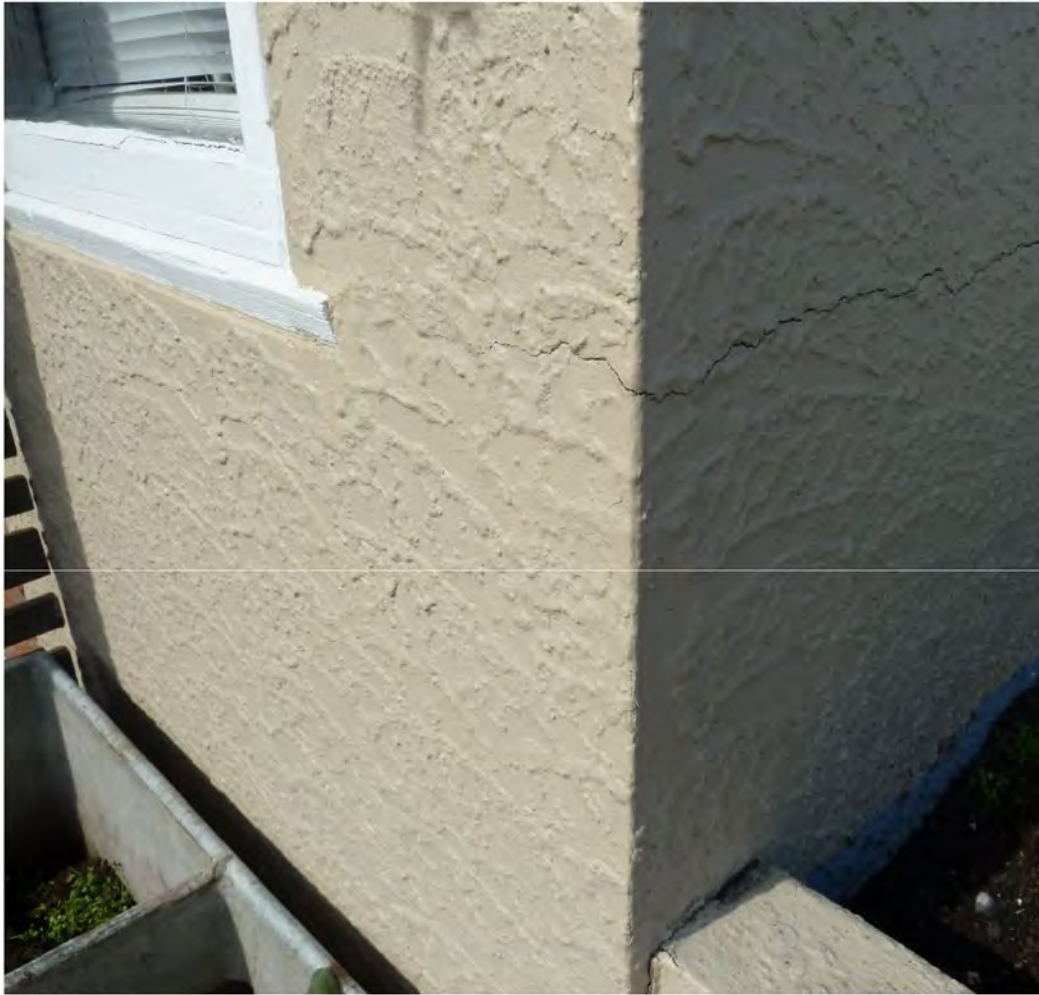
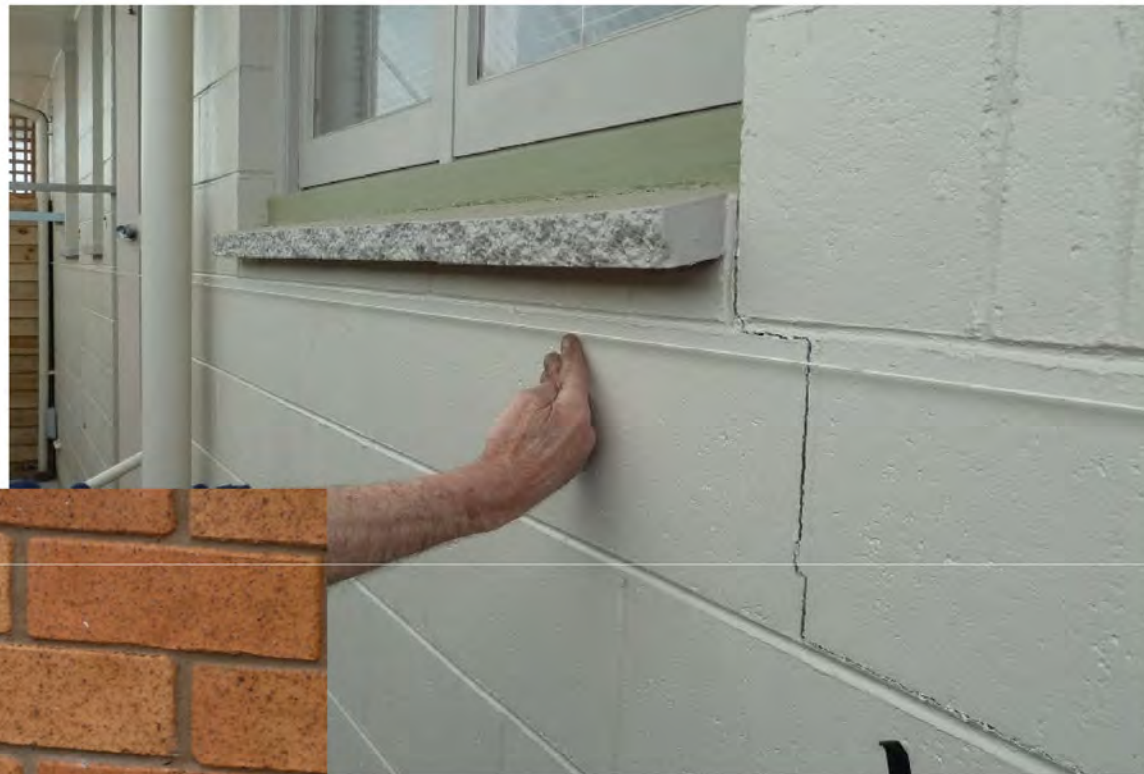
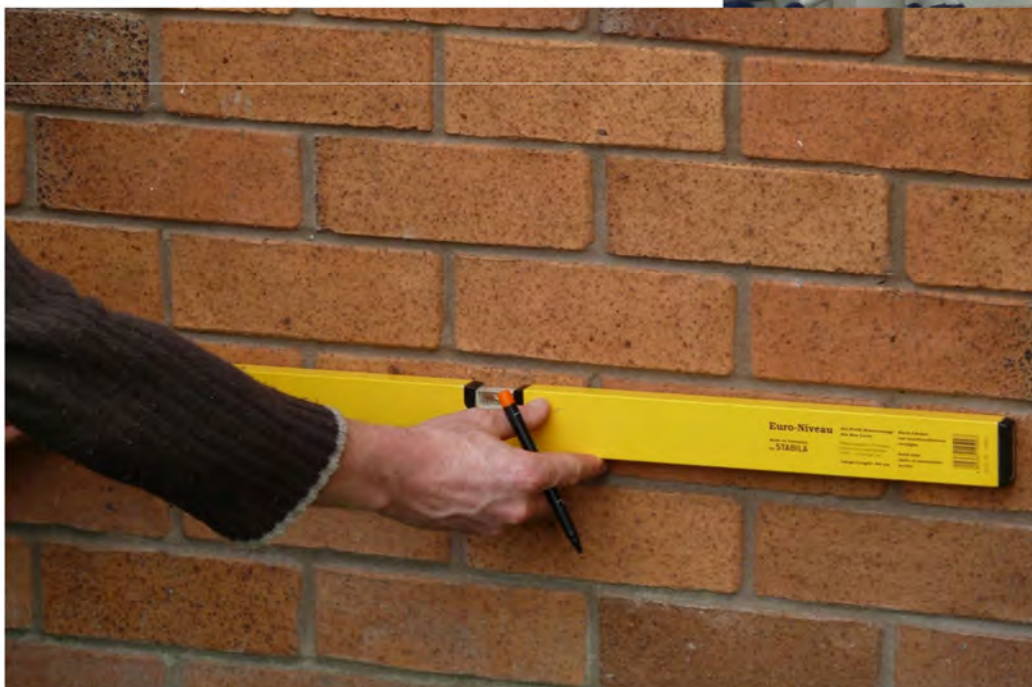
**ORANGE ZONE**

- Visible signs of liquefaction (ejected sand)
- Small cracks from ground oscillations <50mm
- No vertical displacement of cracks
- Some structural damage to buildings
- Moderate differential settlement <1/100
- Moderate damage to roads/ services
- The majority of houses are likely to be habitable in medium term with reduced serviceability but are variable with respect to the cost to repair them

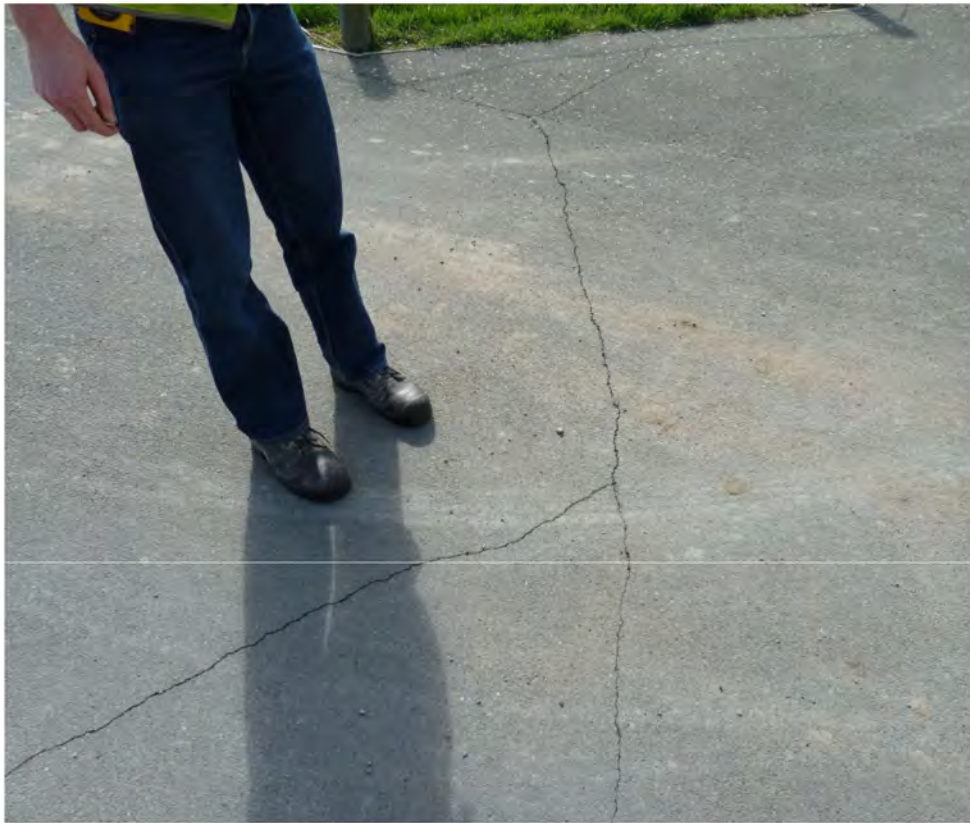
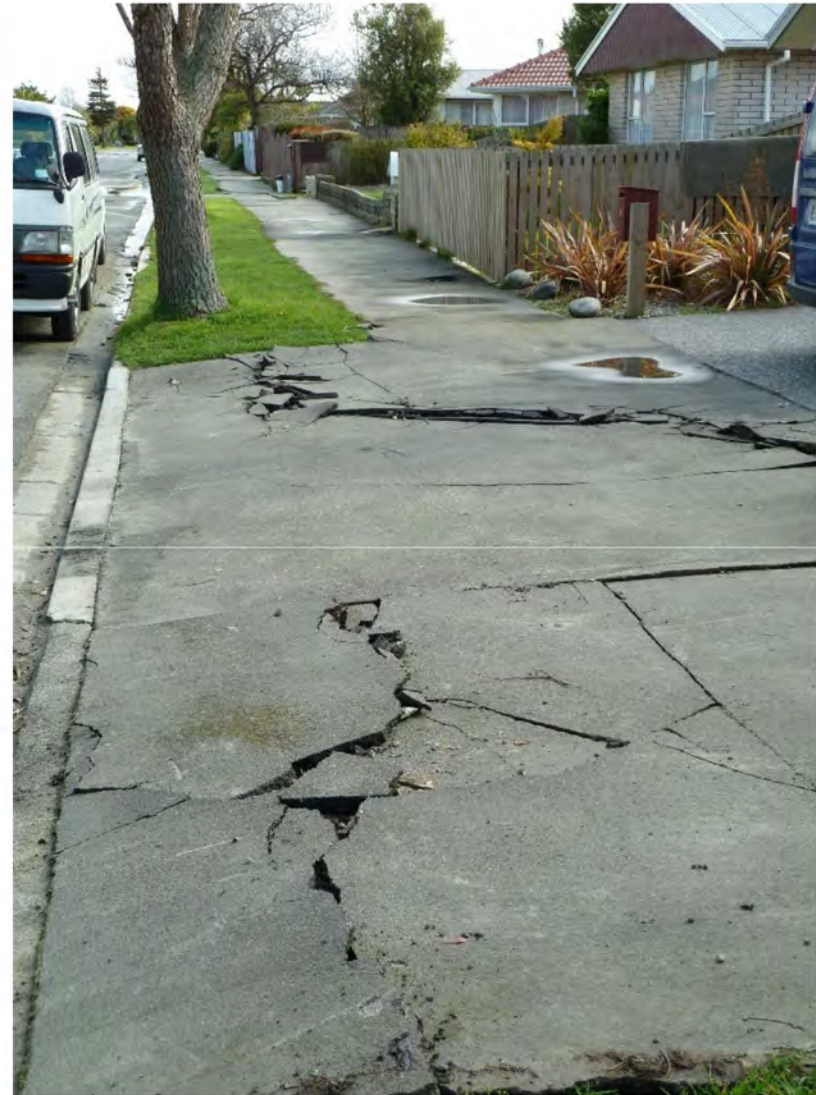
**GREEN ZONE**

- Shaking induced damage – cyclic deformation
- Minor ground cracking (tension) and buckling (compression)
- No liquefaction visible at the surface
- No permanent horizontal or vertical displacements
- Occasional minor structural damage and varying degrees of cosmetic damage
- Minor street, pavement and landscaping repairs required

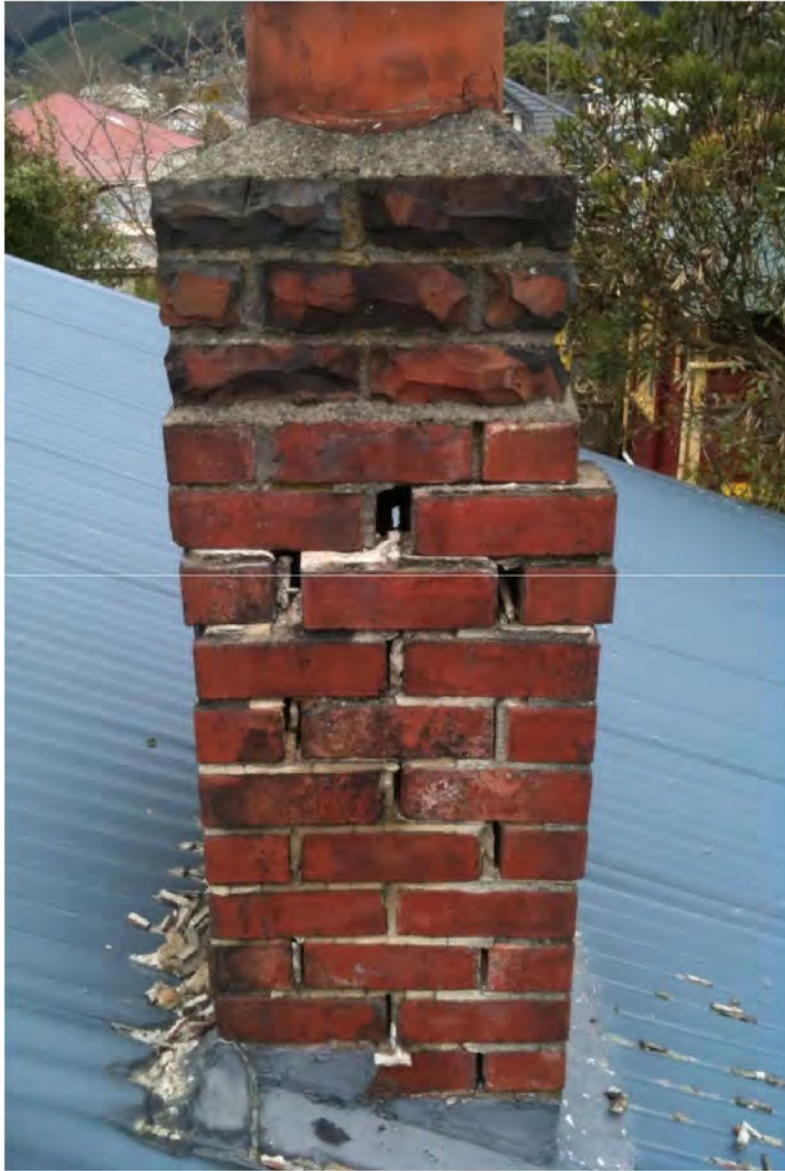
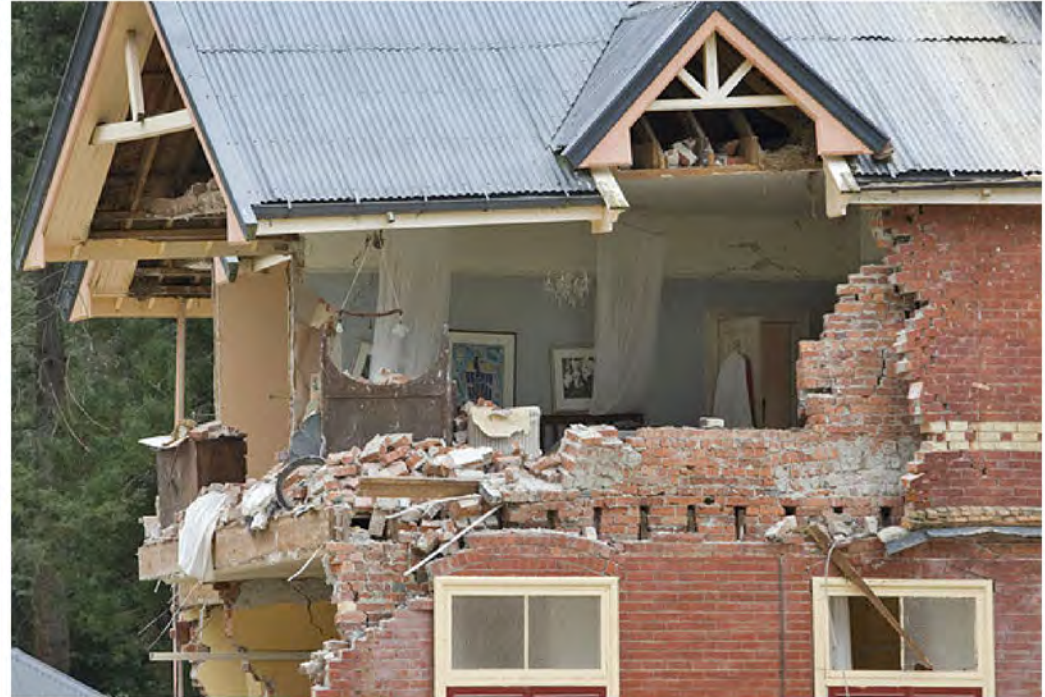
## BLUE ZONE

- No apparent land damage
- No signs of liquefaction at the surface
- Potential building damage due to earthquake shaking, but not visible from the road frontage
  - Potential chimney damage
  - Potential internal and external wall damage
