July 2013 Prepared by Spiire

Kaiwharawhara Pedestrian Over Bridge Structural Assessment

Job No706880 Date 9 July 2013 Ref 706880 R 20130717 RGB

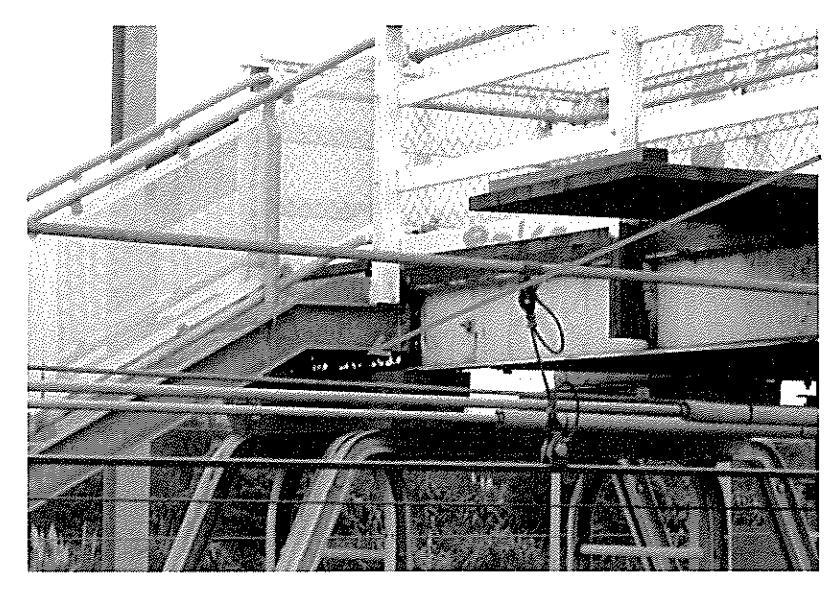
Photo two: Location of corrosion to steel I-beam web.

Daylight through the beam

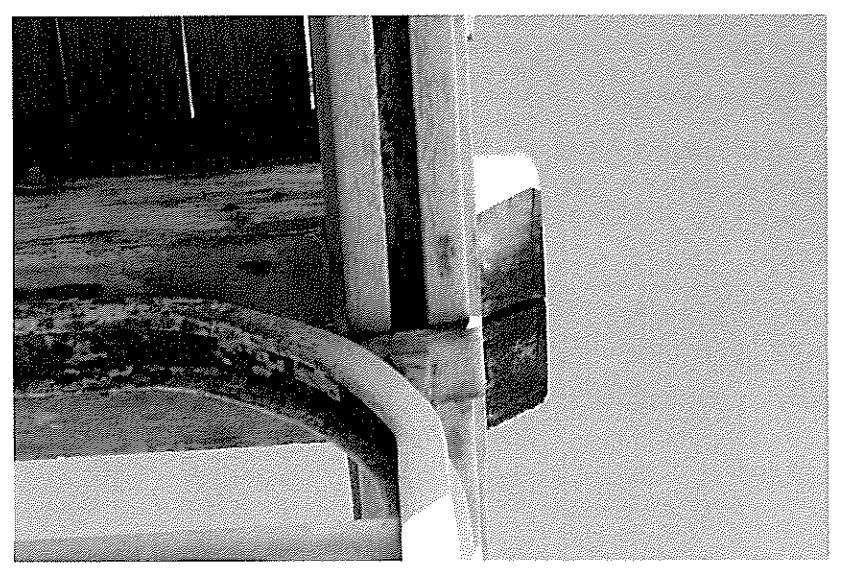
Large timber corbels sit on the rail-iron piers. These were observed to be split along the centre where bolts attach the piers to the l-beams. The splits are typically 5-10mm wide and will weaken the connection between the piers and steel l-beams. 10mm diameter exploratory holes were drilled into the corbel members. The condition of the timber was found to be good with no evidence of degradation. Similar observations were made on holes drilled in the timber packers bolted to the top flange of the main l-beams.

Photo Three: Timber corbel with split along bolt line.

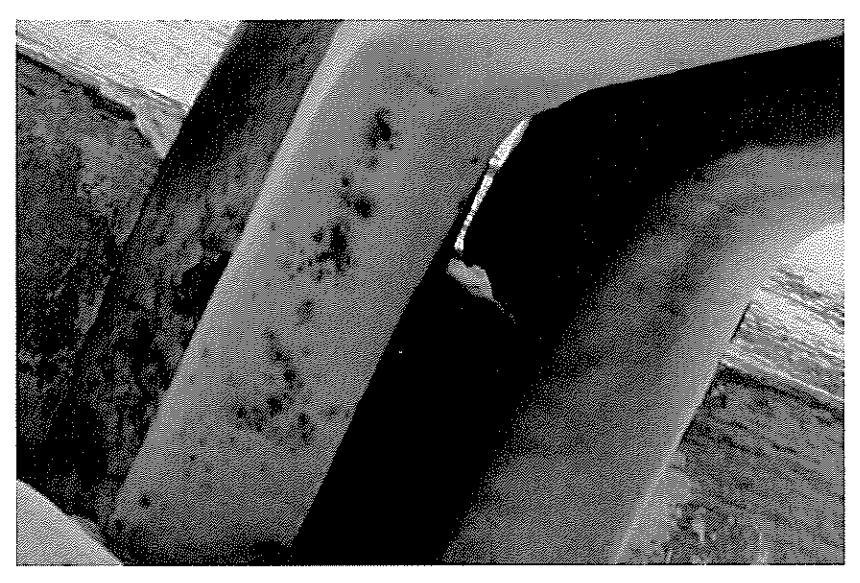
Extensive corrosion was observed on the rail-irons. Significant loss of section has been observed at the base of the legs and also at the top of the piers.

Photo Four: Extensive corrosion of rail section (between members). Surface corrosion and loose rust evident.

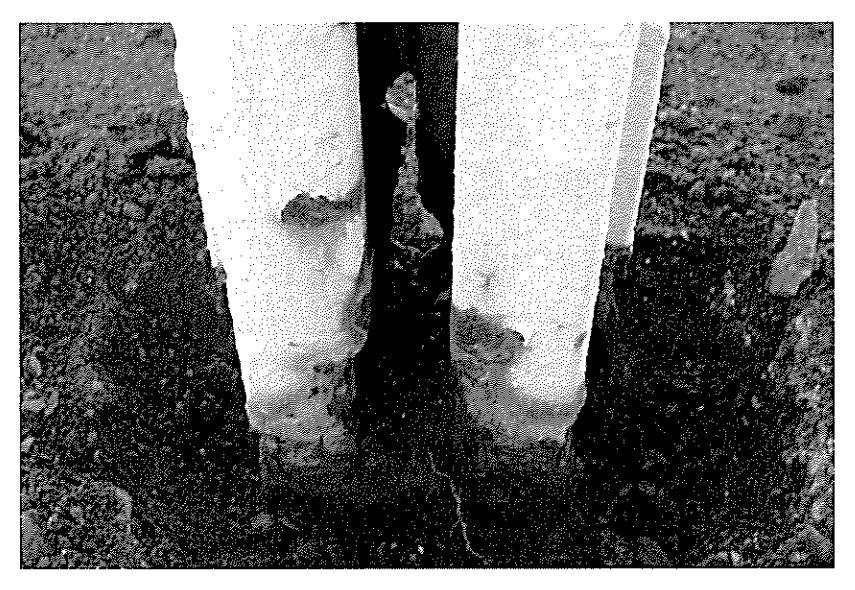
Photographs 5, 6 and 7 show extensive corrosion of the rail-irons below ground level on the east side and central piers.

Photo Five: Extensive corrosion of rail and loss of section at base.

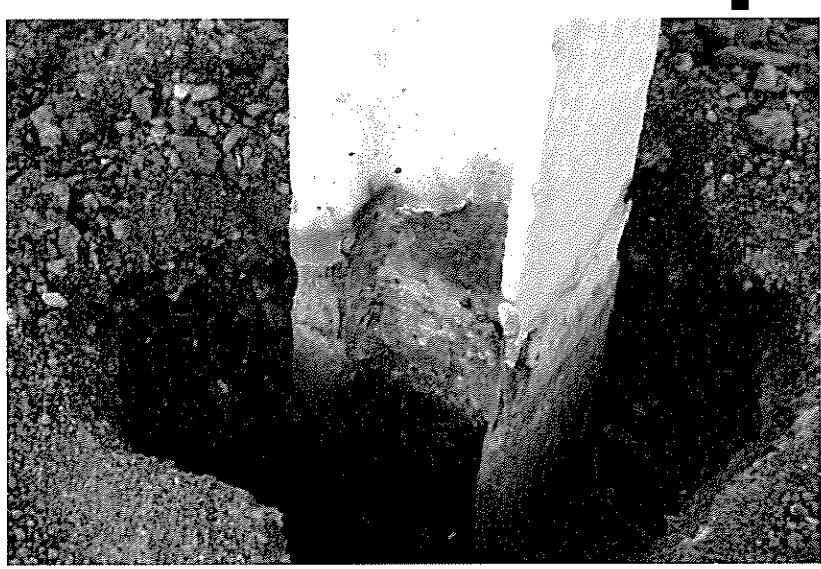
Photo Six: Extensive corrosion of rail section at base

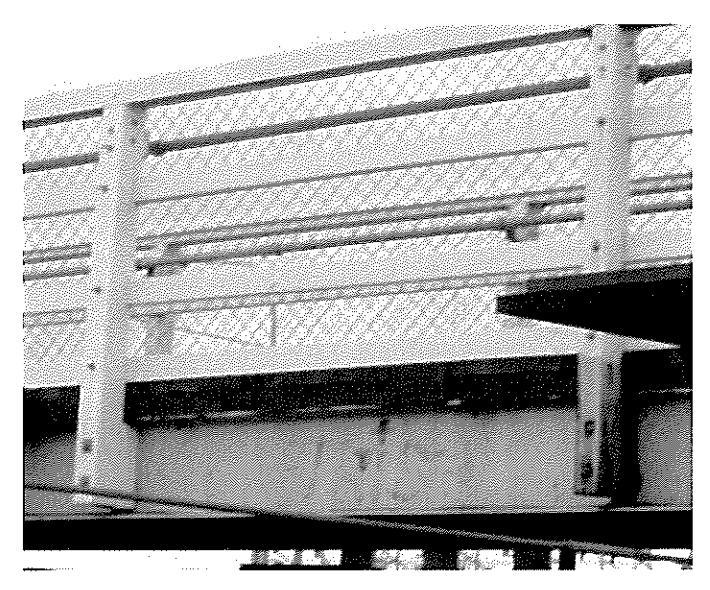
The bridge balustrade looks to have been repaired around the same time as the stairs. Some of the connections between the bridge superstructure and balustrade posts have deteriorated. On the left handside of the photograph 8 a replaced balustrade post can be observed. On the right hand side an original post is seen, the timber blocking fixed to the web of the I-beam has split and half has come away. Note the corrosion behind where the timber blocking used to be.

Photo Eight: Comparison of old and new balustrade supports

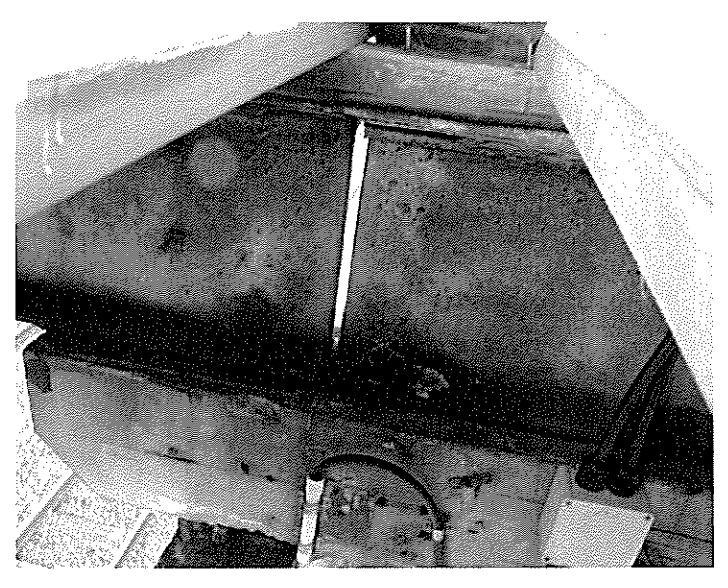
In photograph nine there are areas of significant corrosion of the top surface of the top flange of the beams and also extensive surface corrosion of the beams

Photo Nine: Corrosion to the tops of the top flange of the I-beams under the timber packers supporting the deck.

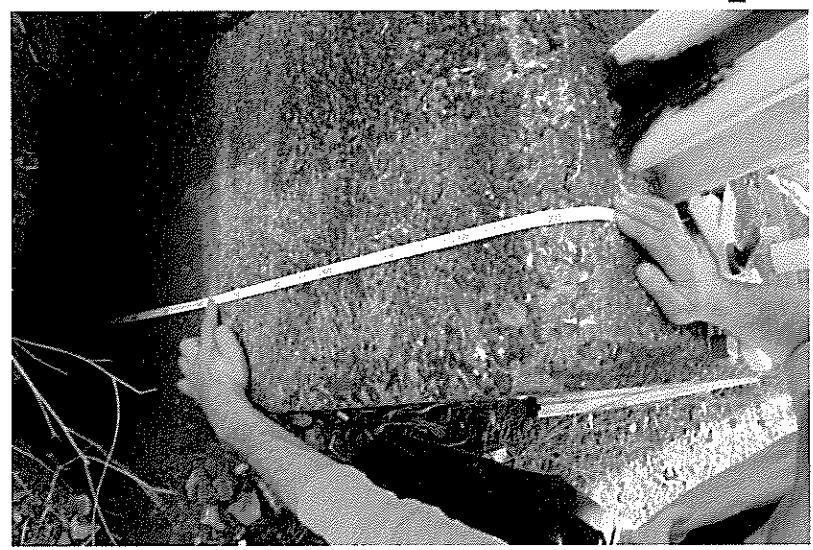
Photo Ten: Bottom of concrete pad foundation adjacent to the west boundary fence is 600mm below ground level, founded on solid ground.

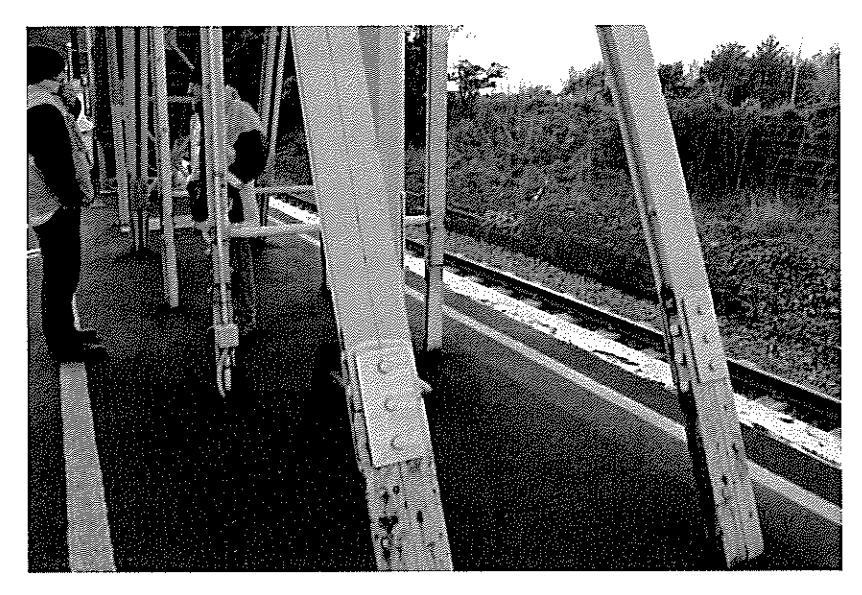
Some steel splice plates have been attached relatively recently to the to the pier legs. These do not address the problem of extensive corrosion of the rail-iron piers.

Photo Eleven: East side pier. Extensive corrosion to the pier leg connecting bolts and the circular hollow section prop between rail-iron legs. Note plates added recently at joint.
