OPERATIONAL REVIEW

Lake Pukaki
Level 3 Vegetation Incident
F3067402
Mount Cook Road
Twizel
29 August 2020

Created by: Operational Efficiency
& Readiness
Fire and Emergency NZ NHQ

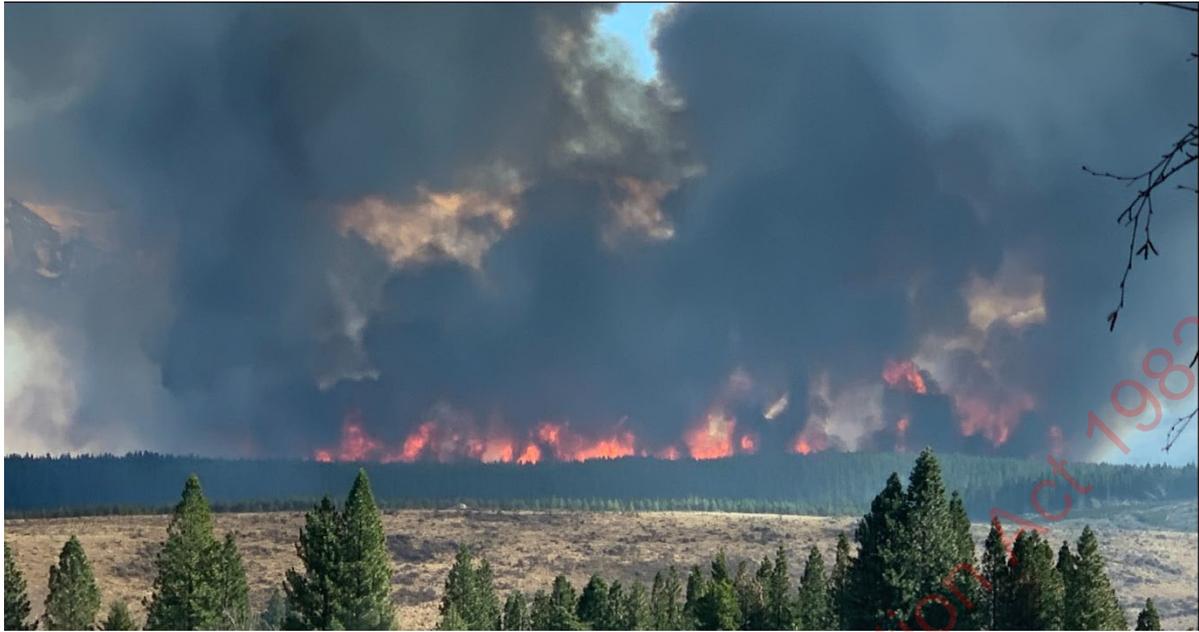
Figure 2. First arriving crews view of the fire

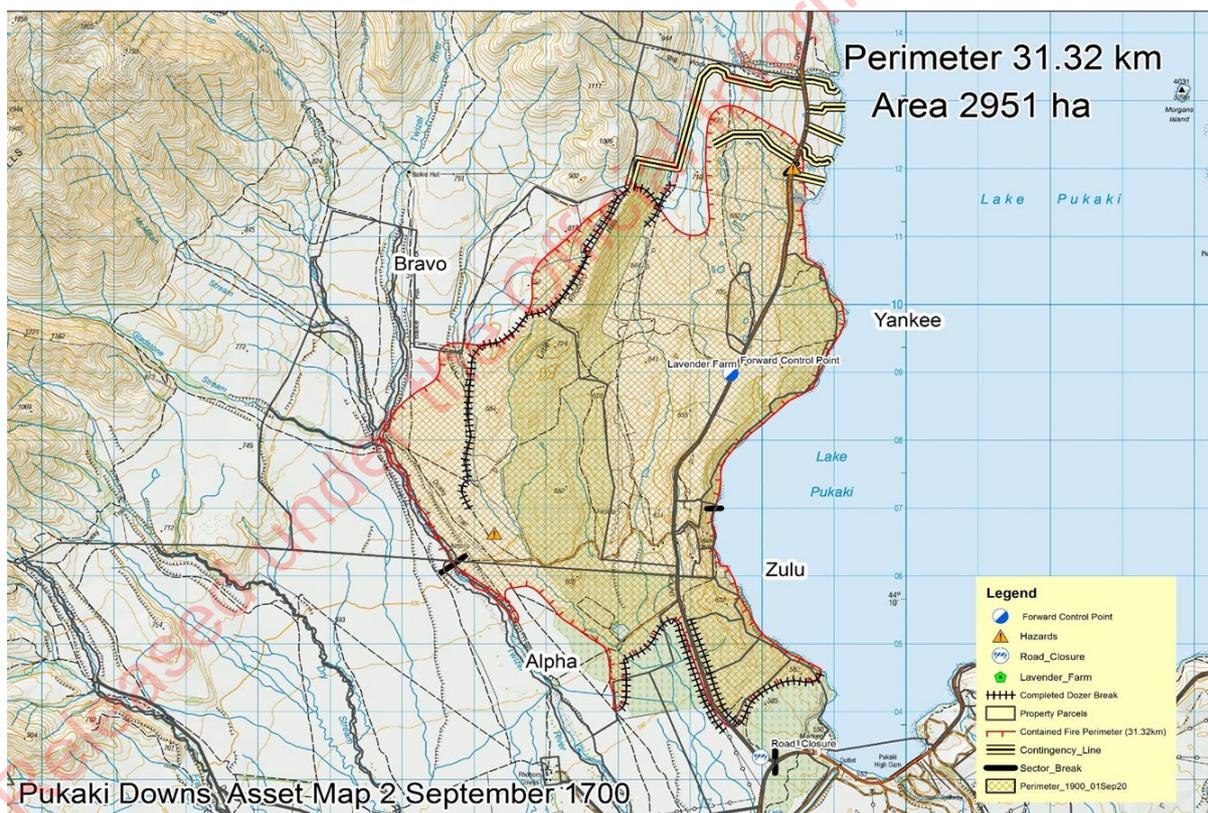
Figure 3. A map showing the Incident perimeter, containment lines and sectors.

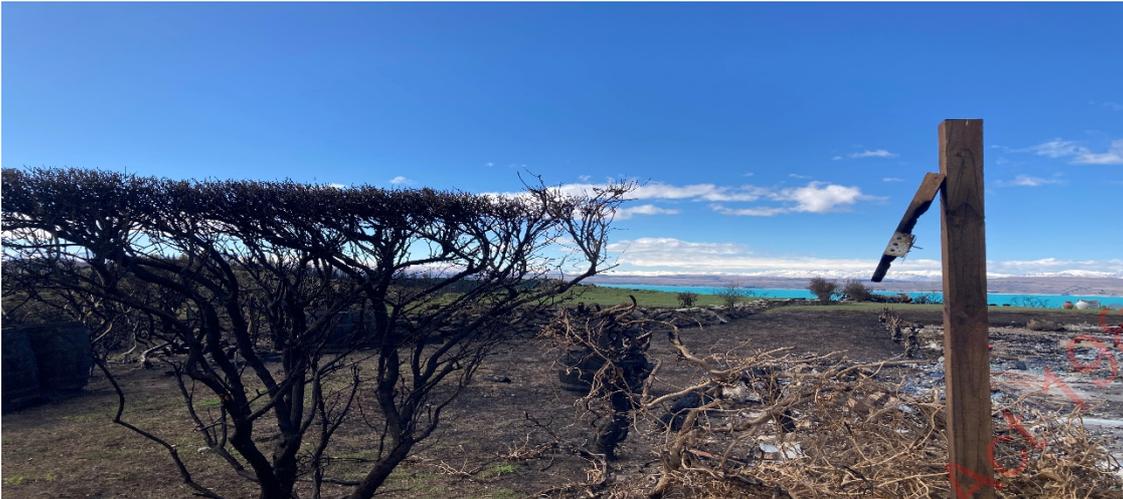
Figure 5 shows a burnt hedge attached to trellis adjoining a lost property.

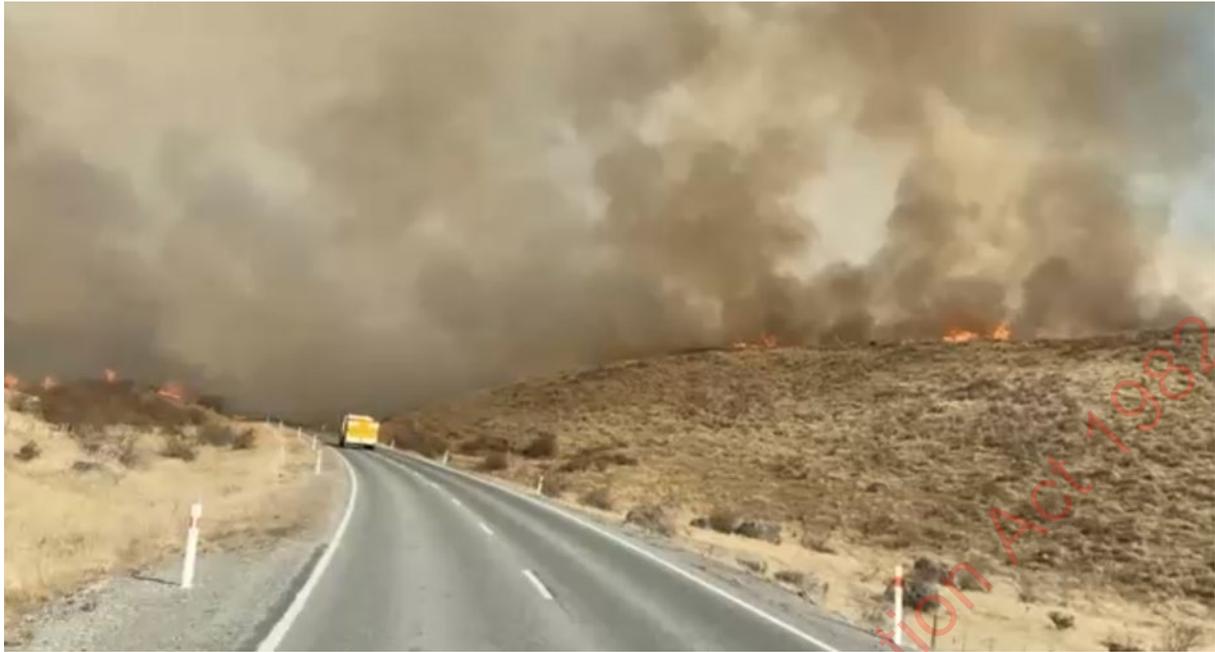
The Command Unit team felt concerned heading to the NZ Alpine Lavender Farm with fires burning on both sides of the road, and at one point, the fire was coming towards them when they briefly evacuated to Peter's Point. They deliberated if the corner of SH80 and SH8 would have been a better location and could have aided in traffic management or road closure. After some consideration, it was decided the fire behaviour was indicating that the wind could have driven over SH8. Considering how short and condensed the grass was at the NZ Alpine Lavender Farm, it was the best option available. The only other possible location would have been Peter's Point; however, this was 6-7kms further up the road, so it was discounted. NZ Alpine Lavender Farm also had space to land helicopters.

Figure 6. State Highway 80 access to the initial ICP was restricted but not unpassable.

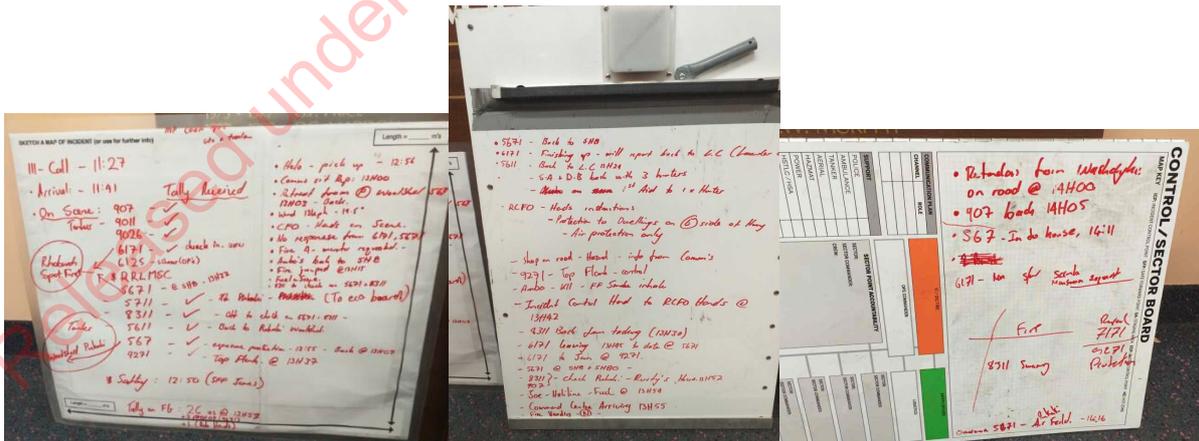
First arriving crews struggled with the available incident boards to collate information, but they did transfer their information into the Command Unit when it arrived. Crews told the review team that they struggled to work in the Command Unit because of little training and knowledge of its operations. The incident boards provided to urban crews are not sufficient for this size of an event.

Figures 7, 8 and 9. Board utilised by crews to gather information at the initial ICP

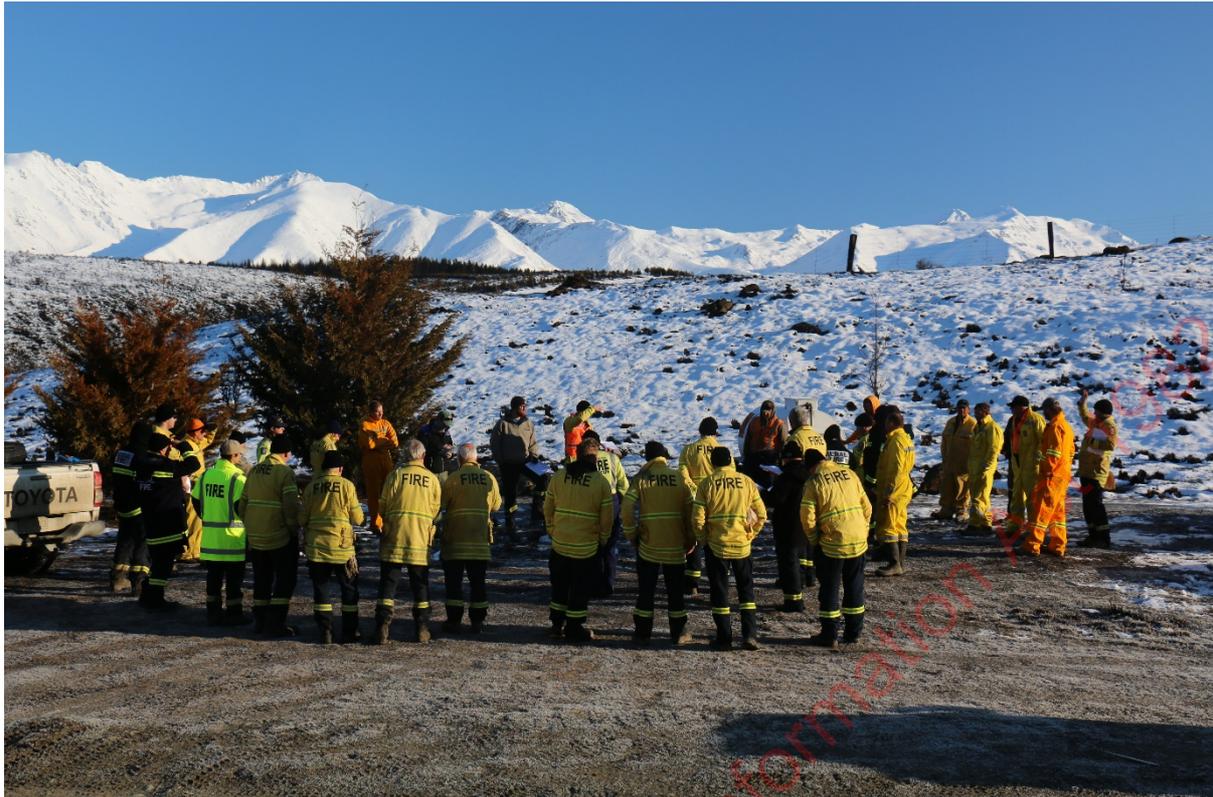
Figure 10, Crews receiving a morning briefing

Operational briefings were conducted at the SFP each morning, typically at 0700hrs. They were good, clear briefings, but some minor issues arose due to teams arriving after the briefing and relying on second-hand piecemeal information, which became a safety issue. Also, they missed other information such as fuel supply locations and accommodation arrangements
