# QUEEN STREET

## ESSENTIAL VEHICLES AREA EVALUATION

4 OCTOBER 2022

Document Title: Queen Street: Essential Vehicles Area Evaluation

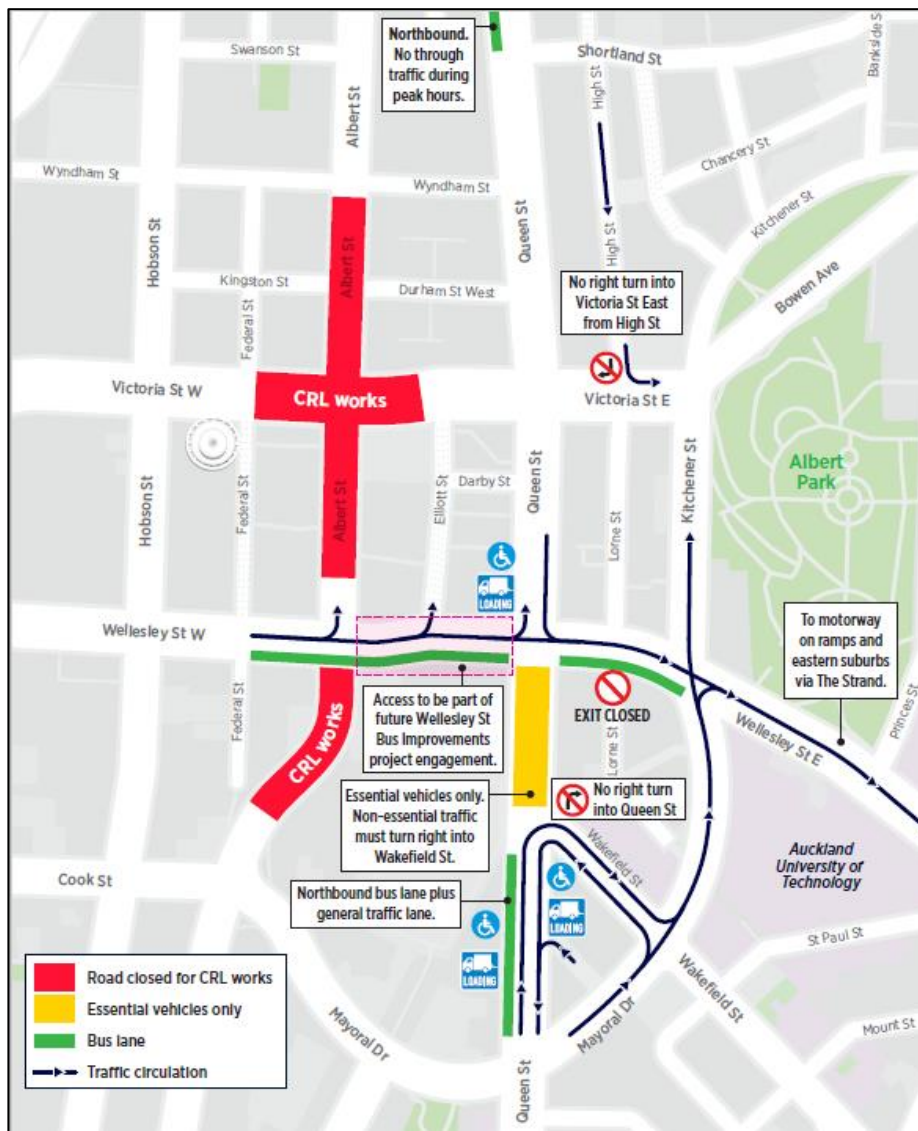
Figure 3: Queen Street EVA (figure supplied by Auckland Transport)

The extent of the Queen Street EVA (in yellow) is shown in Figure 3, as are the routes that non-permitted vehicles can take to travel around the EVA without receiving an infringement fine.

The area within the EVA is closed to private vehicles, taxis, and car share and rideshare services.

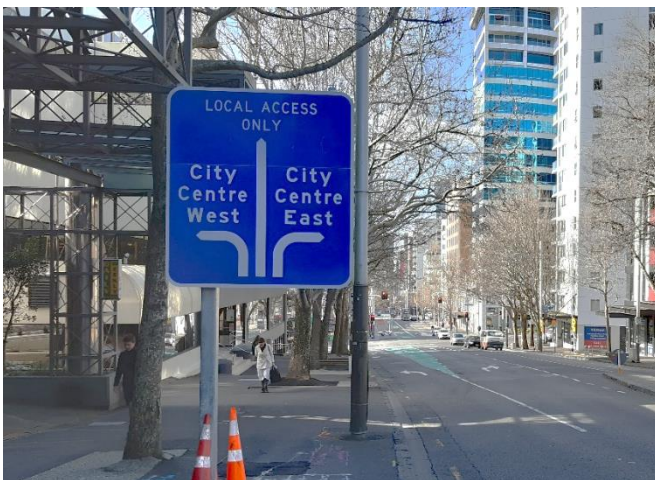
Figure 5: Advance direction stack sign installed between Karangahape Rd and Mayoral Drive (image provided by AT)

While it is not included in Figure 4, an advance direction stack (ADS) sign was also installed on Queen St between Karangahape Rd and Mayoral Drive. This sign, shown below, warns the road user that “local access only” is permitted further down Queen St.

Overall, the signs need to be more conspicuous. It was noted during the review that the blue ADS sign stood out well against the visual background as it is not a common colour at the site. Using this colour and increasing sign size as well as better placement may help drivers notice the signs. Where possible signs should be placed where drivers typically scan rather than high up or a long way off the roadway. However, given the complexity of the site, this may not always be possible.

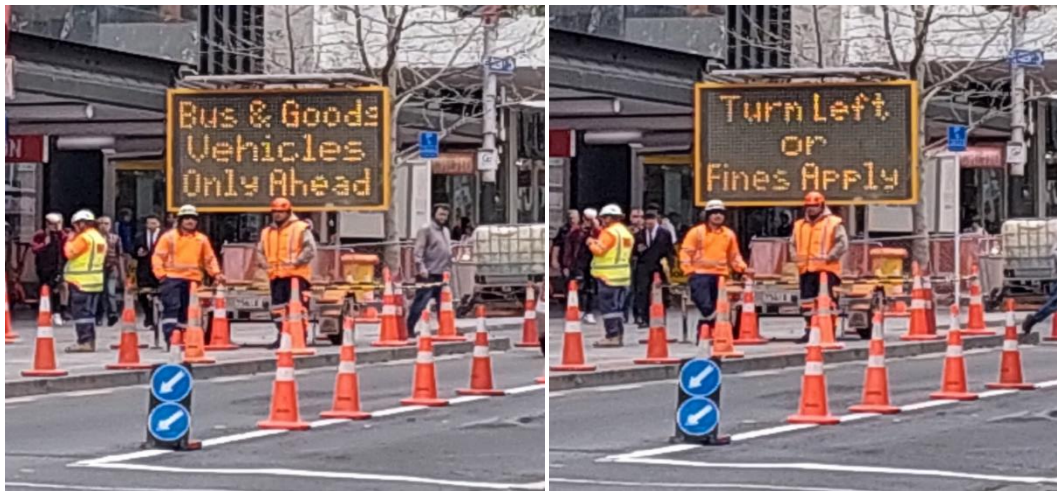
During site observations temporary portable variable message signs (VMS) were also in place for both northbound and southbound traffic on Queen St. The VMS message for southbound road users is shown below.

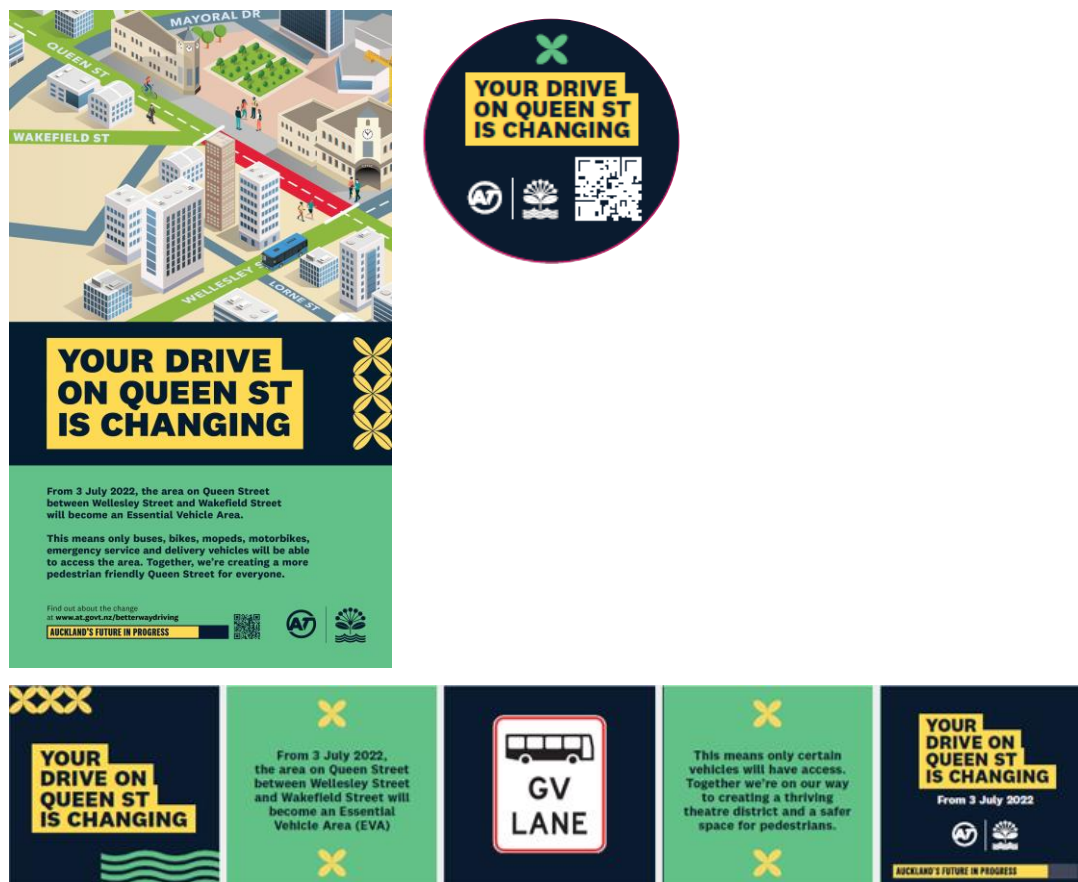
Figure 6: Queen Street EVA communications

The following images show examples of Queen Street EVA communications materials. In addition to the materials identified, further signage and communications regarding the EVA are still underway.

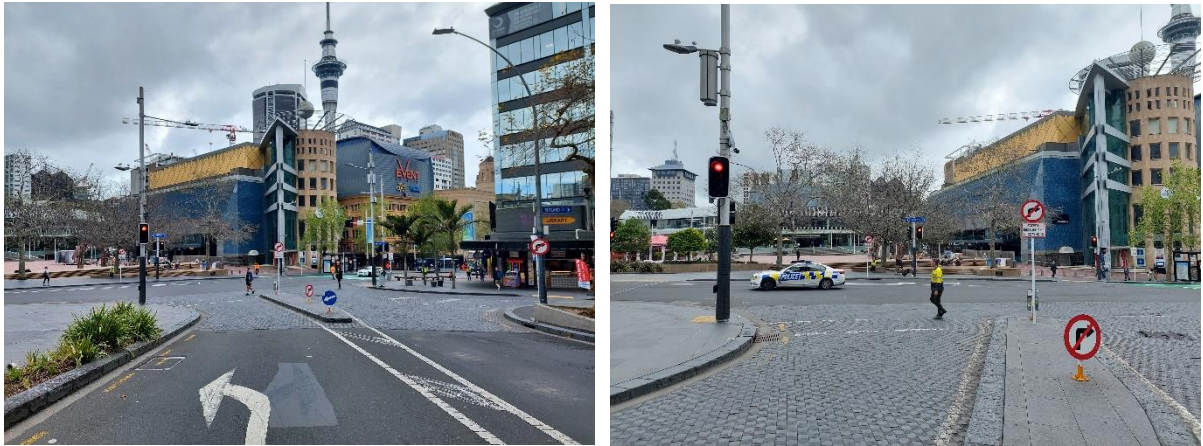
Figure 9: Wakefield St EVA approach

The general environment at the Wakefield St approach is characterised by several tall buildings. However, due to Aotea Square the visual scene is noticeably less cluttered than the approaches at the northern end of the EVA. There are also fewer commercial signs, no roadworks signs (which are currently present at the northern end) and more open sky.

Wakefield St is a feeder route to Queen St, so the traffic volumes are light, and speeds are low. There is only a single traffic lane. As such, drivers do not have to work to choose the correct lane or drive with consideration to drivers in other lanes of traffic travelling the same direction. There are other road users present, although not in large numbers during these observations.

The roadway design at Wakefield St is relatively straightforward. The single lanes in each direction are separated by a small traffic island. The Queen St approach has a left-hand curve at the point of the intersection and checkerboard-textured tiles, both of which provide further cues to slow down. There is a left turn arrow marked on the road.

Behavioural observations suggest that the signage is sufficient to communicate to drivers that they must not turn right into the EVA. However, several drivers were observed approaching the intersection without indicating, pausing at the intersection for quite long periods, or inching slowly around the corner when turning left. A few other drivers performed quite complex manoeuvres, such as U-turns and pulling on to the pavement, that may have been related to trying to navigate the EVA.

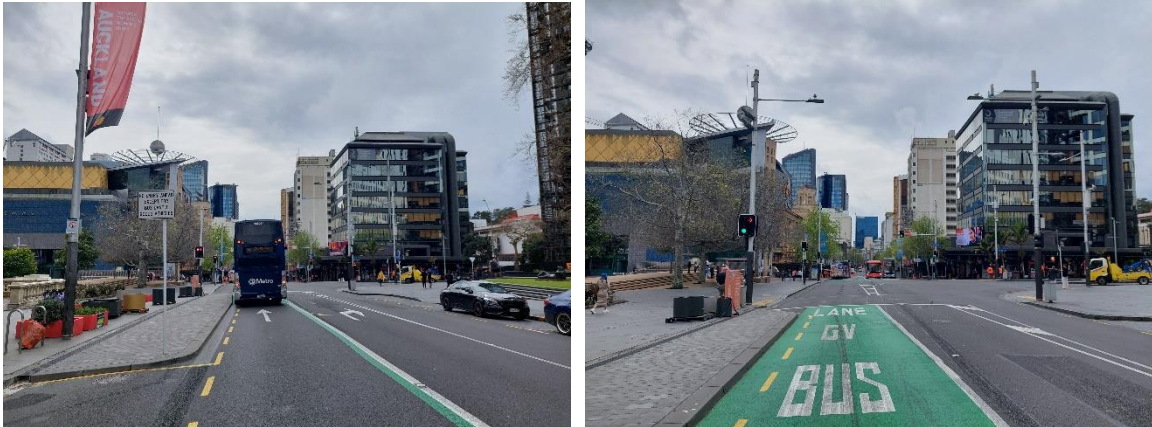
Figure 10: Queen Street northbound EVA approach

Behavioural observations suggest that the signage is insufficient in communicating to drivers that they must not proceed straight into the EVA. Fourteen non-permitted vehicles were observed entering the EVA.<sup>6</sup> Of these 14 vehicles, six were observed following another road user into the EVA. On one occasion four cars approached a red light in the right lane. The first car changed into the left (bus) lane at the light and came to a stop. The car behind copied the lead car and pulled to a stop mostly in the bus lane. The third car then followed suit, pulling slightly into the bus lane. The fourth car then also copied, pulling slightly to the left. The light then turned green and all four cars drove into the EVA.

Several drivers were observed approaching the intersection without indicating, pausing at the intersection for quite long periods, or inching slowly around the corner when turning right. A few other drivers performed quite complex manoeuvres, such as U-turns, that may have been related to trying to navigate away from the EVA. In one such instance a driver approached in the right lane without indicating. They proceeded straight through from the right lane (on a green light with a red arrow) to the threshold of the EVA. They noticed the EVA and quickly performed a U-turn in the middle of the intersection to avoid entering it. They then turned left into Rutland St. These manoeuvres are quite dangerous and put other road users at risk (particularly vulnerable road users) as the behaviour of the vehicles is quite unpredictable.

Several drivers were also observed turning right into Wakefield St and then into Rutland St (probably attempting to continue in a somewhat northbound direction). Upon realising that there is no thoroughfare through Rutland St, they turned around and exited Rutland St by turning left onto Wakefield St. There is no signage at the entry to Rutland St to indicate that there is no exit/no throughfare.

Finally, the issues of drivers following each other into the EVA in error is difficult to resolve. Hopefully the addition of additional signage and route planning information will help drivers be less reliant on following other vehicles.

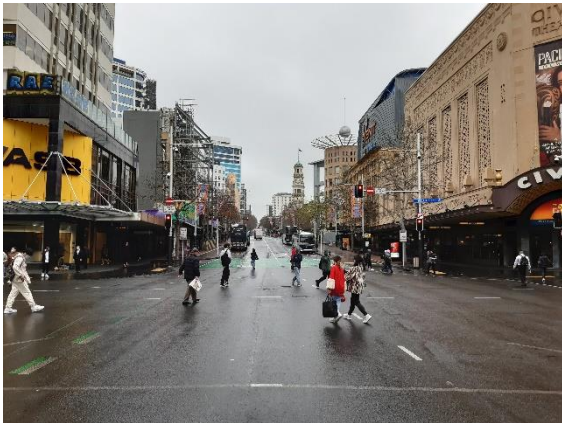
Figure 11: Queen Street southbound EVA approach

Commonly observed behaviours included vehicles approaching the intersection very hesitantly—one driver was even seen stopping to talk to a road worker. Some drivers seemed to realise that the EVA was ahead but could not confidently select another route in time and, therefore, proceeded straight into the EVA (sometimes very hesitantly).

Many drivers were observed turning right into the Wellesley St W bus lane as they were aware of the EVA, but not the Wellesley St W restrictions (or perhaps were aware of the cameras and automatic infringements in the EVA and the absence of a bus lane camera on Wellesley St W).

Wayfinding is also an issue at this site, evidenced by the hesitating behaviour at the intersection when drivers were attempting to plan another route, having expected to be able to travel up Queen St. The hesitations, abrupt turns (sometimes from the wrong lane), and unpredictable manoeuvres like U-turns are dangerous to other road users. Improvements in communicating alternate routes are required.

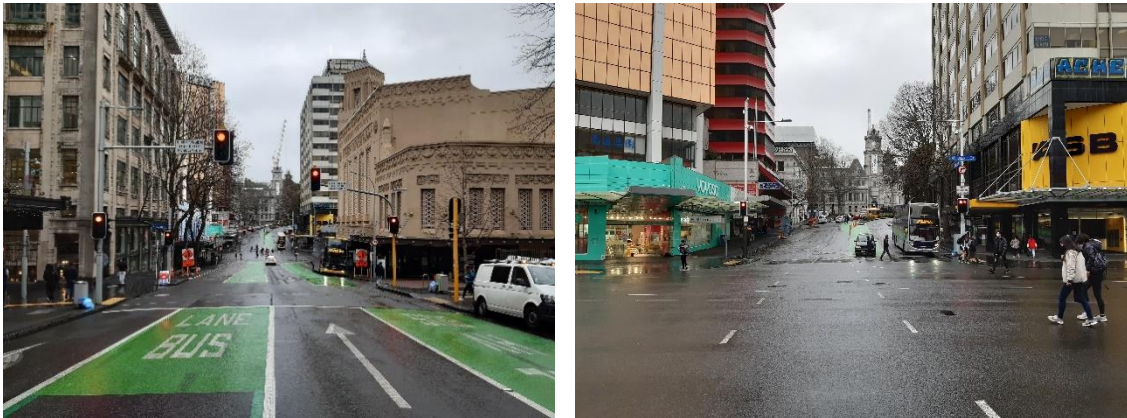
Figure 12: Wellesley Street West EVA approach

Some drivers were observed waiting at a red light in the right lane (indicating right to turn into the EVA) before noticing the signage and driving straight through the intersection (into Wellesley St E). Although some then made U-turns and travelled back along Wellesley St W. Others were observed stopped at a red light for quite some time before turning into the EVA with no indication that they had noticed the signage. On one occasion a vehicle in the right turning lane seemed to notice the EVA and hesitated at the green light. A bus behind began honking and the driver turned right into the EVA, seeming to know that the area was restricted but not having the ability to change route and avoid it.

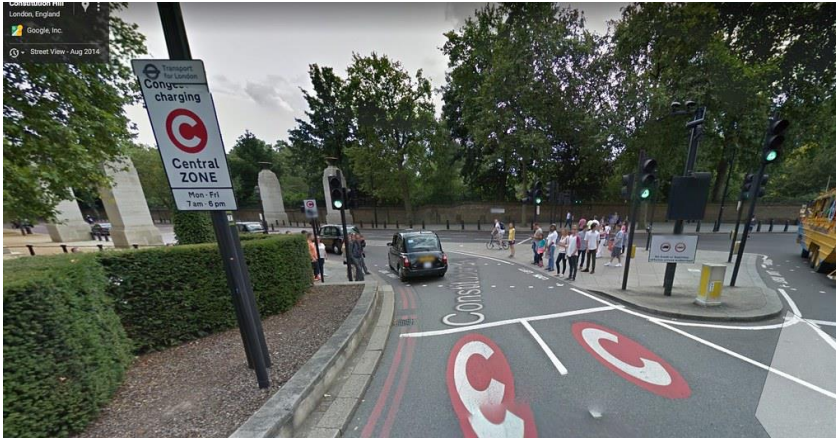
Figure 13: London Congestion Charging Zone.<sup>8</sup>

Figure 13 on the following page shows an example of the gateway concept used for the London Congestion Zone. This example doesn't contain all the elements suggested above but does provide an idea of what a gateway may look like.

At a concept level, we recommend developing gateway signage and road markings that connect the EVA more closely to the broader story of the City Centre Masterplan and the vision for the Waihorotiu/Queen Street Valley, communicating the 'why' of the intervention. We recommend making a feature of the EVA by making the 'gateway' visually eye-catching and including signs explaining the EVA (perhaps with a QR code for easy access to more detailed information and links to trip-planning guides). This should include large, uniquely coloured signs with matching pavement marking. Advanced signage should match the colours used and, if possible, a consistent and recognisable logo or brand should be used.
