From: [REDACTED]
Sent: Friday, 29 January 2016 1:52 pm
To: Blair@interwaste.co.nz
Subject: Interwaste change of conditions

Porirua Waste Treatment Facility

Project No: IZ068200
 Document Title: 2018 Biofilter Assessment
 Document No.: IZ068200W003
 Revision: Final
 Date: 6 September 2018
 Client Name: Interwaste Ltd
 Client No:
 Project Manager: [REDACTED]
 Author: [REDACTED]
 File Name: I:\AEN\W\Projects\IZ068200- Interwaste 2016
 (Porirua)\Technical\2018\IZ068200W003.docx

I have recently taken over as compliance officer for resource consent WGN110357[34191] held by International Waste Limited: to discharge contaminants to air arising from the operation of a waste sterilisation facility at 12 Broken Hill Road, Porirua.

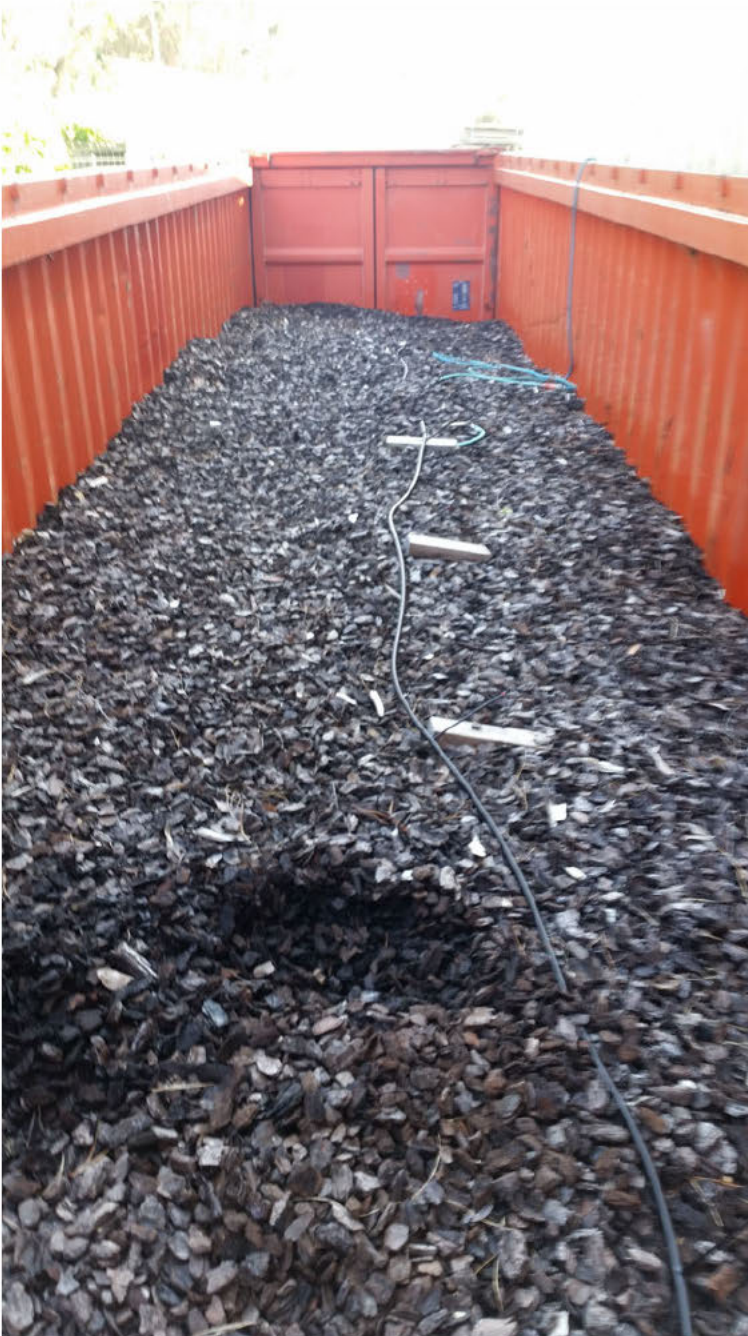
Figure 1 Interwaste biofilter surface

The duct leading into the biofilter connects to a manifold at the bottom of the biofilter to distribute the extracted air evenly throughout the biofilter base. The biofilter bed is contained within a steel shipping container 12 metres long, 2.2 metres wide and 2.7 metres high. The biofilter bed itself is composed of coarse (30 to 40 mm) bark and is designed for a depth of approximately 1 metre. Beneath this layer is gravel/scoria in which the lateral ducts (flexible PVC tubing of 0.1 metre diameter) are embedded. The lateral ducts are capped at their termination and are perforated along their length to disperse waste air evenly throughout the bed. The bed is equipped with a sprinkler to supply water to the biofilter bed which is operated on a timer to supply water to the biofilter on an as needed basis. Figure 1 is photograph of the biofilter surface and a technical drawing of the biofilter is provided in Figure 2.

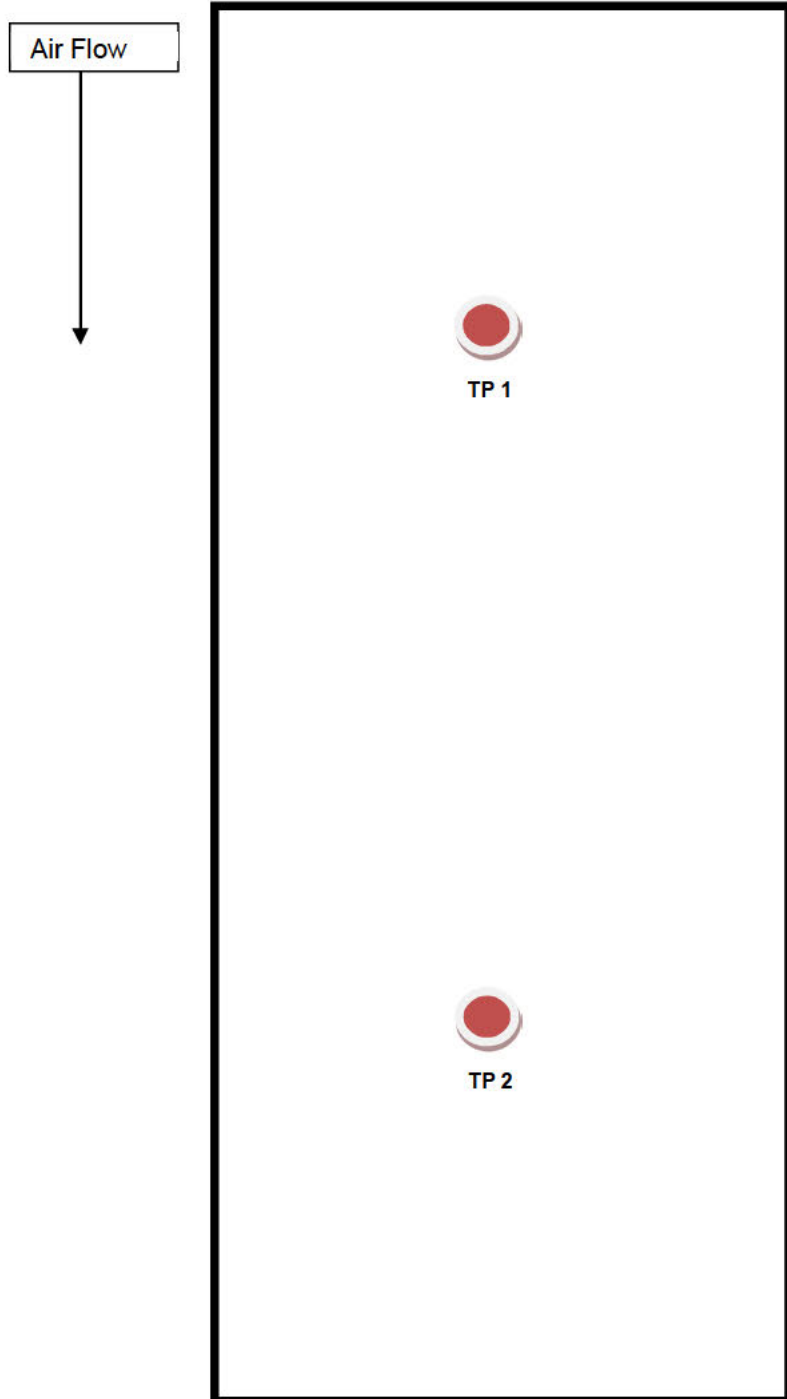
Appendix A. Test Pit Locations

Two test pits were dug in the biofilter and samples collected at two depths (200 mm and 400 mm below the surface). The four samples were sent to a laboratory for analysis of moisture content, pH, and bacterial count. The laboratory test report is included as Appendix B, and the results are summarised in Table 1.

Sample Number	Sample Location	Moisture Content (%) Dry Basis	Media Acidity (pH)	Viable Microorganism Count (cfu/g)
18/41395-01	Test pit 1 – depth 200 mm	63.1	6.8	220,000
18/41395-02	Test pit 1 – depth 400 mm	24.3	5.7	880
18/41395-03	Test pit 2 – depth 200 mm	60.0	6.6	3,200
18/41395-04	Test pit 2 – depth 400 mm	63.1	6.8	3,900

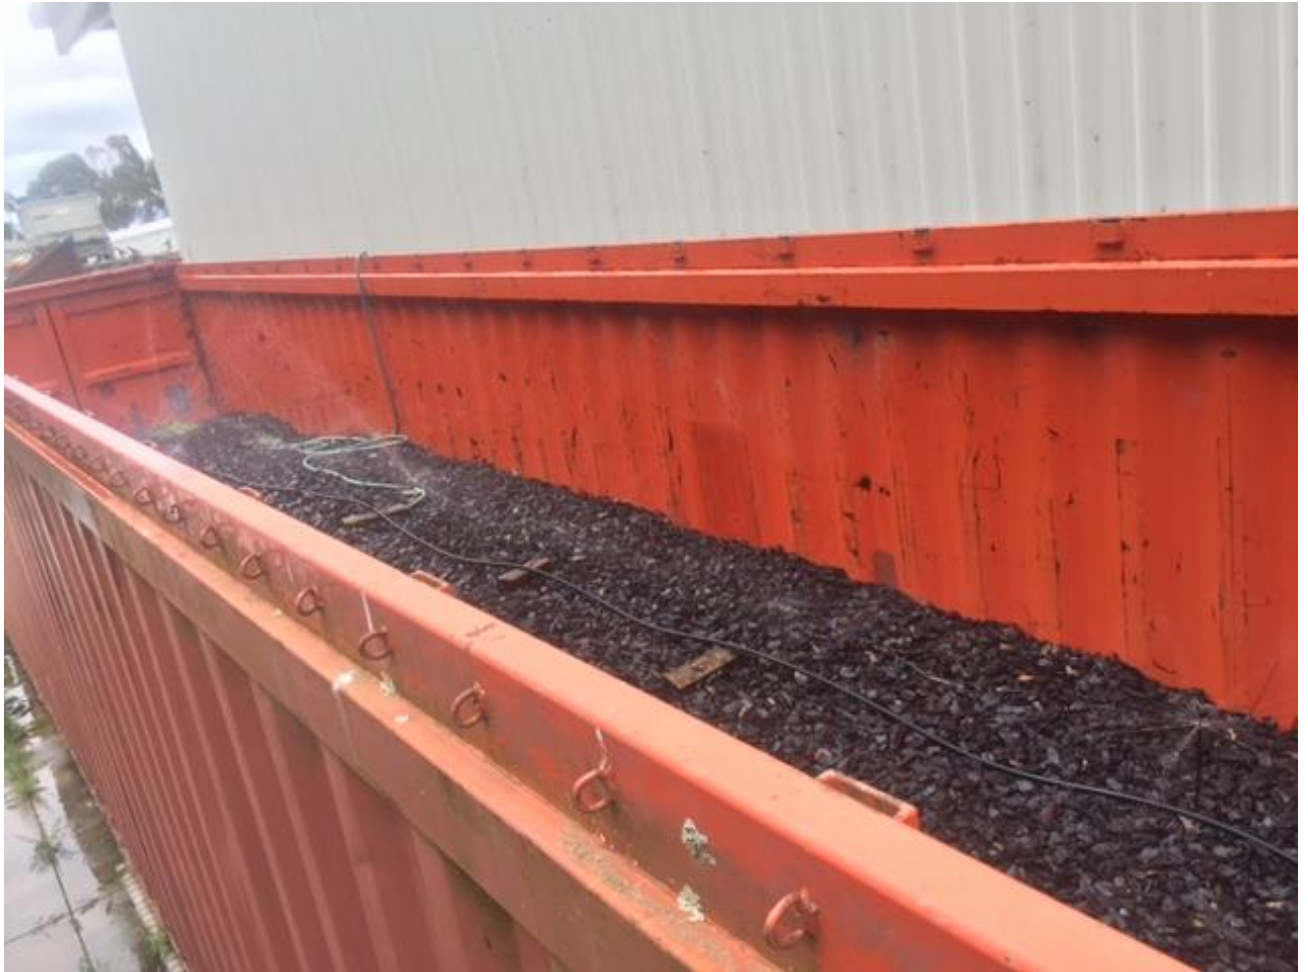
We talked through the consent conditions and Blair confirmed they had taken on board Jacobs advice at their last assessment regarding increased water application in the biofilter so that the bark doesn't get too dry. They have a sprinkler system in the biofilter, which they regularly keep an eye on to ensure it doesn't get too dry.

Figure 1 top of biofilter and sprinkler system

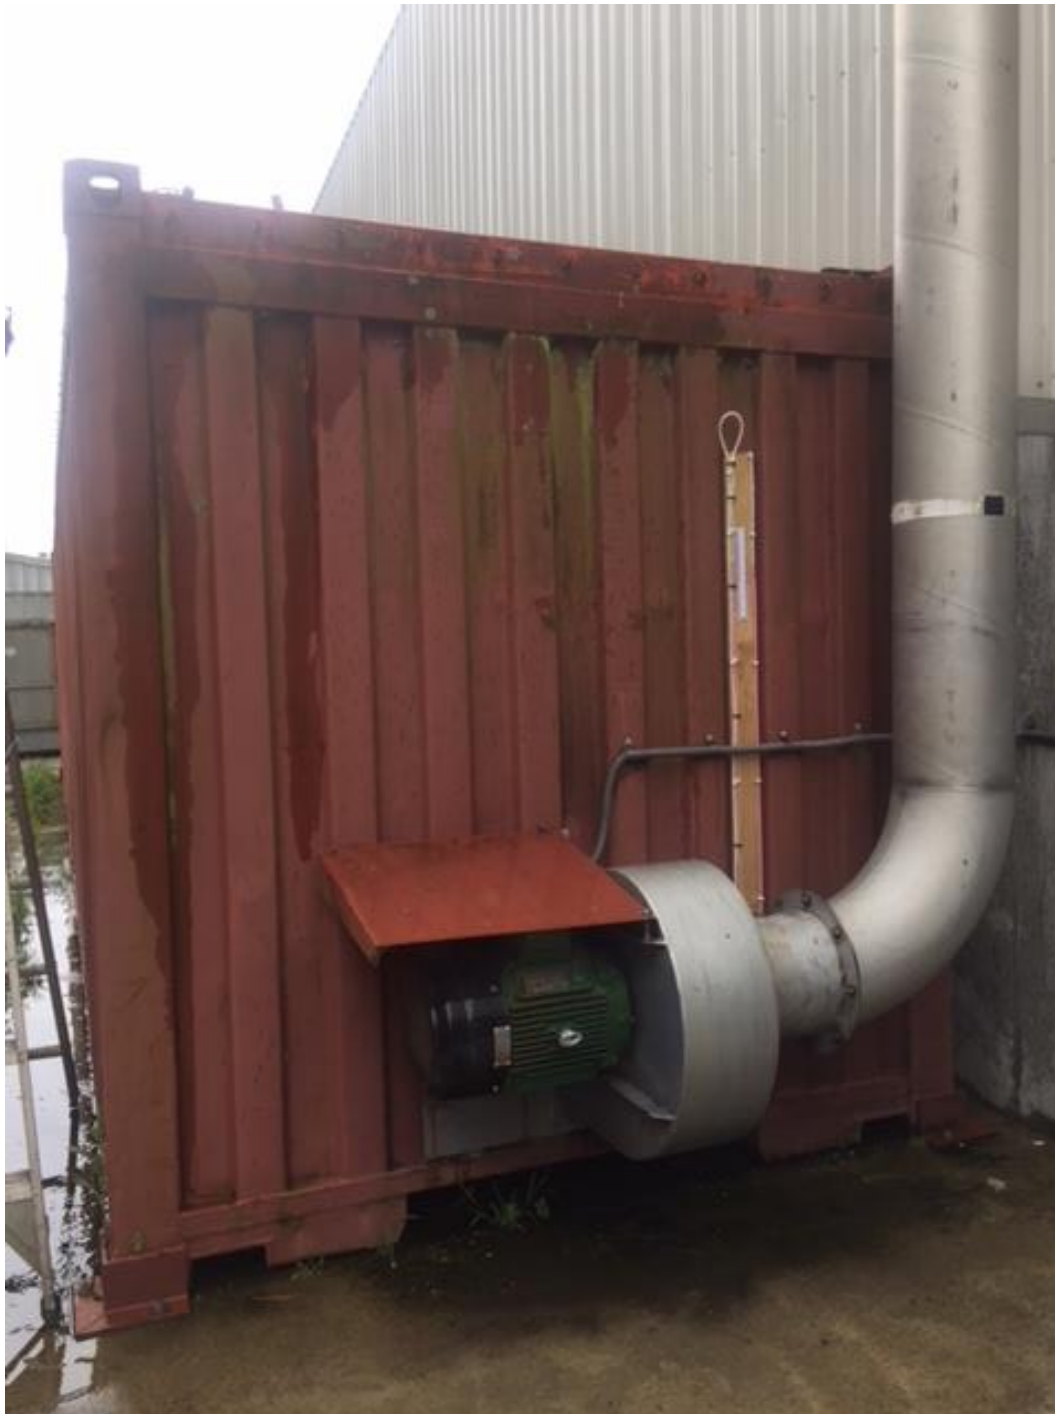
Figure 2 outside of biofilter with gauge and vent

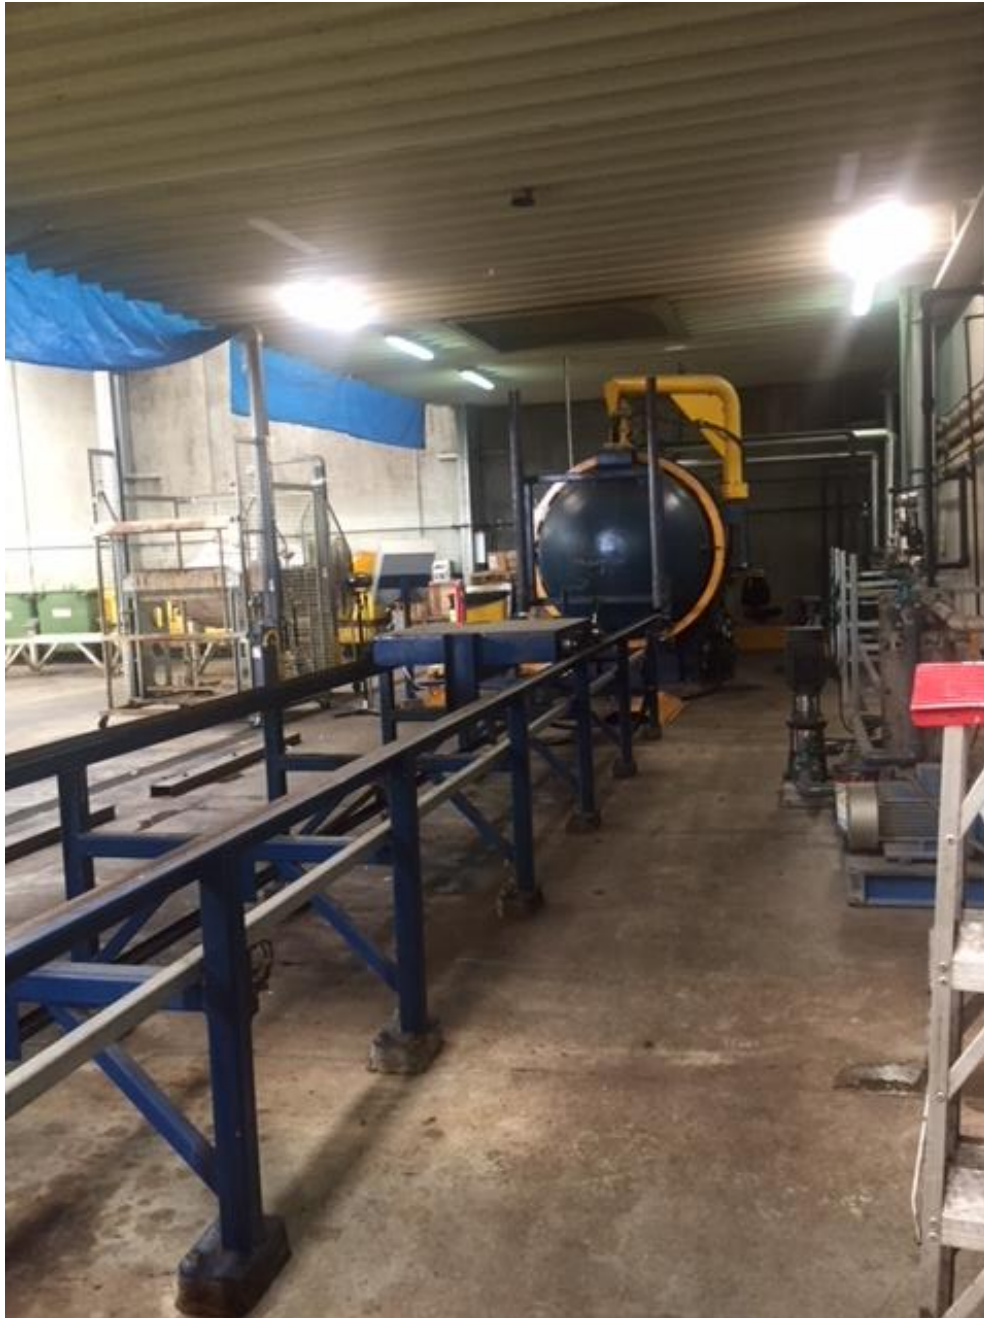
Figure 3 Autoclave machine
