Lake Okareka Fire Station

Geotechnical Assessment Report

Date: 22/08/2018
Reference: 4-52149.02
Status: FINAL

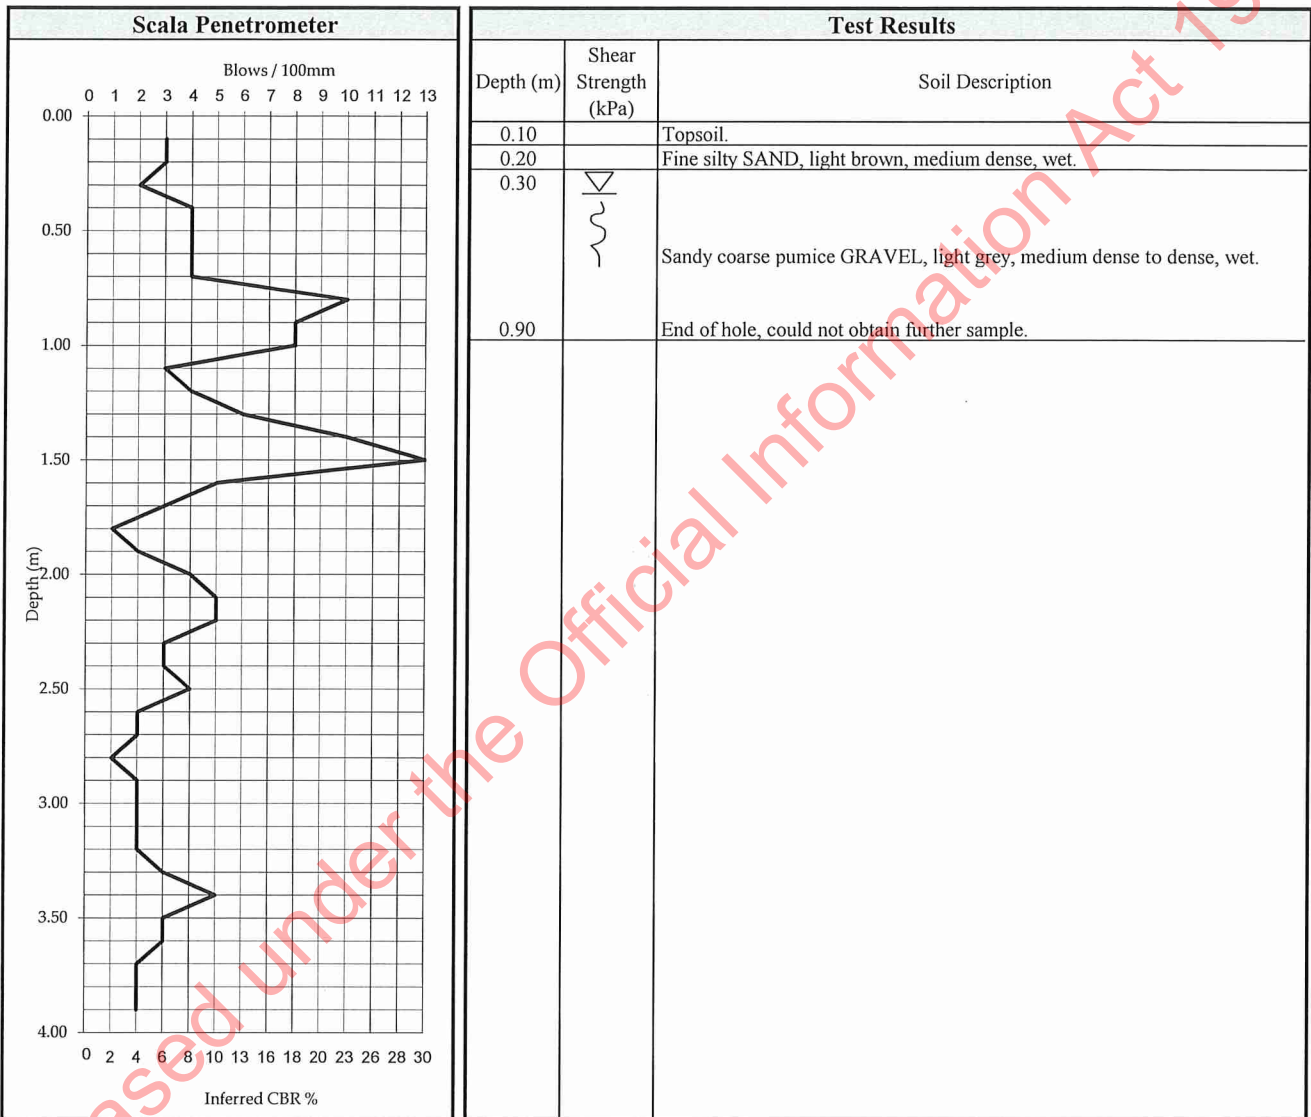
Project No : 4-52149.00
Lab Ref No : RT1097
Client Ref No : 00GEO

Project : **Lake Okareka Fire Station**
 Location : **Corner of Okareka Loop Road and Acacia Road**
 Client : **WSP Opus**
 Contractor : **Unknown**
 Test number : **1**
 Shear vane number : **N/A**
 Shear vane correction : **N/A**
 Water level (m): **0.3**
 Reduced level (m): **N/A**

Test Methods	
Determination of Penetration Resistance of a Soil, NZS 4402 : 1988, Test 6.5.2 Shear Strength using a Hand Held Shear Vane: NZ Geotechnical Soc Inc 8/2001 Inferred CBR values taken from Austroads Pavement Design Manual 2004	Field Descriptions of Soils and Rocks by NZ Geotechnical Society Dec 2005, Scala over 1.5m and Inferred CBR values are not IANZ accredited

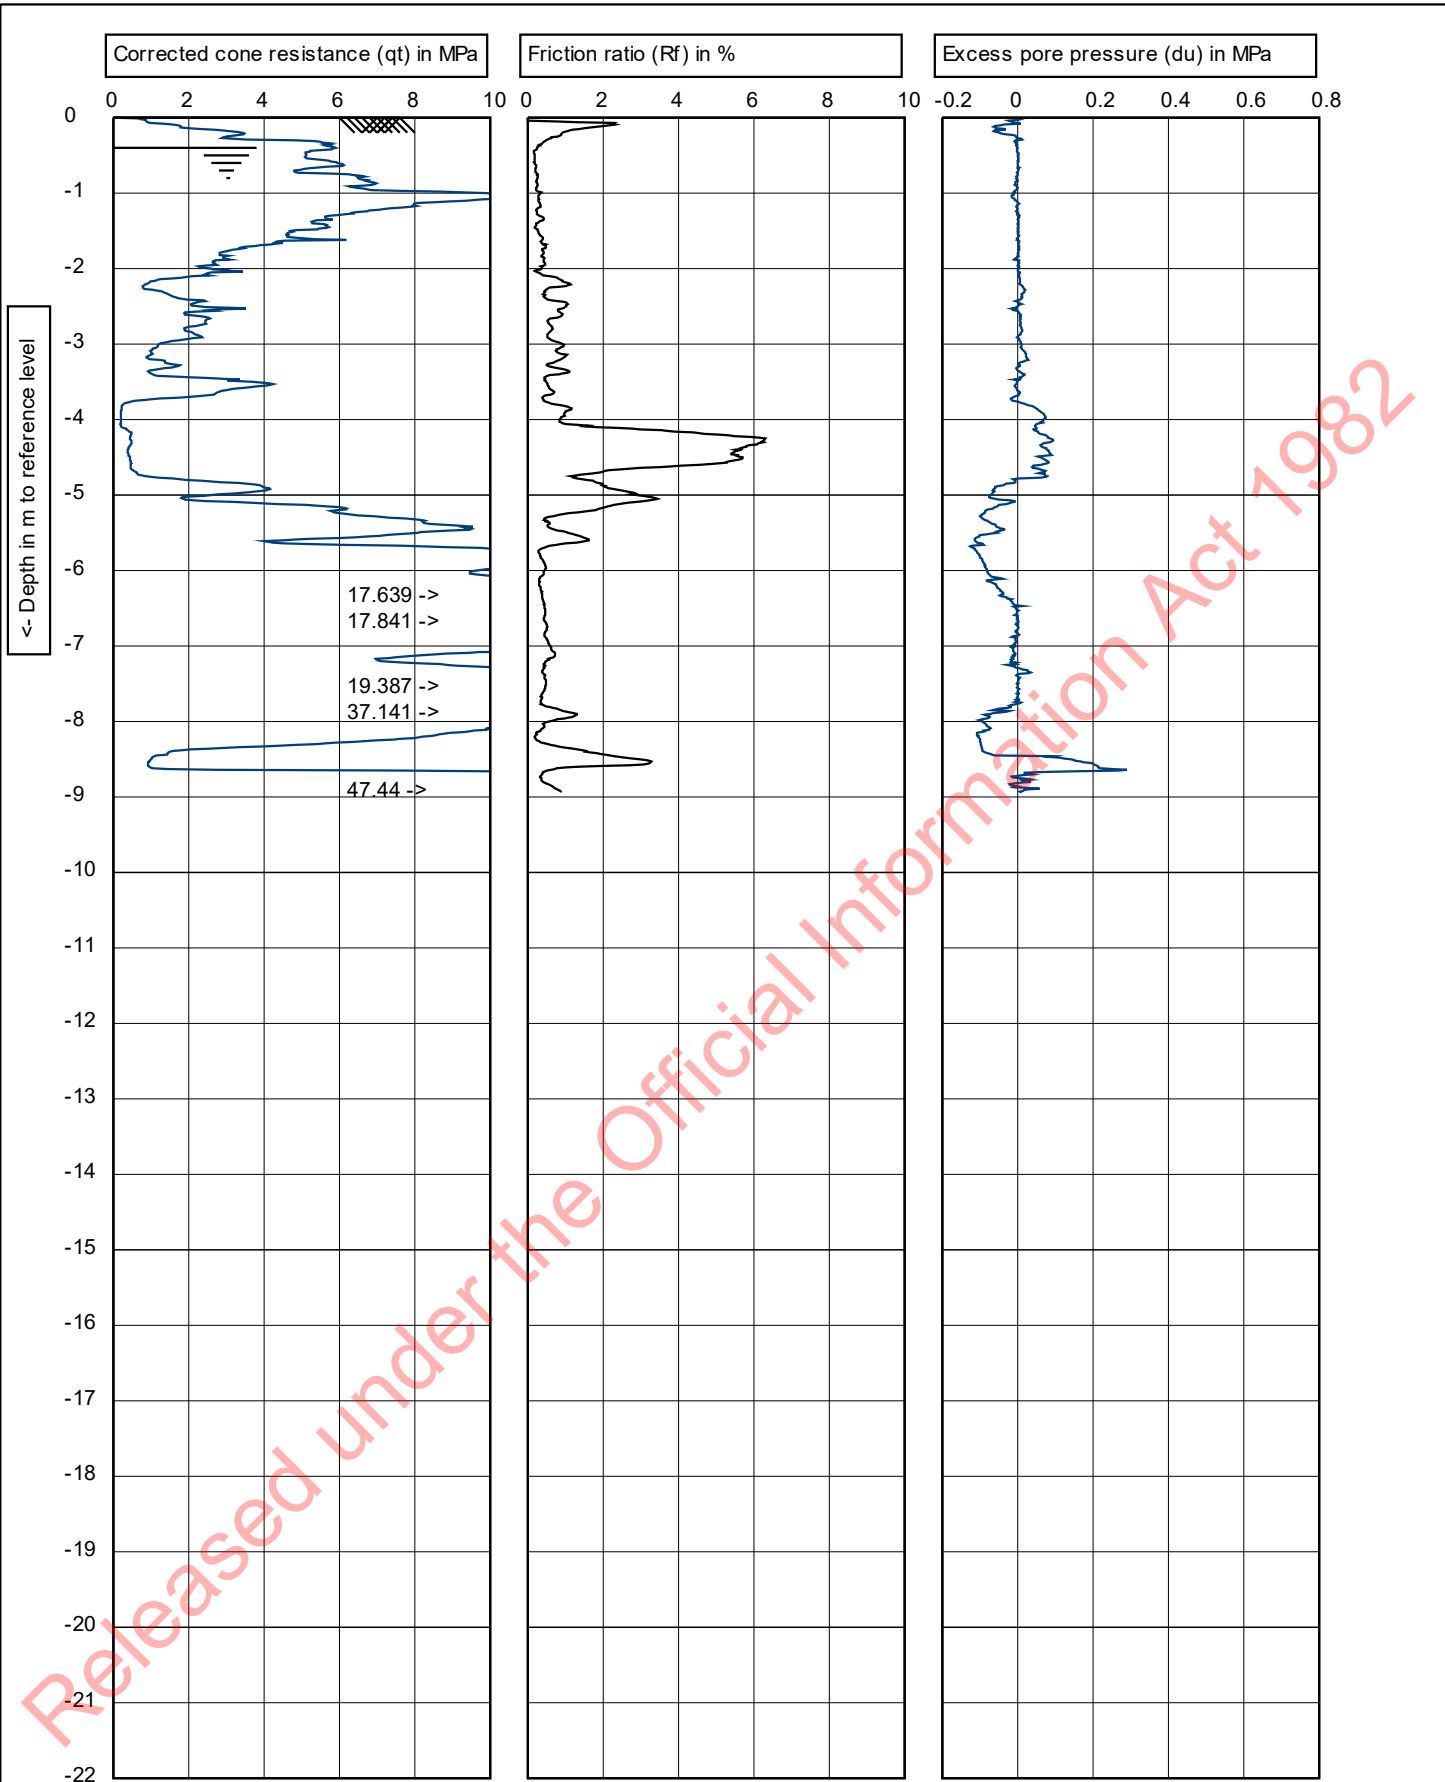
Cone no.: C10CFIP.C15211
 Project no.: 4-52149.02_HA3040
 CPT no.: 01

Refusal (qc 40+ MPa)

EOH - Dipped - GWL @ 0.4m

Project: Lake Okareka Firestation
 Location: Okareka Loop Rd - Lake Okareka
 Position: 1893208, 5769393 NZTM

Ground water table was found in every geotechnical test location at depths ranging from 0.1m to 0.4m below ground level.

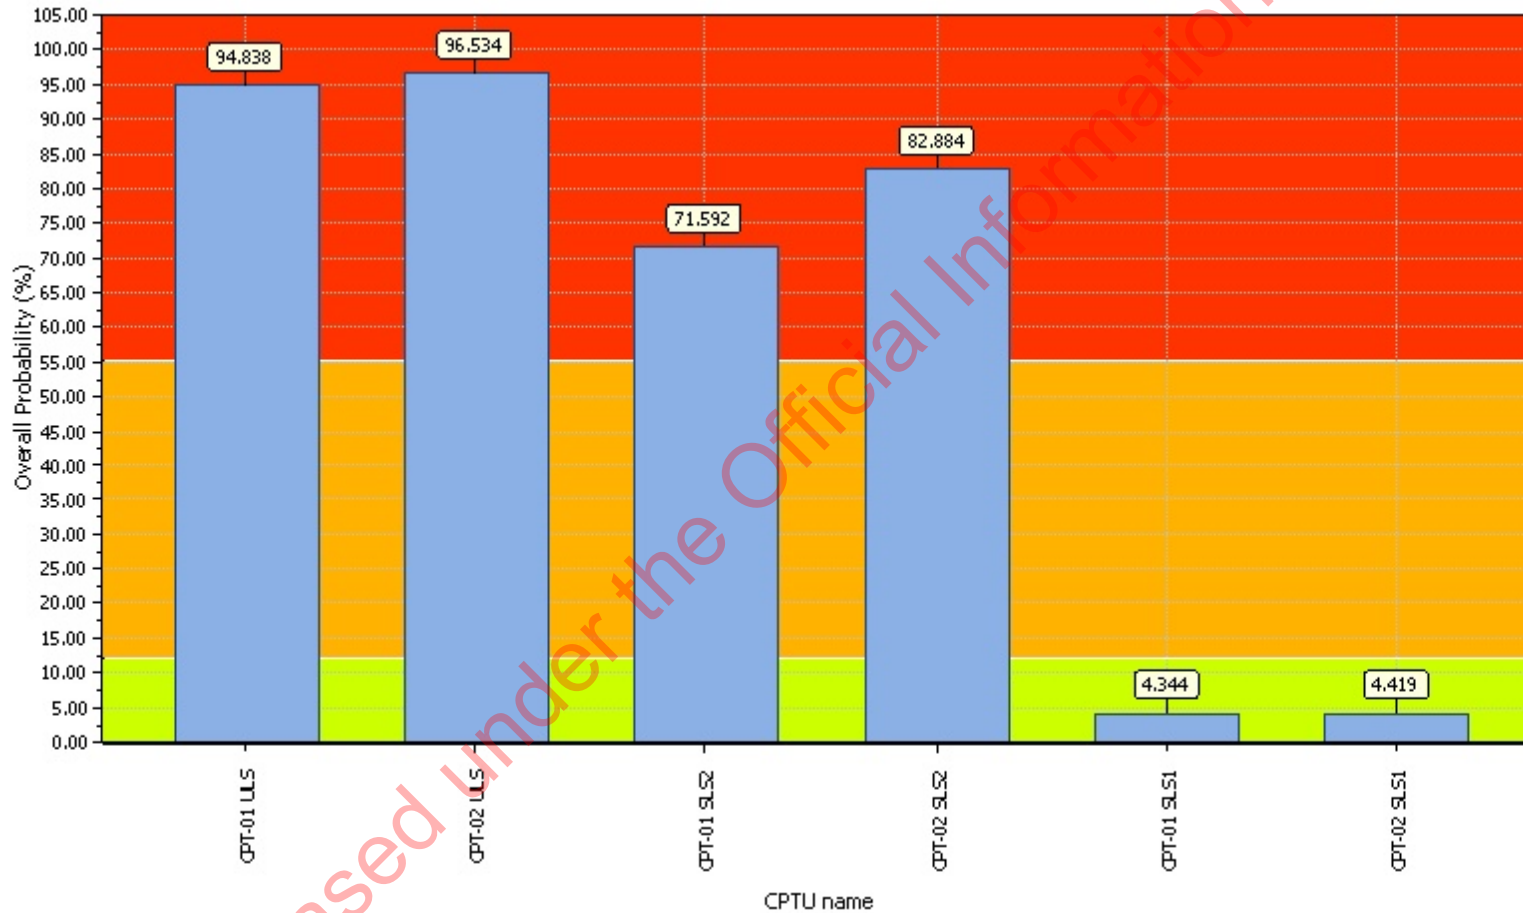
Overall Probability for Liquefaction report

- Very High Probability
- High Probability
- Low Probability

A quantitative assessment of liquefaction potential has been undertaken using proprietary liquefaction analyses software Cliq (V.1.7) by Geologismiki, which provides an assessment of liquefaction potential using the available CPT test data. The liquefaction assessment was undertaken using the Idriss and Boulanger (2014) calculation method. The Cliq outputs are presented within Appendix D.

The surficial Holocene alluvial granular subsoils encountered at the subject site typically comprise variable very loose to medium dense sands, that if saturated, maybe susceptible to liquefaction during an extreme seismic event, as shown in Table 4.
