# **Level Crossing Safety Impact Assessment Totara Street Rail Crossings**

# Level Crossing Safety Impact Assessment

## Totara Street Rail Crossings

Date: 13 November 2017  
Reference: 2-9B278.09  
Status: Issue 2

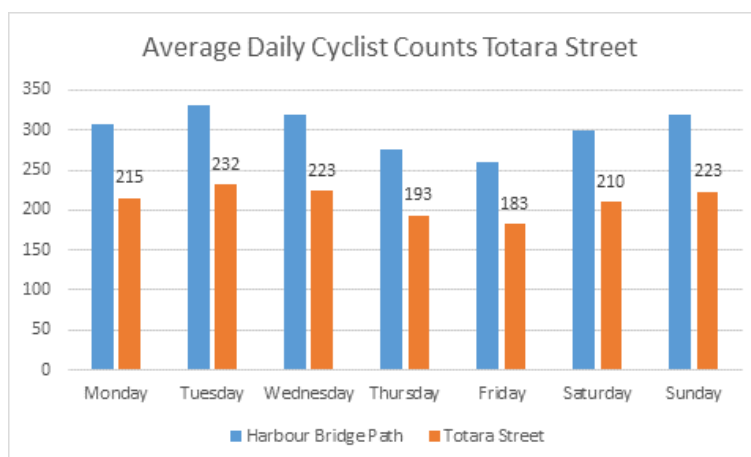
**Figure 1: Totara Street Daily Averages – Cyclists**

Tauranga City Council have provided the following graph of Cyclists Counts on Totara Street. They estimate 67,369 cycle trips per annum are completed on the Totara Street route. The 5-day cyclist average is 209 cyclists per day, and the 7-day average is 212 cyclists per day for Totara Street. No dates of counts were supplied. This data has been used in the LCSIA assessment as a basis for the future cyclist volumes using the separated cycle facility.

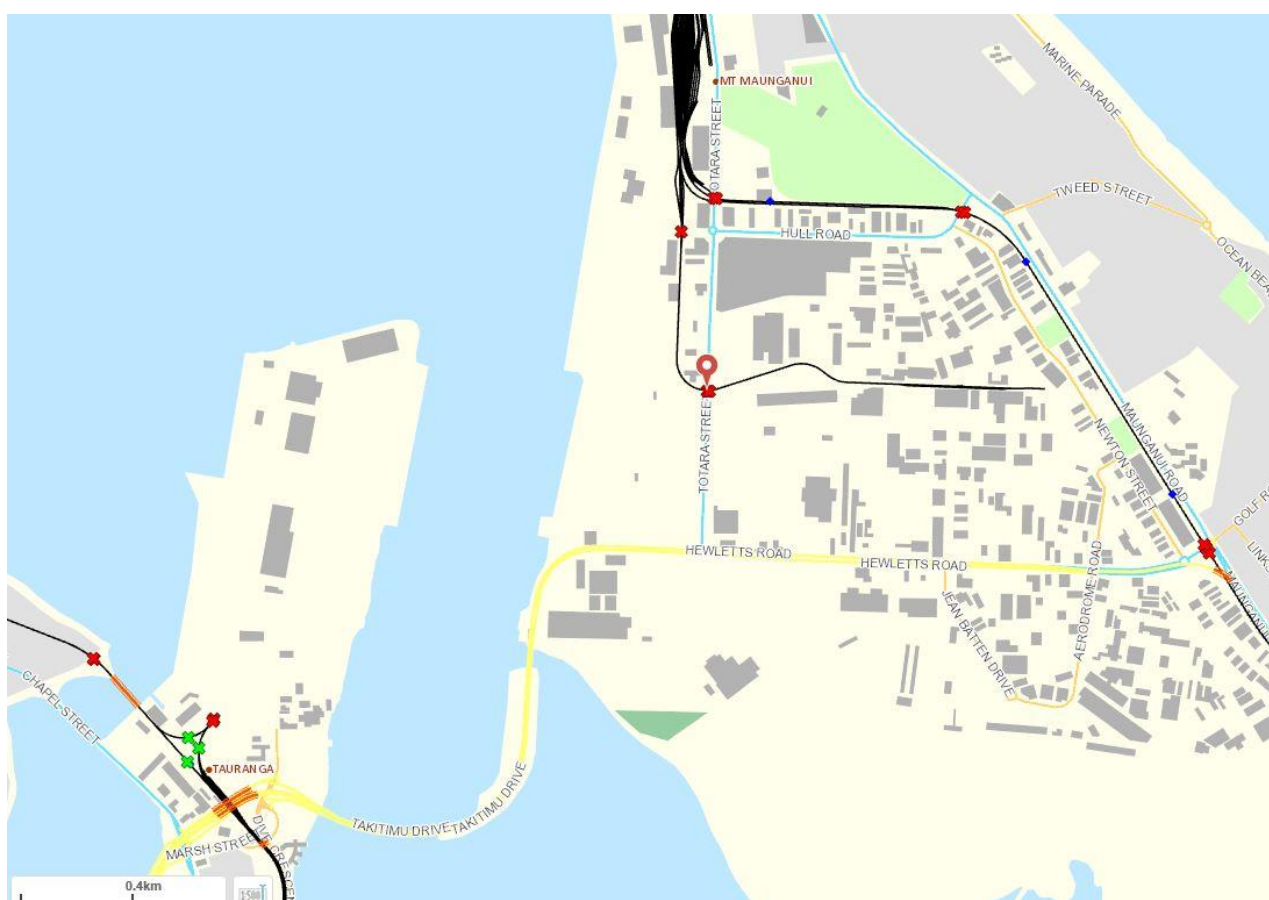
**Figure 3: Location diagram**

The Road/Rail at Grade crossing (1926/1927) is located approximately 200 metres south of Astrolabe Street on Totara Street. The road has one lane in each direction with traffic islands in the median, marked on-road cycle lanes and a narrow footpath on the eastern side of the road. A location plan identifying the crossing within the KiwiRail Network is below, along with an aerial photograph of the crossing.

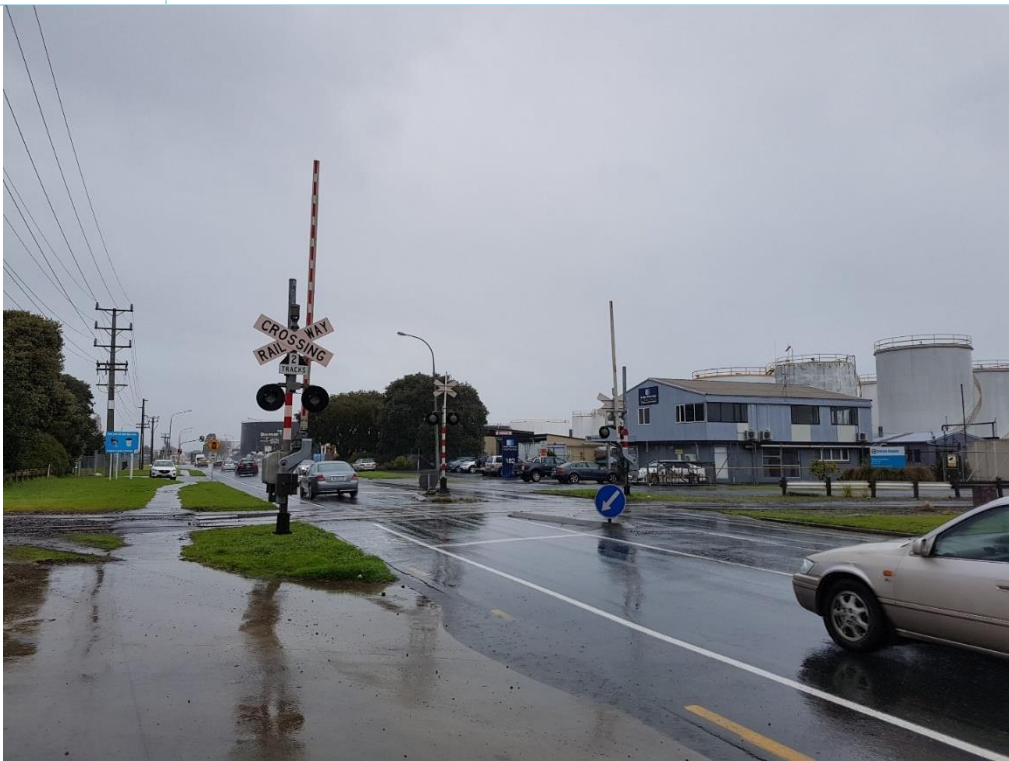
Score	Narrative/Scenario
<b>Category 1: Crossing Type</b>	
6/10	Acceptable visibility with flashing lights not facing all approaches. No maze or chicane, pedestrian facilities on one side of the road only. No 'Look for Trains' signs. Additional FLB assembly in the median is facing northbound traffic only.

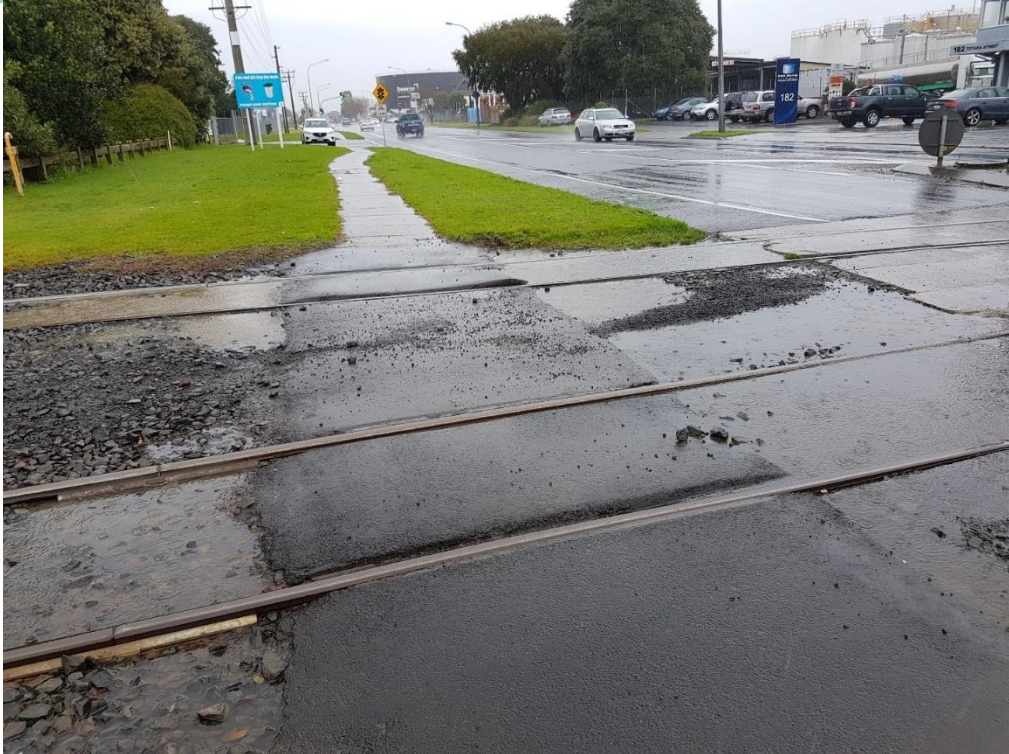
<b>Category 2: Flange Gap wheel entrapment</b>	
5/5	Flange gaps up to 8cm present on both tracks. Assessed as 'bad' flange gaps that a wheeled pedestrian could become trapped. Low pedestrian numbers who could otherwise assist them to safety or to be freed.

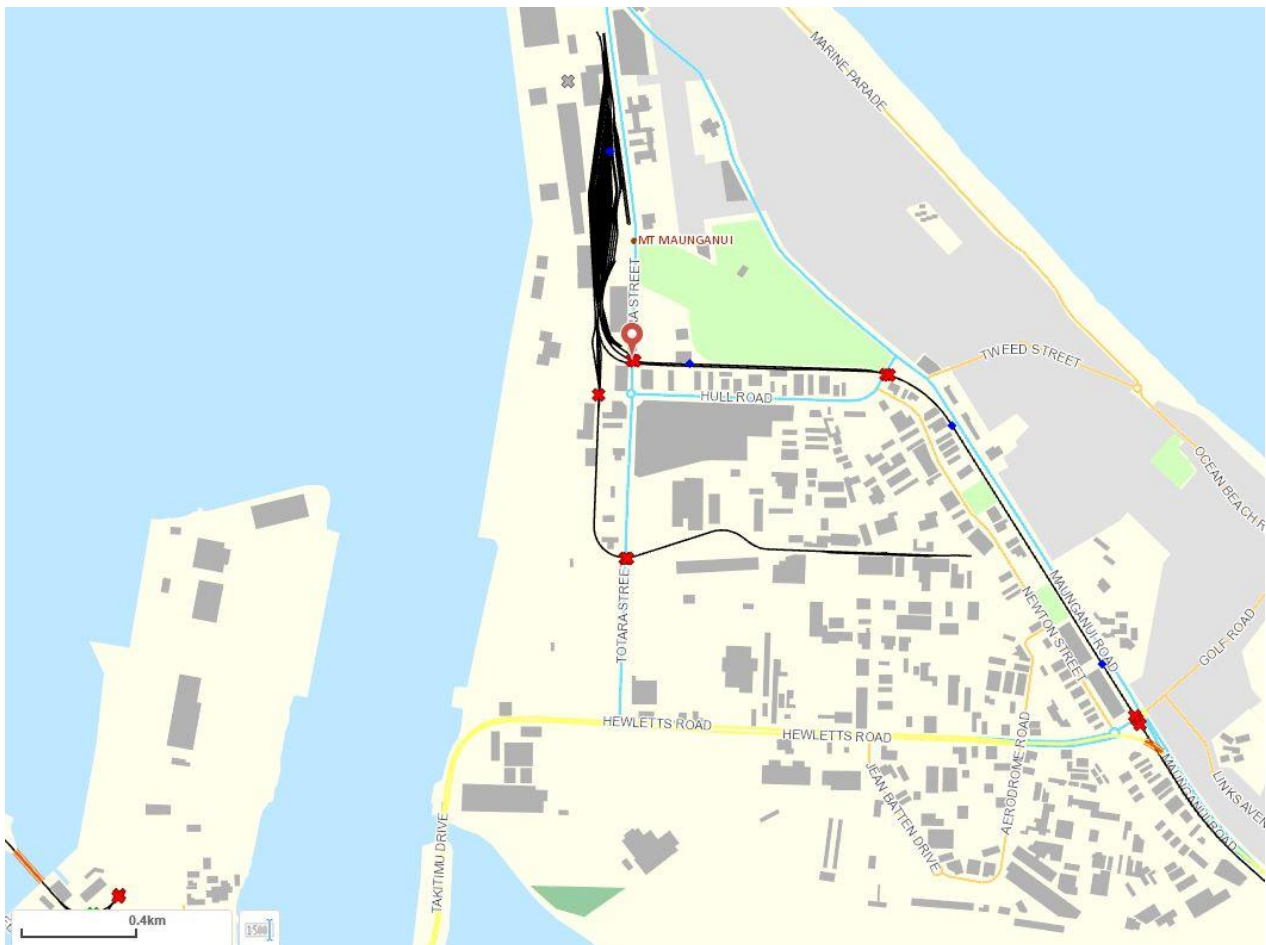
**Figure 9: Location diagram**

The Road/Rail at Grade crossing (1590/1591) is located approximately 100m north of Hull Road on Totara Street. The road has one lane in each direction and a narrow footpath is provided on the eastern side of the road. The crossing is in close proximity to the major Mt Maunganui freight yard servicing the Mt Maunganui Port. A location plan identifying the crossing within the KiwiRail Network is below, along with an aerial photograph of the crossing.

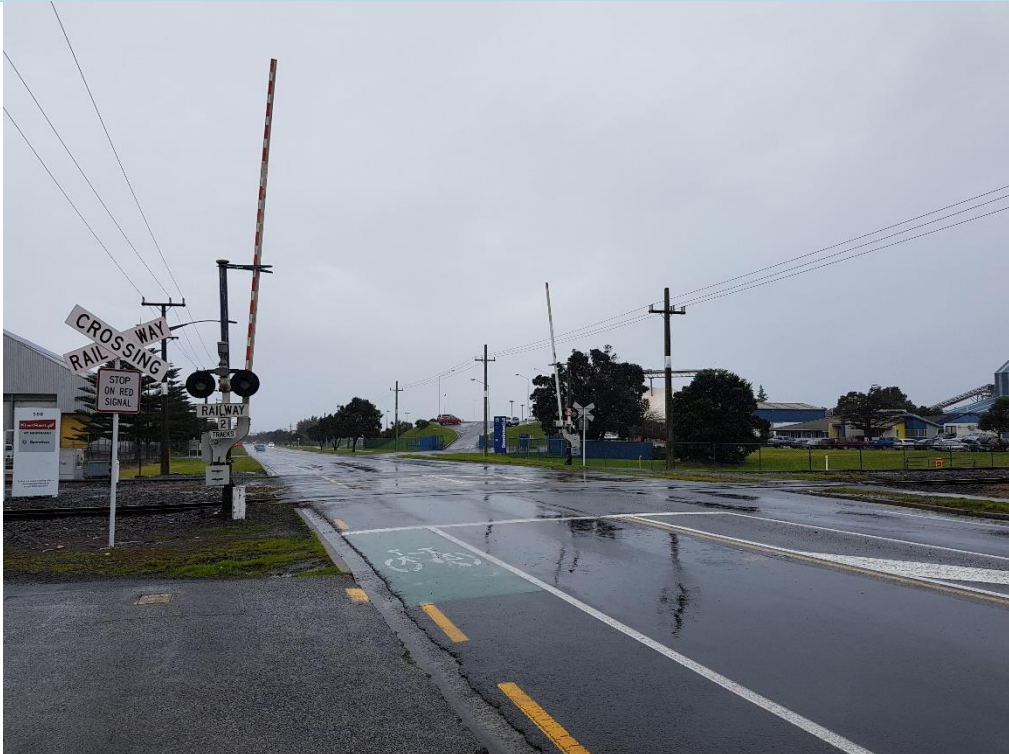
Score	Narrative/Scenario
<b>Category 1: Crossing Type</b>	
5/10	Good visibility with flashing lights not facing all approaches. No maze or chicane, pedestrian facilities on one side of the road only.

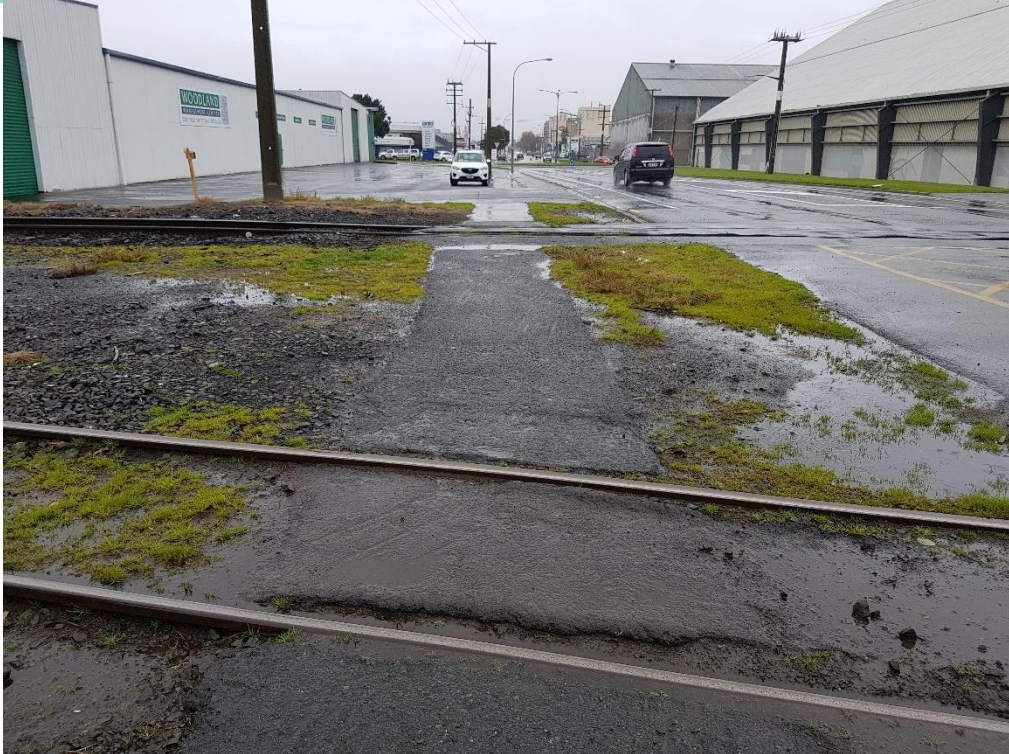
<b>Category 2: Flange Gap wheel entrapment</b>	
5/5	Flange gaps up to 12cm present on both tracks. Assessed as 'bad' flange gaps that a wheeled pedestrian could become trapped. Low pedestrian numbers who could otherwise assist them to safety or to be freed.

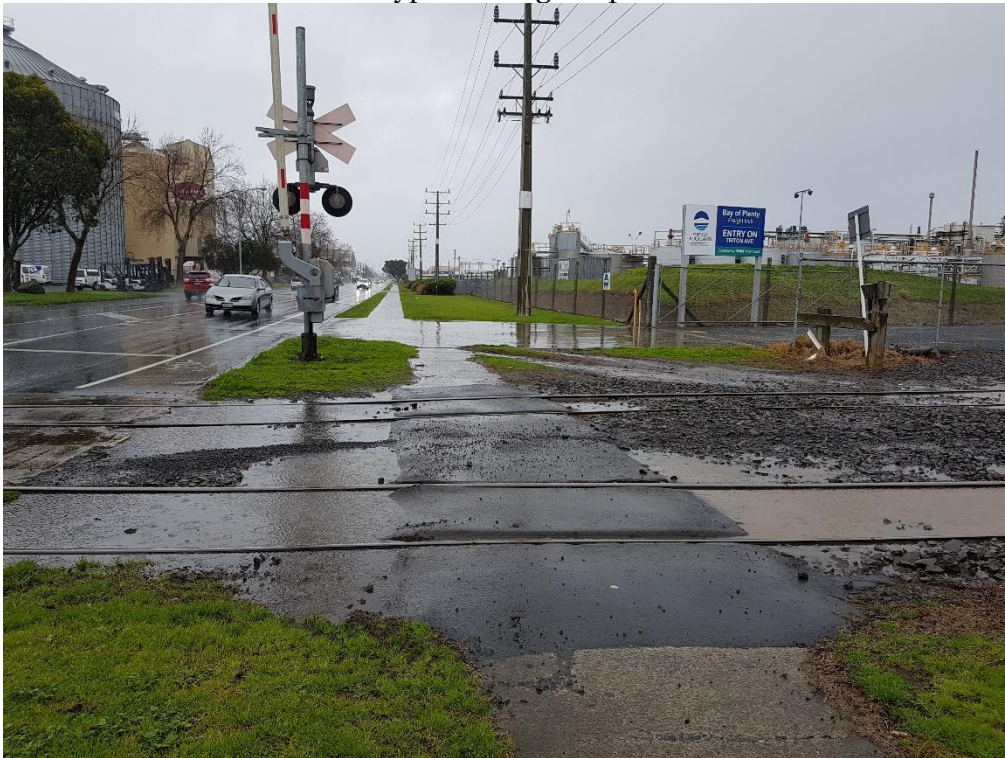
The surface of the footpath at the level crossings is uneven and create trip or trap hazards for pedestrians.

Footpath – looking North from the east side

**Recommendation:**

Provide a level and even path surface free of trip hazards and obstacles.

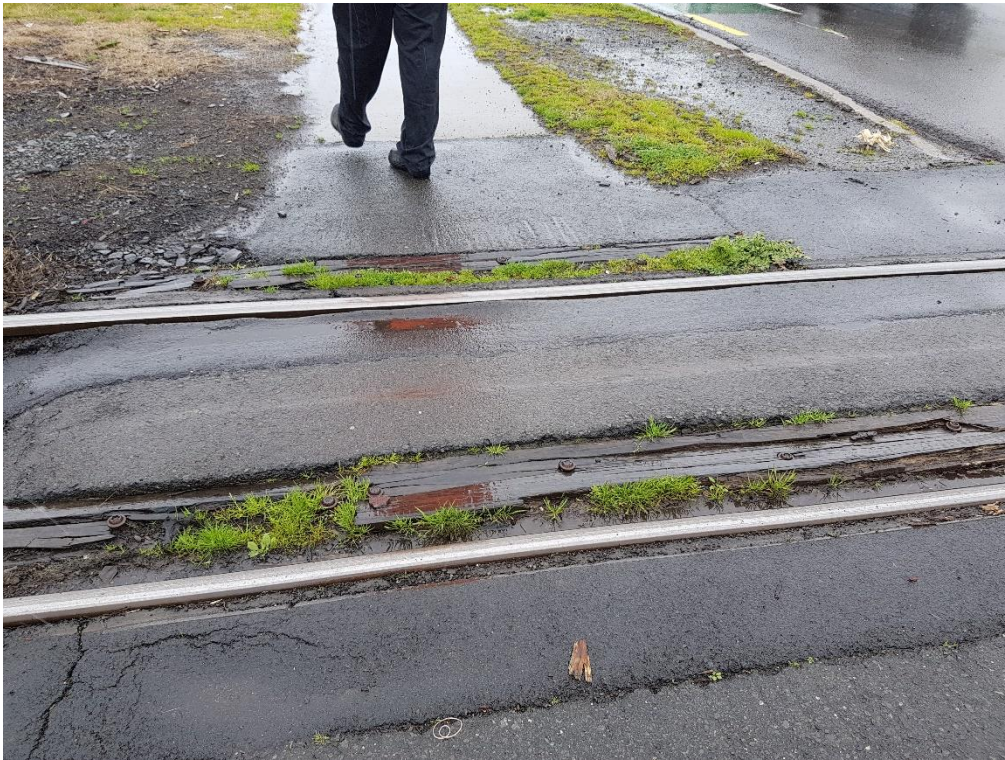
Typical Flange Gaps

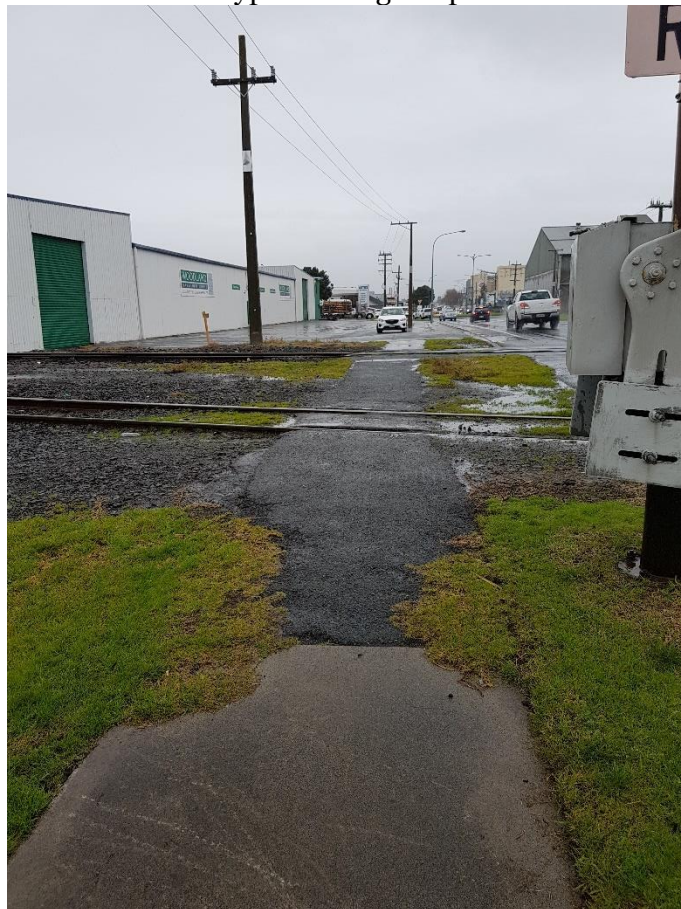
The surface of the footpath at the level crossings is uneven and creates trip or trap hazards for pedestrians.

Footpath – looking south from east side

***Recommendation:***

Provide a level and even path surface free of trip hazards and obstacles.
