**Assessment of rock fall risk at Mintaro Hut site on
the Milford Track, and evaluation of potential new
sites for Mintaro Hut in the upper Clinton valley,
Fiordland National Park**

**GNS Science Consultancy Report 2012/315
May 2013**

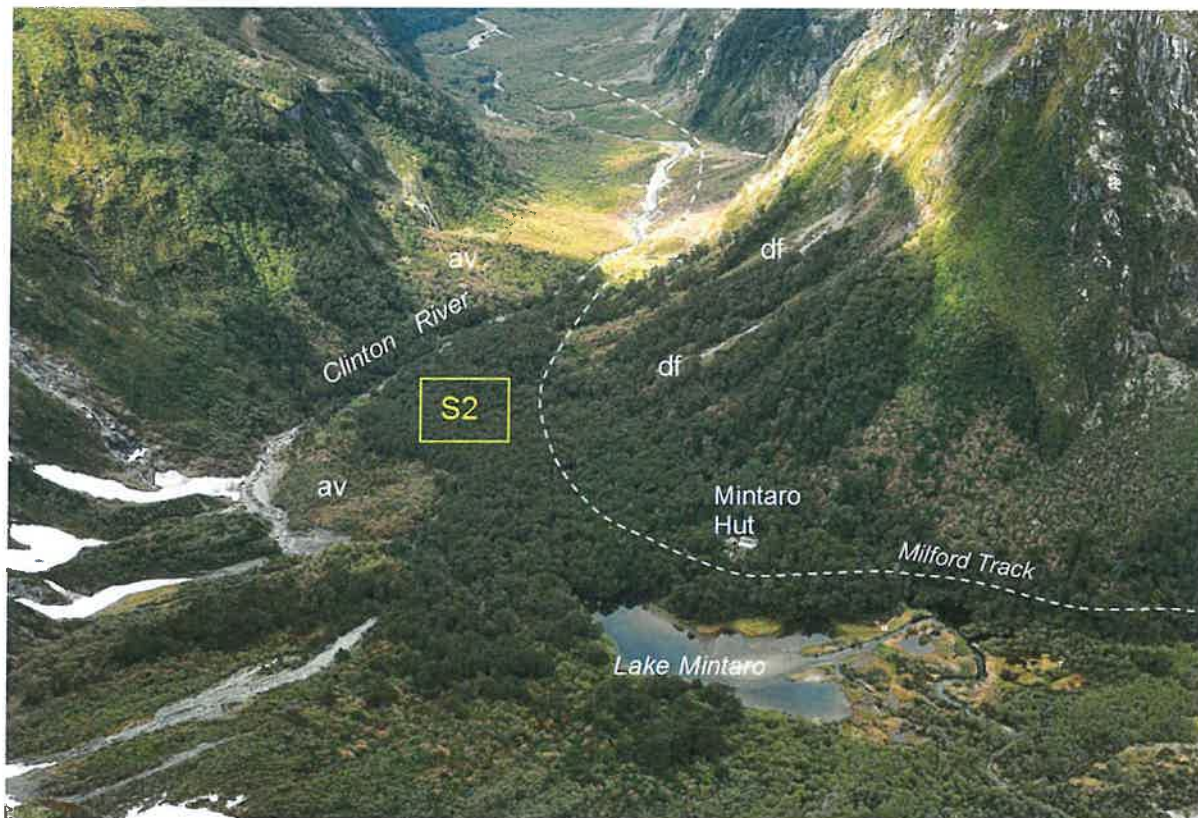
Figure 5 Aerial view of potential hut Site 2 (S2) located in beech forest on the true right left (west) side of the Clinton River, about 500 m down valley from Mintaro Hut. Although the site is generally clear of the avalanche blast zones on the east side of the valley (*av*) and debris flow paths on the western side (*df*), the site and general area is littered with old rock fall boulders under the bush cover.

Site is located in beech on the east side of the Milford Track about 500 m downstream from the current Mintaro Hut site. Snow avalanche paths from the eastern side of the valley are present upstream and downstream but do reach the site (Figure 3 and Figure 5).

The area of Site 2 was inspected from the air and on the ground. The ground inspections showed that below the beech forest canopy, the ground surface around Site 2 and areas on both sides of the Milford Track down to the river was littered with rock fall boulders at least ~0.3 to 1 m or more across. The site was therefore interpreted as being within an ancient rock fall runout zone (Figure 3), probably formed by periodic rock falls from the west (true right) side of the valley.

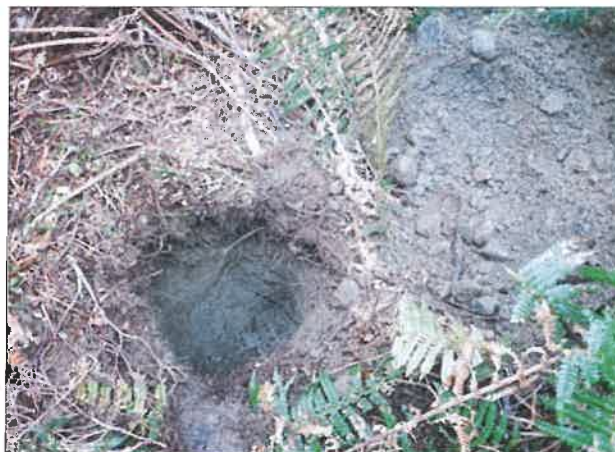
Figure 9 Photo of test pit TP2 at hut Site 3 (depth 400 mm) showing the thin (50 mm) brown organic top soil, underlain by 60 mm of sub-angular gravel and medium grey sand with occasional large cobbles. These materials are typical of the alluvium underlying the forest floor across the potential site area.

The main activities undertaken to assess the site during the field visit included: (a) geomorphic reconnaissance of rock fall, flood zone, and avalanche paths, (b) basic GPS survey of site features, including the Milford Track and footbridge, rock fall boulders, a flood overflow channel, and 5 shallow test pits dug at the site. The locations and extent of these features are shown in the site map of Site 3 (Figure 7). The soil materials found in the test pits are summarised in Table 2. Figure 9 shows the fine gravel and sand deposits found in TP 2, which are generally typical of the river alluvium (gravel and sand) underlying Site 3.

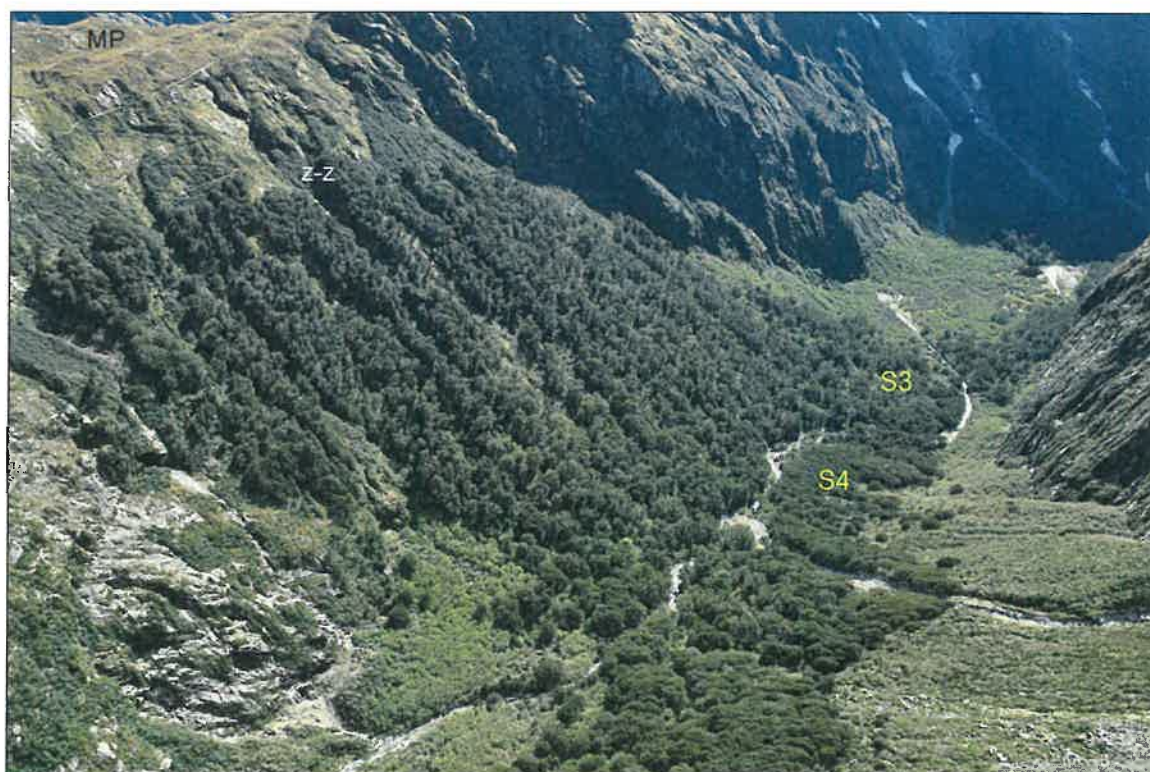
Figure 10 Aerial view of potential hut sites 3 and 4 looking down the Clinton Valley below Mackinnon Pass (MP). The zig-zag (z-z) section of the Milford Track below the pass traverses an old rock fall deposit on the northern side of the valley. Both sites are located in bush near the centre of the valley and are outside the main rock fall zone (left) and the known avalanche paths (Zig-zag and Mintaro, Figure 7). Site S4 is also outside the potential flood zone and debris fan (lower right).

Site 4 is located on the true right of the Clinton River, about 250 m upstream from the footbridge (Figure 7, Figure 8, Figure 10, Figure 11, and Figure 12). Site 4 was initially overlooked during the November site visit, but was identified later during preparation of this report, and inspected on the ground at our request by Ross Kerr on 4 January 2013, following a severe weather event.

Site 3: There is both physical and anecdotal evidence of minor flooding hazard in the area of Site 3 (Figure 7 and Figure 10). Flooding caused by a back-up of water from Lake Mintaro periodically overtops the heli-pad and covers the Milford Track upstream to the footbridge and across the Site 3 area to a depth of up to 1 m during severe rainstorms, possibly every 5 years or so (pers comm. Hamish Angus, DoC Te Anau, 14/11/2012).

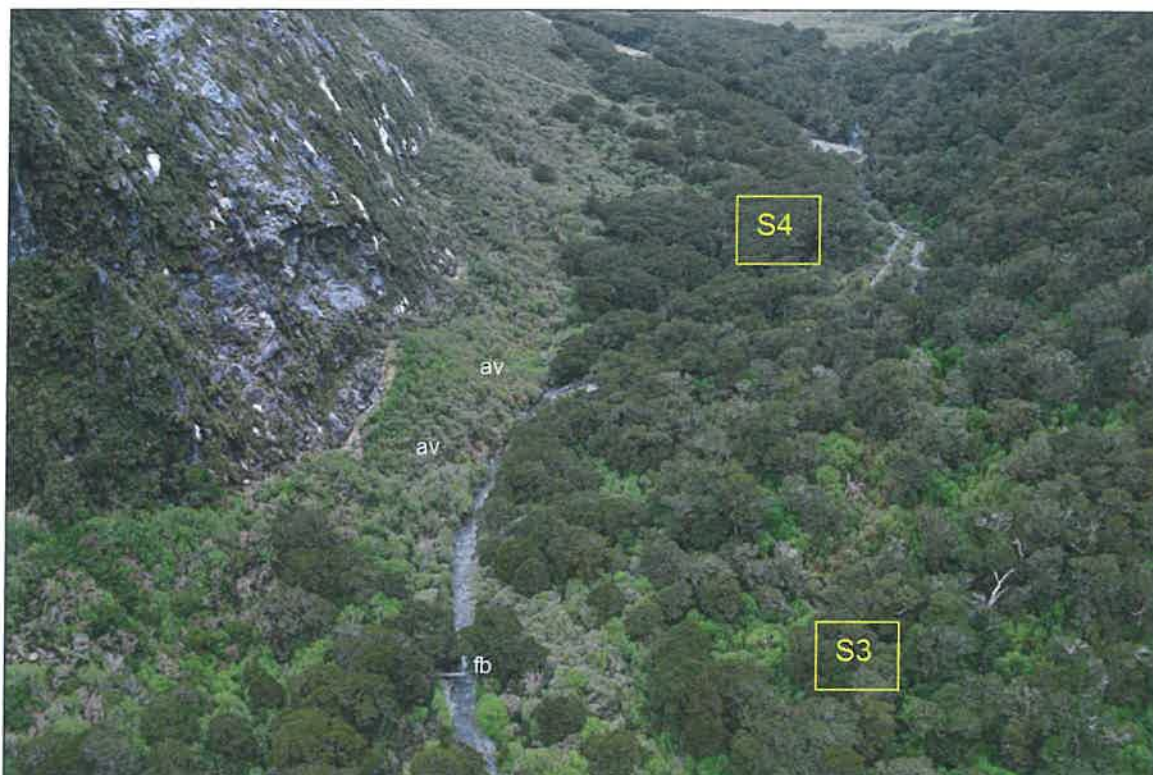
Figure 11 Aerial view looking up the Clinton River towards potential hut Site 3 and Site 4. Site 3 is in an area of large beech trees (dark green) and ribbonwood and fuchsia forest (lighter green). Site 4, which is located in thick beech forest ~250 m upstream from the footbridge (*fb*), is outside the known rock fall, debris flow, flooding, and snow avalanche hazard zones in the area.

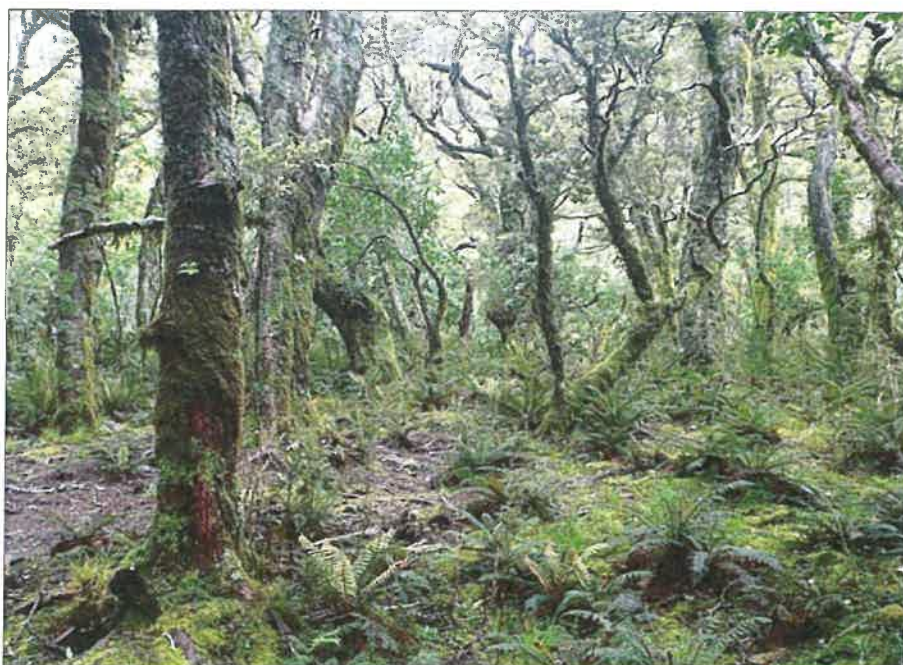
Figure 12 Ground view of Site 4 showing the undisturbed sub-alpine beech forest growing across the area. The site is gently sloping, free of rock fall boulders, and is well elevated about 2–3 m above river level. *Photo by Ross Kerr, 04/01/2013.*

Based on the vegetation at the site, which is generally undisturbed tall sub-alpine beech forest (see Figure 12 and Figure 13), and its slightly elevated position above river level, Site 4 is considered to be located outside the flood inundation zone from the Clinton River and back-up from Lake Mintaro. This interpretation appears to have been confirmed by Ross Kerr's ground inspection report (above) following the major floods that hit the area in January 2013. However, ongoing monitoring of Site 4 during future flood events is needed to establish a longer-term basis on which to assess the rock fall, debris flow, flooding, and snow avalanche hazards at the site.

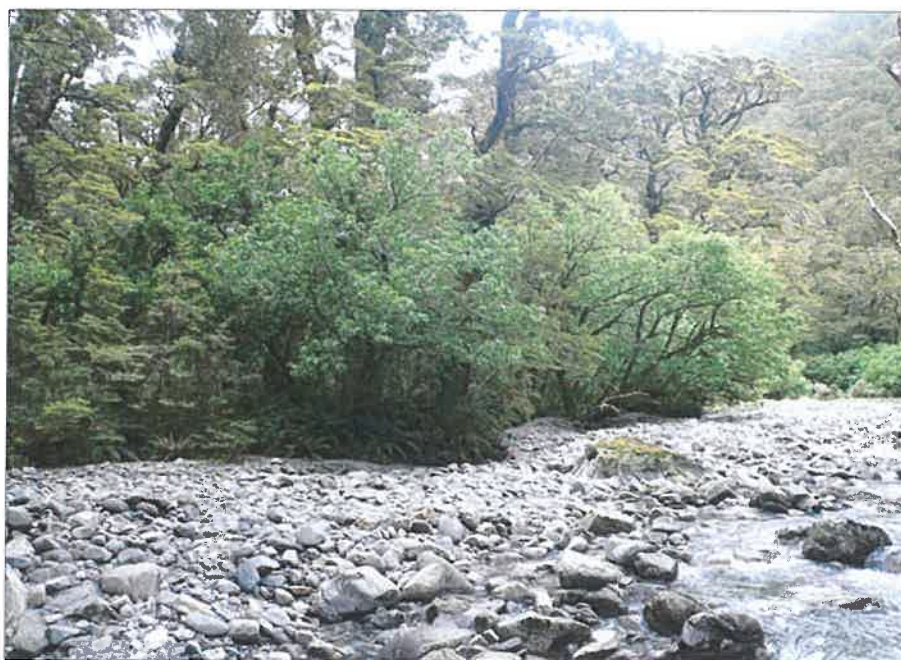
Figure 13 View of Site 4 (upper left) from river level. The site is elevated about 2–3 m above the upper Clinton River, and shows no evidence of past flood damage. *Photo by Ross Kerr, 04/01/2013.*

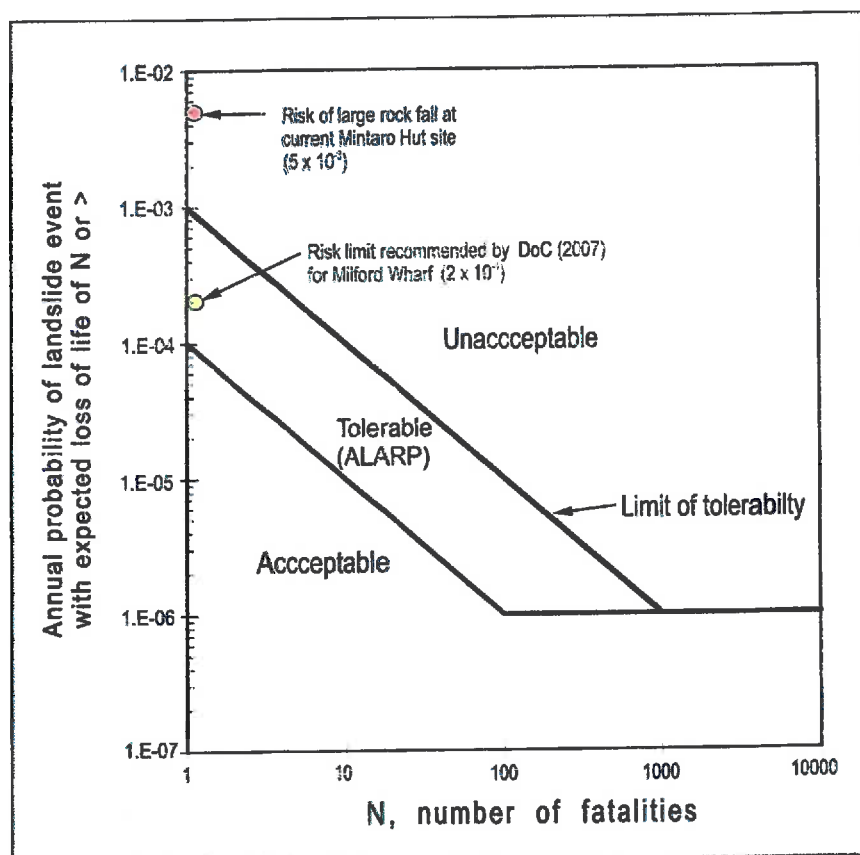
Figure A 3 Estimated annual risk from a large rock fall at the current Mintaro Hut site in relation to the ANCOLD (2003) Risk Criteria and the risk limit proposed by DoC for the Milford Wharf.

The ANCOLD (2003) tolerable risk limit of 10^{-4} per annum is consistent with the value proposed by the Australian Geomechanics Society (AGS, 2007), which suggests that for existing slopes or existing developments (as at Mintaro Hut) the Tolerable LOL Risk for the individual most at risk is 10^{-4} per annum. Figure A 3 shows the risk (annual probability of loss of life) estimated for a large rock fall at the current Mintaro Hut site (5×10^{-3}) plotted in terms of the "Acceptable" and "Tolerable" risk limits currently in use by ANCOLD.
