# NORTH HEAD: THE DEVELOPMENT OF A FORT

SCIENCE AND RESEARCH INTERNAL REPORT NO. 79

NORTH HEAD: THE DEVELOPMENT OF A FORT

D G Veart

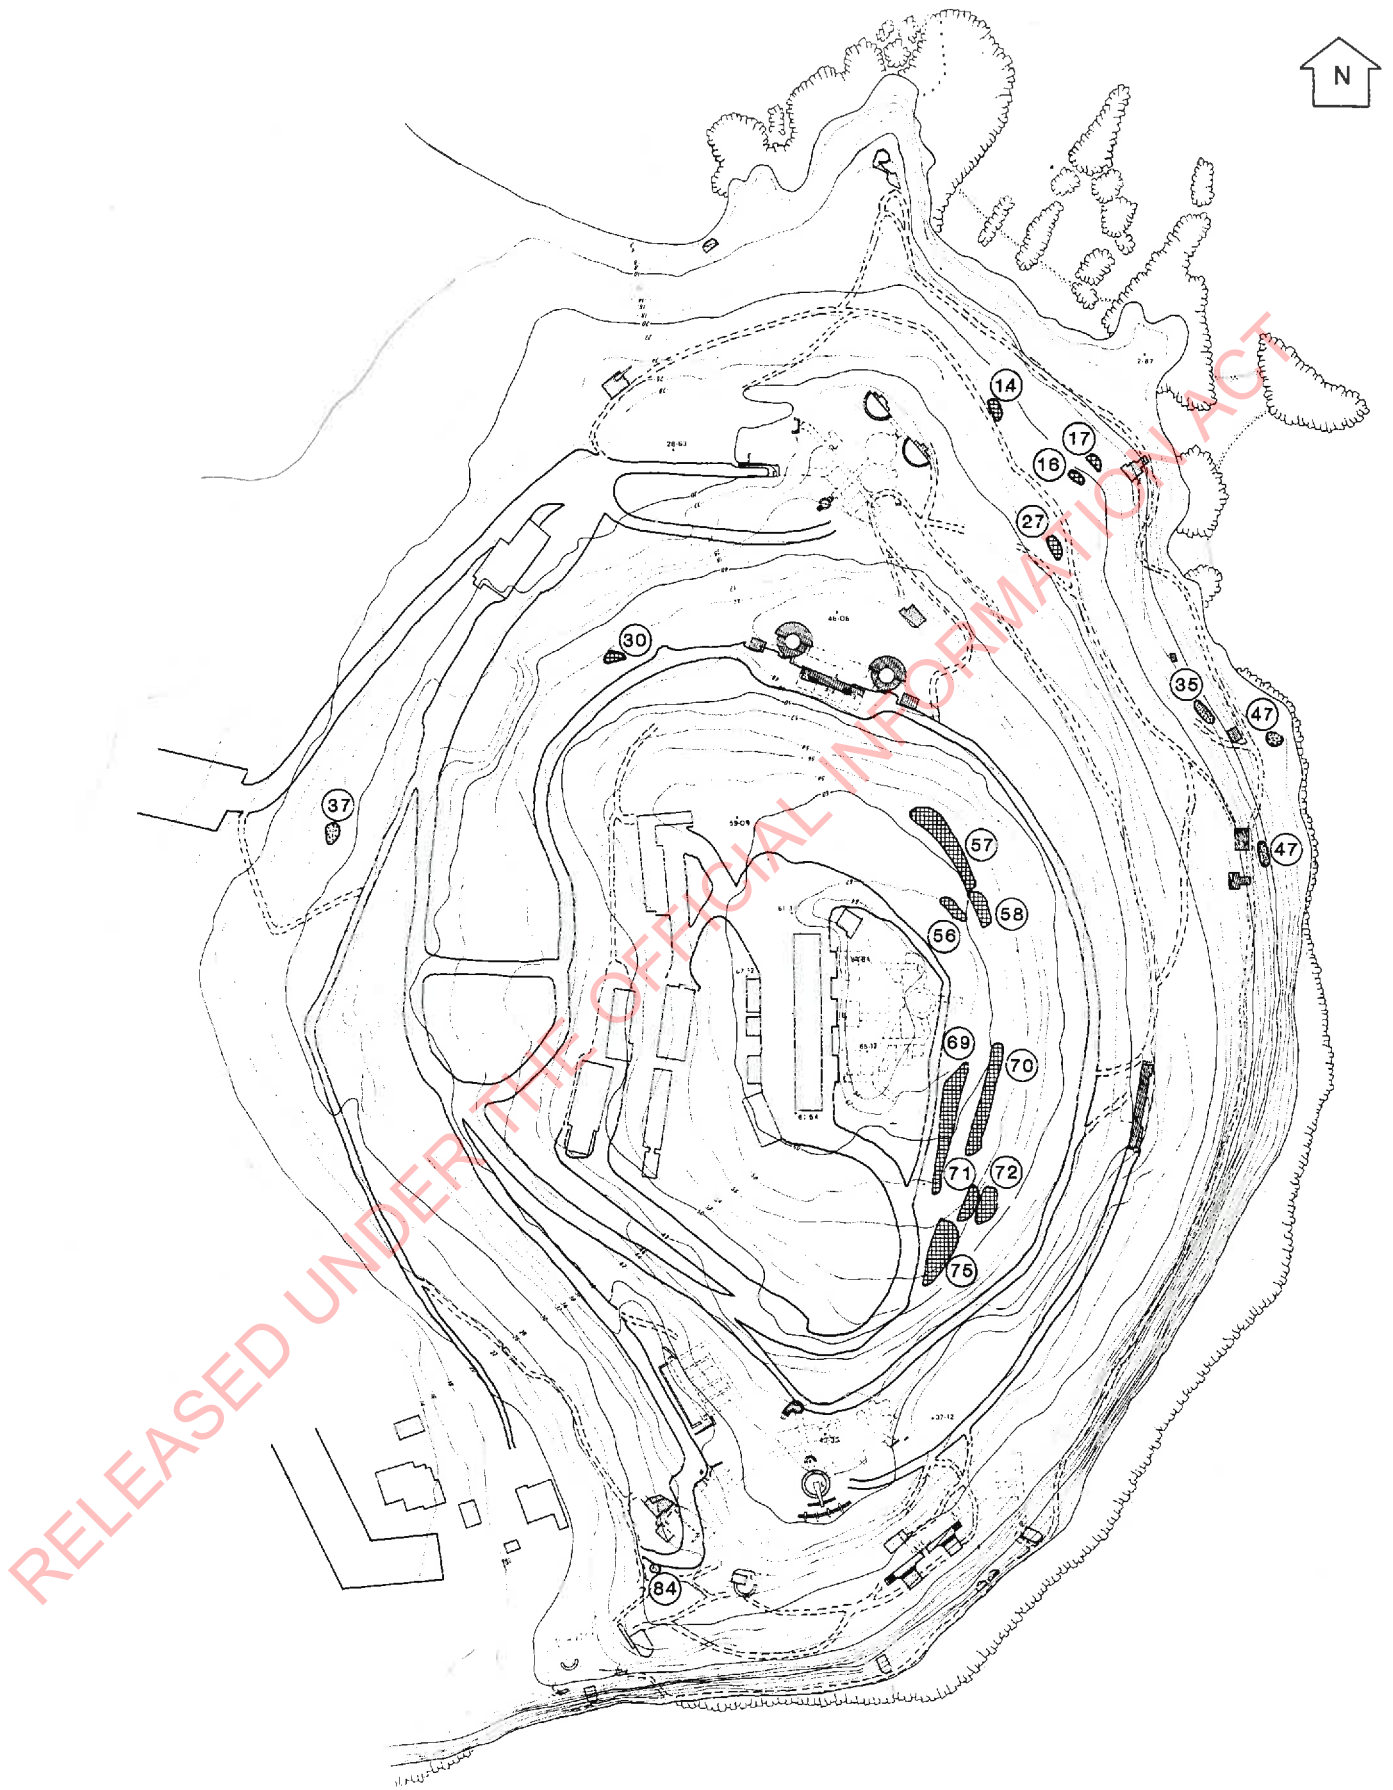
Figure 3: North Head showing areas where prehistoric features may remain.

The eastern flank is the least modified area, the damage being limited to the roads linking North and South Batteries and the road associated with the 6" Mk VII Battery (see Fig 3 & 5 below). It is in this area that the terracing recorded by Phillips is the most likely to be of prehistoric origin. These terraces were recorded by Phillips as features 56, 57, 58, 69, 70, 71, 72 and 75 (see Fig 3). The other main area is on the north-east corner where features 14, 16, 17 and 27 may be of prehistoric origin (see Fig. 3). Another obvious sign of occupation at other cone pa in Auckland is the presence of shell midden. For example at R11/109 Takaranga pa (Mt Victoria) there is an extensive shell midden eroding from a road cutting near the summit. Phillips's survey located only four, possibly five small midden deposits features 35, 37, 47 and 84 (Fig. 3).

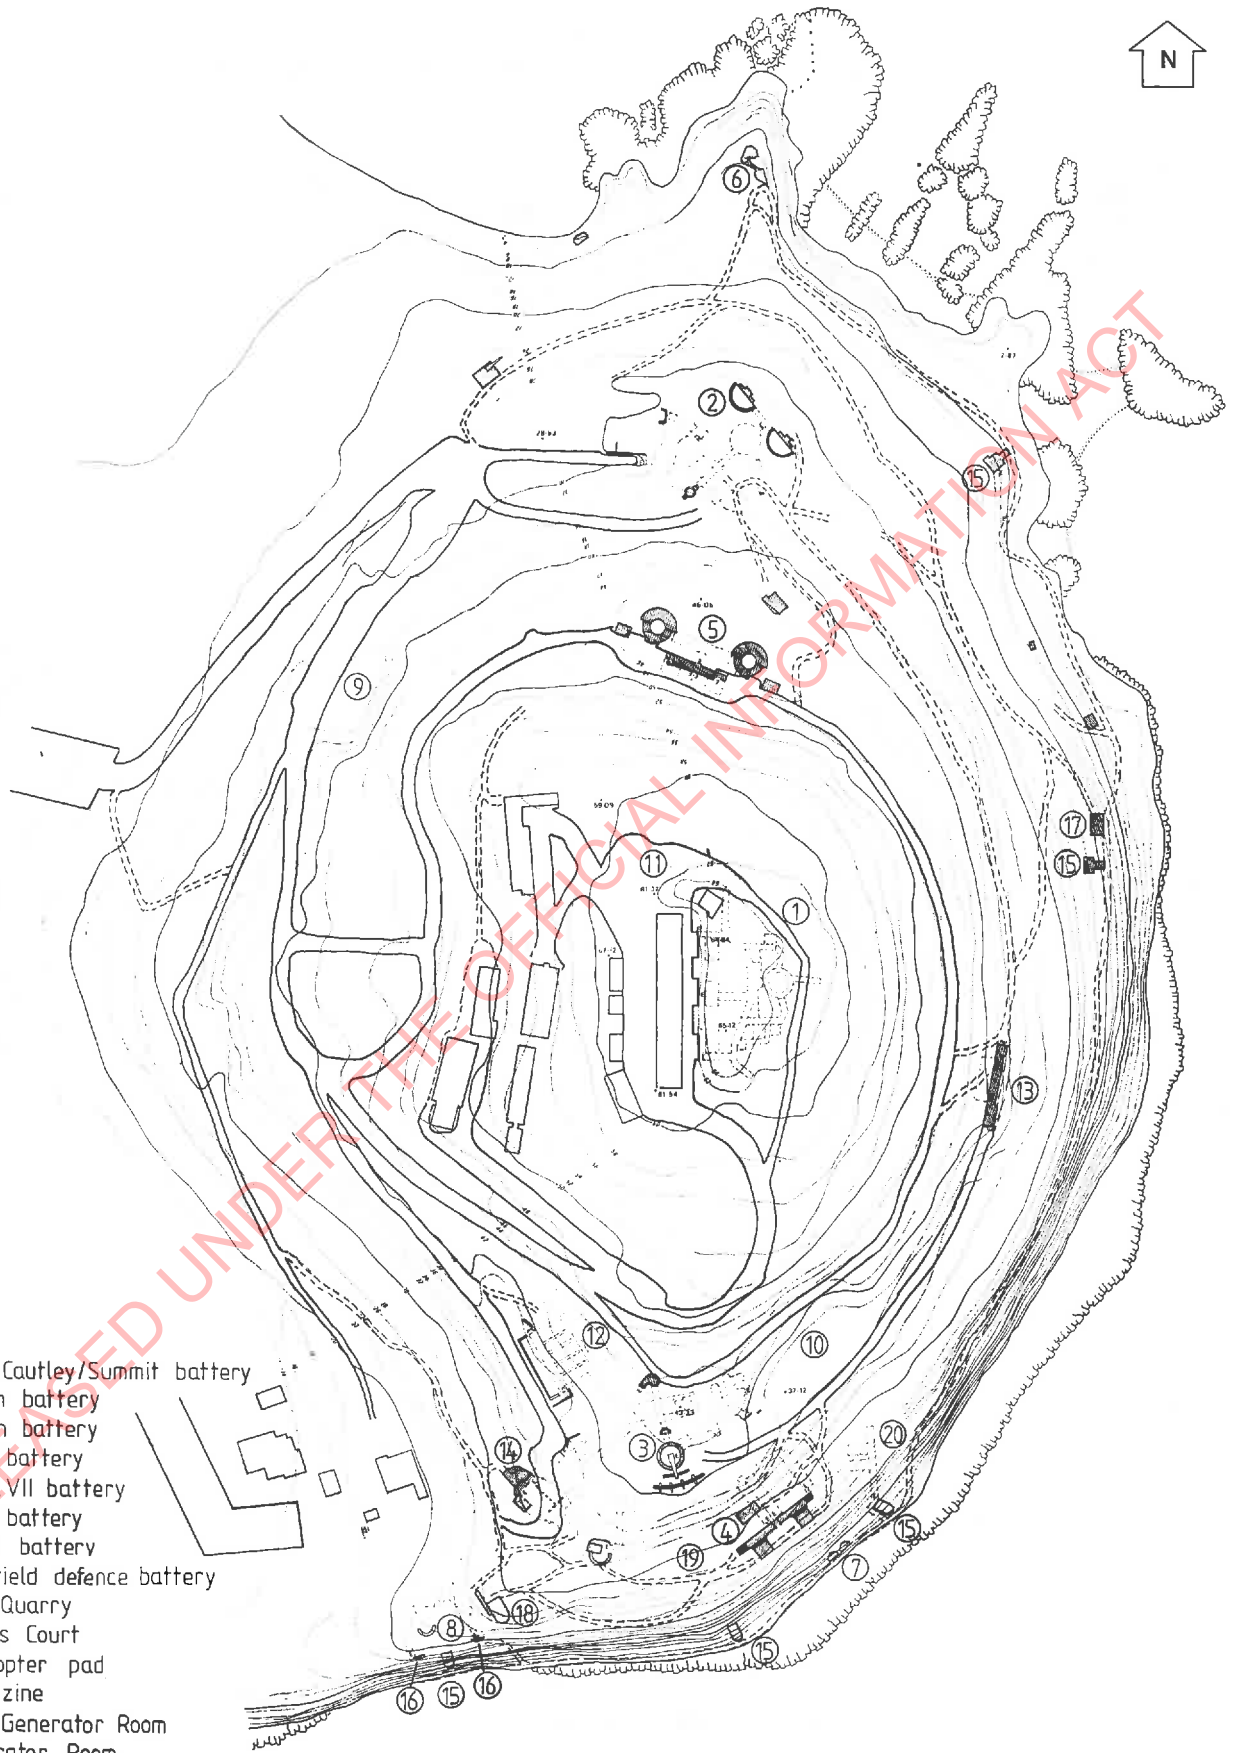
Figure 5: North Head, location of major installations.

- 1 Fort Cautley/Summit battery
- 2 North battery
- 3 South battery
- 4 12pr battery
- 5 6" Mk VII battery
- 6 6 pr battery
- 7 Boom battery
- 8 Minefield defence battery
- 9 The Quarry
- 10 Tennis Court
- 11 Helicopter pad
- 12 Magazine
- 13 Test/Generator Room
- 14 Generator Room
- 15 Searchlights
- 16 Old Searchlights 1 & 2
- 17 Generator room foundation
- 18 Minefield defence control
- 19 Gunnery training area
- 20 Annies Cave

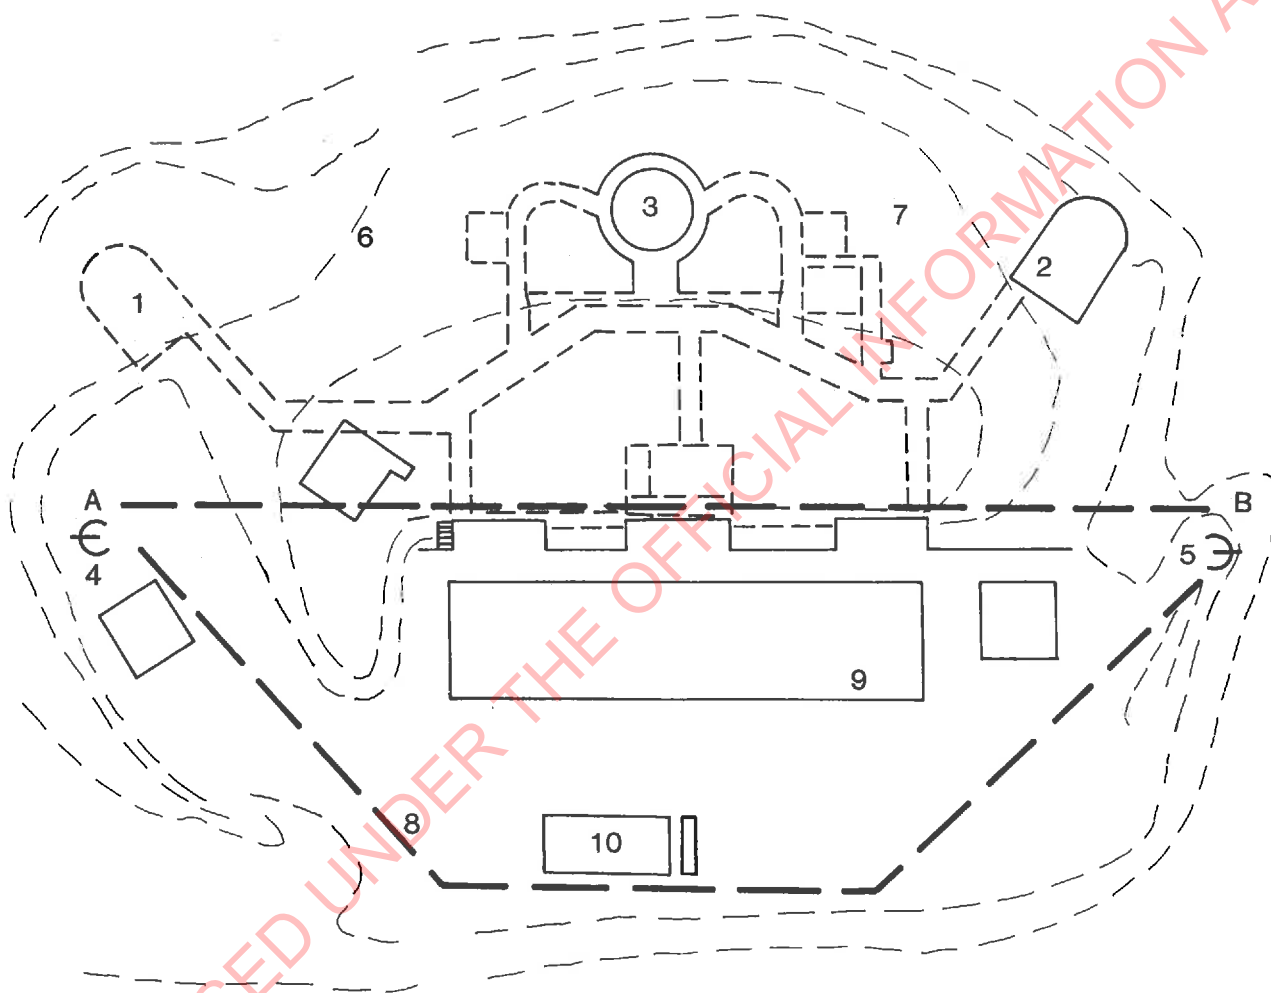
- — — — — Approximate trace of Earthwork 1880's
- 1 Probable location of 7" RML Emplacement
  - 2 7" RML Emplacement
  - 3 8" H.P. gun emplacement
  - 4 5 Probable locations of 6pr Nordenfelt flankguns
  - 6 7 Possible location of 1887 O.P.s
  - 8 Entrance through Earthwork
  - 9 1880s Barracks building
  - 10 Stone Building

The rear of the summit was levelled at this period and an earthwork with musketry parapet was built with a ditch encircling the whole fort. When complete this parapet was 12'5" (3.79 m) high (F.R.B. Chapter III). This earthwork is most clearly shown in Plates 3 & 4.

This was not drawn to scale, although presumably north is on the left hand side of the drawing. This part of the Fort Record Book (Chapter III) also states that the 8" BL H-P was mounted 70 feet in from of the front trace, the outside of the earthwork. It is possible, using the 1946 map (Fig. 8) and these dimensions together with the Winkleman panorama, the 1911 photograph and White's Aviation photographs (Plates 3, 4, 7 & 8), to approximate the outline of the earth work defences. (See Fig. 6.)

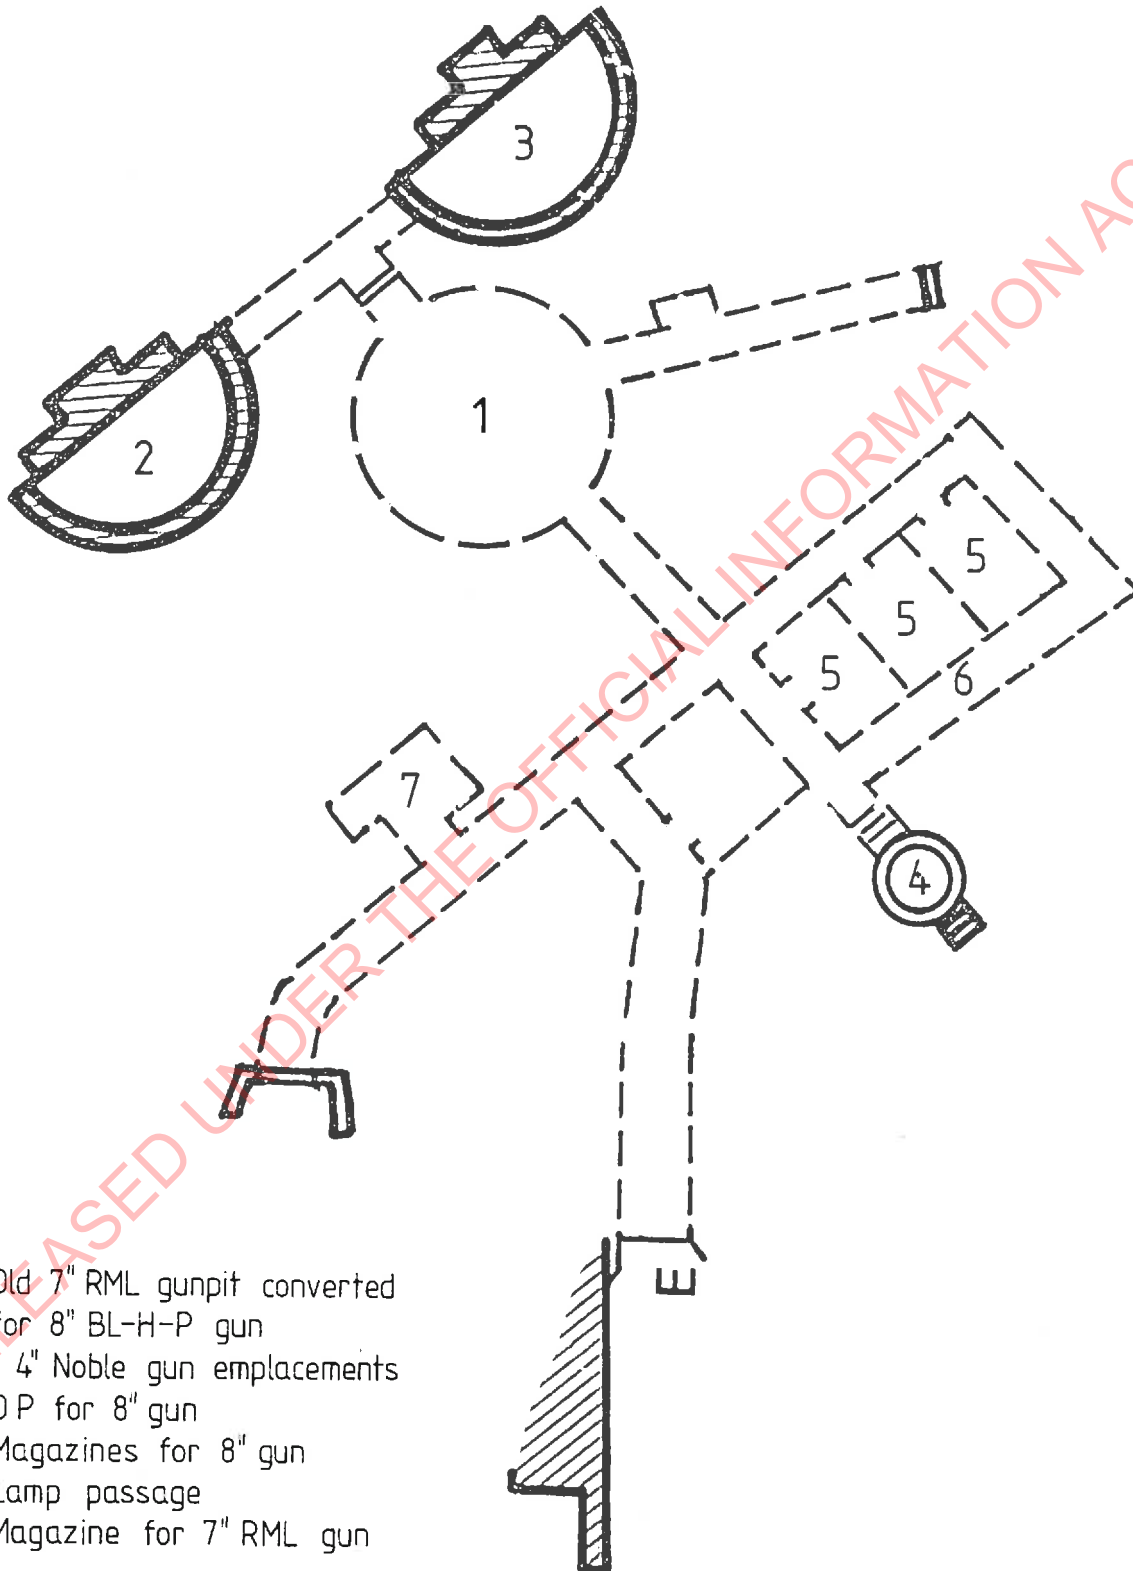
Figure 9: Plan of North Battery.

- 1 Old 7" RML gunpit converted for 8" BL-H-P gun
- 2 & 3 4" Noble gun emplacements
- 4 OP for 8" gun
- 5 Magazines for 8" gun
- 6 Lamp passage
- 7 Magazine for 7" RML gun

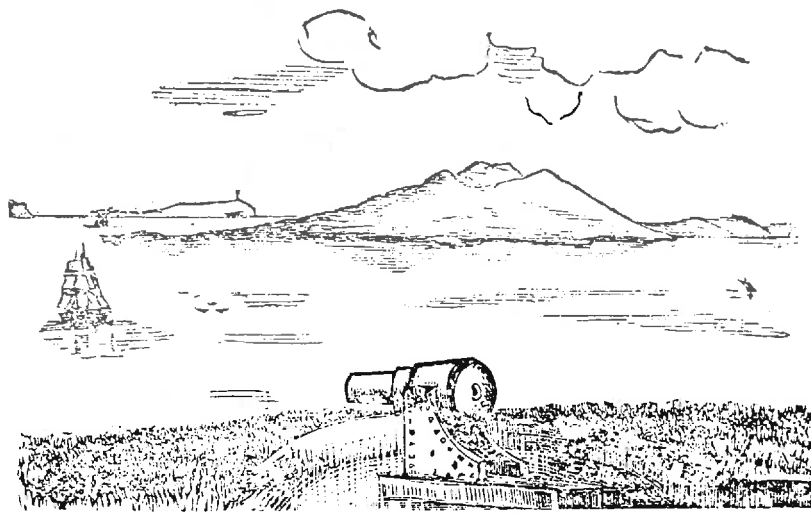
Figure 10: Auckland Fortifications from Auckland Weekly News 25 April 1885

This view gives a general sketch of the 7-inch gun to be mounted in the position facing Cheltenham Beach. This, like all the other guns, is mounted "en barbette." This is a phrase which may be new to some of our readers, and we may explain that barbette is an earthen terrace inside the parapet of a rampart, serving as a platform for heavy guns. It has such an elevation that the guns may be fired over the crest of the parapet instead of through the embrasures, to give them freer scope by swivelling round into different directions. This class of battery has disadvantages and advantages. The former consist mostly in the fact that the gun is necessarily partially exposed, but on the other hand it has the advantage of a wider sweep, and greater command of space. Indeed its angle is so great that it may almost form the diameter of a circle. With stone work protections of course the gunners would be limited only to the embrasures. After the gun en barbette is discharged, it is run back, and the muzzle depressed for loading, after which it is again run out to the rampart ready for action. With these guns there are adequate appliances, winches, &c., and on a pinch six men can work the gun, although the complement is twelve. Our sketch is taken from the rear of the fortification on the side of the hill, and overlooking the Rangitoto Channel. The gun has full command of the Channel outwards through the Whangaparaoa Passage, and inwards to the point of Rangitoto Reef.

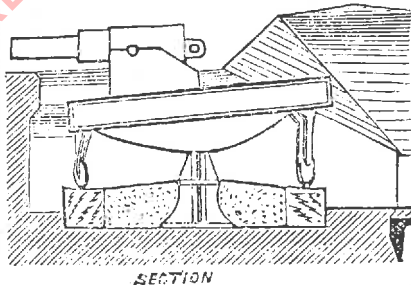
SECTION

The second sketch is a section showing the gun on its carriage looking over the parapet, with the ammunition chamber and passage at the rear.

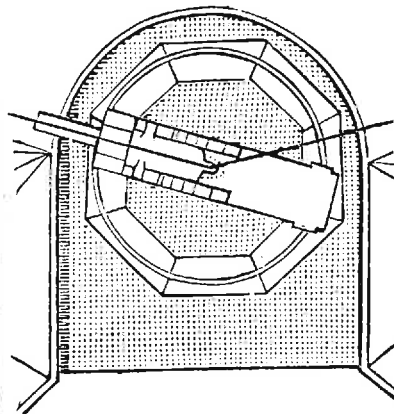
The third sketch is the most important, being the actual plan of the fortification. The two black lines, one running through the gun and the other at an obtuse angle from it, show the line of angles on which the gun can be brought to bear. The octagonal frame shows the platform, and the dotted ground inside and outside the platform is concrete. No better idea as to the great variety of range of those guns can be given than that which is conveyed in this cut, and in this respect its great advantage over casemate guns must be apparent. In regard to the present fortification works, no doubt as soon as the more important work is completed, the loose earthwork thrown out from the excavations and roads will be sloped off and planted with grass or sods, and this will be all the more necessary with respect to the fortifications themselves, so that there should be nothing to distinguish the position of the guns from any other part of the hill.

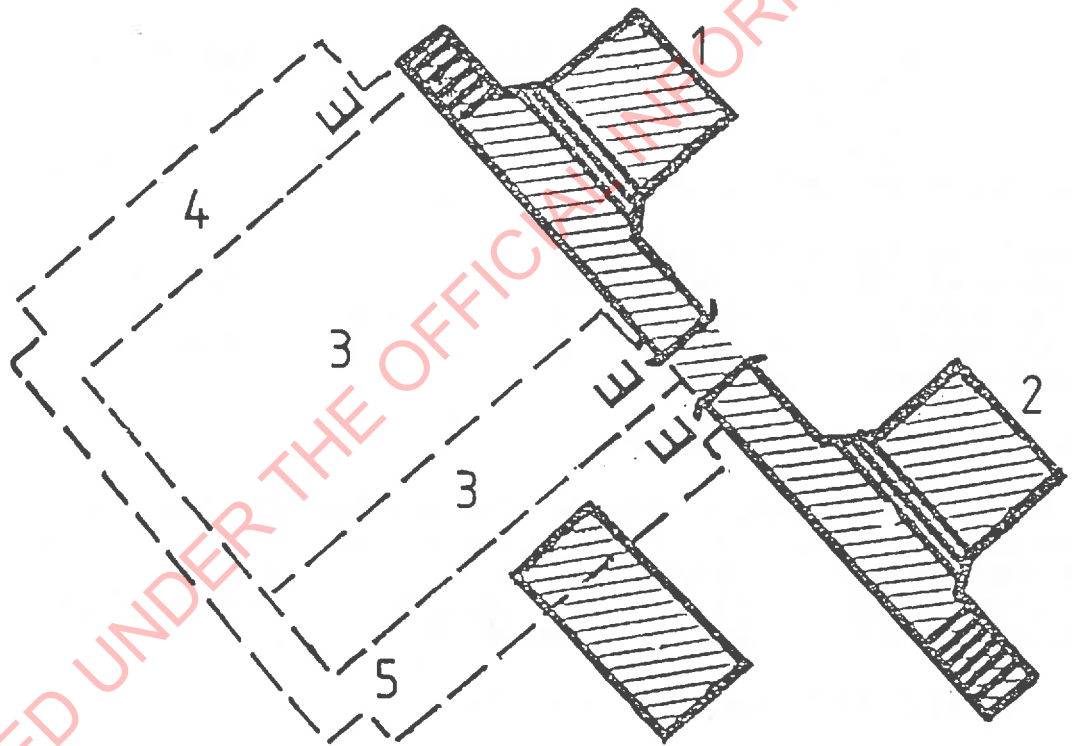
Figure 12: Plan of 12pr Emplacement.

- 1 & 2 Gun emplacements
- 3 Magazine
- 4 Accomodation
- 5 Lamp passage

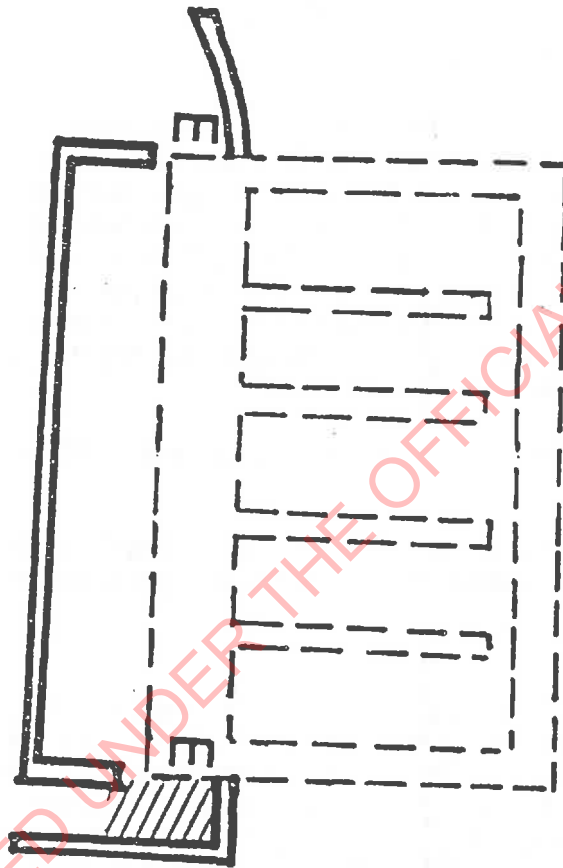
Figure 19: Plan of Magazine.

The 1893 report (RNZ DW & A, 1893:6) states that at this time there was no main magazine although the presence of lamp passages suggest that this structure was built soon after this date. It is difficult to see on the 1900 panorama (Plate 3), however, there is a smoother patch of grass on the slope to the left above the engine room entrance which may be the camouflage over the magazine. The 1946 map (Fig. 18) shows the magazine complete with the lamp passages associated with the pre-electricity era magazines elsewhere on North Head. These are not accessible at present. The lamp passages allowed oil lamps to be set up to shine into the magazines through windows without exposing the ammunition to naked flames. It was in use during World War II and in the 1930s used to store reserve ammunition for the 6" guns (Nutsford pers. comm. 1989). Originally the magazine was camouflaged by being earth covered to match the contour of the hill. This camouflage was still present in 1962 (Plate 10), but appears to have been partially removed.

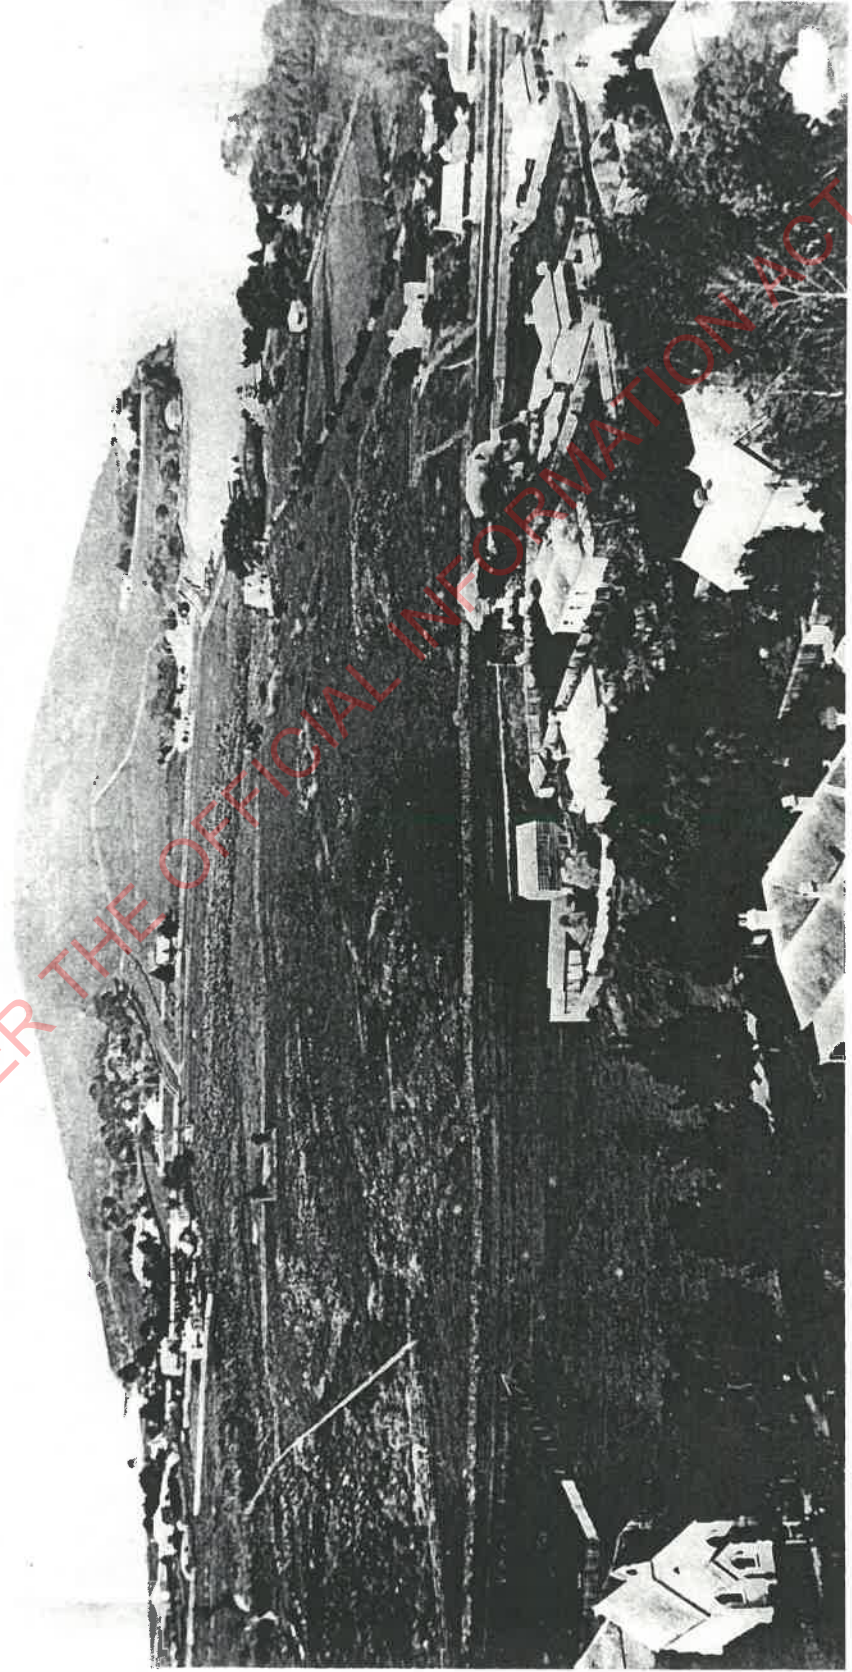
**Prior to European Fortification.**

**Note absence of visible terracing and presence of stone wall boundaries on the Head.**

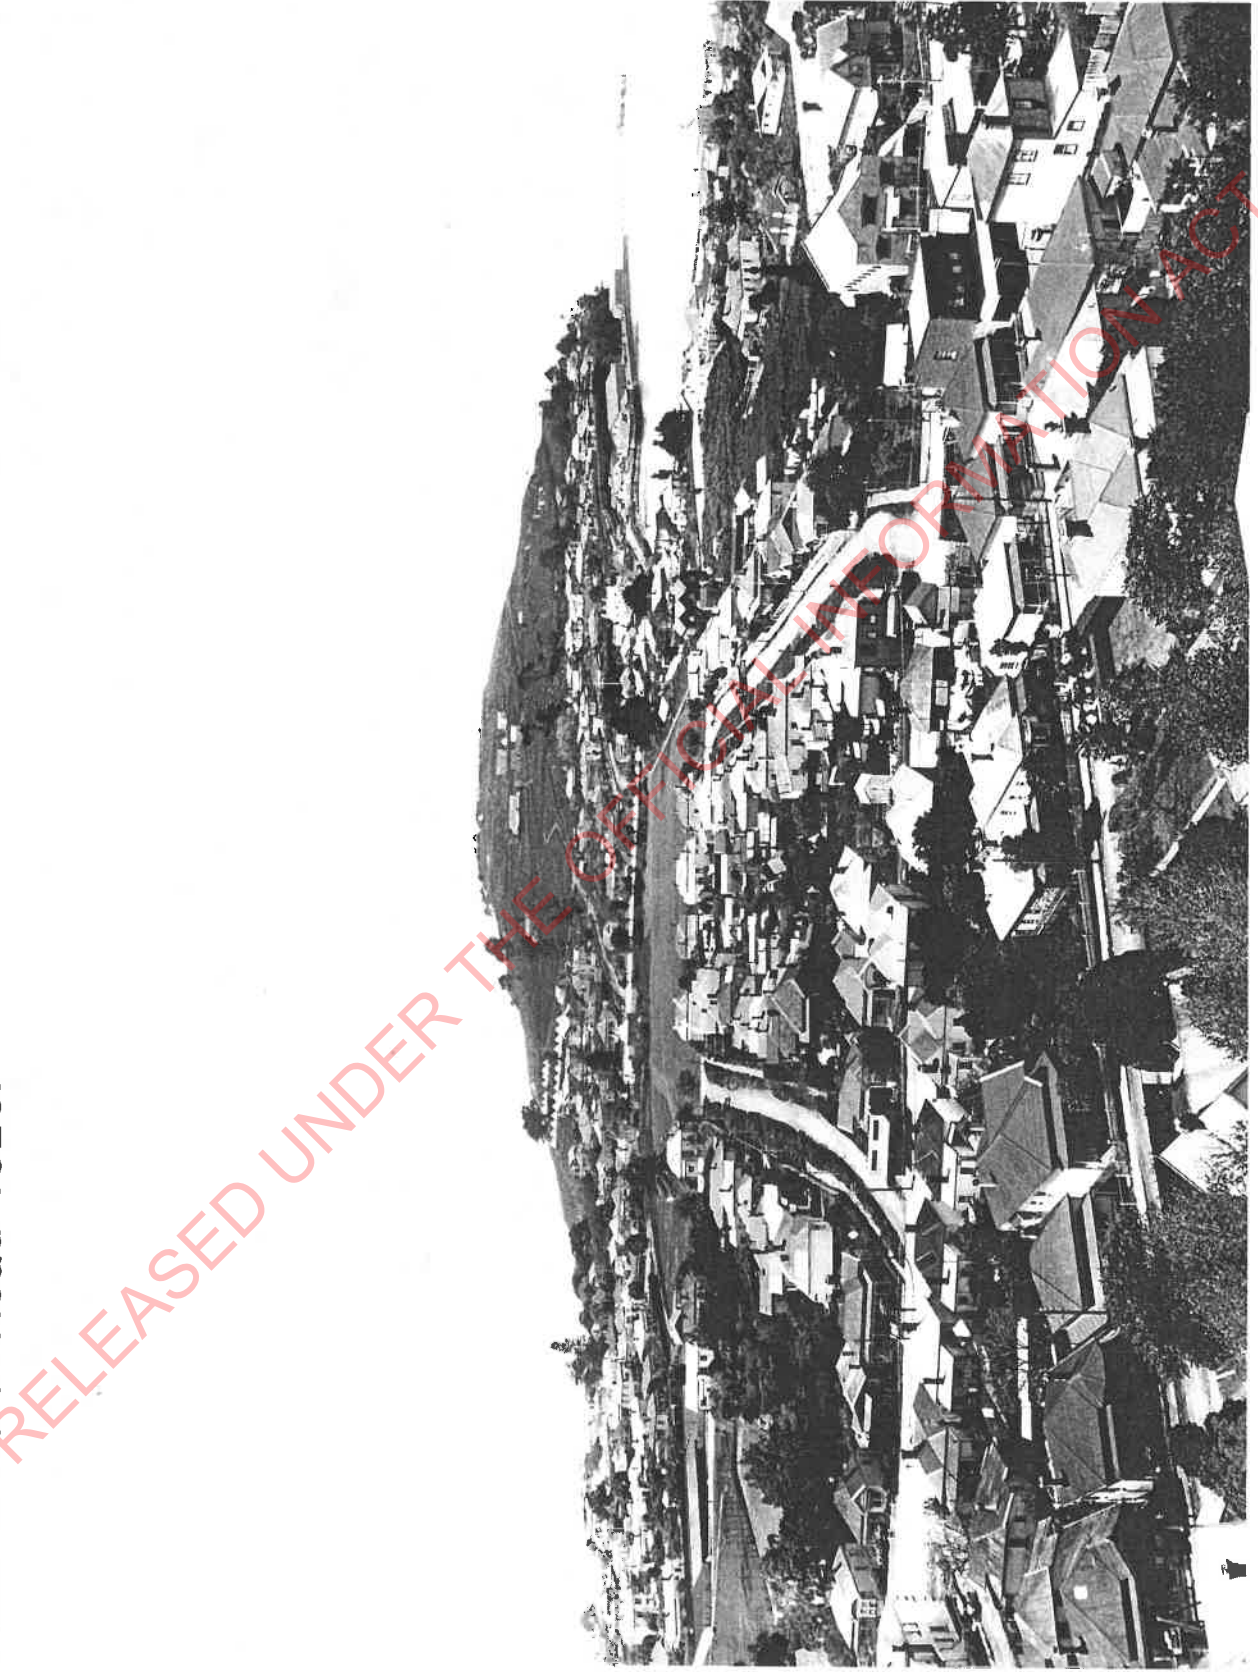
Plate 7: North Head Aerial View 1939.

Old 8" BL H-P emplacement

6" Mk VII gun emplacement

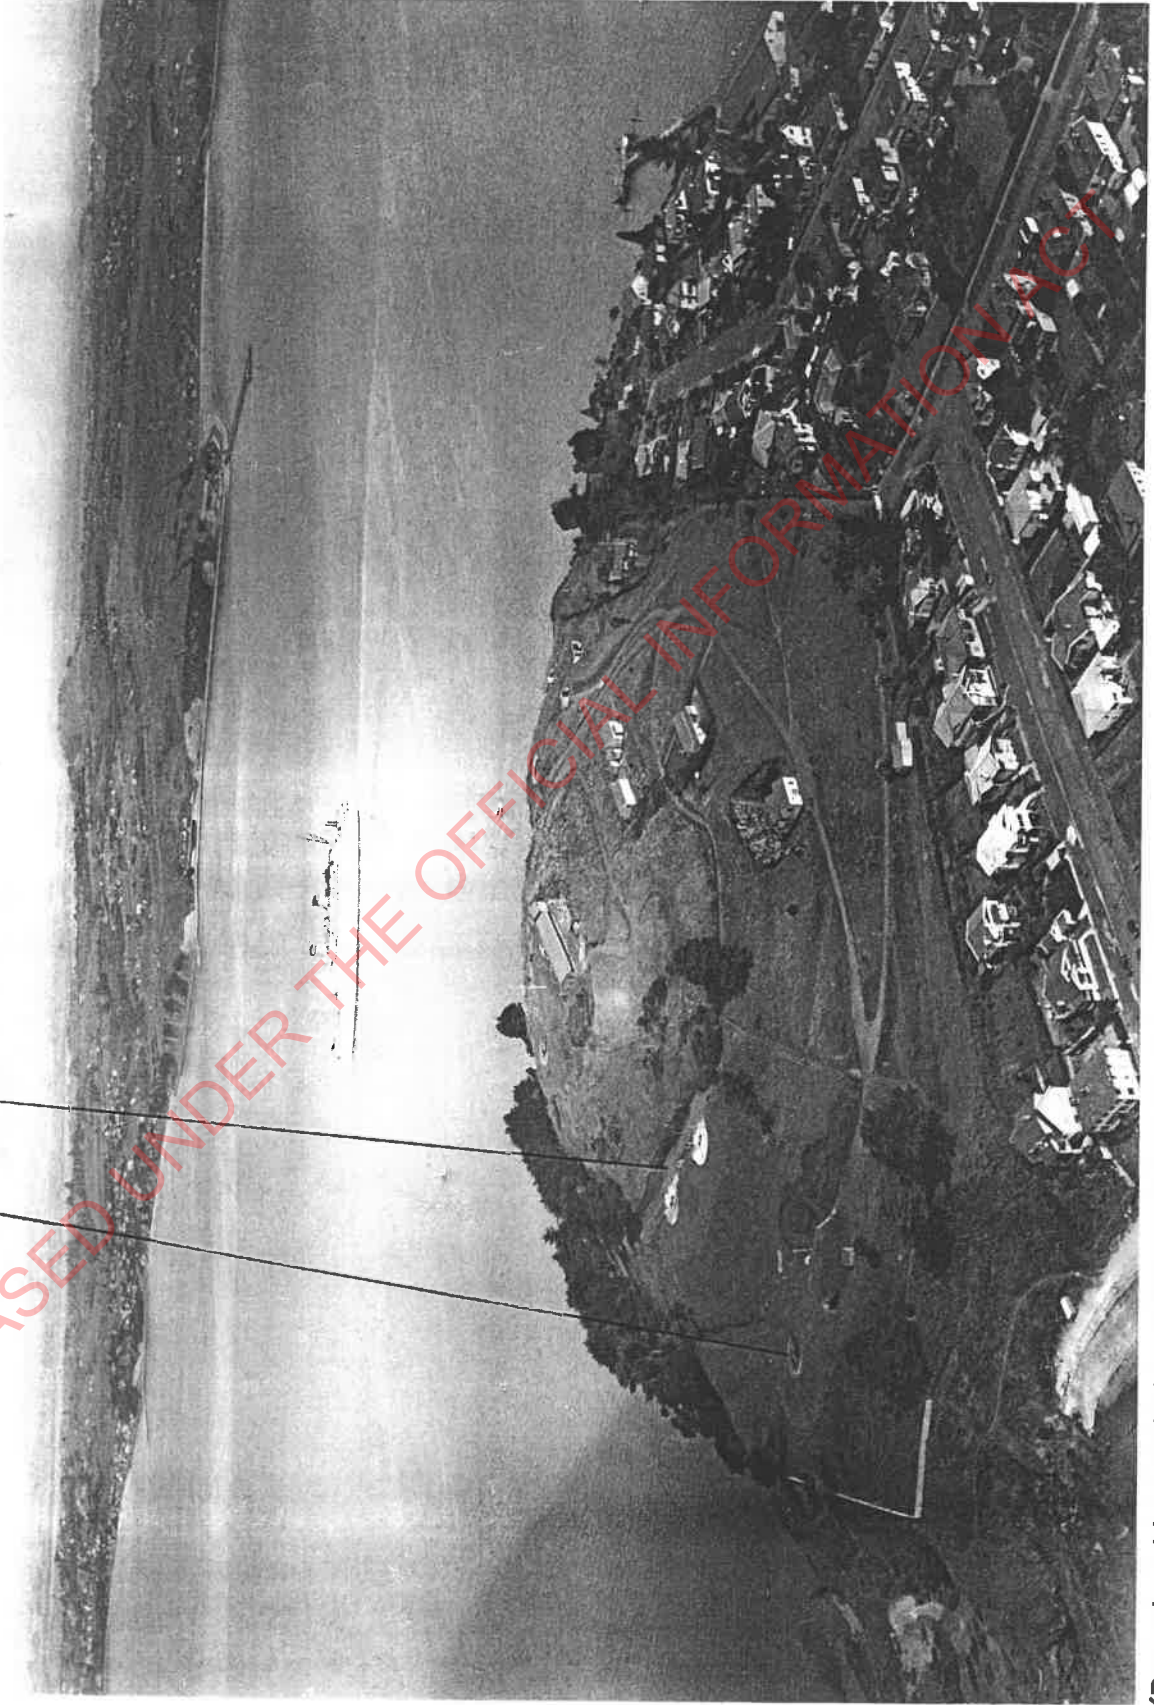
Plate 8: North Head Aerial View 1939.

- Old north battery 8" BL H-P emplacement
- 6" Mk VII emplacement
- Old barracks now a house
- Area disturbed during construction of aborted 6" battery
- 1880s barracks
- 8" BL-H-P emplacement
- Lab
- 6pr flankgun emplacement
- Magazine
- Old south battery 8" BL-H-P emplacement
- Old 64pr ML emplacement
- Engine room entrance
- Minefield O.P.

The 1939 White's Aviation aerial photographs (Plates 7 & 8) show the buildings at this date. Little appears to have changed since 1926. The long Barracks building on the summit, the stone building, and the small building to the south of the Barracks, remain. Most of the buildings on the western slope are still present with the exception of the smith shop and associated buildings to the south of the old Barracks, at this date converted into a house (Nutsford pers. comm.). The double gabled building in the quarry remains, although later photographs (Plate 9) indicate that this was replaced by other buildings, probably during the Second World War. These are listed as a canteen and orderly room in the 1946 map (Fig. 18).

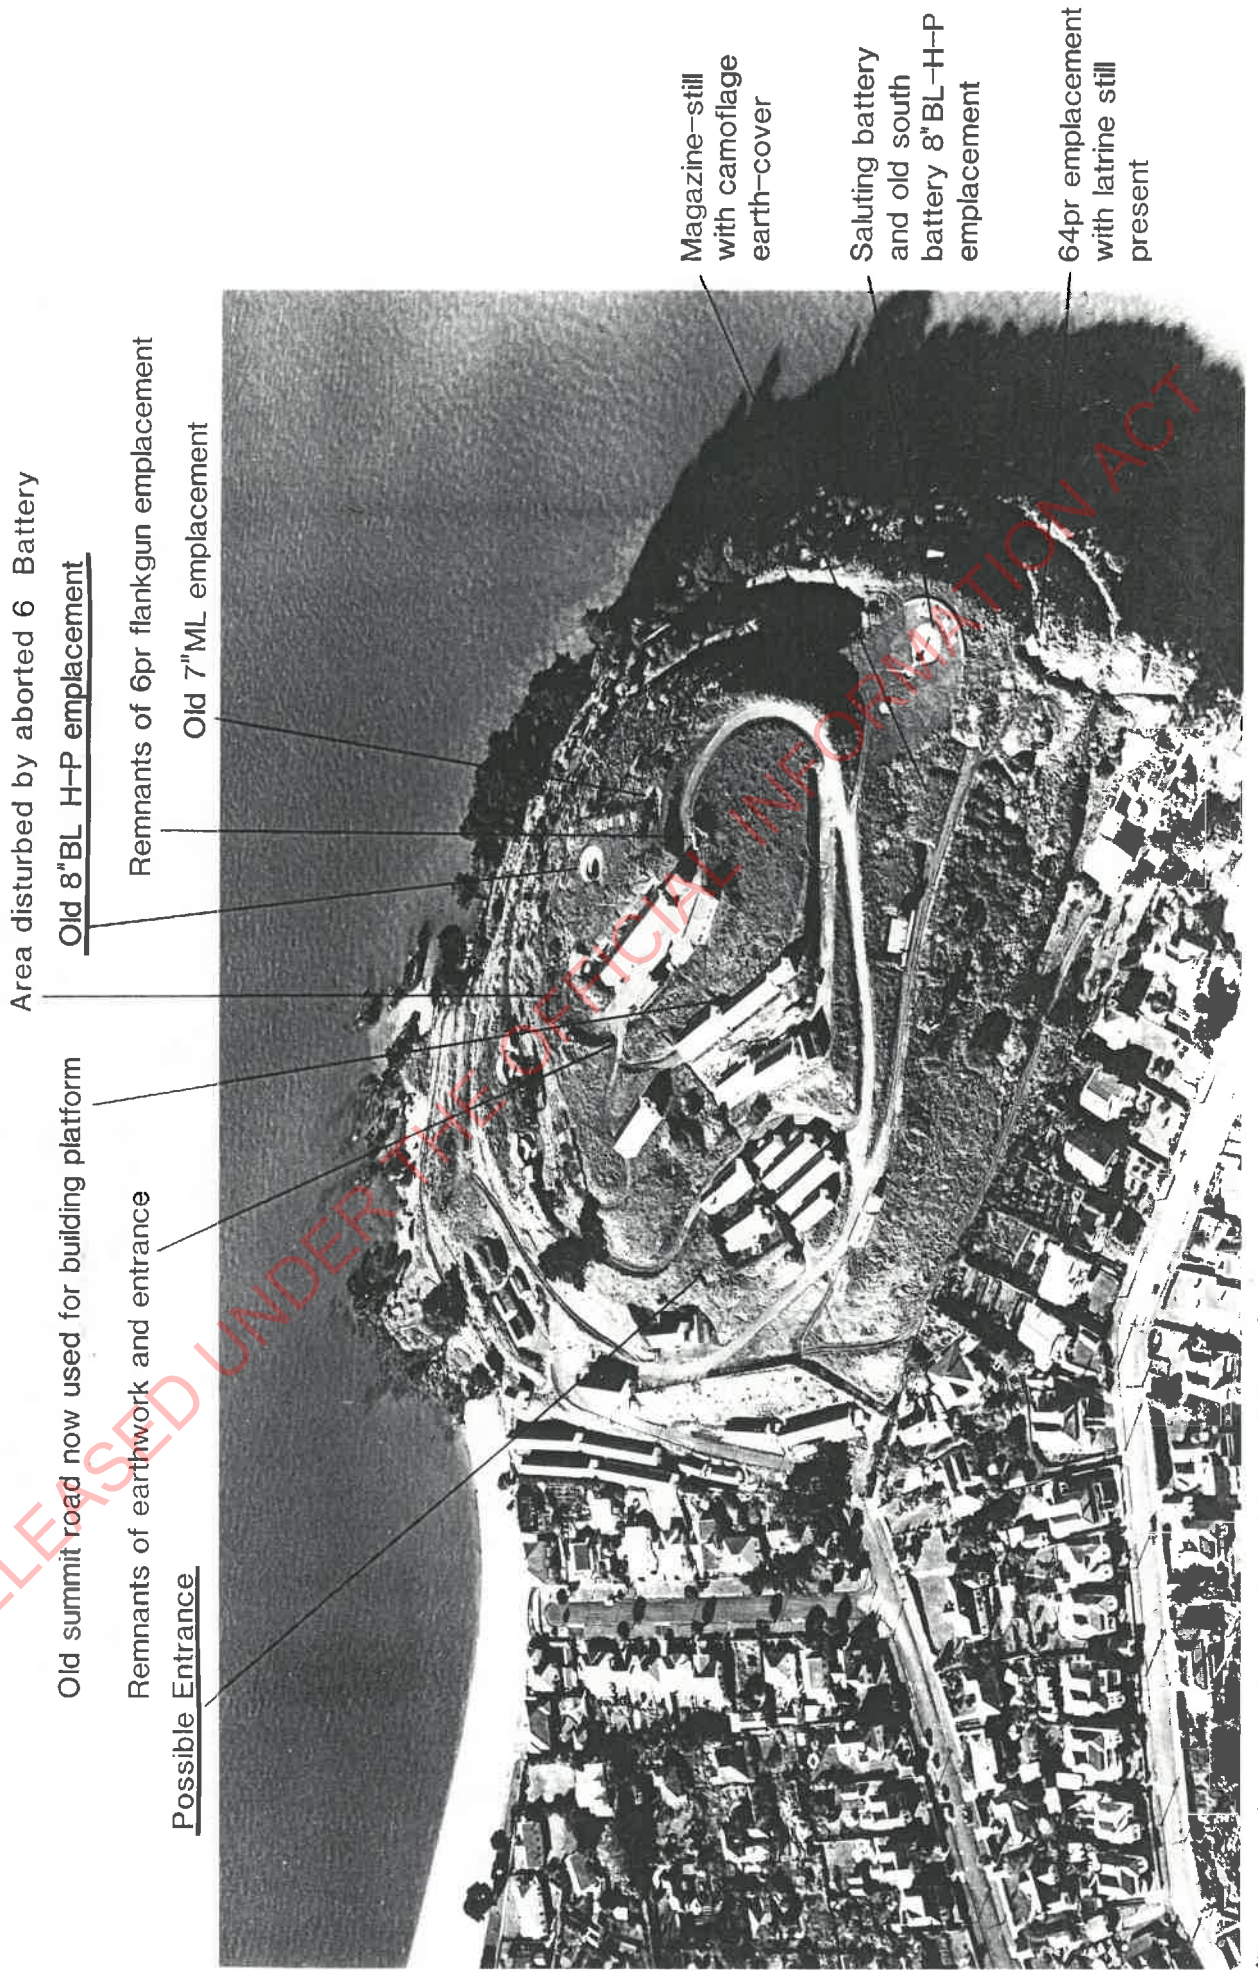
# Plate 10: North Head Aerial View 1962.

Note removal of remnants of earthwork, flankgun emplacement and original entrance also removal of W.W.II buildings
