## Infrastructure Committee Agenda

**Date:** Thursday, 13 May, 2021

# INVESTMENT AUDIT REPORT

## Technical Audit of Whangarei District Council

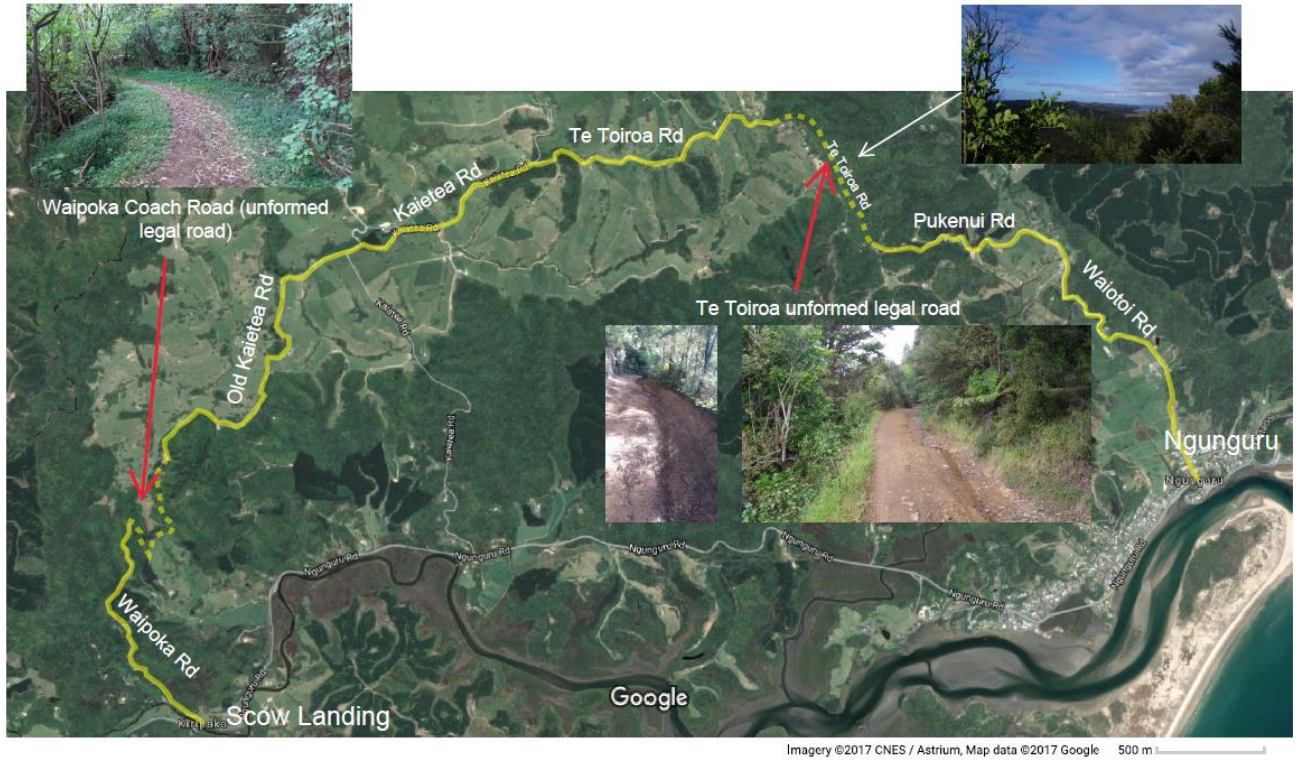
Diagram 1 - Scow Landing to Ngunguru Route

- the “Waipoka Coach Road” (approx. 1.5 km) is an unformed legal road (“paper road”) however is not suitable for vehicles and is used now as a walking/ cycling track and bridleway. This is in good condition but required some reshaping and gravel in a few short sections (photo in attachment 1, diagram 1). The Waipoka Coach Road section

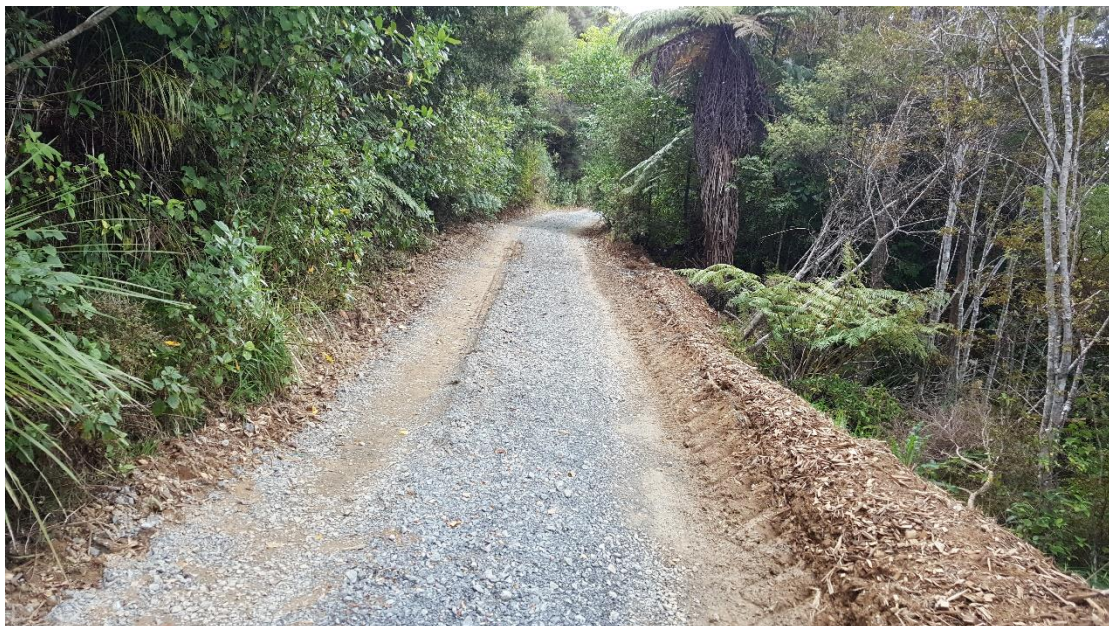
Example of the upgraded track

However, because no soil testing has been carried out along the track we have no evidence to confirm that kauri die back is either present or absent from the site, it is recommended that as soon as ground conditions are suitable soil tests be carried out at various sites along the track and around the single kauri seen close to the track. If these soil tests come back as positive to *Phytophthora agathidicida* then management of the track will need to be re looked at to come up with ways risks can be minimised, but in its current state I believe the upgraded track poses a fairly low risk of introducing *Phytophthora agathidicida*.

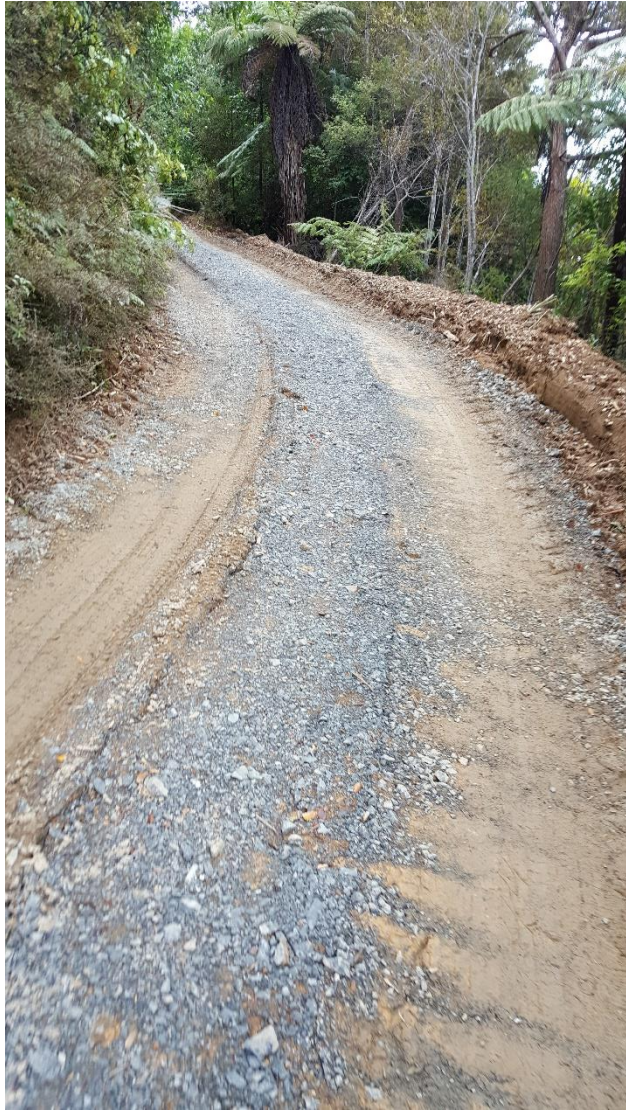
Example of margins of the track showing mud exposed by recent vehicle movement

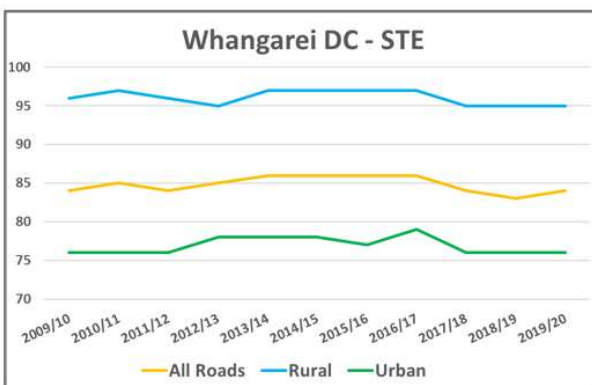
Further analysis of STE (graph below on left) reveals that the urban network is considerably rougher than the rural network. A similar analysis of PII (below right) indicates a divergent trend where urban pavement condition is deteriorating at a faster rate than rural. These are concerning features that Council needs to investigate, understand and address.

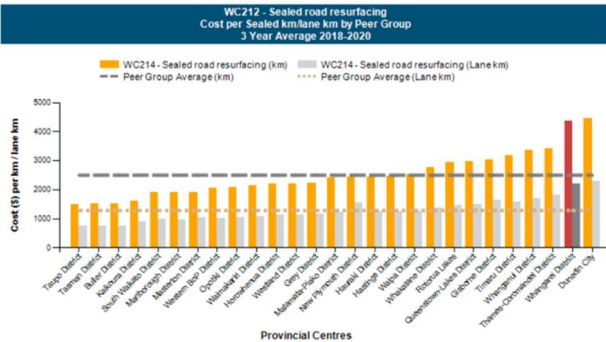
The cost per km for maintenance, operations and renewals (excluding emergency works) as a three-year average (2018-2020) is \$12,013/km, which is significantly over the peer group average of \$9,035/km. Resurfacing and pavement rehabilitation costs contribute to this high rate of expenditure. See graphs below for comparisons with peer councils. We were unable to ascertain the reason for this high cost differential during the audit and recommend that Council investigate further.

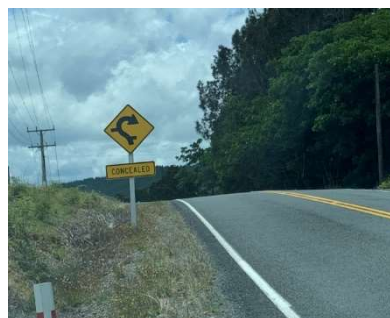
- The curve orientation on a curve permanent warning sign does not match the road alignment ahead (ie Vinegar Hill Road - refer to the photo to the right)
- Outdated black and white chevron signs (outdated signs are unlikely to meet reflectivity requirements and may not be sufficiently conspicuous)
- Damaged and faded signs
- Twisted signs (generally intersection signage in urban areas)
- Missing STOP and GIVE WAY signs (in remote rural areas)
- Signs obscured by trees, vegetation or placement of other signs
- Inconsistent use of edge marker posts, width markers and hazard markers
- Compliance (e.g. WN2 Hump signs not correctly located, RD6R Keep Right signs missing from bulbous kerbs)
- Broken and/or unpainted sight rails.

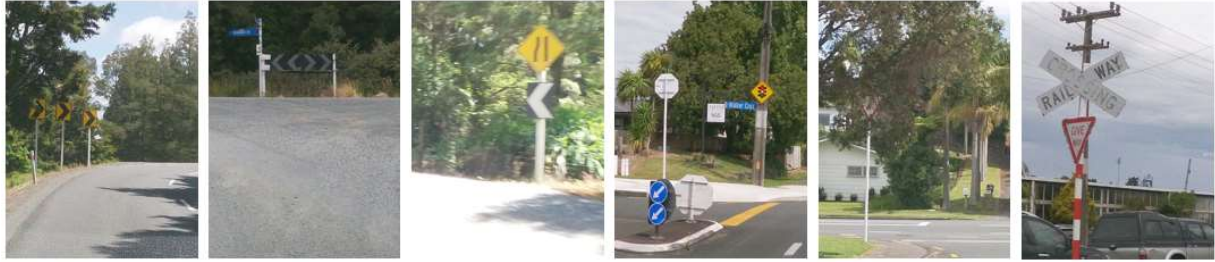
Examples of sign issues are in photos below – these include noncompliant layout of single chevrons, faded black and white chevron board, noncompliant sign combinations, twisted signs, signs obstructed by vegetation and illegible, lichened signs.

Night inspections are undertaken by the contractor on an infrequent basis. It is suggested that more inspections be undertaken and that they utilise a driver unfamiliar with the network (provide “fresh eyes”). It is leading practice to ensure all roads are inspected at least annually at night to ensure the adequacy of existing delineation, hazard warning and regulatory signs.

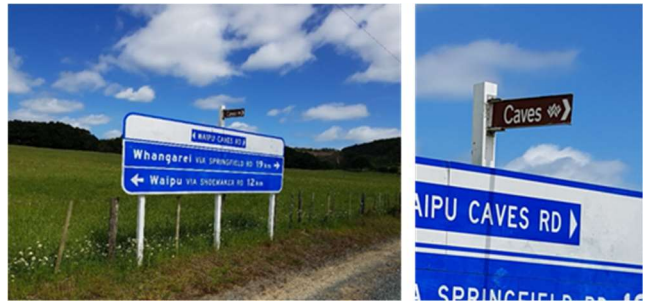
drivers unfamiliar with District roads. We found the guide signage on the network to be confusing, inadequate and often missing. The photograph above shows the inconspicuous destination sign for Waipā Caves. On the journey to the Caves, we observed that locals had painted their own signs to direct visitors, highlighting the deficiency. Popular destinations such the Caves should be signed in accordance with section 6 of Part 2 of the *Traffic Control Devices* manual (TCD manual)<sup>5</sup>. Tourist destinations should be signed from the Twin Coast Discovery Highway.

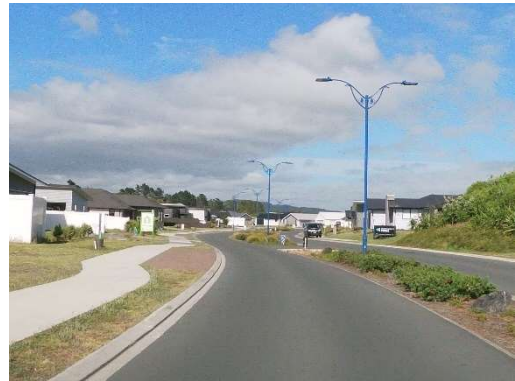
Our field inspections included new subdivisions and other developments, where we noted that many features don't align with current best practice (e.g. mountable kerb) or with sustainable maintenance/renewal practice (e.g. decorative lamp posts, AC used on access / low volume streets). Other concerns included carriageway and verge widths, culvert headwalls, swales and rain gardens, street tree placement and speed treatments. The team was concerned that a lack of control of these design aspects will lead to a marked increase in compliance costs to meet and maintain standards (e.g. ongoing maintenance from poor drainage feature design; cost of adding or upgrading pedestrian facilities for accessibility).

It is recommended that Council review their subdivision development standards and update as required, including strengthening linkages to the District Plan and NZS 4404. The inclusion of a comprehensive review, or standalone review, of asset design specifications and detailed drawings will facilitate cost effective maintenance/renewal and ensure best whole of life costs by standardising the asset specifications.

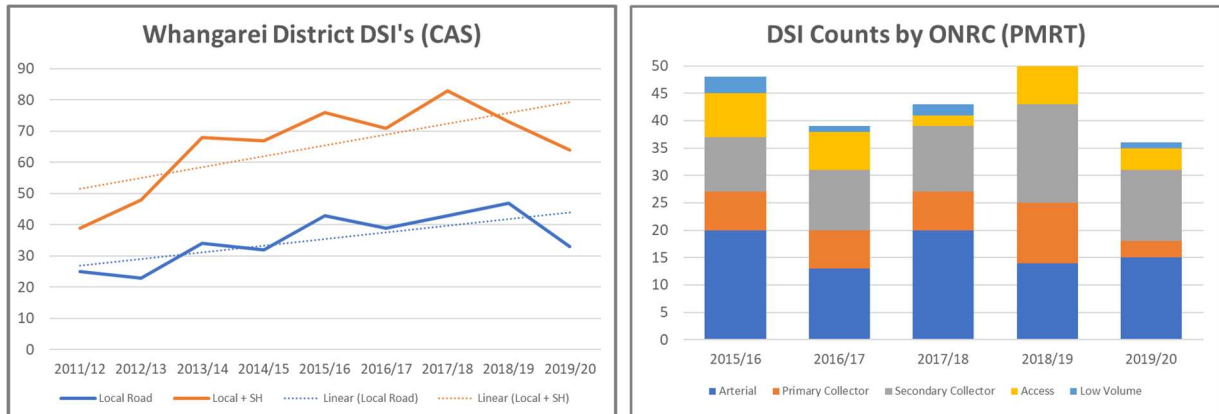
The annual number of deaths and serious injuries (DSI's), listed in New Zealand's Crash Analysis System (CAS) as occurring in the Whangarei District on the local road network, has been steadily increasing over the past eight years. There was a notable drop-off in 2019/20, most likely due to the COVID-19 travel restrictions in place during that year. Numbers on the state highway network are increasing at a slightly faster rate. CAS data is illustrated on the graph below on the left. The graph on the right is taken from the ONRC PMRT and shows crash distribution by road category. Crashes on Arterial roads and Secondary Collector roads contribute significantly to the DSI totals.

The levels of collective risk (crashes per km) generally align with peer group averages but are a little higher on rural Secondary Collector roads. Personal risk (crashes per VKT) is comparatively higher on most road classifications, particularly rural Primary and Secondary Collectors. The *Communities at Risk Register 2019* identifies pedestrians as a risk area of high concern. Rural road loss of control &/or head-on is included as one of four areas of medium concern. It is also noted that four areas which were of medium concern in 2018 are no longer ranked as concerns under the 2019 evaluation.

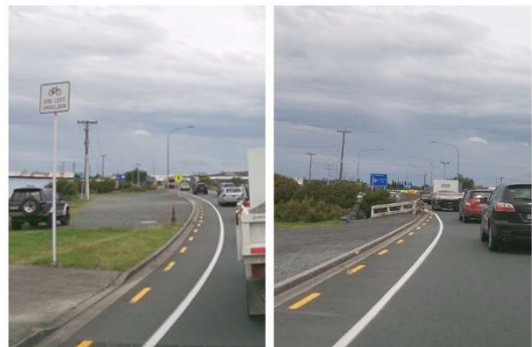
We also commend Council on the well planned and connected walking and cycle network in and around Whangarei City. However, we did note some incidences of inadequate maintenance (poor signage, sunken catchpits, loose aggregates, etc) on the on-road cycle lanes. The *Whangarei District Walking and Cycling Strategy 2018* recognises that it is necessary to “ensure that the maintenance and inspection programmes for the road network consider the safety of cyclists, particularly in relation to the condition of road shoulders” and we would reinforce this requirement. On Port Road (just south of Okara Drive) we observed a cyclist “use left shoulder” sign on a marginal width shoulder. Within a short distance, at the bridge, that shoulder width reduces to approximately 100mm adjacent to the lip of channel. While retrofitting cycle lanes into existing road networks can often lead to this sort of scenario, some thought should be given to providing safe and sound guidance to vulnerable network users.

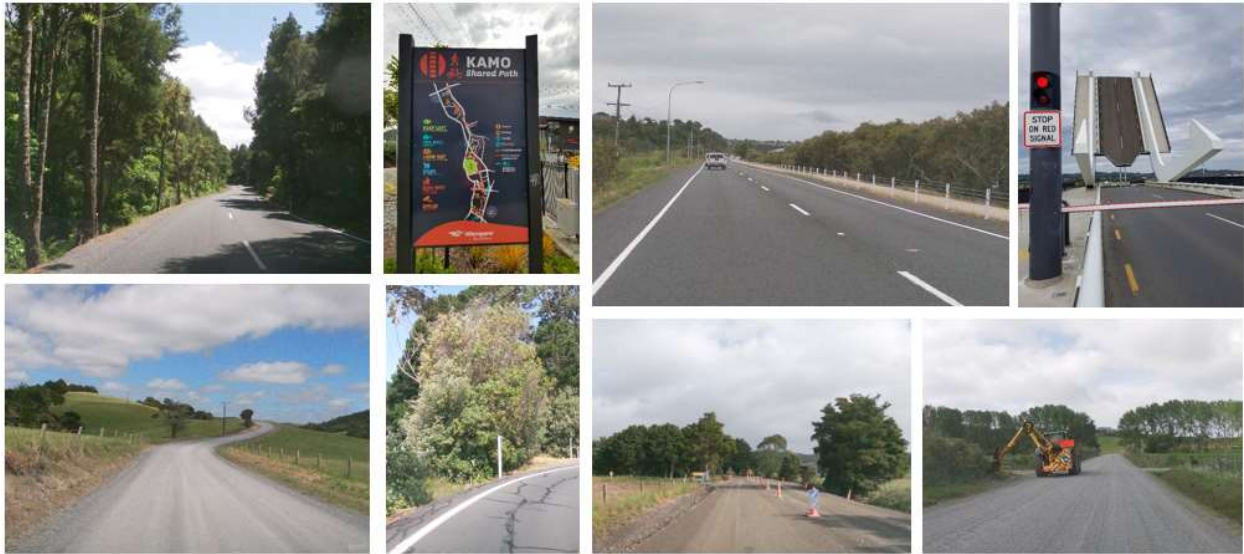
Highlights from the Whangarei District audit include (clockwise from top left) a good standard of work on rehabilitations and reseals, safety improvement projects supporting active travel facilities, the growing strategic cycle network, Whangarei City's harbour bridge (Te Matau ā Pohe), maintenance contractors seen working safely and effectively on network, good traffic management at worksites, use of crack sealing to extend surface and pavement life, and a good standard of ride on unsealed roads.

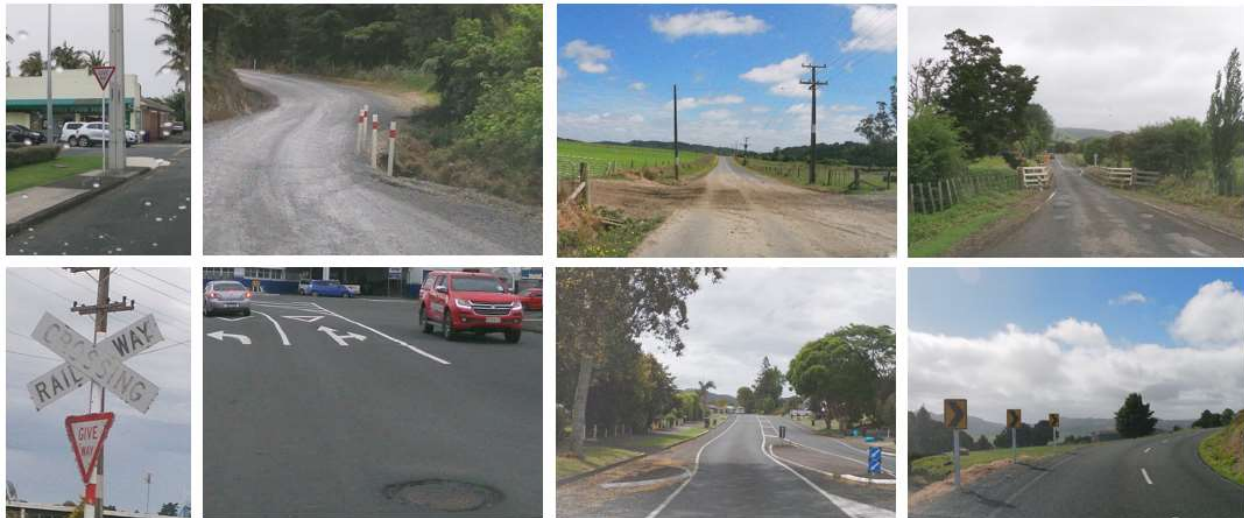
Some areas for improvement include (clockwise from top left) providing unobstructed footpath width, appropriate and consistent warning devices around slumps and dropouts, management of stock crossings, maintenance of bridge approaches, consistent road and curve delineation, warning of kerb extensions/traffic islands on the left (keep right signs), maintenance of utility lids/covers in the traffic lanes and maintenance of signs.

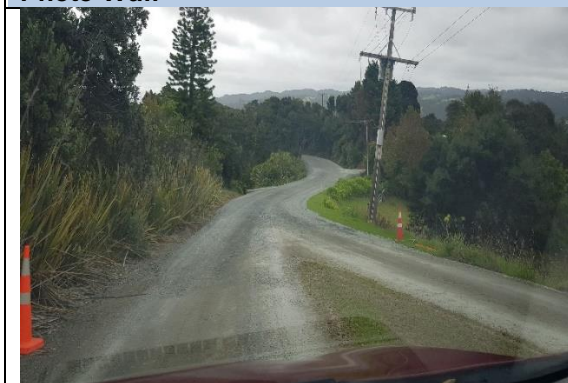
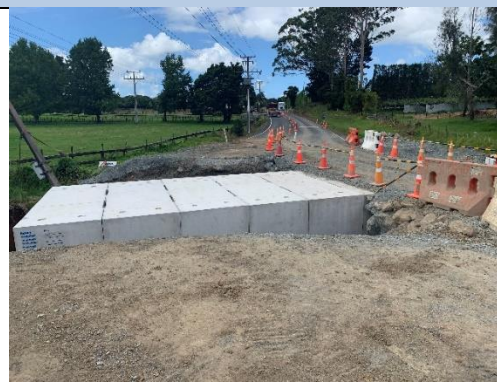
Photo Wall	
Tahunatapu Rd/ Seal Extension Placing overlay aggregate	Cemetery Road/Culvert Replacement

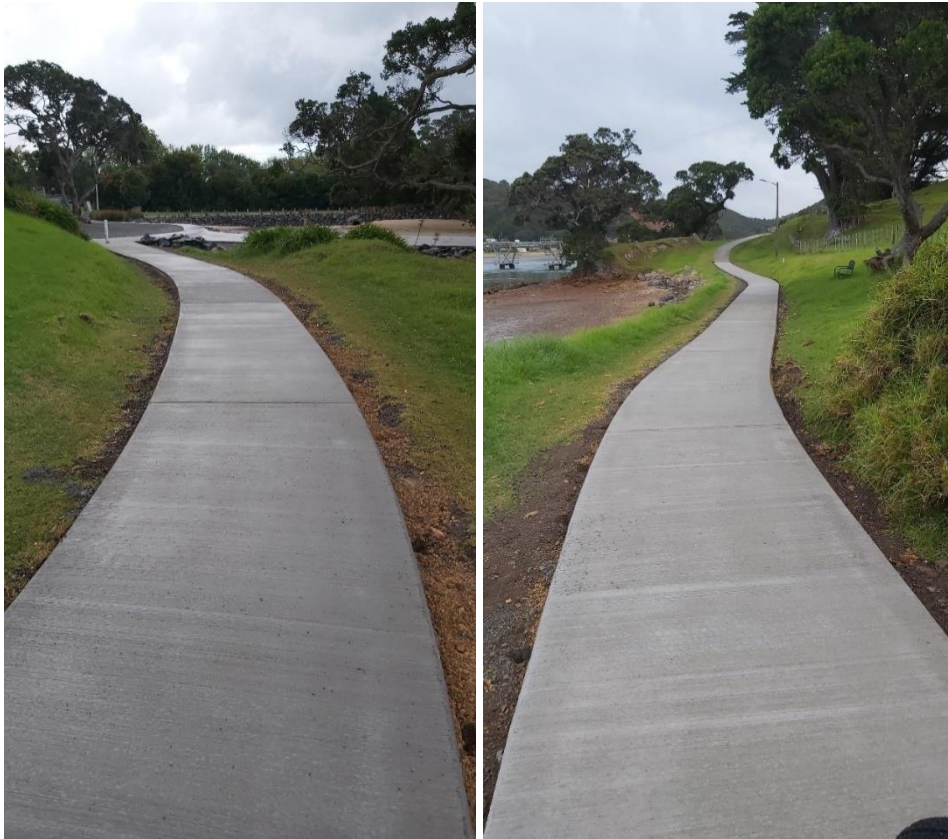
Pataua North rate payer's association identified a section of unformed path as hazardous for the increasing number of users, especially the elderly and parents of new born. Parks provided funding with the community working together to complete the pathway.

***Pataua North completed walkway section***

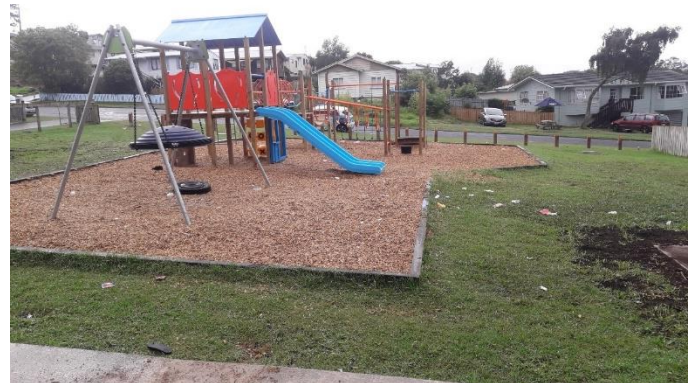
Hedley Place playground – while it has been popular with the local kids, the litter on this site has increased hugely. We are looking at installation a litter bin.

During March, the contractor had to repair a vandalised playground at Potter Park and repaired some broken equipment at the Town Basin playground. One of the trampolines was damaged and the fittings of a rope play came loose. The Hedley playground has just been renewed along with new bollards and a picnic table. The Taurikura playground is currently being replaced and the edging boards at Korau St, Taurikara and Insley playgrounds are being replaced.
