Fifteenth Avenue Corridor
Improvements

**Preliminary Design Stage Road Safety
Audit Report**

September 2018

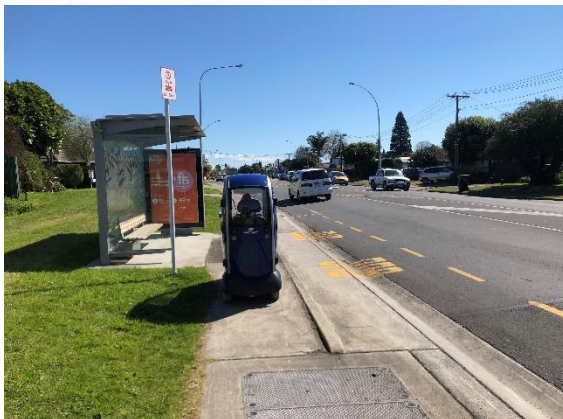
Photograph 1: Exiting user - mobility scooter

The shared path on the south side of 15th Avenue is being retrofit within the existing berm immediately behind the kerb. The SAT noted that the shared path will be used by cyclists, pedestrians, prams and mobility scooter users (see Photographs 1 and 2). There are several safety concerns with this placement and the resulting path geometry, as follows:

1. *Provide a separation strip of up to 1 m between the shared path and the kerb.*
2. *Construct the shared path at a safe cross-fall and gradient suitable for all users.*
3. *Ensure shared path surface is of a good quality, smooth and free of any trip and wheel trap hazards.*

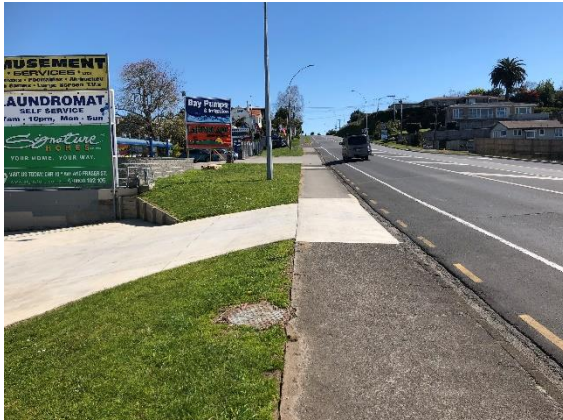
Photograph 3: Existing steep driveway shown to be incorporated into shared path

- Desirably the shared path should have a cross-fall of no more than 2% to provide a safe and comfortable path for all users which includes cyclists, pedestrians and riders of mobility scooters. However, the shared path is proposed to undulate with the existing topography resulting in a cross-fall that significantly exceeds the recommendation and, in some instances, may be up to 16% (e.g. Section 4 on Sheet 010, and Photograph 3).

Designer Response: We have reviewed the shared path geometry and driveway cross falls to lessen the variability in the path gradient as much as possible whilst maintaining acceptable driveway gradients and avoid flooding properties. The steep sections in the cross sections have been addressed as far as possible.

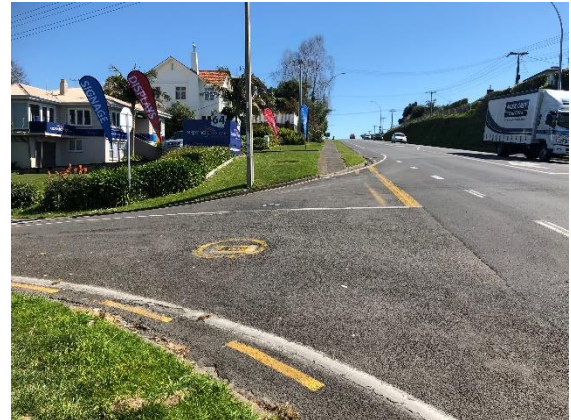
Photograph 4: Existing steep berm on southwest side of Scantlebury Street

- Where the shared path crosses Scantlebury Street there is no earthworks currently indicated and yet the existing berm on the southwest corner is considered too steep to safely construct a shared path particularly with the possible speed of eastbound cyclists and the limited visibility to vehicles on the side road (Photograph 4). Regrading of the shared path is considered necessary with consideration to all shared path users.

Detail added around the walls as suggested.

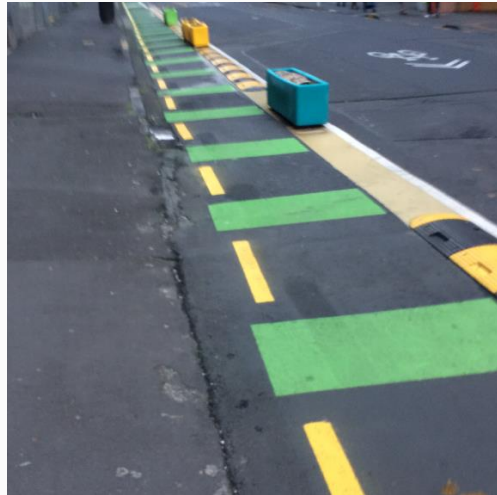
Designer Response: *We propose to incorporate small speed bumps and possibly shared path paint marking similar to the photo below on the shared path through the commercial area.*

Accept designer response. Confirm treatments at commercial entranceways prior to construction.

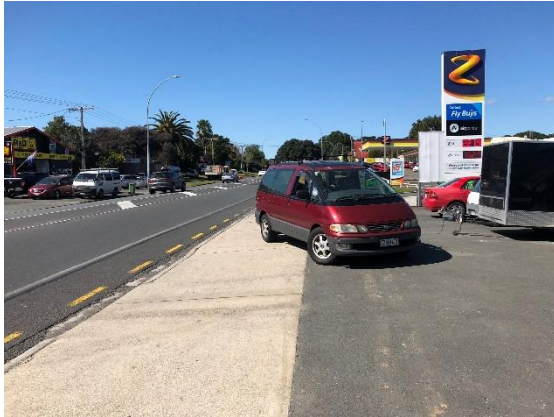
Photograph 5: Manoeuvring from businesses east of Burrows Street

The businesses between Burrows Street and the Z service station, currently have full width angle parking (mostly within the road reserve) over the street frontage resulting in a near continuous vehicle crossing. Vehicles currently use the shared path to provide for manoeuvring from these parking spaces as shown in Photograph 5. The proposed relocated shared path will be closer to the buildings and rear of parked vehicles which will result in exacerbating two existing issues:

- Vehicles reversing into the shared path users at risk particularly if sight lines are restricted by other adjacent parked vehicles. As noted at the driveways above, drivers may not adequately check for path users before pulling into the shared path.
- The lane widening will reduce the manoeuvring space which and the space previously used for turning, as shown in Photograph 5, within the T3 lane and therefore potentially conflicting with traffic on 15th Avenue.

Remove angle parking adjacent to the shared path.

Designer Response: This parking is in the road reserve and will be removed. Line marking will be used to delineate the path.

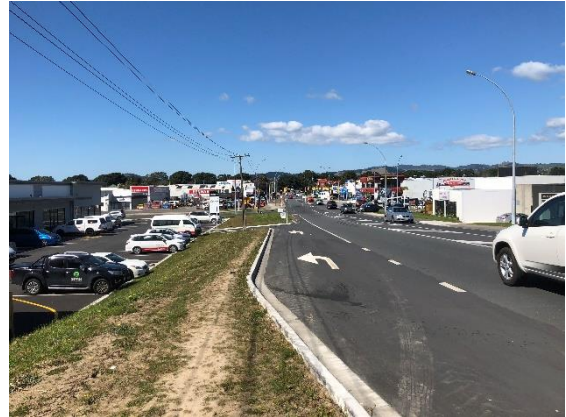
Photograph 6: Existing left turn slip lane to retail outlets on the northwest corner of Burrows Street intersection.

The proposal intends to remove an existing slip lane serving the retail activity on the northwest corner of the Burrows Street intersection and use the space for the one of the intersection approach lanes (Photograph 6).
