Executive Summary

Tauranga City Council

15th Avenue Corridor Improvements

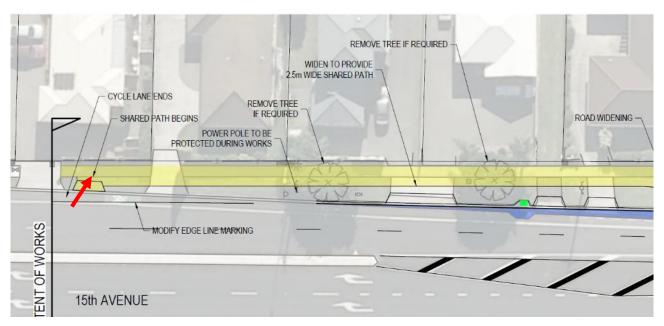
Figure 4-1: Departure angle proposed in design

The proposed cycle crossing from the on-road cycle lane on to shared path (north side) is too direct and requires the cyclist to make too sharp a turn. The more acute the turn the less likely a cyclist will be inclined to use the shared path as intended. The drawings show a high angle of departure for cyclists traversing from the on-road facility to the off-road facility, as shown in Figure 4-1 below.

A high angle departure associated with a low nib at the back of the channel (typically 25mm at a cut down) can result in the wheels of bike being pushed sideways due to the angle of approach. This could result in a cyclist tipping into the adjacent traffic lane.

- 1. Realign cycle lane transition from road to shared path to a less acute angle. Provide a construction detail of how the transition kerb cut-down will minimise any potential risk of wheel trap hazard.
- 2. Redesign the crossing point to a shallower angle, with a full dished channel without the nib typical of a kerb cutdown.
- 1. Reconsider location of shared path meeting the existing cycle lane move further east to minimise the need for extra, and narrow, cut down.

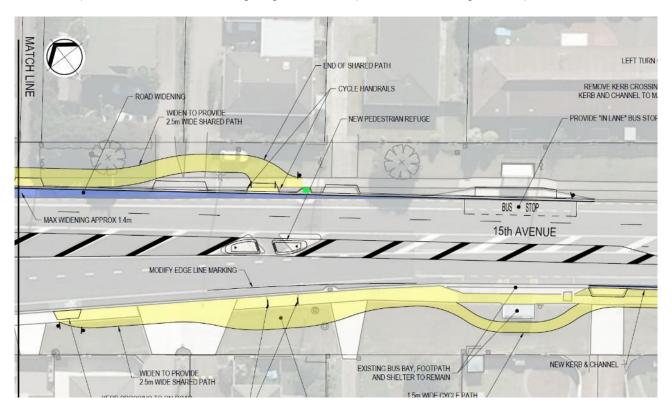
Figure 4-2: Proposed crossing point over 15th Avenue

Where the proposed shared path meets the existing footpath at the proposed 3.6m wide kerb crossing point the current plans do not reflect the possible impact of the existing slope up to the existing boundary fence, the possible need for a retaining edge and the impact on the existing service pit levels in this area.

The design should reflect the actual desire paths of the various user types, and the path adjusted accordingly to reflect these, incorporating any adjustment that is required to maintain effective access to adjacent properties.

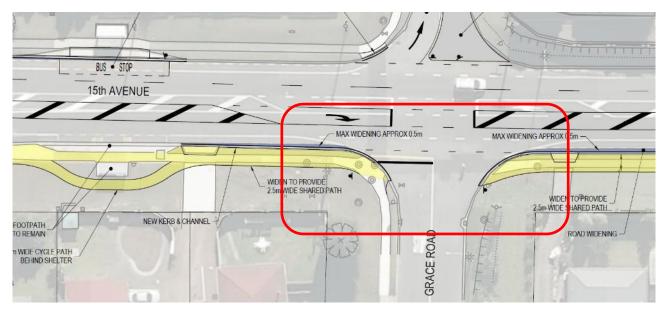
Figure 4-5: Grace Road (West) intersection. Proposed design.

The proposal for the shared path extension on the corner of 15th Ave and Grace Road, south side, lacks detail around how the proposed shared path is to be constructed when considering the space around existing service covers, along with the alignment up and across the existing steep gradient.

In addition to this – it is best practice to have the crossing cut-down locations over Grace Road formed such that a visually impaired / mobility impaired user crosses the cutdown at as close to a 90-degree angle as possible. In this instance it may require the crossing point to be further down the side road, but final placement needs to be aware of the sight lines required at the crossing location.

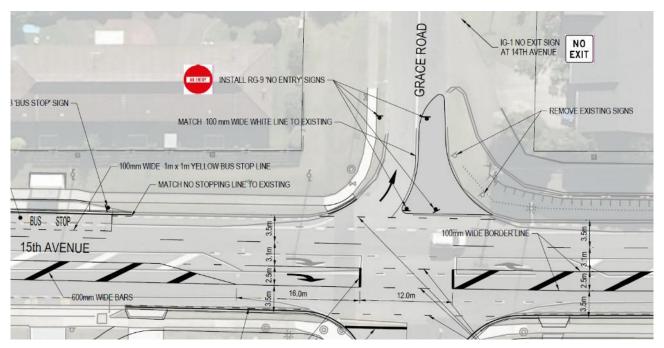
Figure 4-8: Grace Road (east) Intersection. Proposed design.

The audit team note that Grace Road, north side, is to be altered to a left turn in only from 15th Avenue. The team acknowledge that the proposed concrete island will form a lane closure preventing drivers from undertaking a left turn exit on to 15th Avenue.

It is noted that the island is up to 10M wide and 15M long and does not reflect the high amenity streetscape values (wide grassed berms and tree planting) of Grace Road, nor does it add any aesthetic or amenity value to 15th Avenue itself.

The team consider that the amenity value of the street could be enhanced with the provision of suitable planting or landscaping.

- 1. Replace proposed concrete with a combination of planting, trees, and grass.
- 2. Review the design to incorporate suitable restrictions for the right turn in movement, along with the crossing movement on Grace Road.
