**Greater Wellington Rail Limited
Kaiwharawhara Pedestrian Over Bridge
Structural Assessment and Repair Options Report**

July 2013
Prepared by Spiire

Structural Assessment of
Kaiwharawhara Pedestrian Over Bridge

Design Features Report

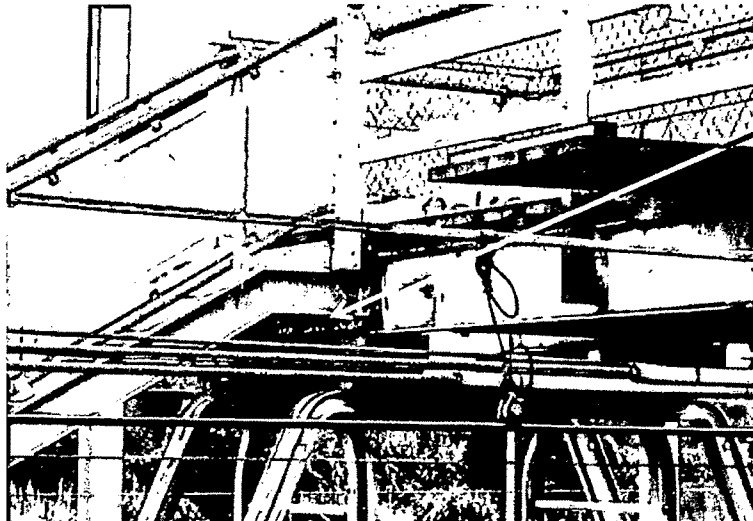
Photographs one and two show extensive corrosion below the connection between the stairs and bridge.

Daylight through the beam

Photo two: Location of corrosion to steel I-beam web.

The steel I-beams and rail irons forming the piers require replacement due to the extent of corrosion. It is not considered practical to repair these members.

The main bridge I-beam spans are severely corroded and require replacement. The rail iron piers are also in very poor condition with significant loss of section evident and are in need of replacement. We consider that the only parts of the bridge able to be incorporated into an upgraded structure are the three relatively new sets of stairs. These are constructed of galvanised steel channel stringers with galvanised folded plate treads and risers.

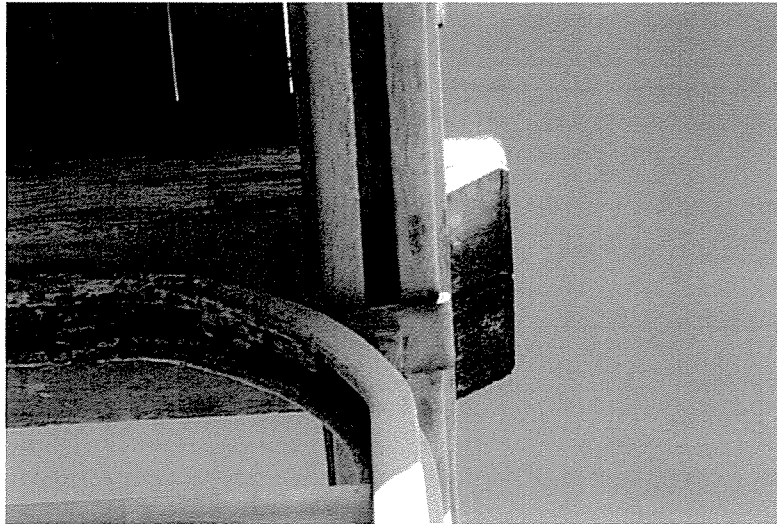
Large timber corbels sit on the rail-iron piers. These were observed to be split along the centre where bolts attach the piers to the I-beams. The splits are typically 5-10mm wide and will weaken the connection between the piers and steel I-beams. 10mm diameter exploratory holes were drilled into the corbel members. The condition of the timber was found to be good with no evidence of degradation. Similar observations were made on holes drilled in the timber packers bolted to the top flange of the main I-beams.

Photo Three: Timber corbel with split along bolt line.

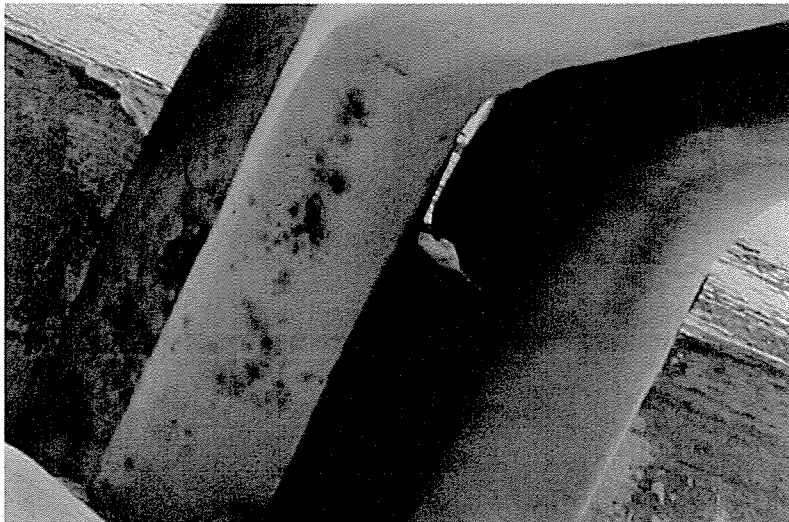
Extensive corrosion was observed on the rail-irons. Significant loss of section has been observed at the base of the legs and also at the top of the piers.

Photo Four: Extensive corrosion of rail section (between members). Surface corrosion and loose rust evident.

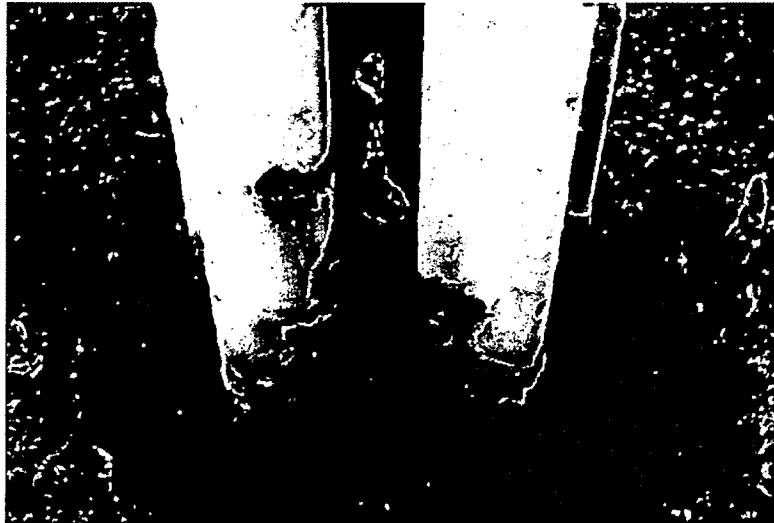
Photographs 5 , 6 and 7 show extensive corrosion of the rail-irons below ground level on the east side and central piers.

Photo Five: Extensive corrosion of rail and loss of section at base.

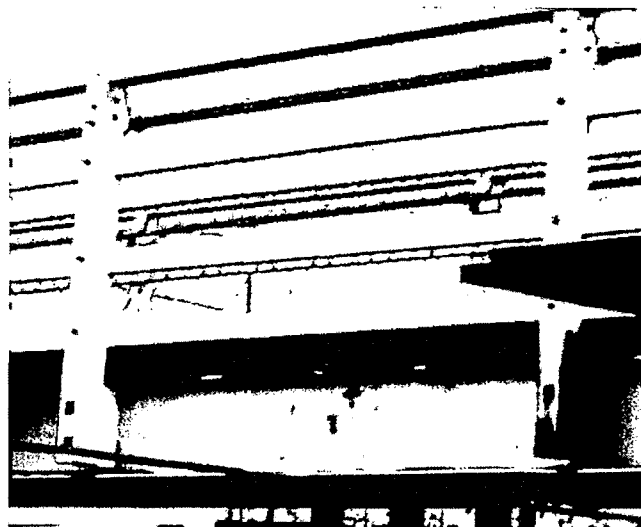
The bridge balustrade looks to have been repaired around the same time as the stairs. Some of the connections between the bridge superstructure and balustrade posts have deteriorated. On the left handside of the photograph 8 a replaced balustrade post can be observed. On the right hand side an original post is seen, the timber blocking fixed to the web of the I-beam has split and half has come away. Note the corrosion behind where the timber blocking used to be.

Photo Eight: Comparison of old and new balustrade supports

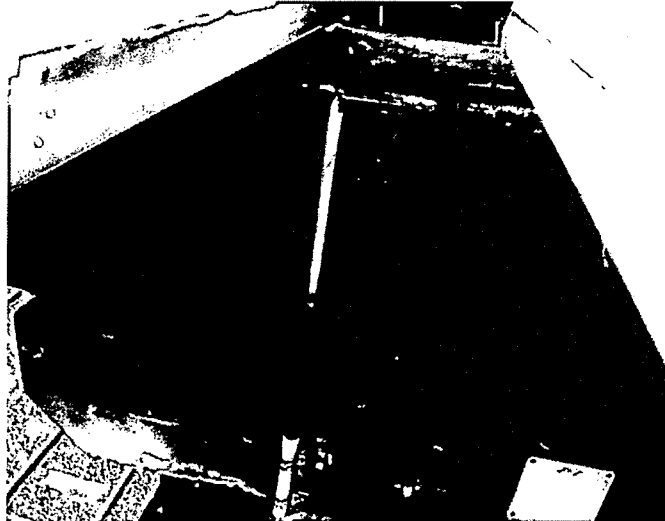
In photograph nine there are areas of significant corrosion of the top surface of the top flange of the beams and also extensive surface corrosion of the beams

Photo Nine: Corrosion to the tops of the top flange of the I-beams under the timber packers supporting the deck.

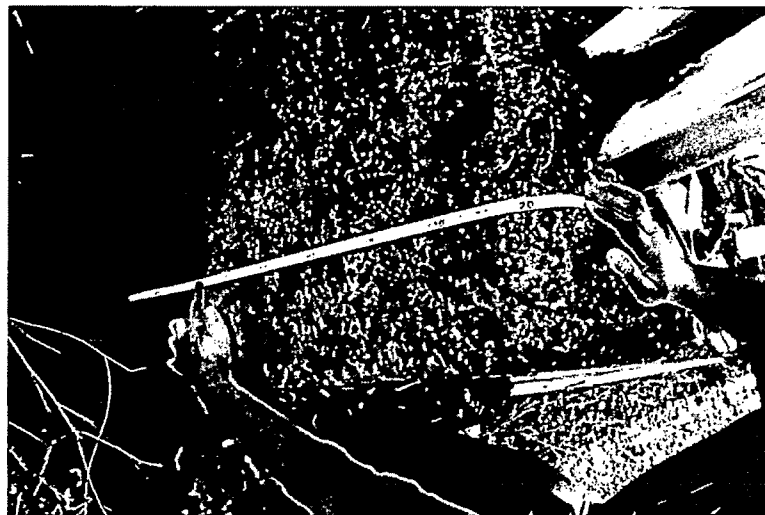
Photo Ten: Bottom of concrete pad foundation adjacent to the west boundary fence is 600mm below ground level, founded on solid ground.

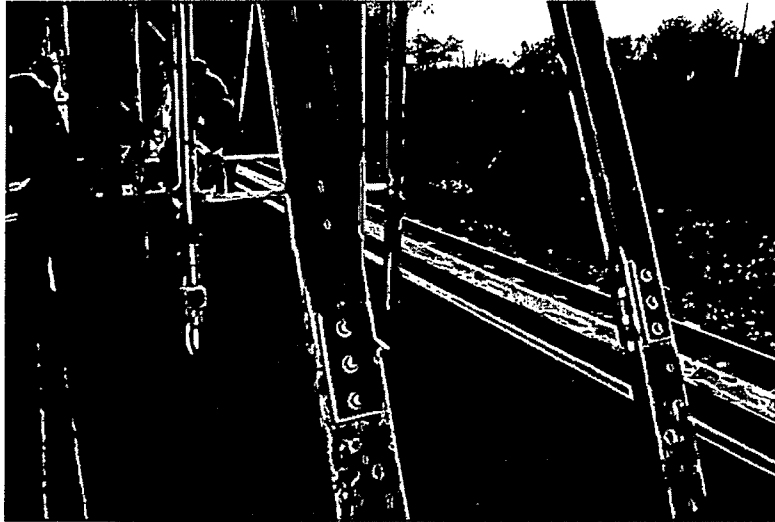
Some steel splice plates have been attached relatively recently to the to the pier legs. These do not address the problem of extensive corrosion of the rail-iron piers.

Photo Eleven: East side pier. Extensive corrosion to the pier leg connecting bolts and the circular hollow section prop between rail-iron legs. Note plates added recently at joint.

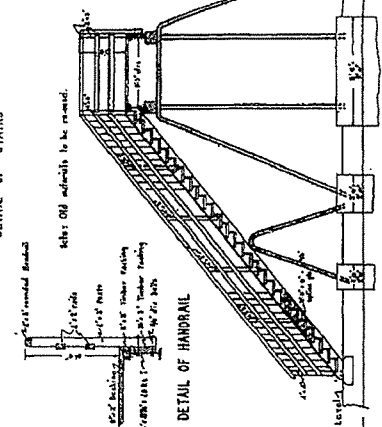
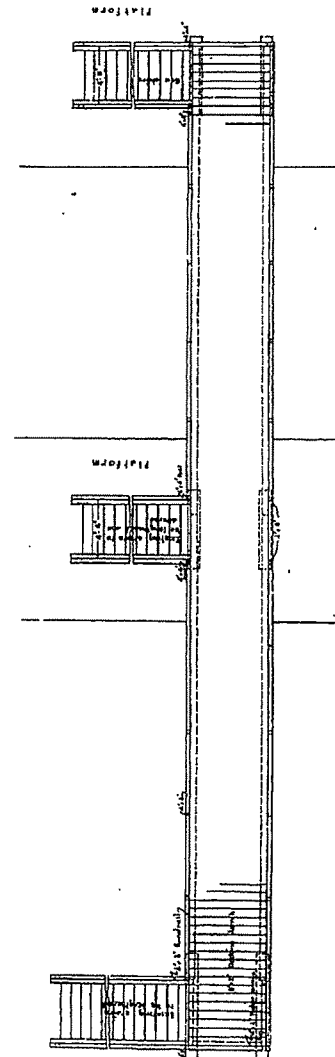
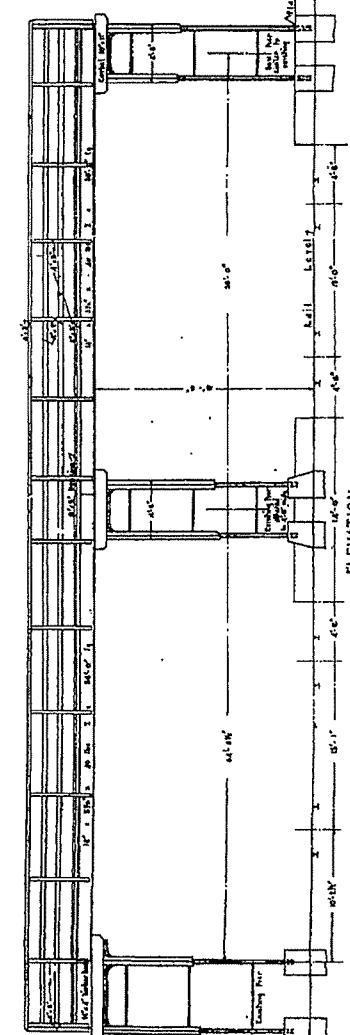
KAIWARRA
 PROPOSED FOOT OVERBRIDGE.
 SCALE 4" & 2" TO 1"

CROSS SECTION

PLAN

ELEVATION

The bridge appears to have been constructed approximately in the middle of the 20th century. We have viewed drawing 45847 in Appendix 1 (undated) which we believe is a drawing of the subject Kaiwharawhara Bridge. It appears in drawing 45847 that the rail-iron piers are older than the I-beam spans. The stairs were replaced in 2005. The timber deck and handrails have been replaced recently.

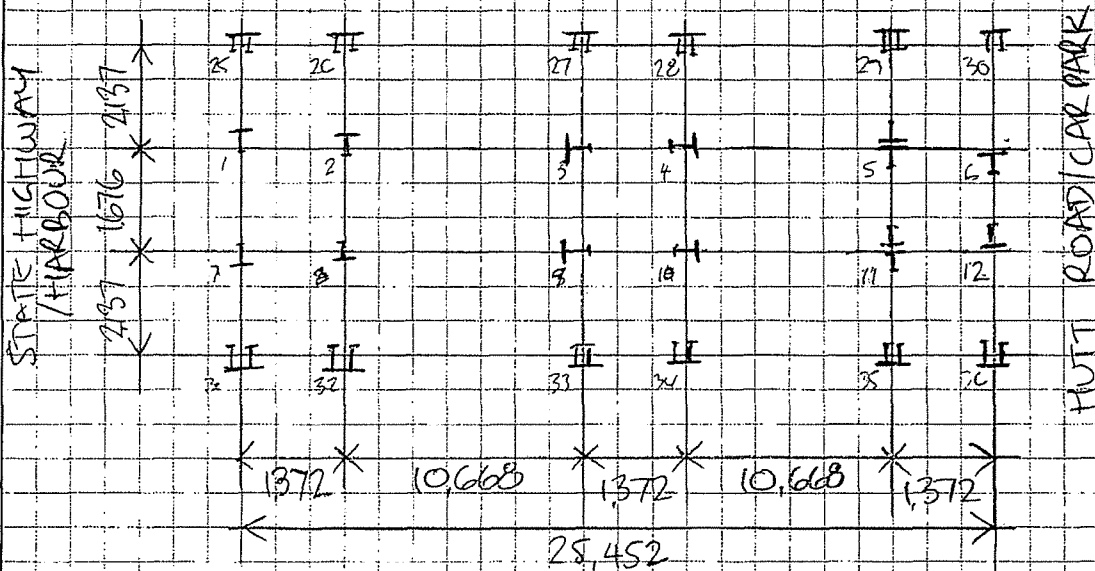
PLAN SHOWING SET OUT DIMENSIONS & MEMBER ORIENTATION.

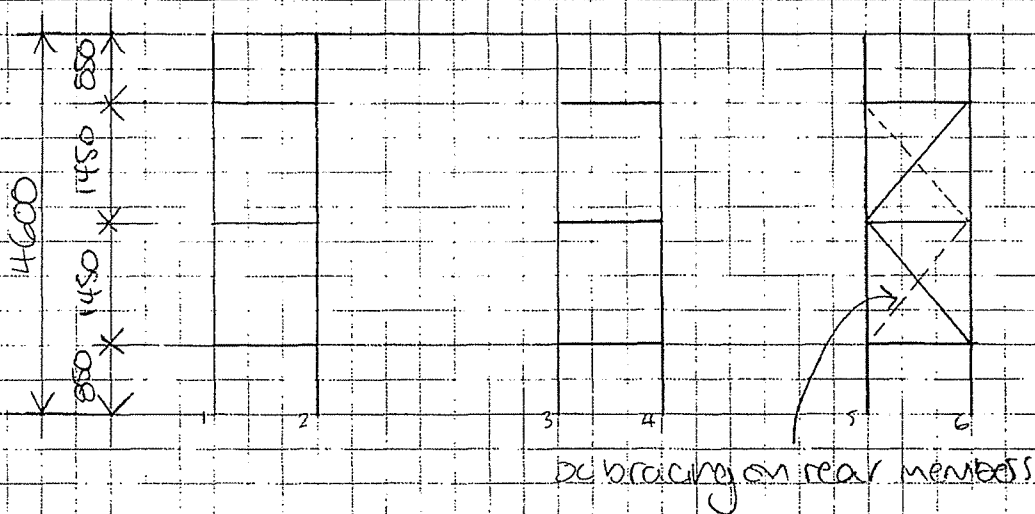
ELEVATION.

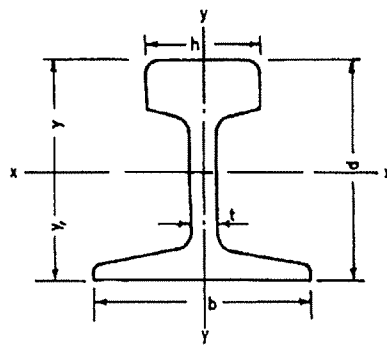
Following a visit to site & measurement of the rail sections forming the legs / piers of the footbridge, it is thought that the members are similar to 'So NZR'

53 N.Z.R.
PROPERTIES USED
