Table of Contents

1.	1. Paramata Wastewater Update Email	1
2.	2. Paramata Wastewater Rising Main	13
3.	3. Copy of Aotea pipe break Paramata overflow Enterococci monitoring (cfu100mL)	38
4.	4. Email correspondence between WWL and PCC	40
5.	5. Email correspondence between PCC and WWL	41

UPDATE 19 20:30 25 July 2021

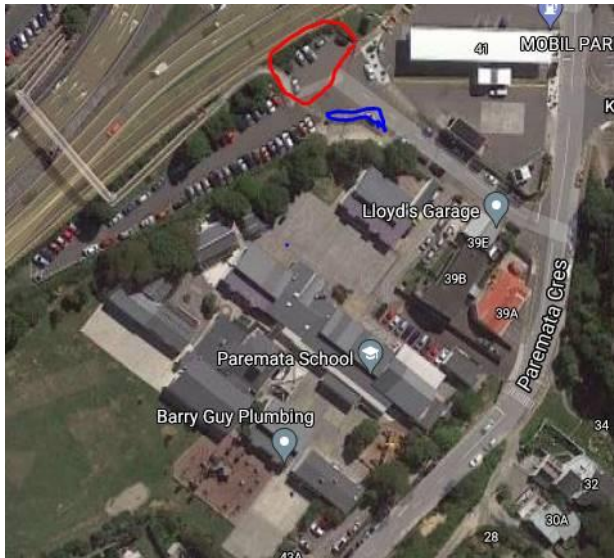
The team were successful in completing the repair this evening and the rising main is now operational. Our team will be monitoring the repair overnight. Note that we will still have some carparks coned off in the turning circle of the carpark due to machinery being onsite for monitoring purposes. Please see the picture below for approximate location of pumps (in blue) and carparks in red.
