Interference report – The Base shopping complex

Investigation date	12/01/2022
Radio Spectrum Investigator	Mervyn Frericks
Client	The Base shopping complex
Location	Te Rapa shopping complex, Hamilton
Service impacted	433.92 MHz GURL – vehicle remote fobs
Case number	31375

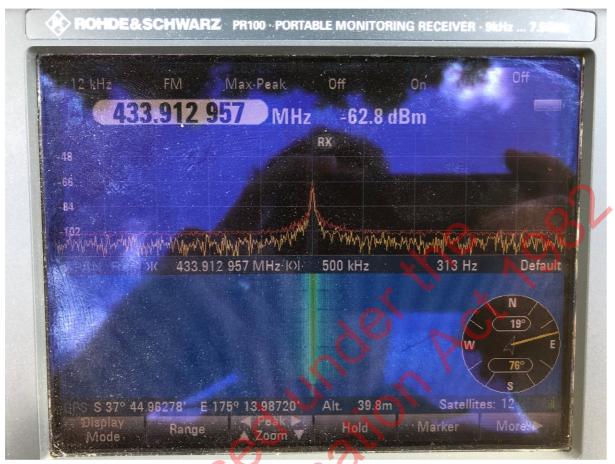
Spectrum trace identified from the antenna location.
