Fire Investigation Report

Vegetation Fire

Fire Authority Name: Otago Rural Fire Authority
Fire Name: Saddle Hill Fire
Fire Date: 7 October 2015
Date of Investigation: 8 October to 12 November 2015
Report Completed By: James. P. Cowan

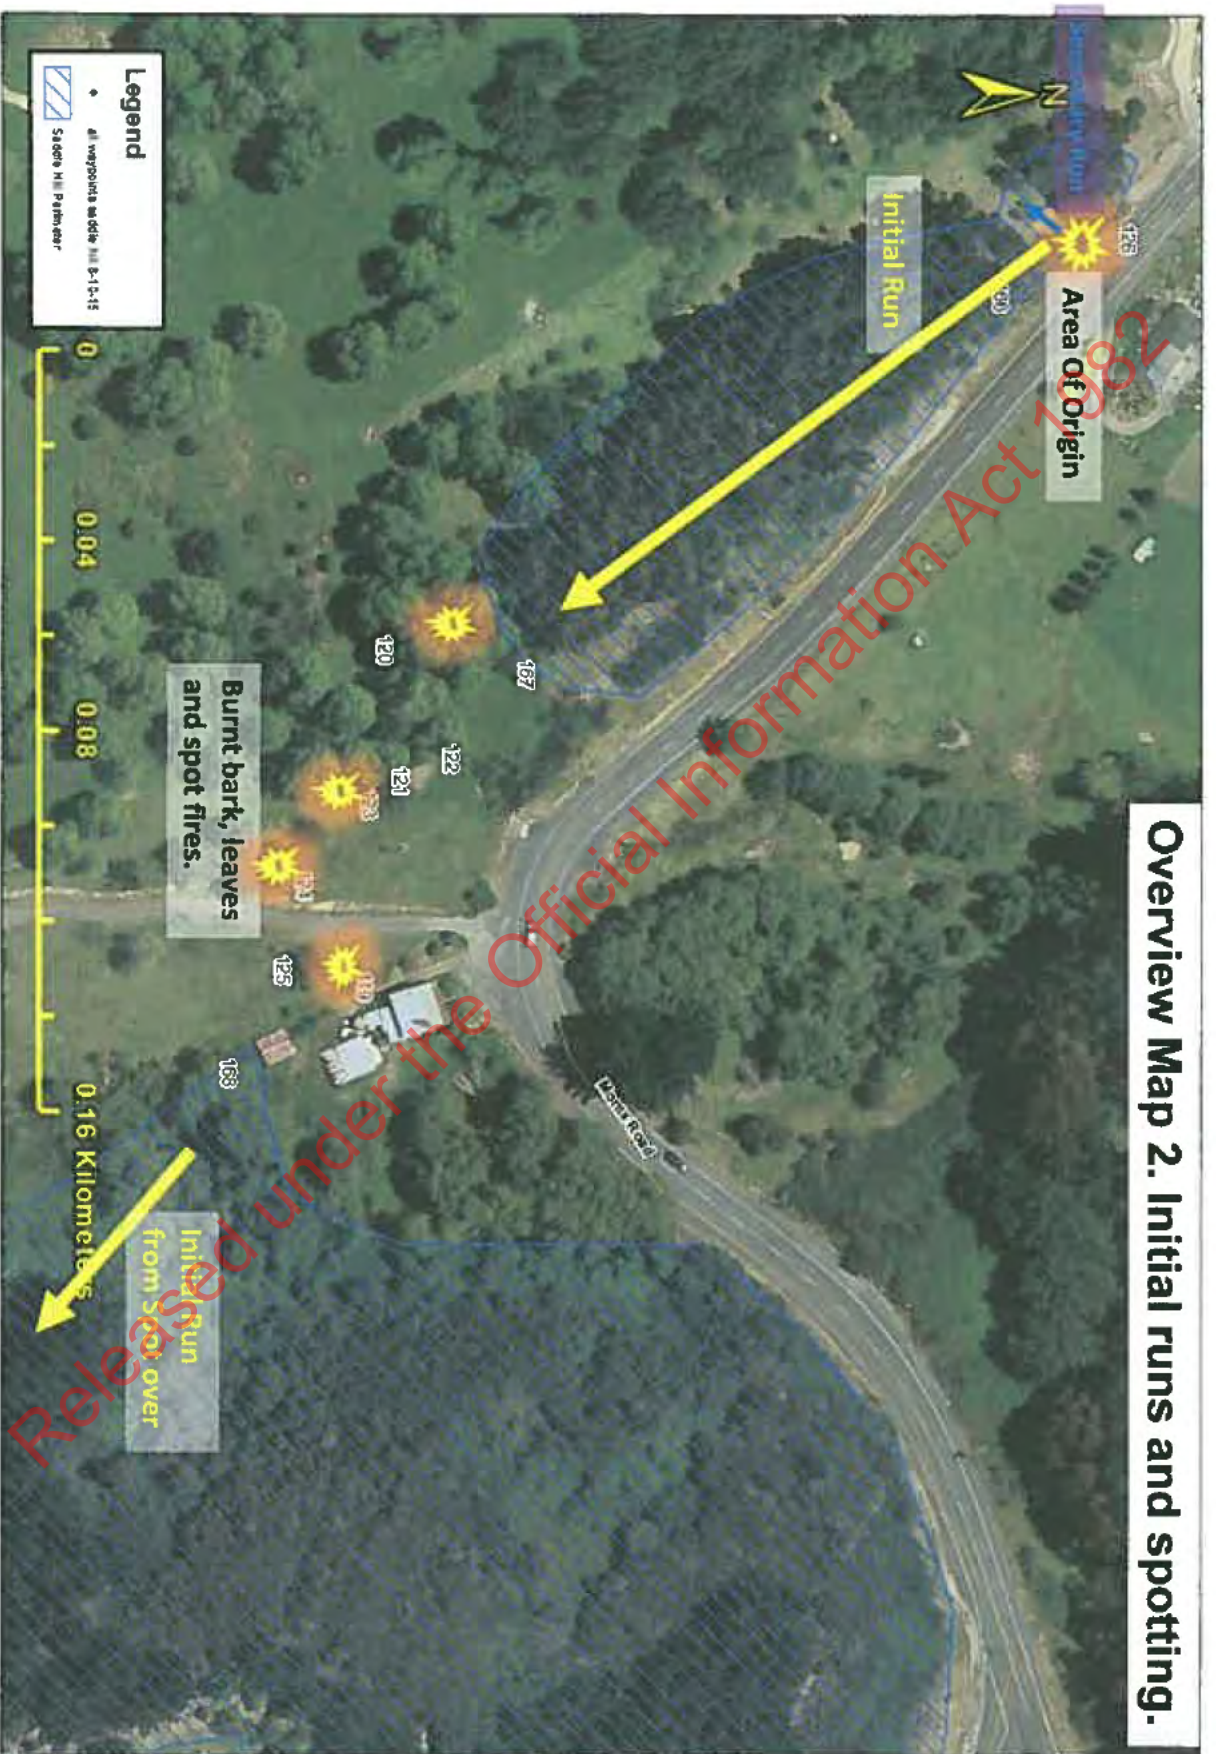
Photo 910-AOO, the initial fire run advancing to the SE, the angle of Char greater than the slope, a clear indication of the fires initial run direction.

Burn and char patterns are evident and obvious in the gum plantation supporting the AOO. The macro indicators include an angle of char greater than the slope across the whole gum plantation, flame wrap on the gum trunks and freeze on the leaves of the shrubs in the vicinity of the gums.

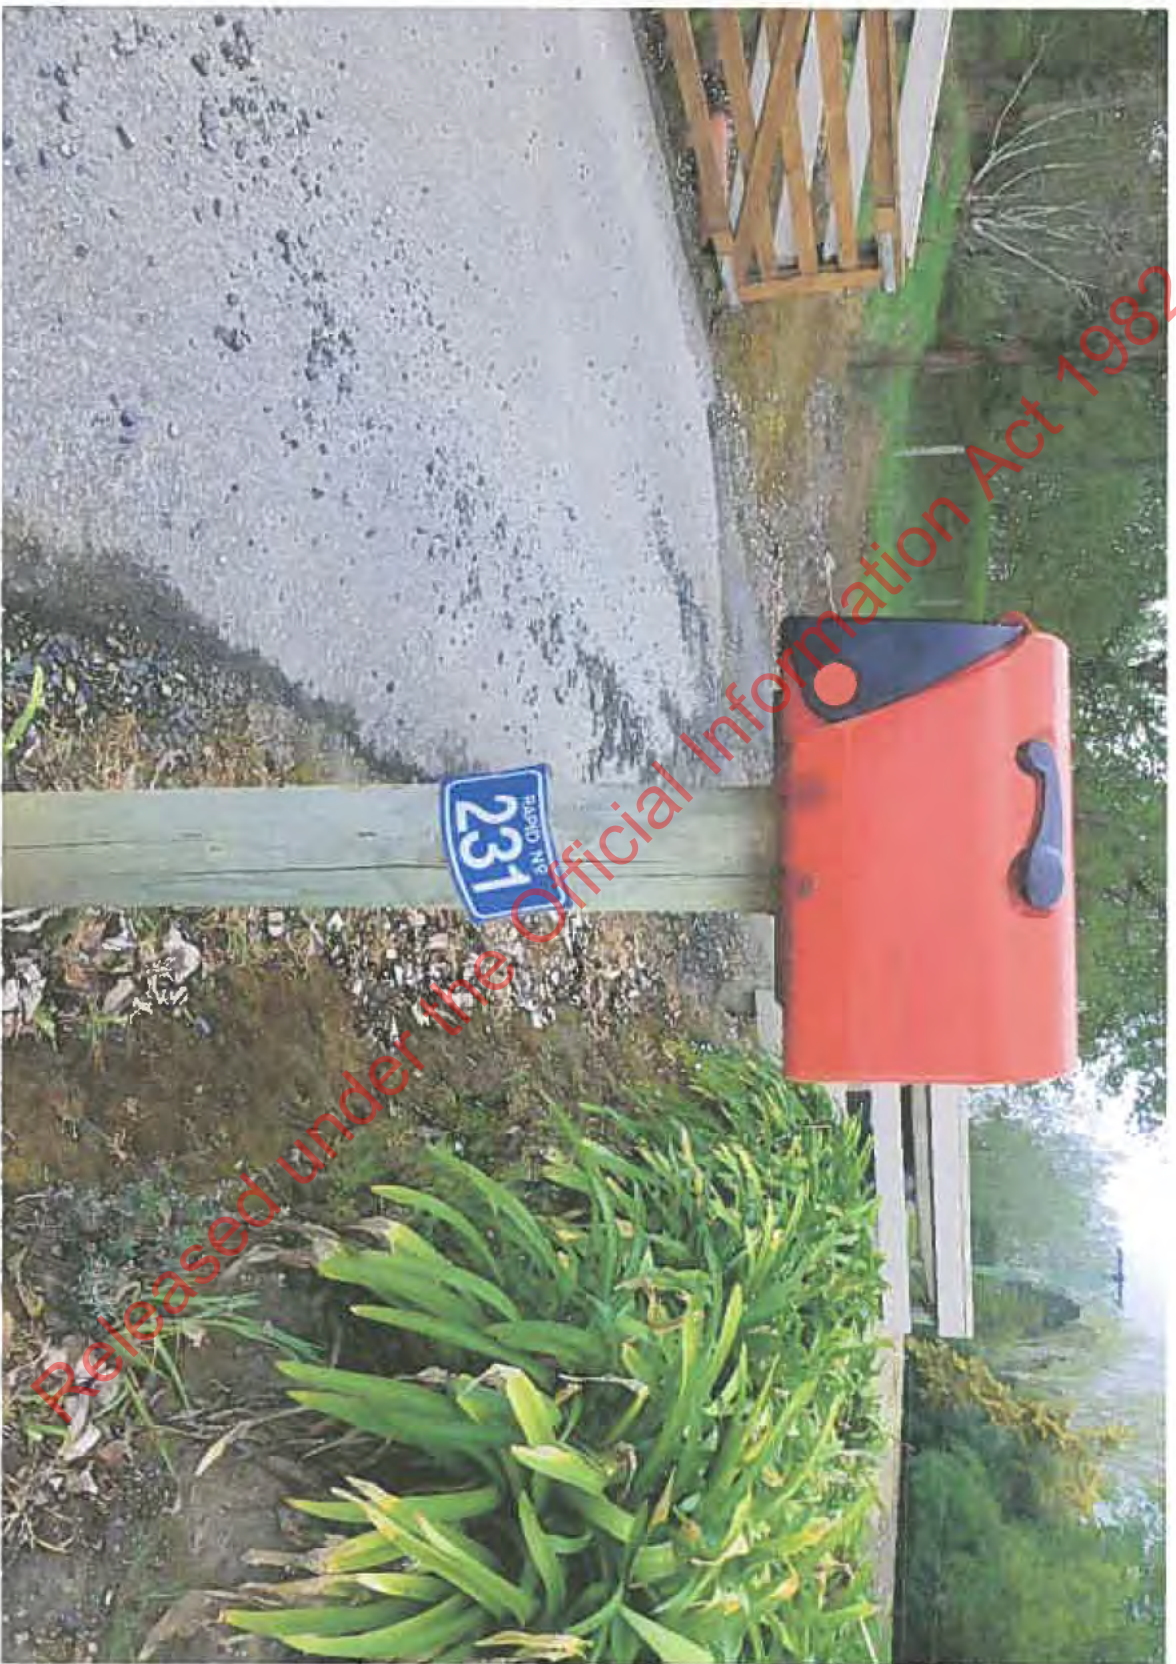
Photos 921 -A00 pole 821286.

I then back tracked the main run into the stand of Gums and back to an area around power pole 821286 on the line known as East Taieri 2 (ET2).

This pole has a recloser (ID 2339R) fitted that acts essentially like a large fuse in the event of a fault. This recloser is monitored and fault data specific to it was subsequently provided by Delta (See Appendix 3).

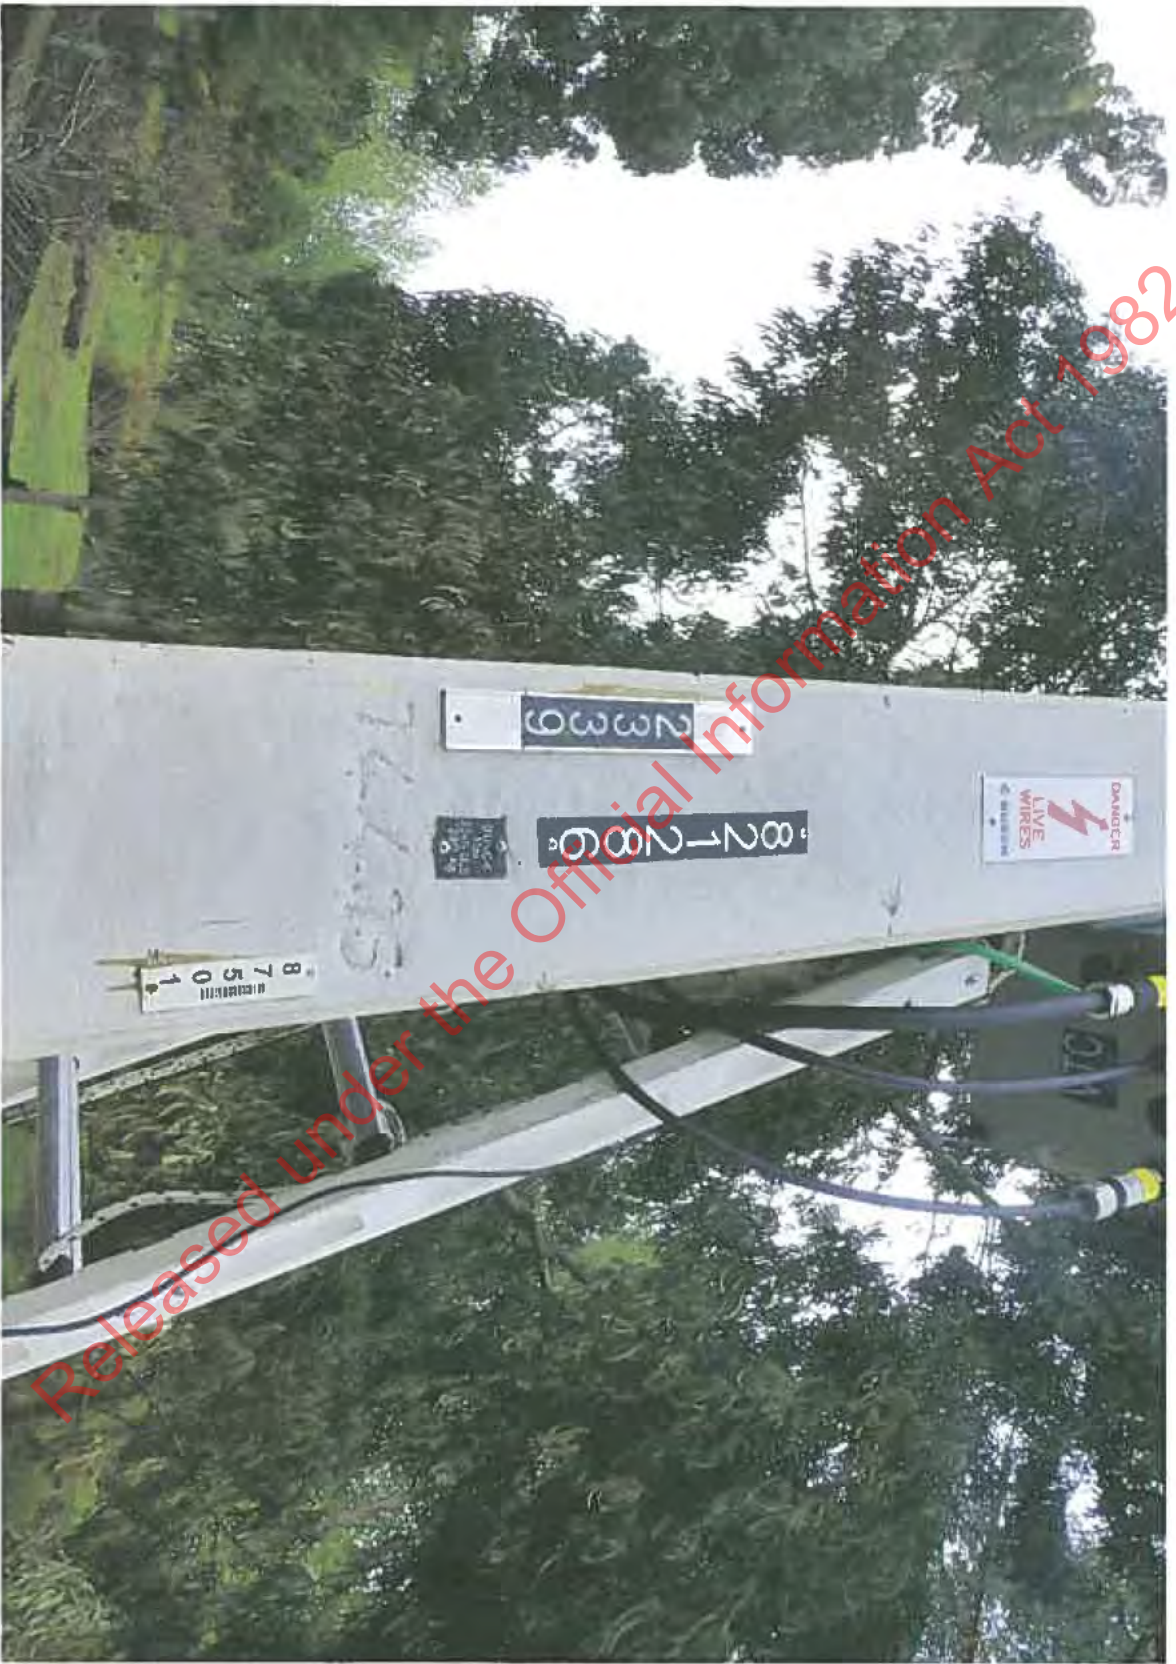
Photos 3 (4) Delta – Recloser unit on AOO pole 821286. Shows damage, carboning and charring to Recloser.

I noticed that the recloser had charring on it and a melted lifting ring. This was subsequently confirmed by Delta and photos of the damage were provided. I continued to observe, photograph and note burn and char patterns that supported an area of origin (AOO) on the road side of the fence around pole 821286.

Physical Site Evidence Damage to the recloser in the form of carboning, charring, melting and molten metal splattered over parts of it. Ignition locations have been logged by GPS.

Photos 3 (4) Delta – Recloser unit on AOO pole 821286. Shows damage, carboning and charring to Recloser.

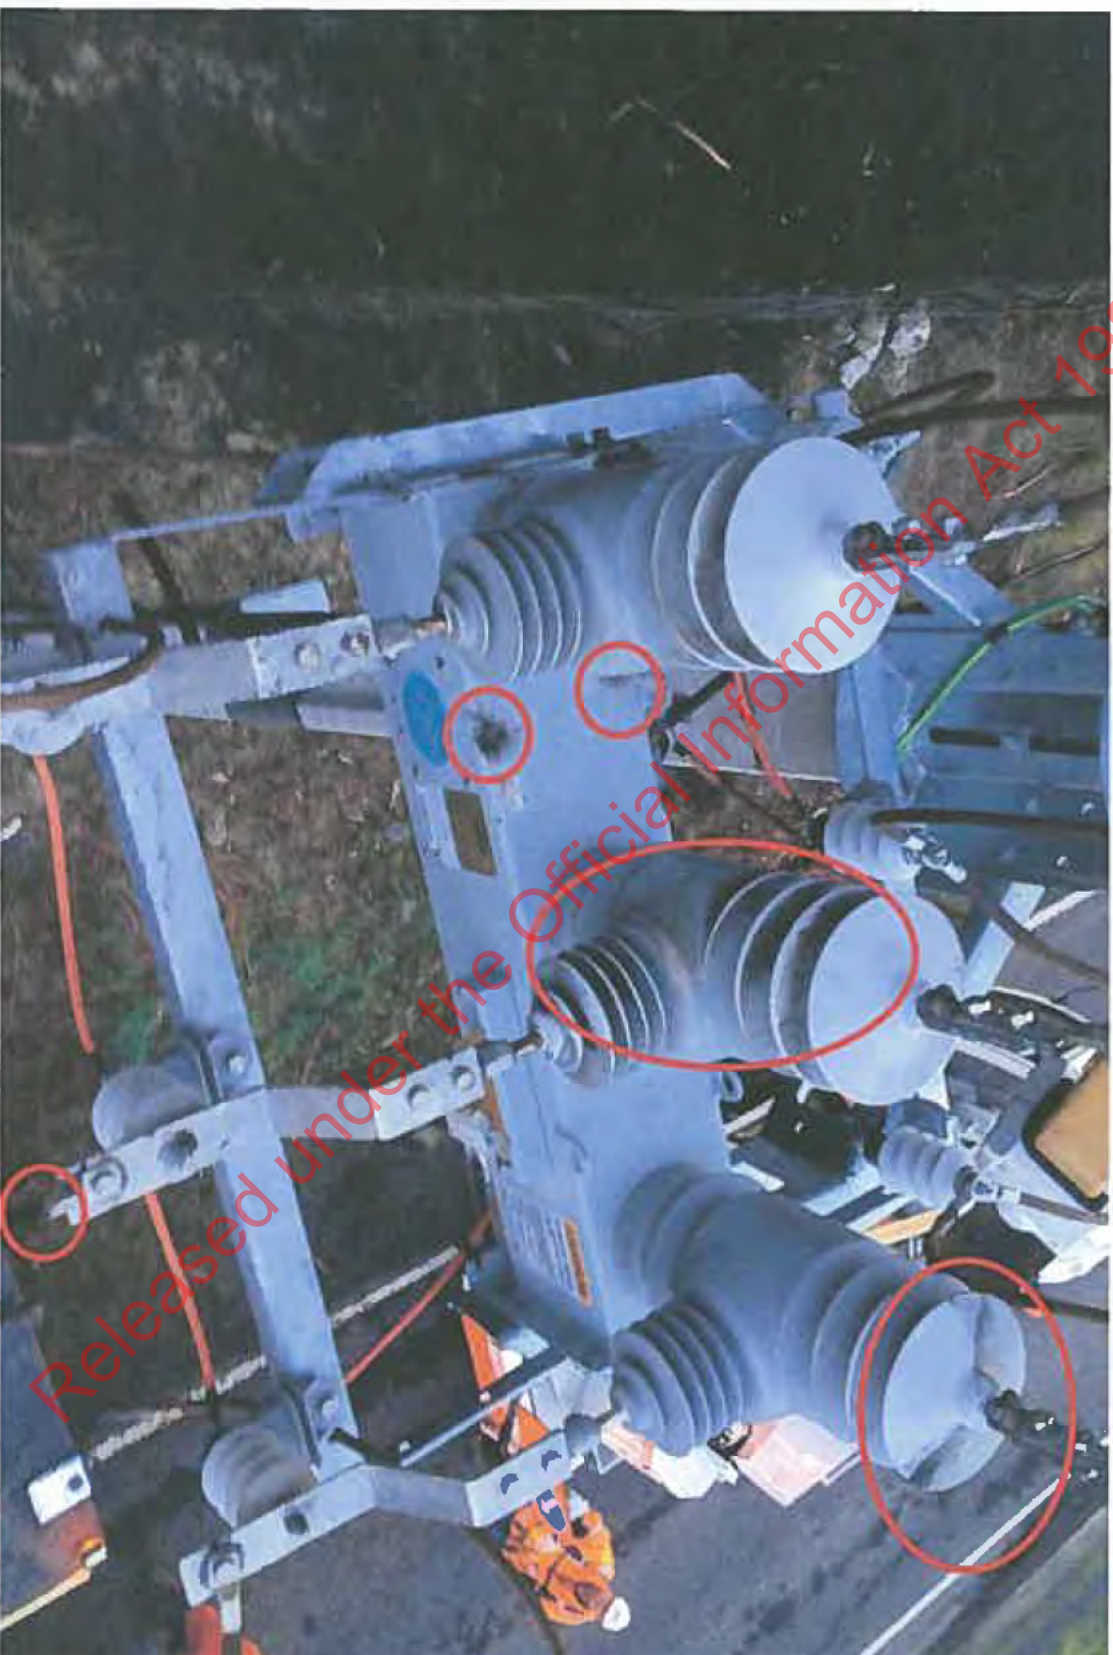
Photos 5 (2) Delta – Recloser unit on A00 pole 821286. Shows damage, carboning and charring to Recloser.

Photos 5 (2) Delta – Recloser unit on AOO pole 821286. Shows damage, carboning and charring to Recloser.

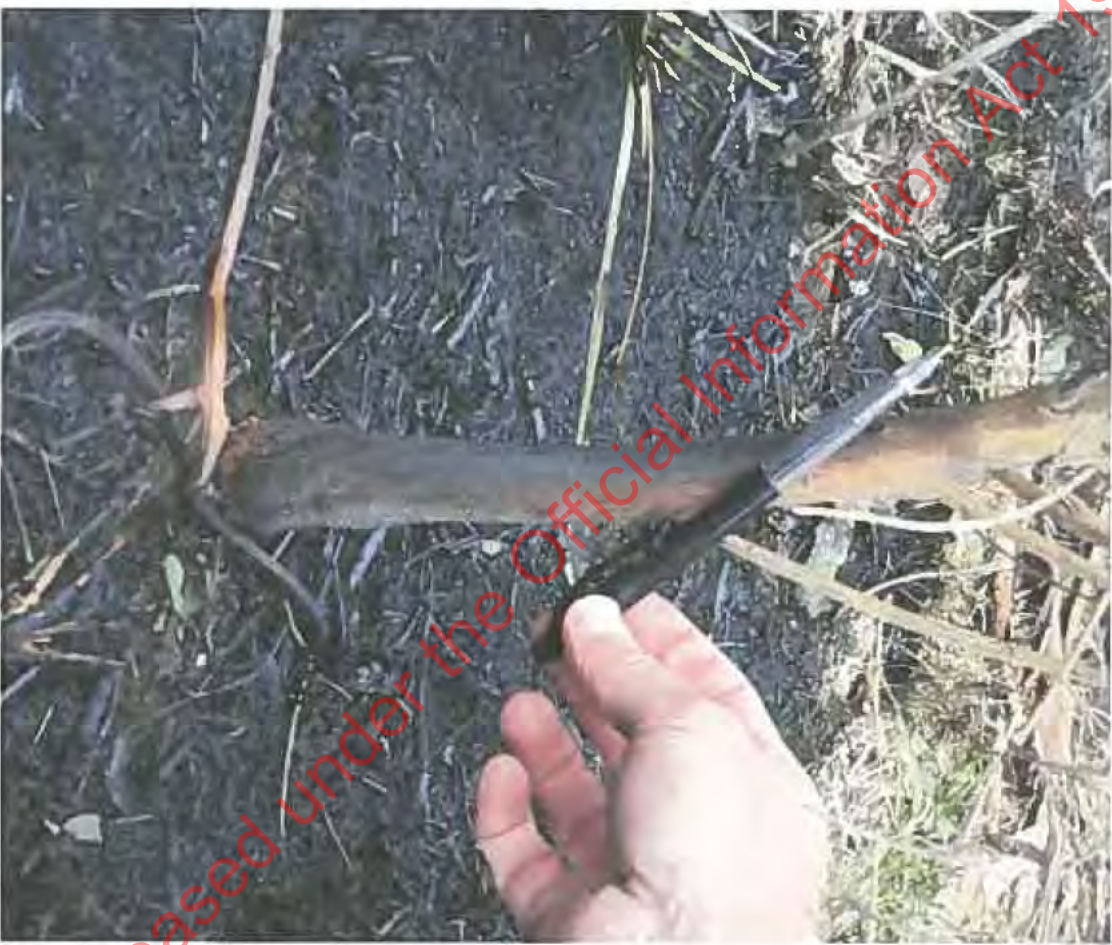
Photos 923- Burnt gum bark Spot fire approx 14m out in front of the advancing fire at the end of the Gum plantation.

Photos 923– Burnt gum bark Spot fire approx 14m out in front of the advancing fire at the end of the Gum plantation.

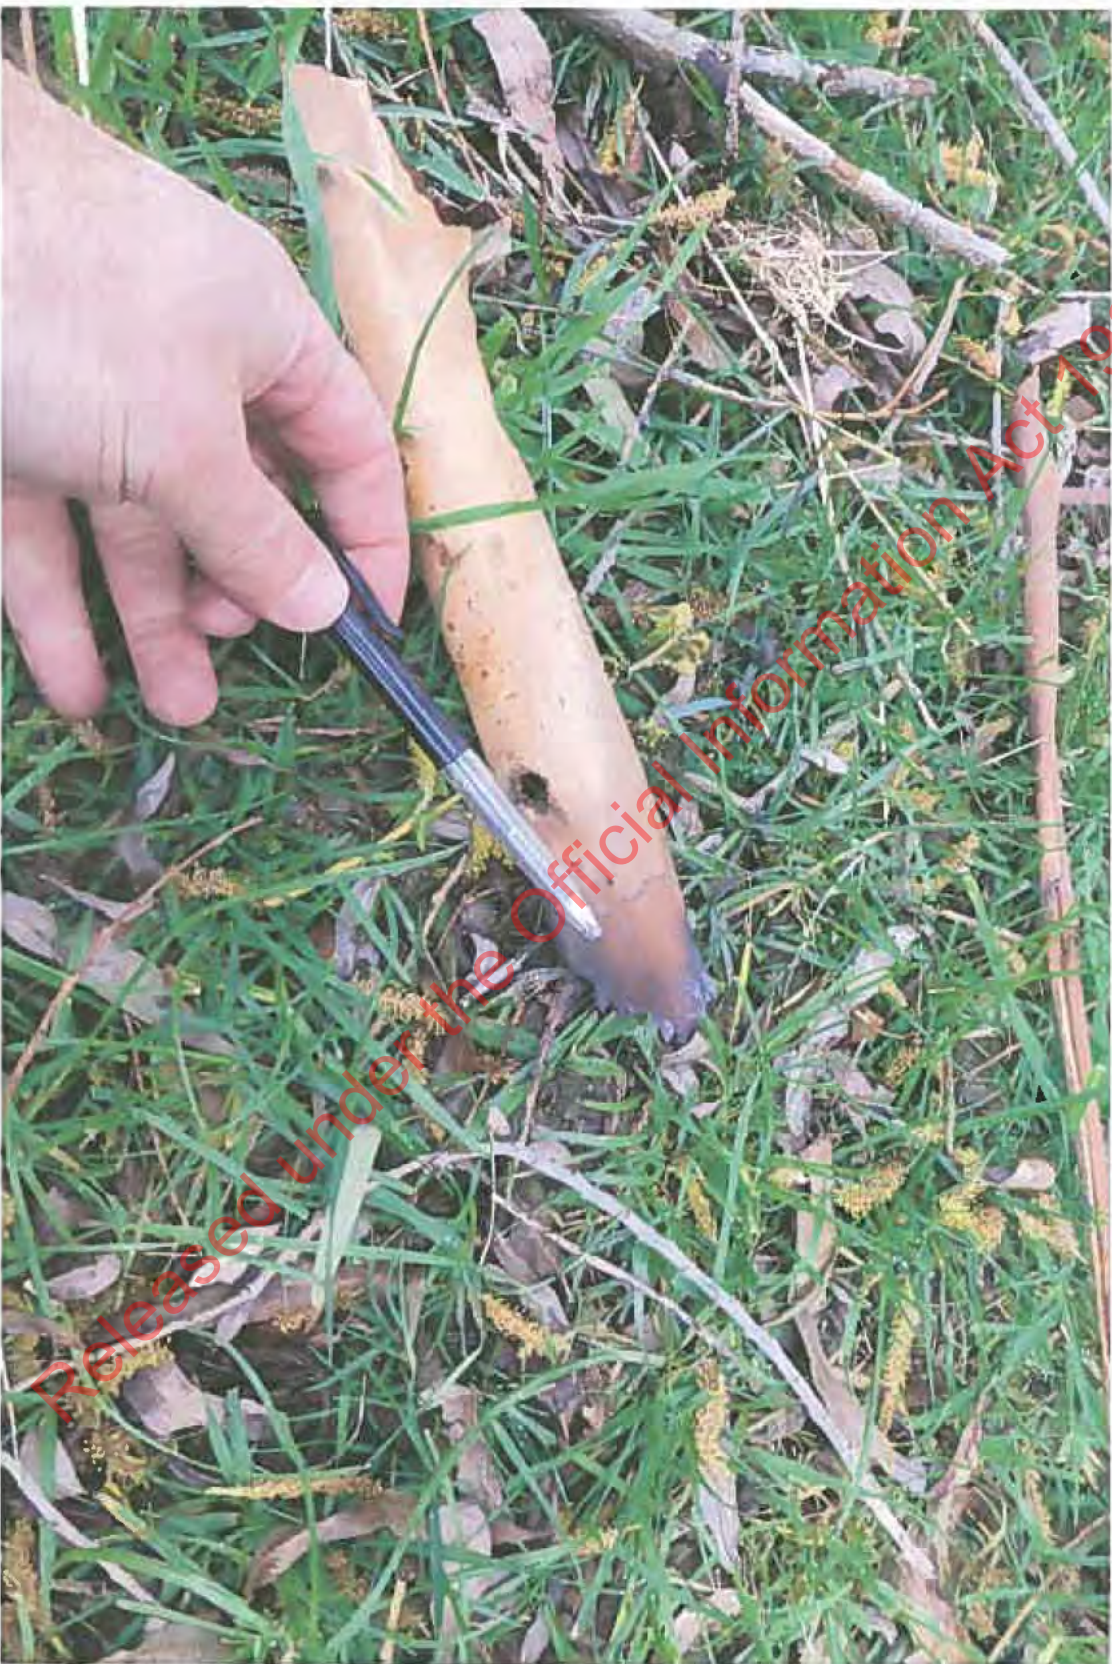
Photos 926– Spot fire approx 15m out in front of the advancing fire at the end of the Gum plantation.

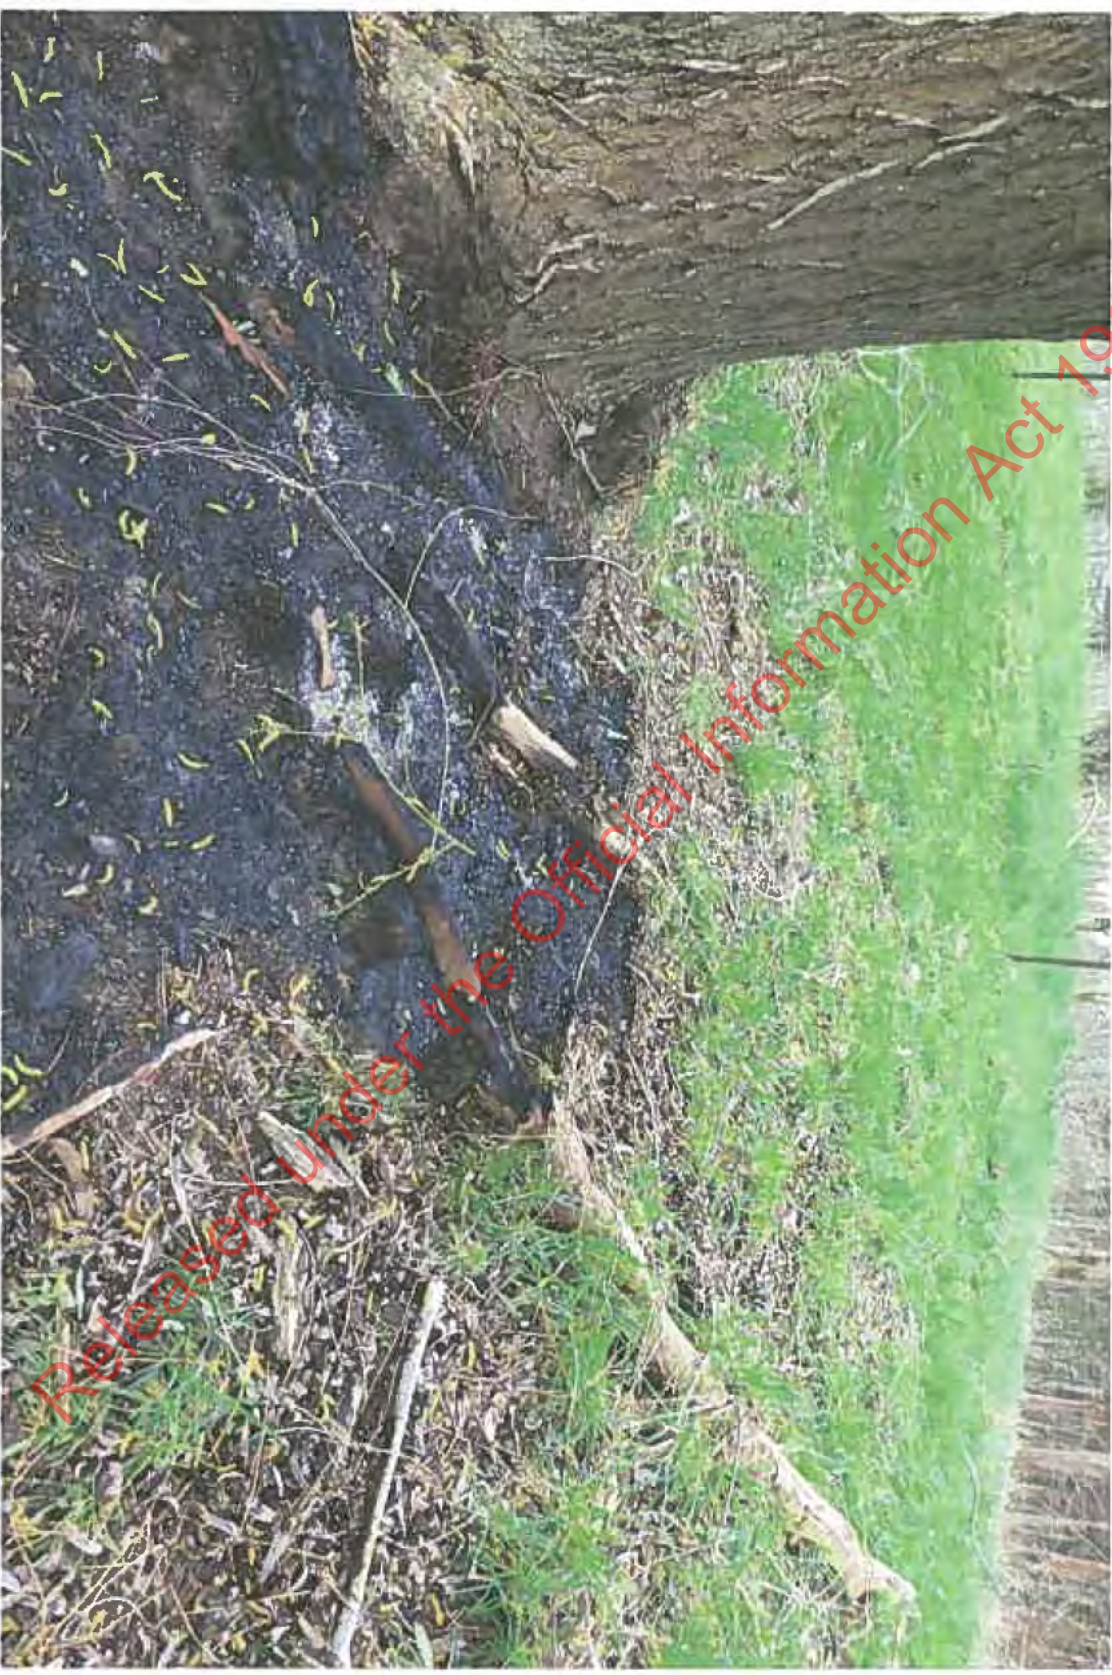
Photos 923-- Burnt gum bark out in front of the advancing fire at the end of the Gum plantation.

Photos 923– Burnt gum bark out in front of the advancing fire at the end of the Gum plantation.

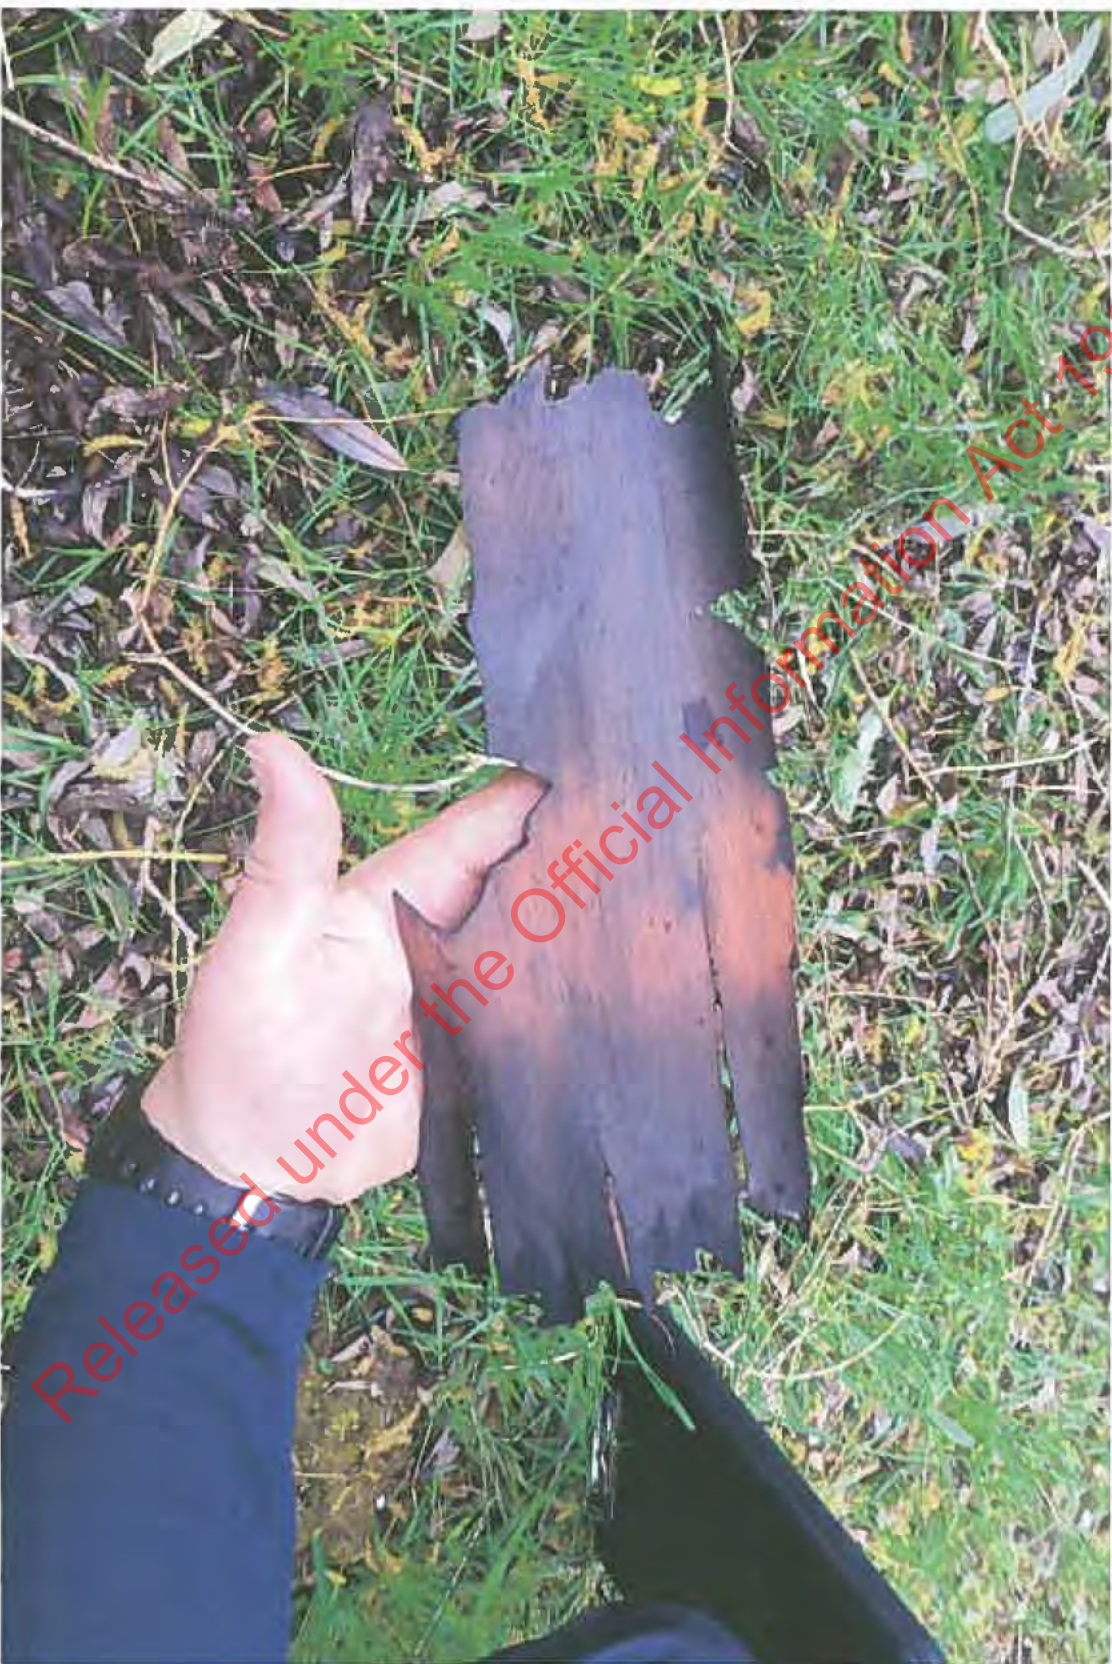
Photos 931 – Burnt gum leaves approx. 30m out in front of the advancing fire at the end of the Gum plantation.

Photos 931– Burnt gum leaves approx. 30m out in front of the advancing fire at the end of the Gum plantation.

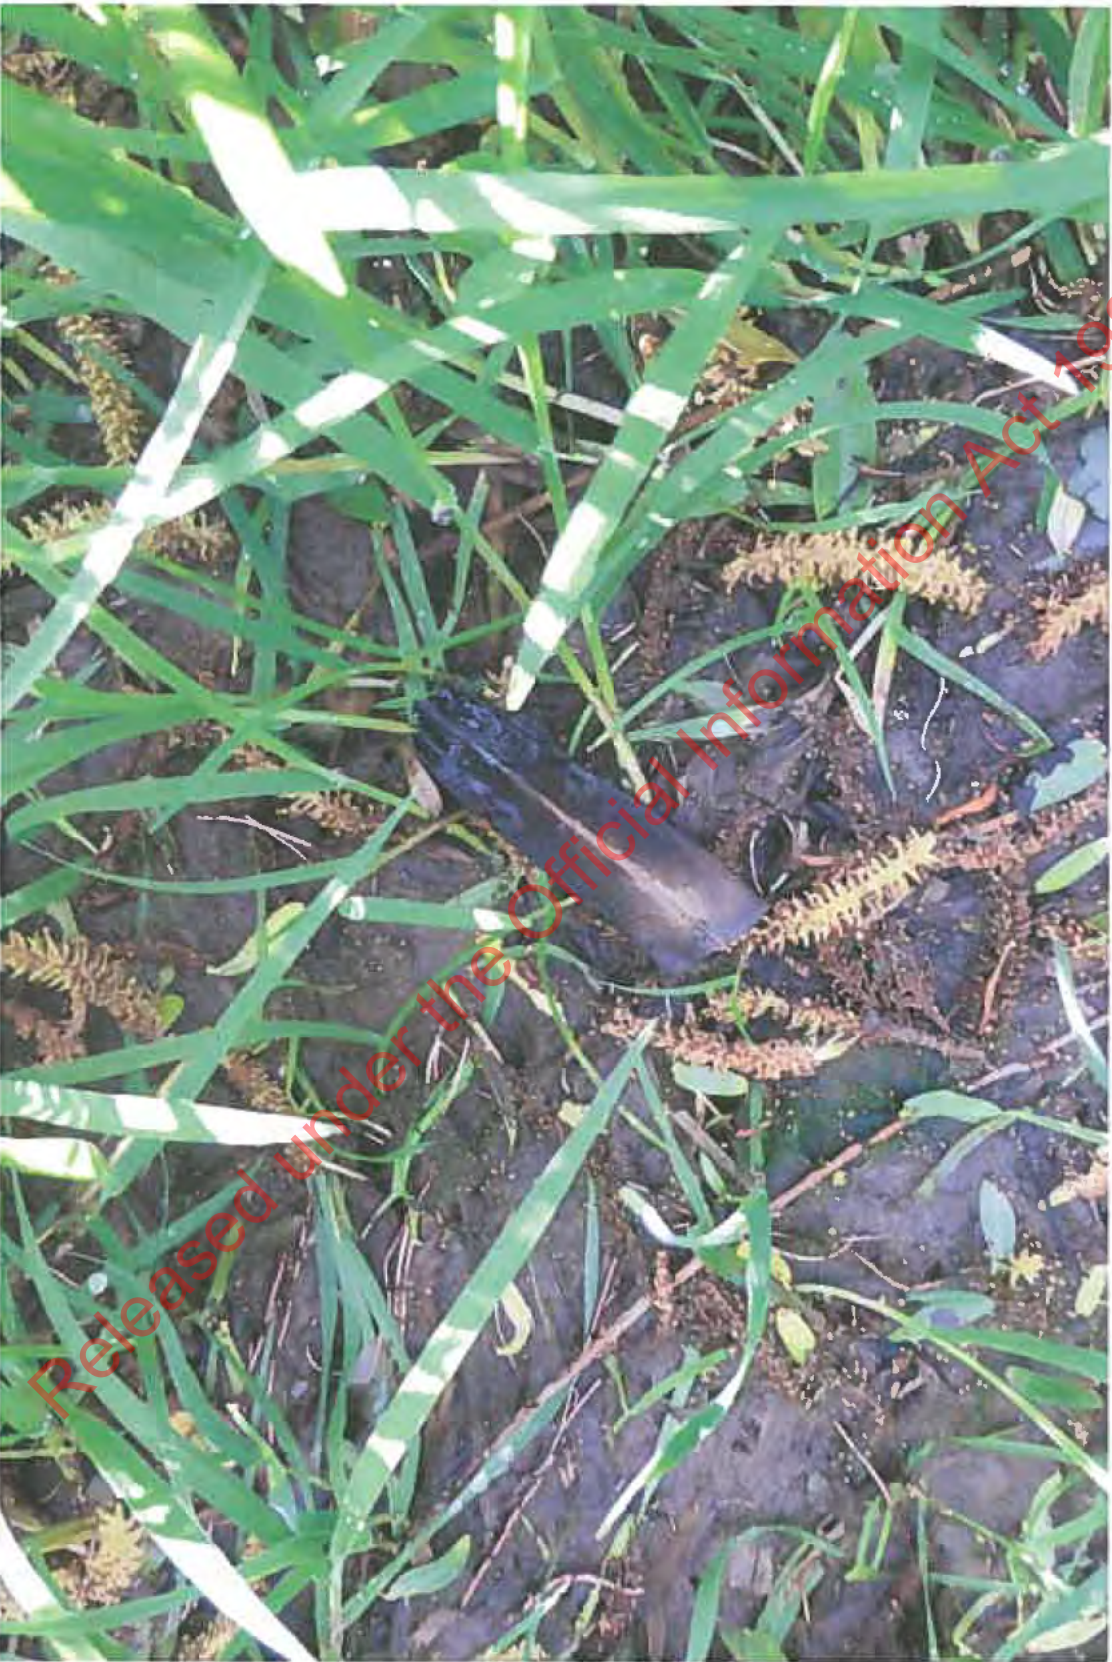
Photos 935— Spot fire 65m out in front of the advancing fire past the end of the Gum plantation.

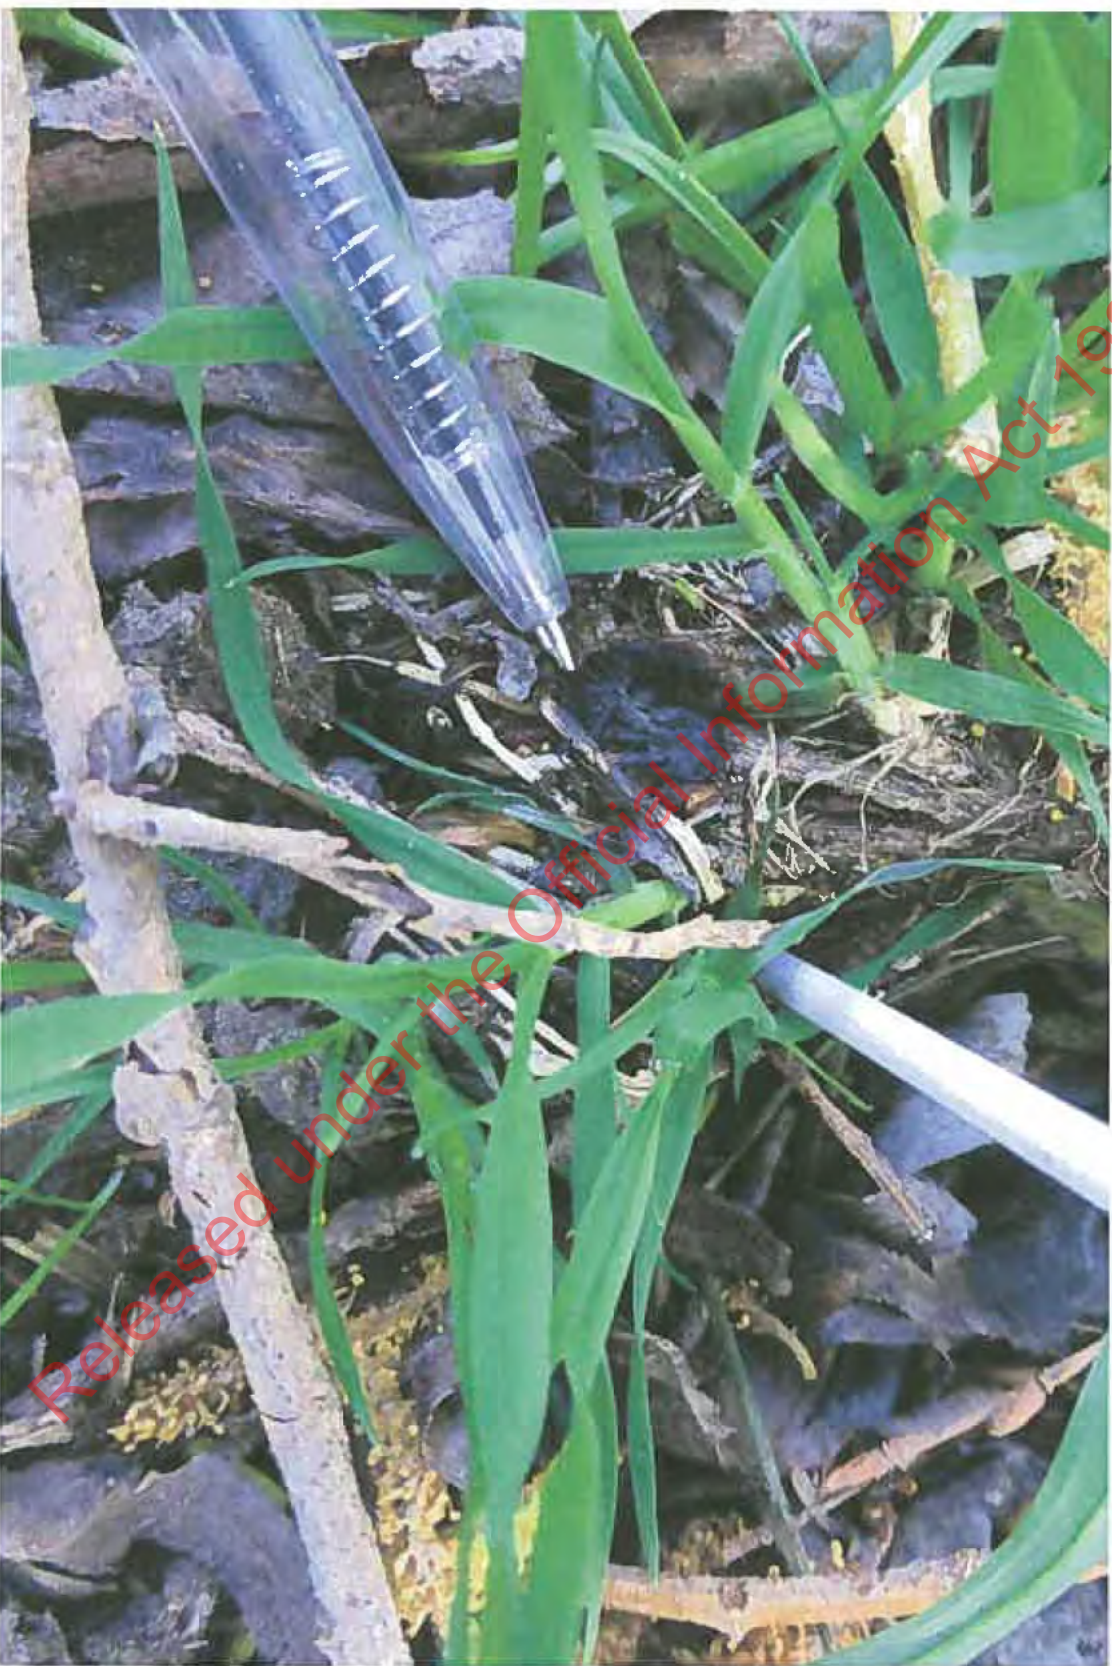
Photos 934— Spot fires, burnt gum leaves and bark flagged out in front of the advancing fire past the end of the Gum plantation.

Photos 934– Spot fires, burnt gum leaves and bark flagged out in front of the advancing fire past the end of the Gum plantation.

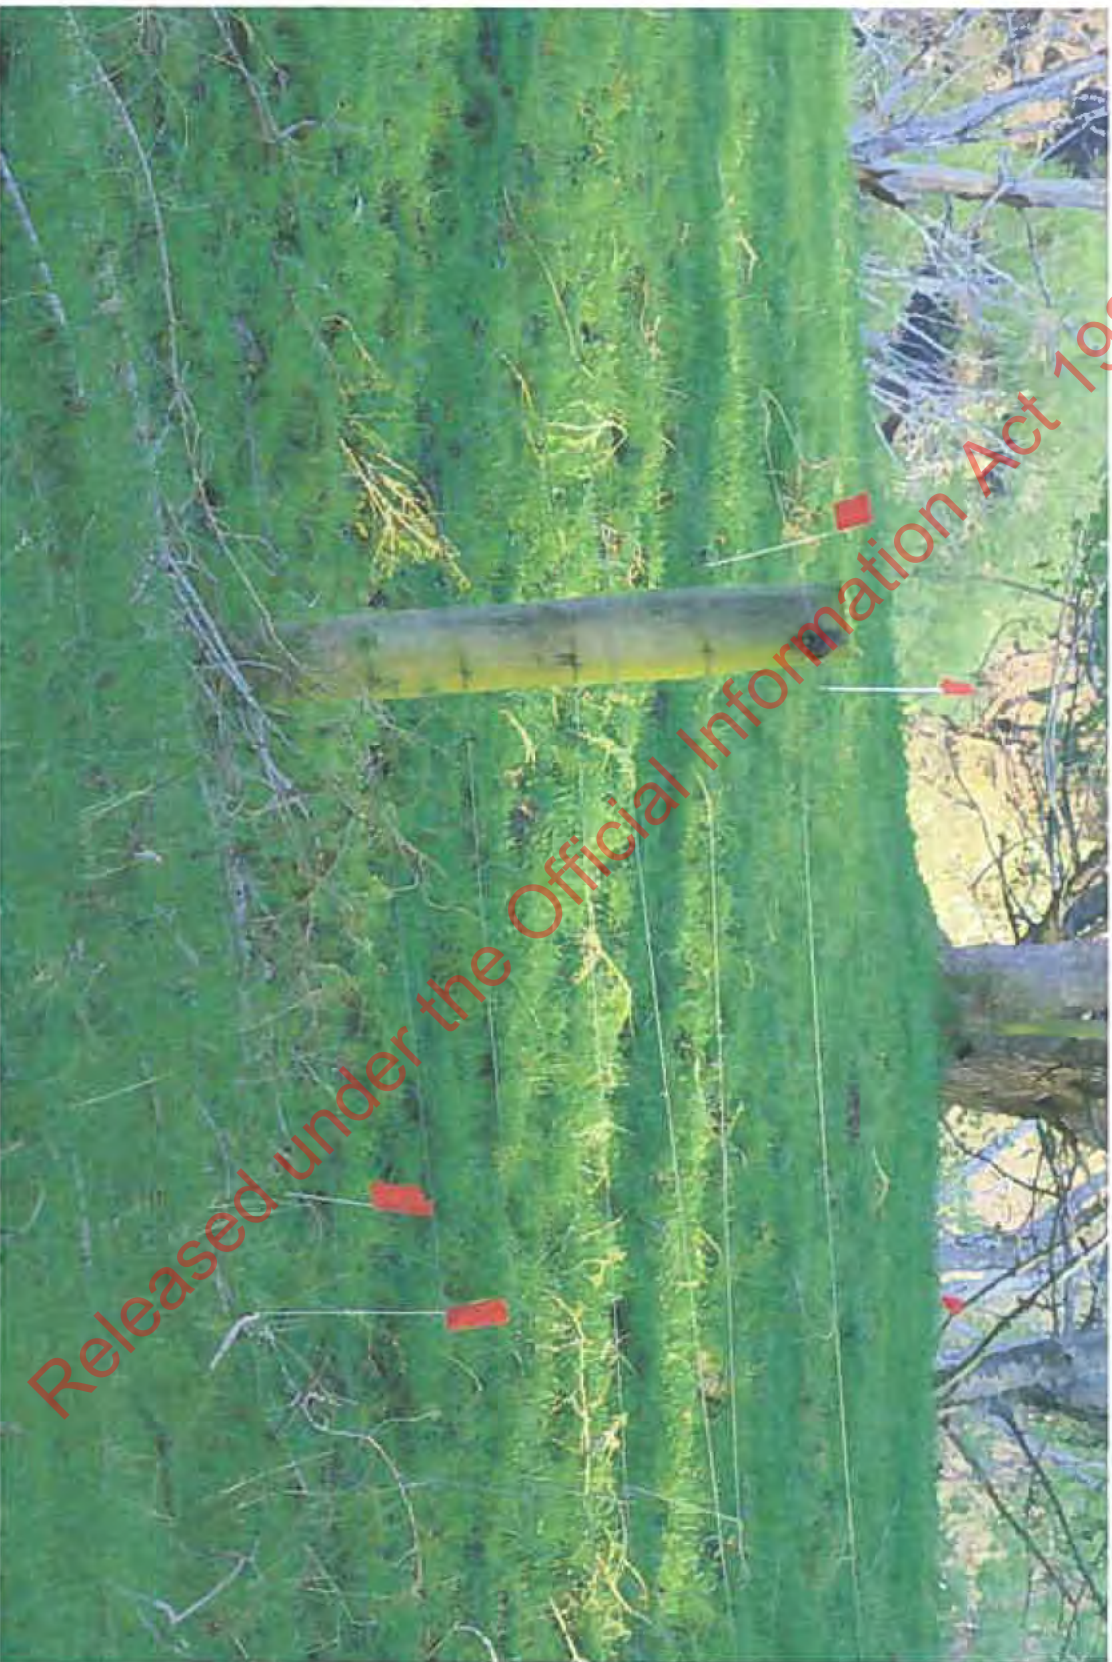
Photos 940-- Ember transfer evident by this burning spar on the hill behind 205 Morris road. (Chicks house).

We followed these for approx 103 m to where the next fire had started behind the house at 205 Morris road. I flagged, photographed and GPS'd these examples of ember transfer to help determine if the fire could have spotted from the gum plantation to the area behind the house at 205 Morris road. It was evident that this was the case.

Photos 940– Ember transfer evident by this burning spar on the hill behind 205 Morris road. (Chicks house).

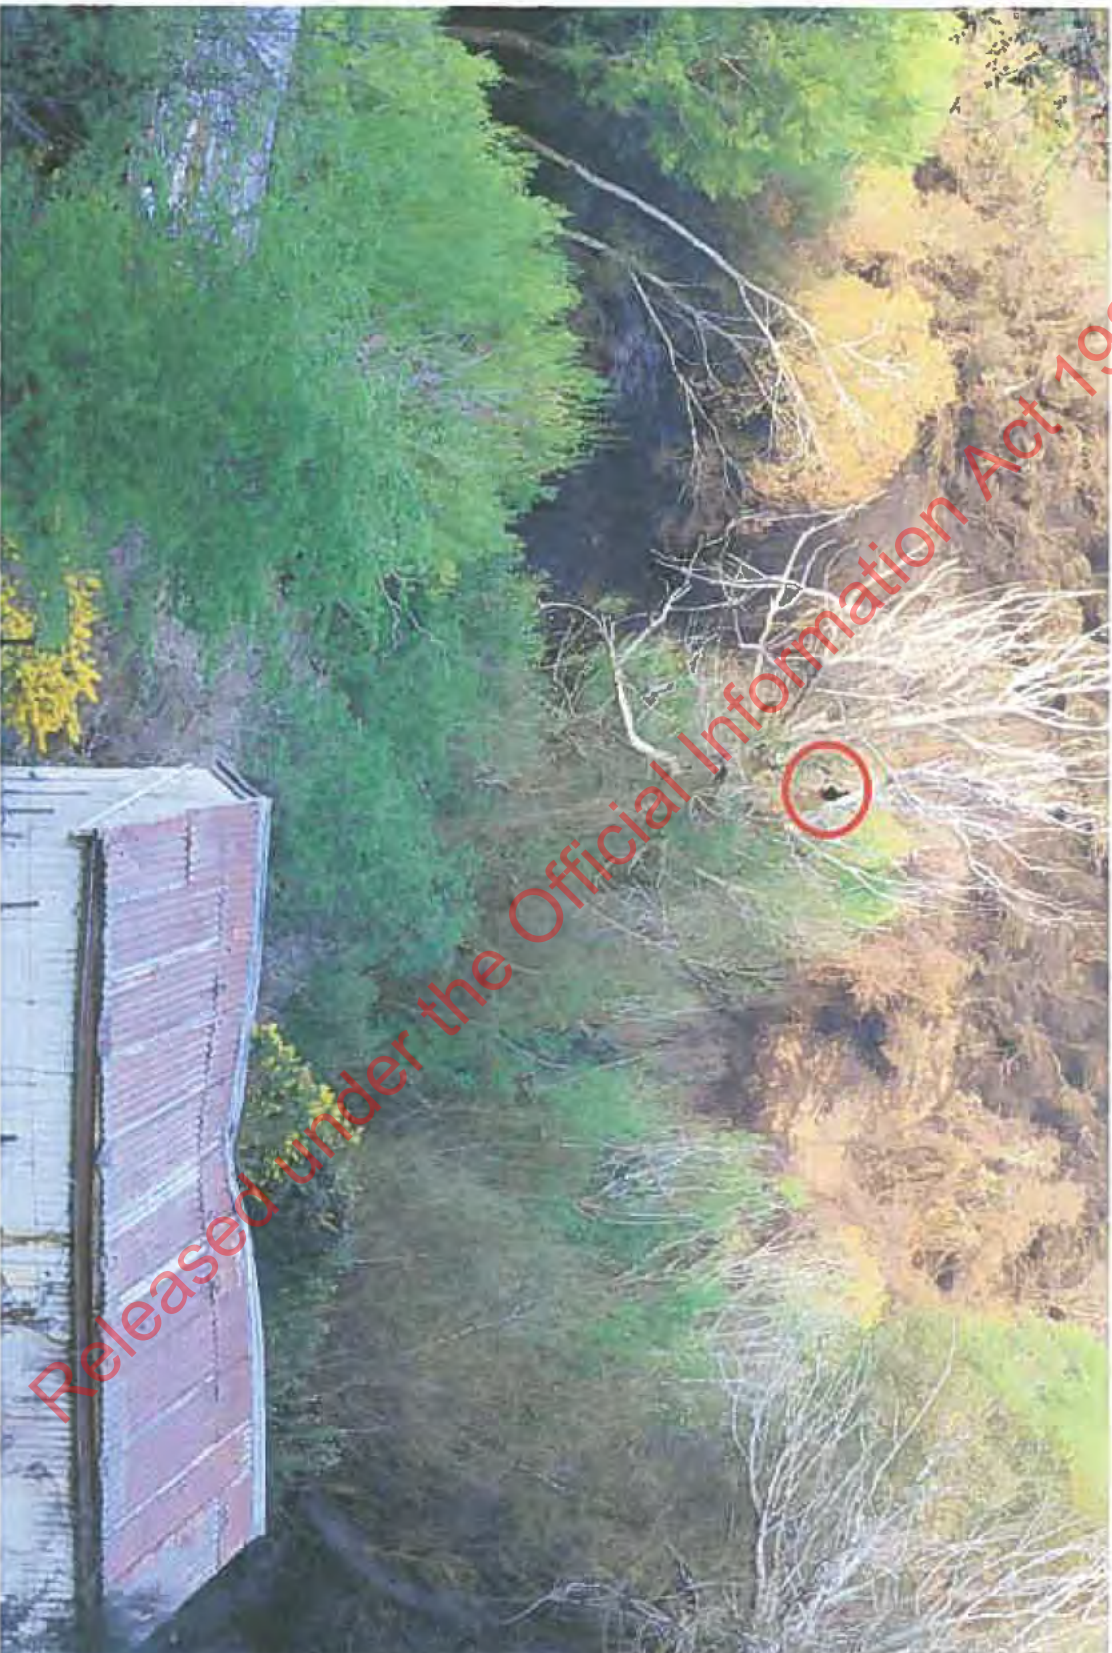
Photos 946-- AOO showing low intensity and remaining fuel in the fence burnt off at the base. Flanking/Transition.

Photos 946– AOO showing low intensity and remaining fuel in the fence burnt off at the base. Flanking/Transition.
