Fire Investigation Report

Vegetation Fire

Fire Authority Name: Otago Rural Fire Authority
Fire Name: Saddle Hill Fire
Fire Date: 7 October 2015
Date of Investigation: 8 October to 12 November 2015
Report Completed By: James. P. Cowan

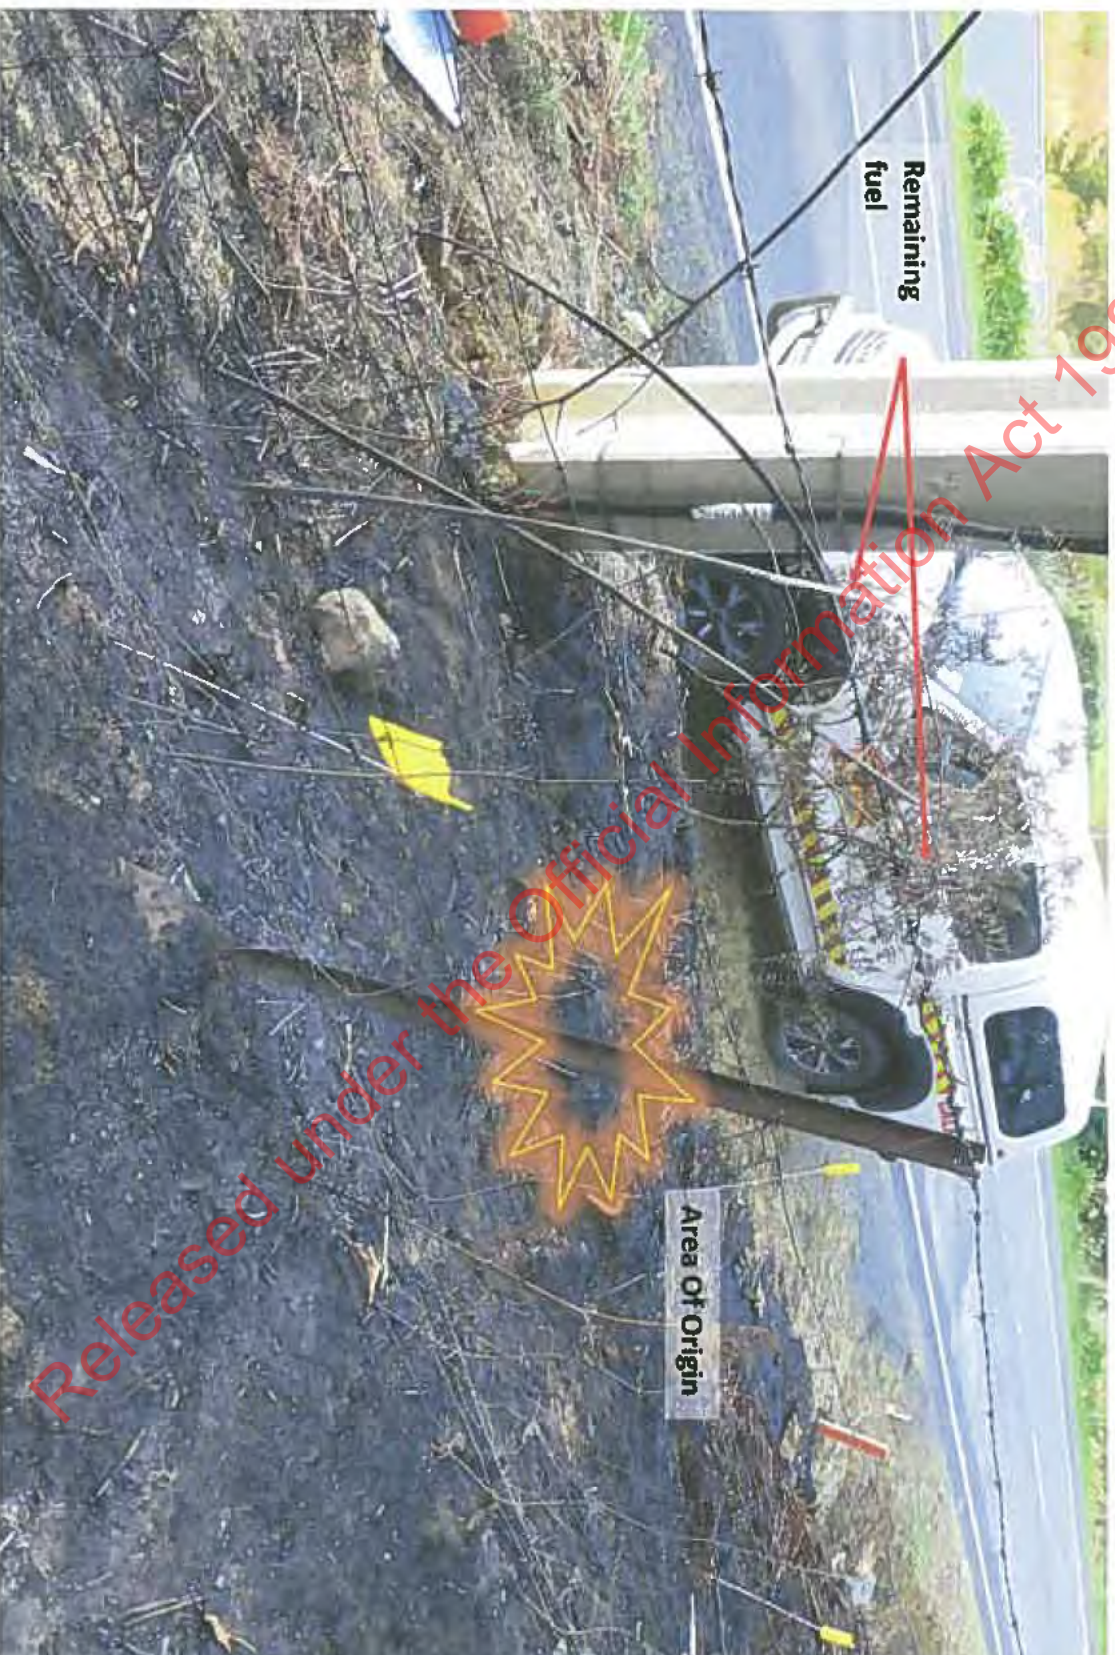
Photo 951 – Shows Pole 821286, the AOO, the initial fire run advancing to the SE, the angle of oxidation and identifies the 3 iron fencing standards used in the following slides.

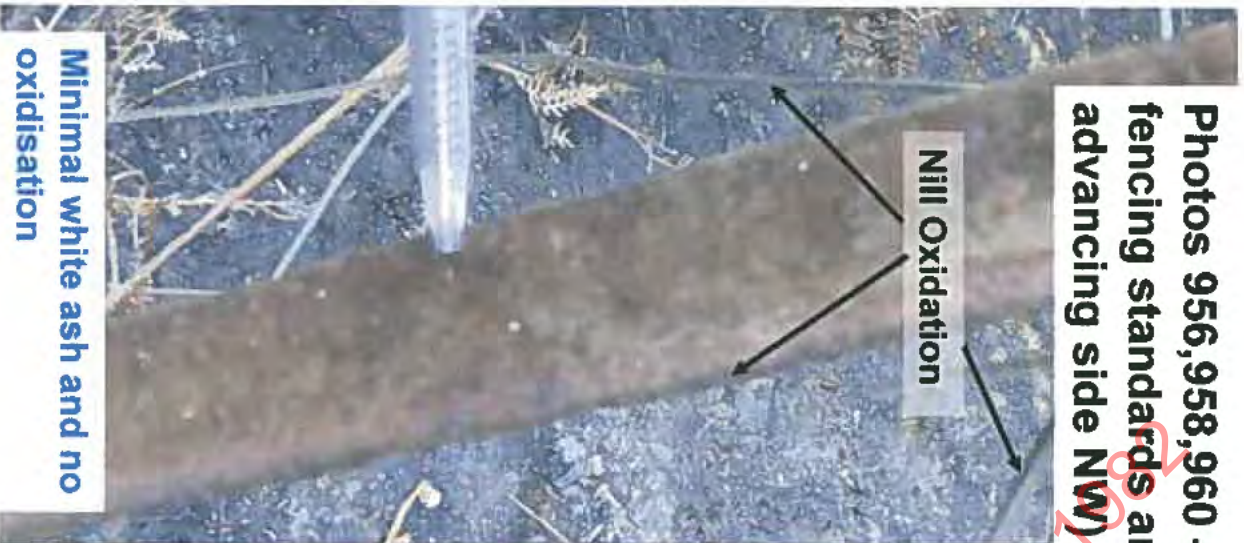
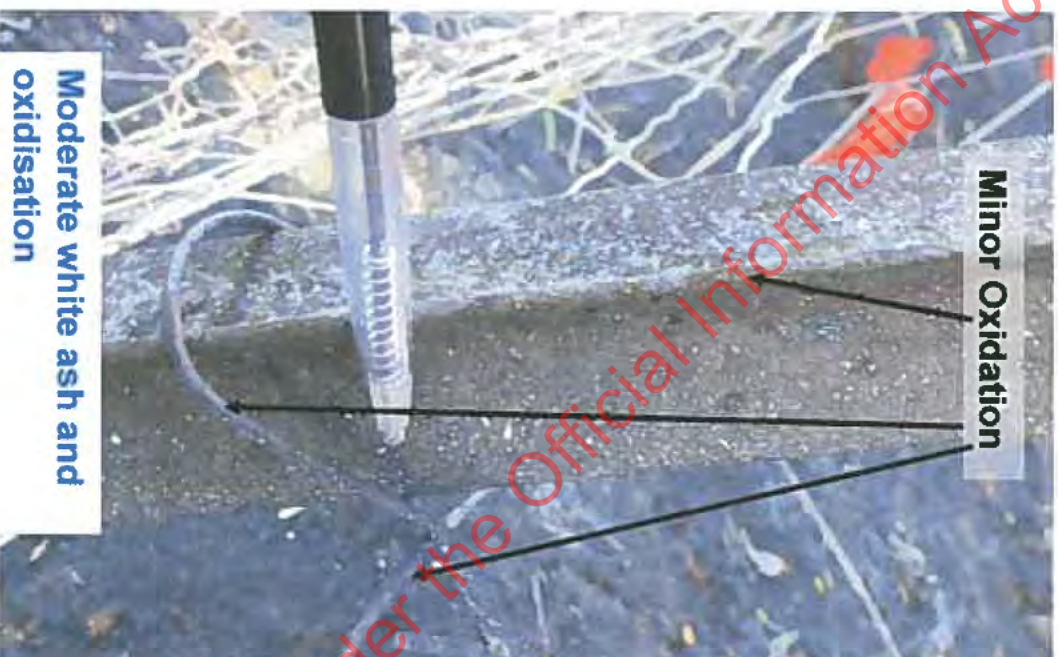
Photos 956, 958, 960 – Shows the sequential build up of white ash on the Iron fencing standards and corresponding oxidising on the wires. (Viewed from the advancing side NW)

Of special note was the sequential buildup of white ash on several iron fencing standards from the AOO leading away to the SE and corresponding increasing levels of oxidation on the fence wires. This combined with unburnt bracken fern left hanging in the fence provided very strong evidence to support my AOO findings.

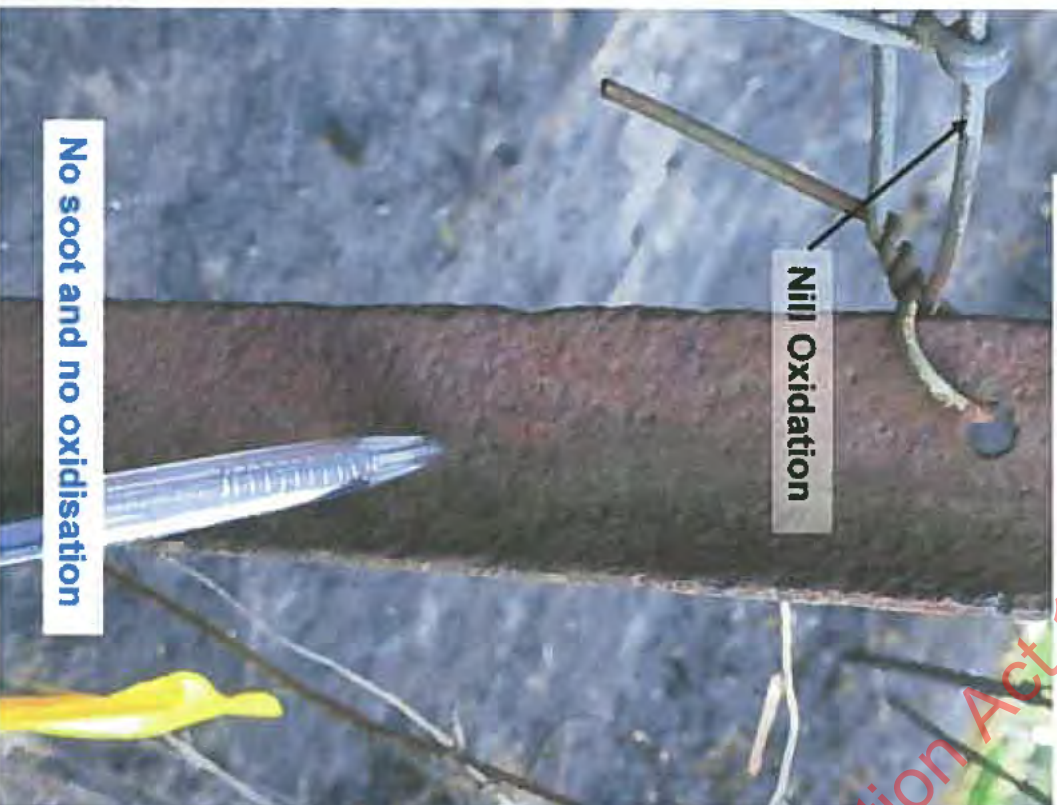
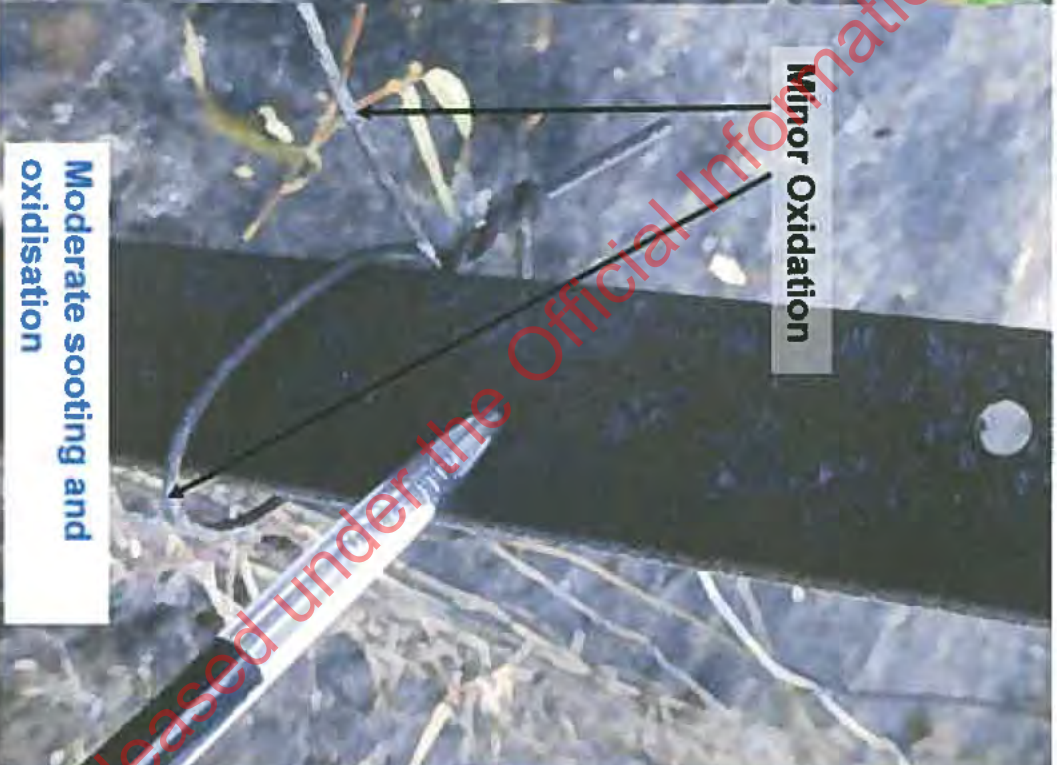
Photos 957, 959, 961 – Shows the sequential build up of soot on the Iron fencing standards and corresponding oxidising on the wires. (Viewed from the protected side SE)

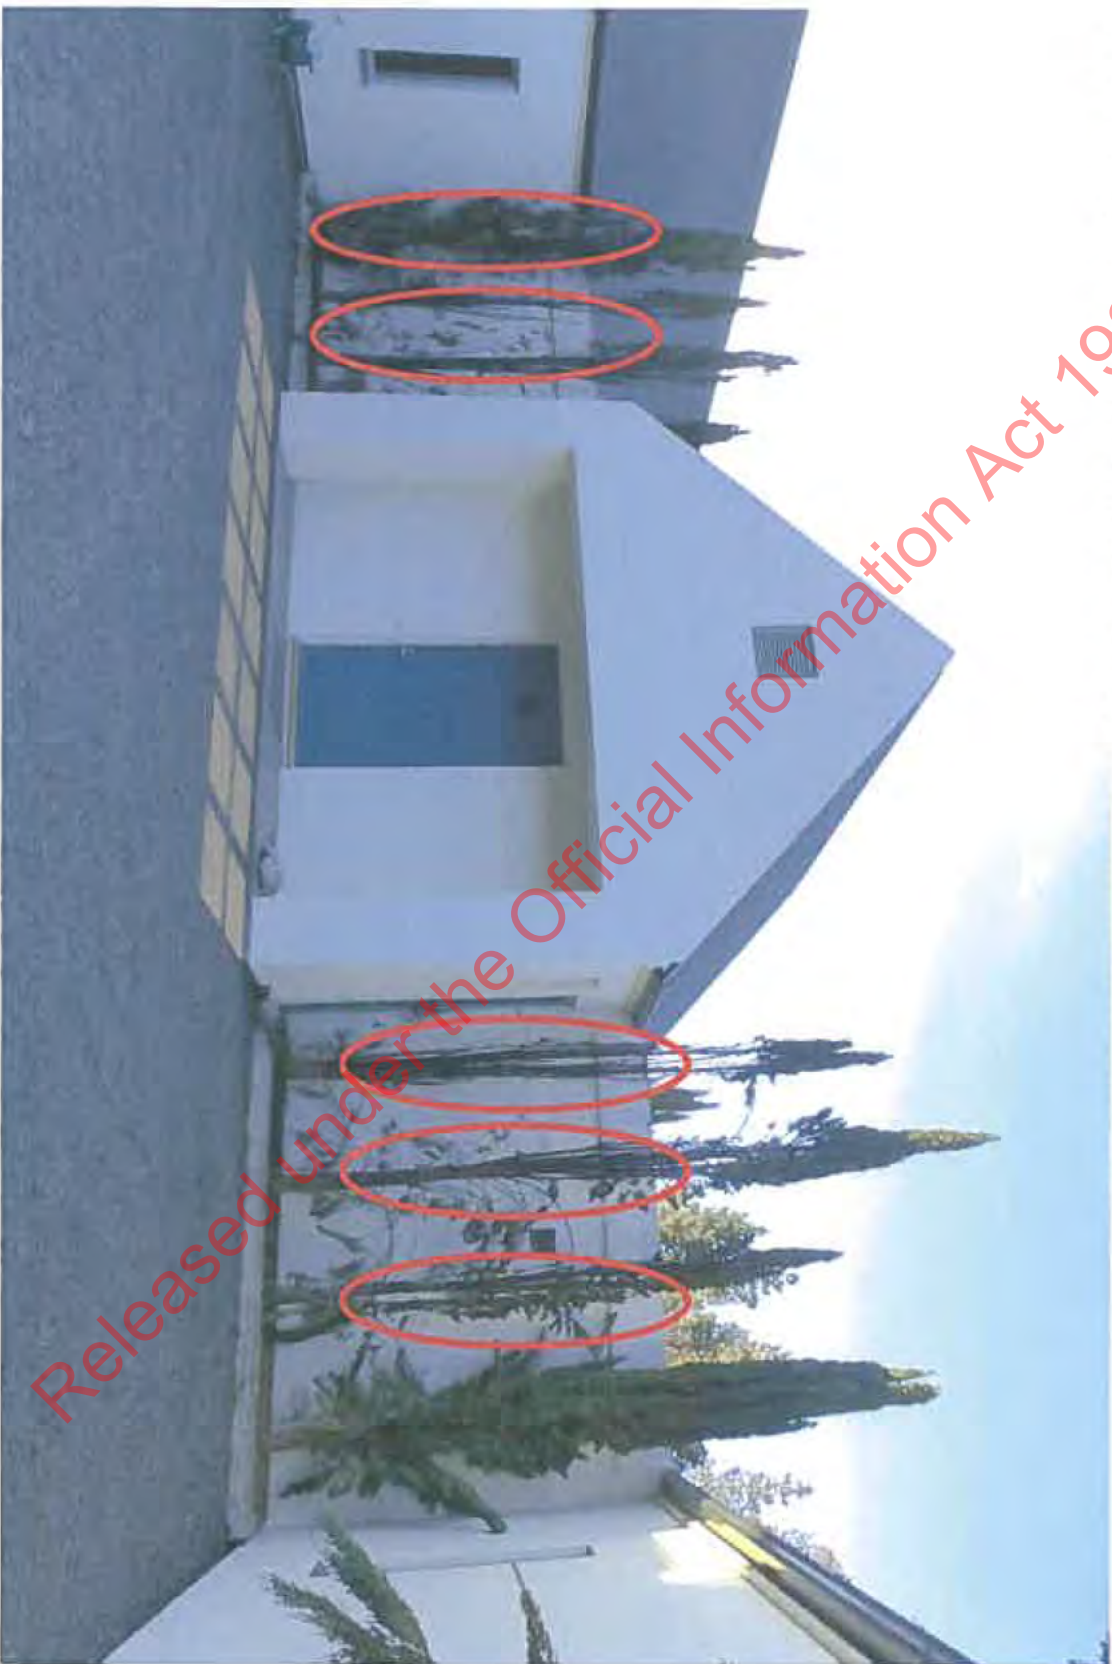
Photos 006 – Freeze on trees on the drive near 47 Coalstage road, showing the wind direction from the SW after the wind change.

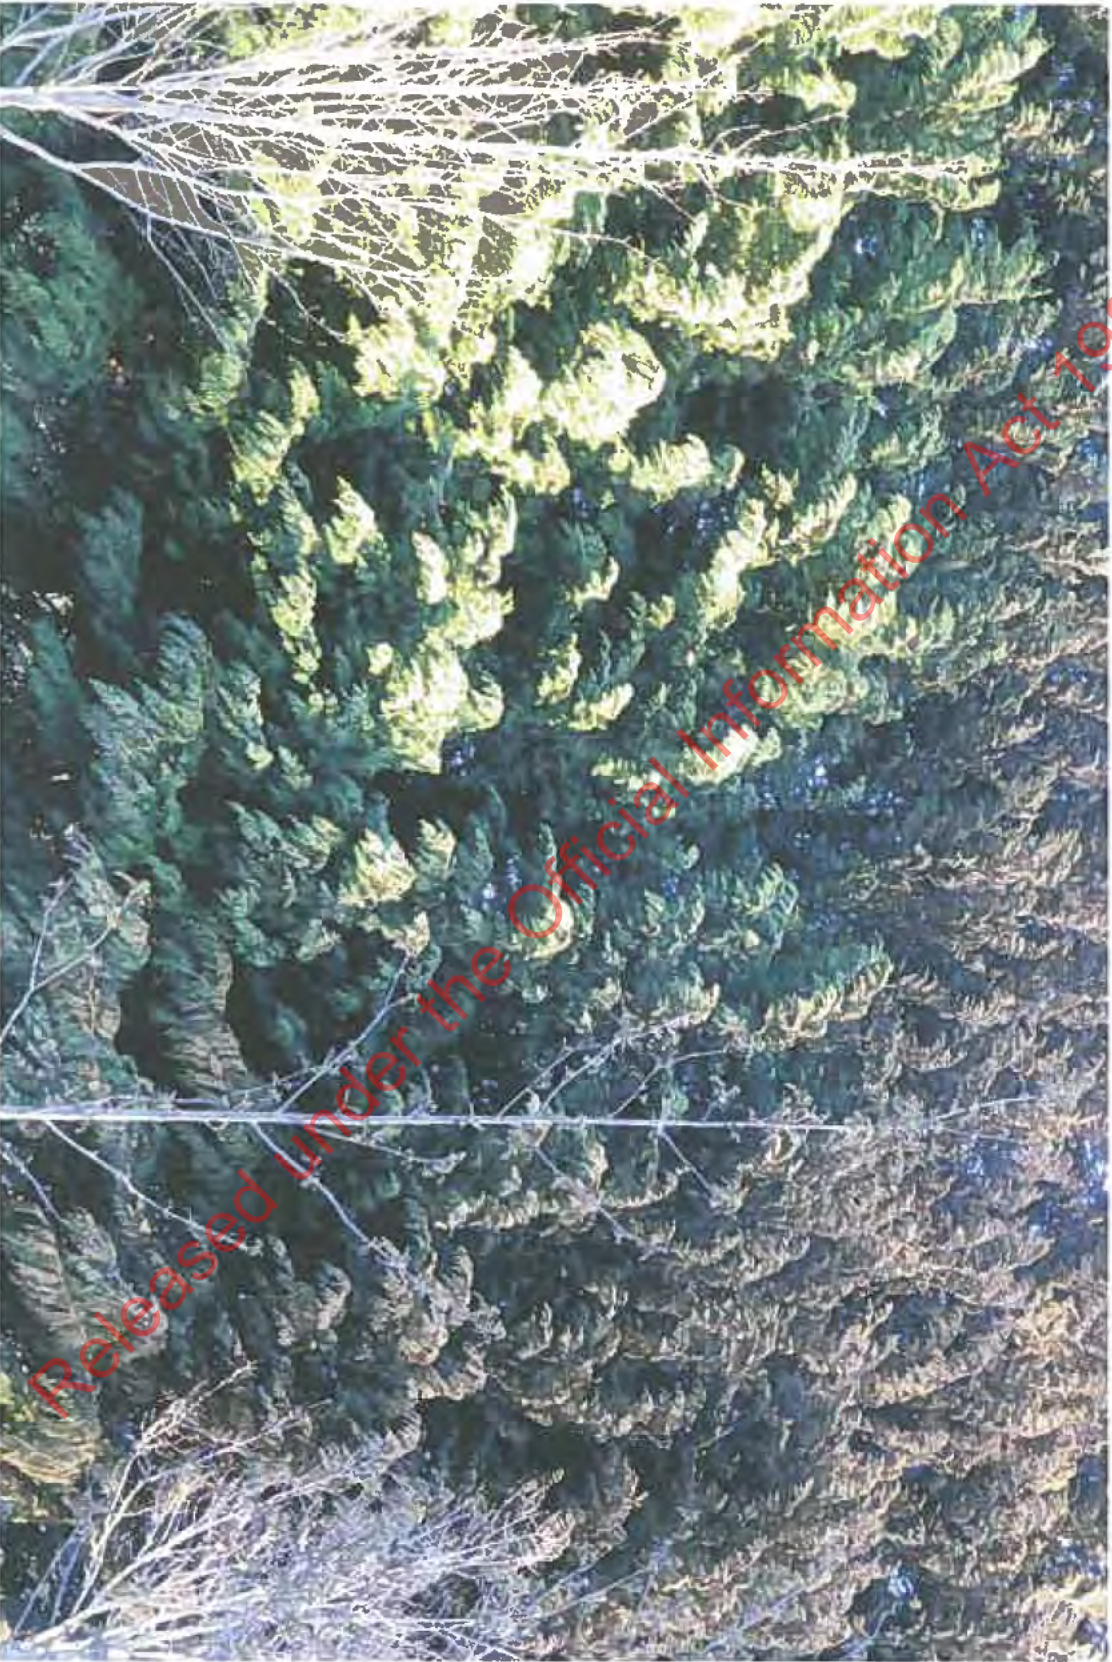
Photos 979 – Old trimming scars on the Gum tree closest to the Recloser (A00) pole showing historic trimming.

It is evident by scarring on the trees around the Area or Origin and along Morris Road that at some point trimming had been carried out to keep vegetation clear of the power lines, however it is obvious that this practice has not been kept up to date as vegetation was within 500mm of touching the power lines in multiple places. The "Trim Zone" has not been maintained, however in this case I was unable to determine if this has likely contributed to the event that has caused this fire.

Recommendations That "Trim Zones" be maintained at all times to minimize the risk of fire.

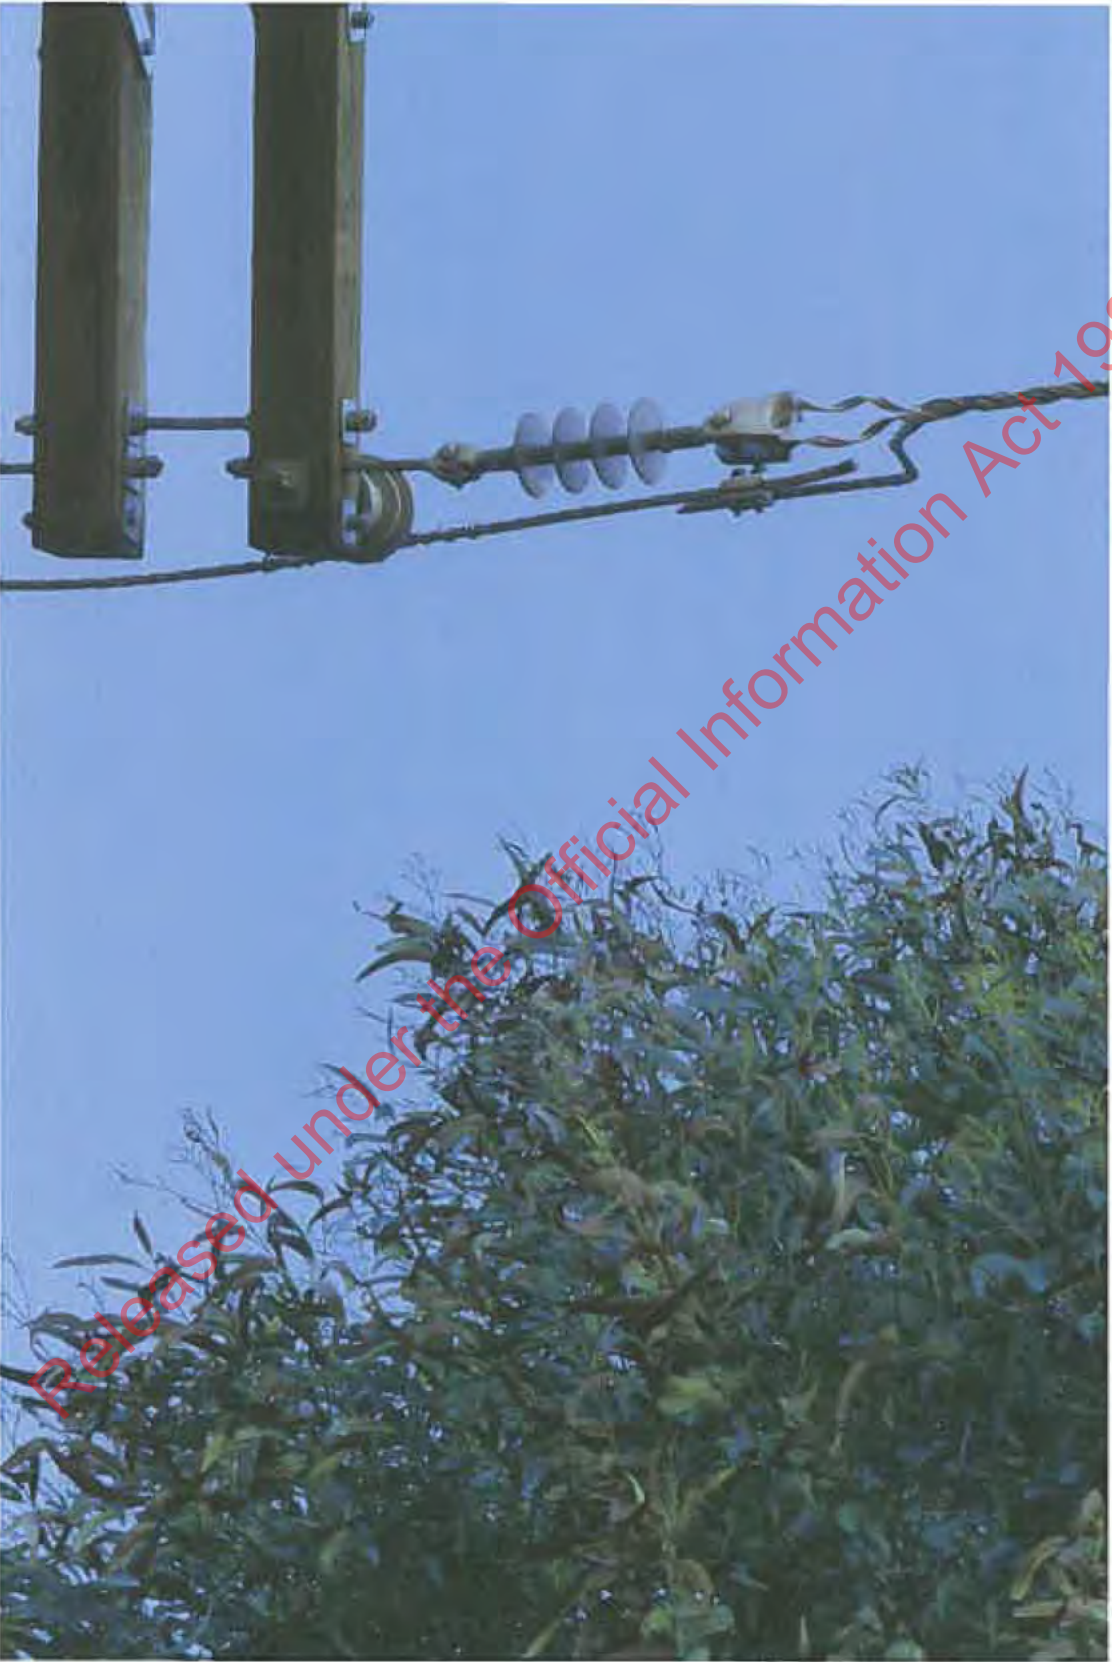
Photos 945 – Further non maintained trim zones on ET2 above 205 Morris Rd.

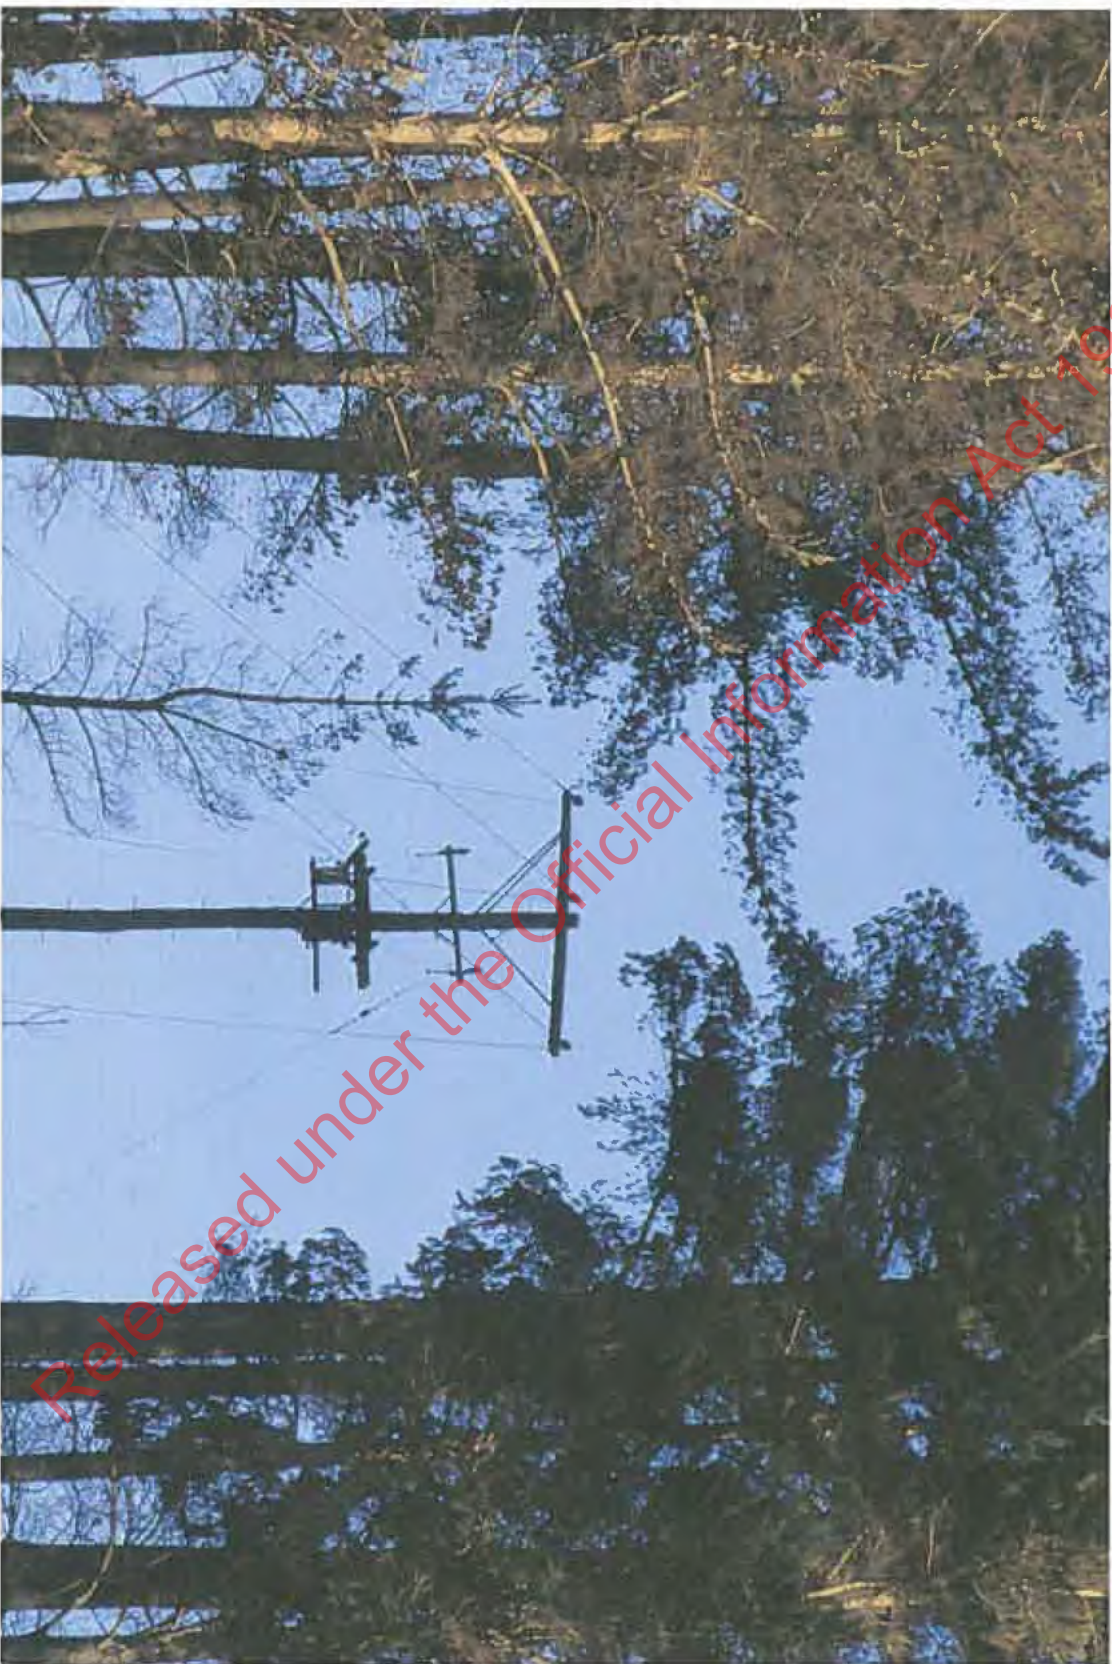
Photos 997 – Shows the Heavy build up of bark in the gum trees. This contributes to spotting and also could have been blown onto the lines.

Typical of gum trees, long strands of bark were evident hung up in the trees. These are known to provide a high potential for spot fires (See photo 997).

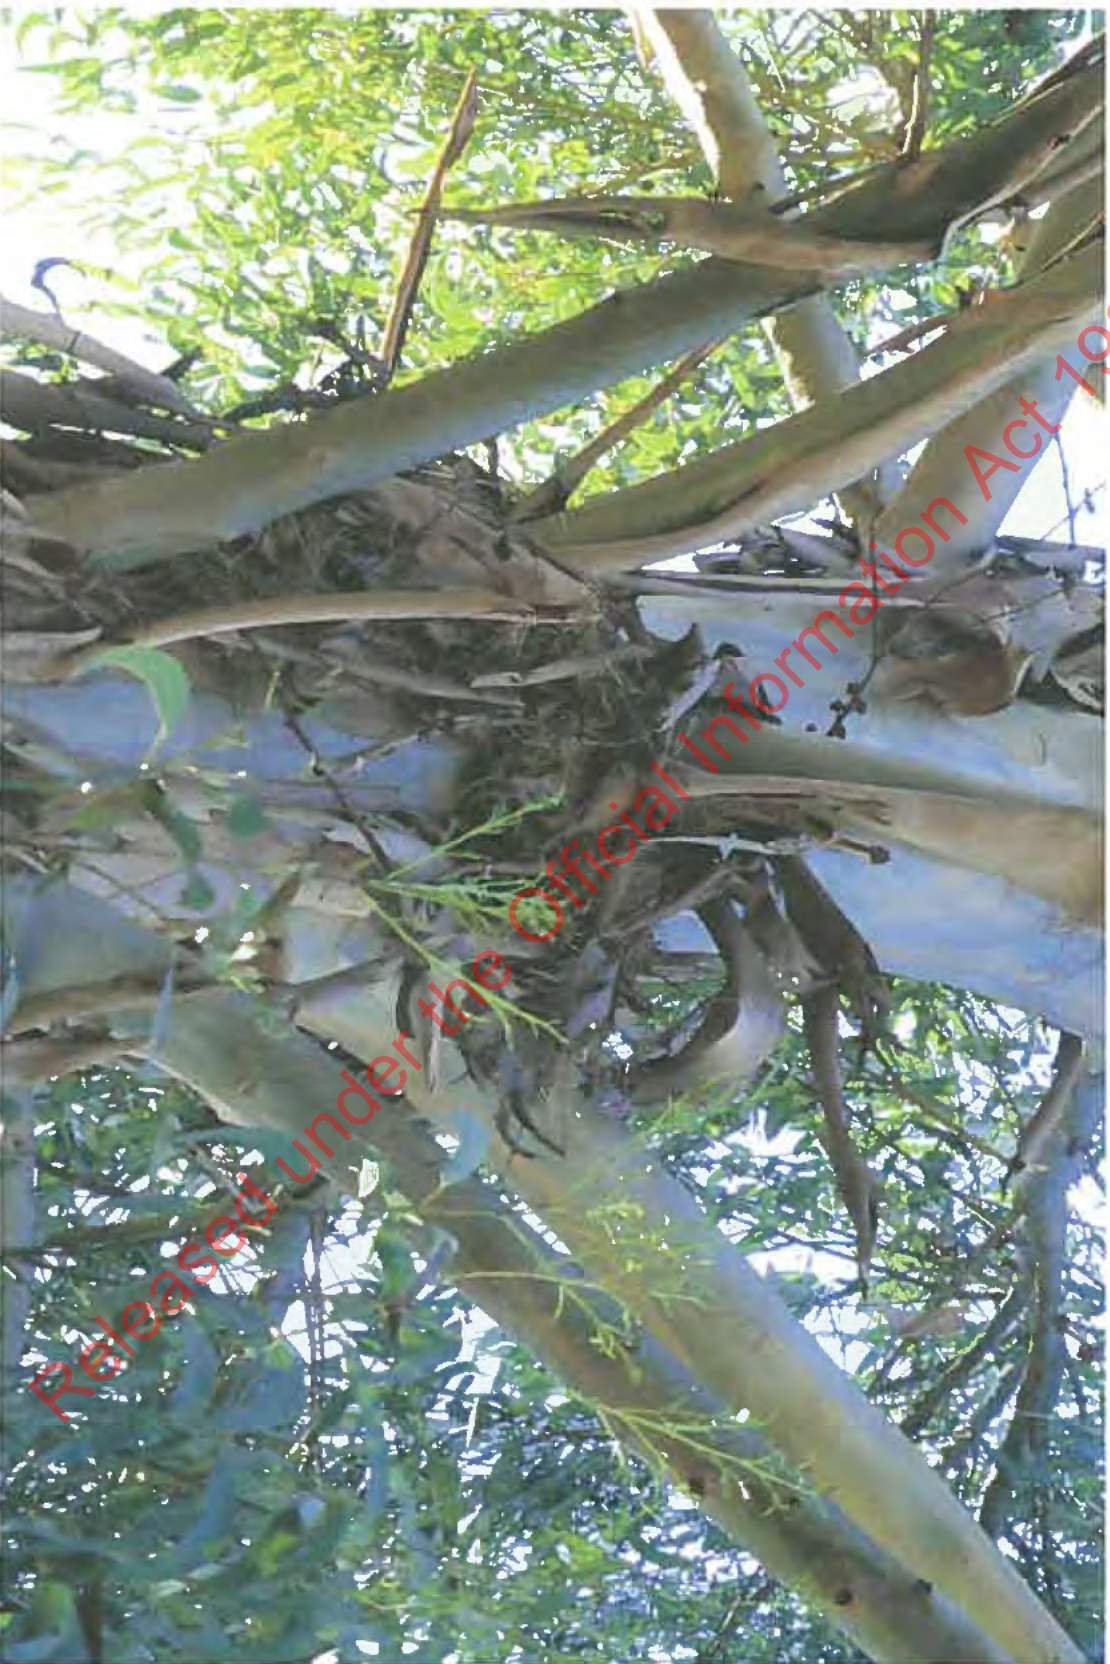
Photos 998 – Long strips of bark near the AOO from the gum trees. This contributes to spotting and also could have been blown onto the lines.

- Photos 998 – Long strips of bark near the AOO from the gum trees. This contributes to spotting and also could have been blown onto the lines.
- Photos 962 – View from [REDACTED] property where he watched the fire.

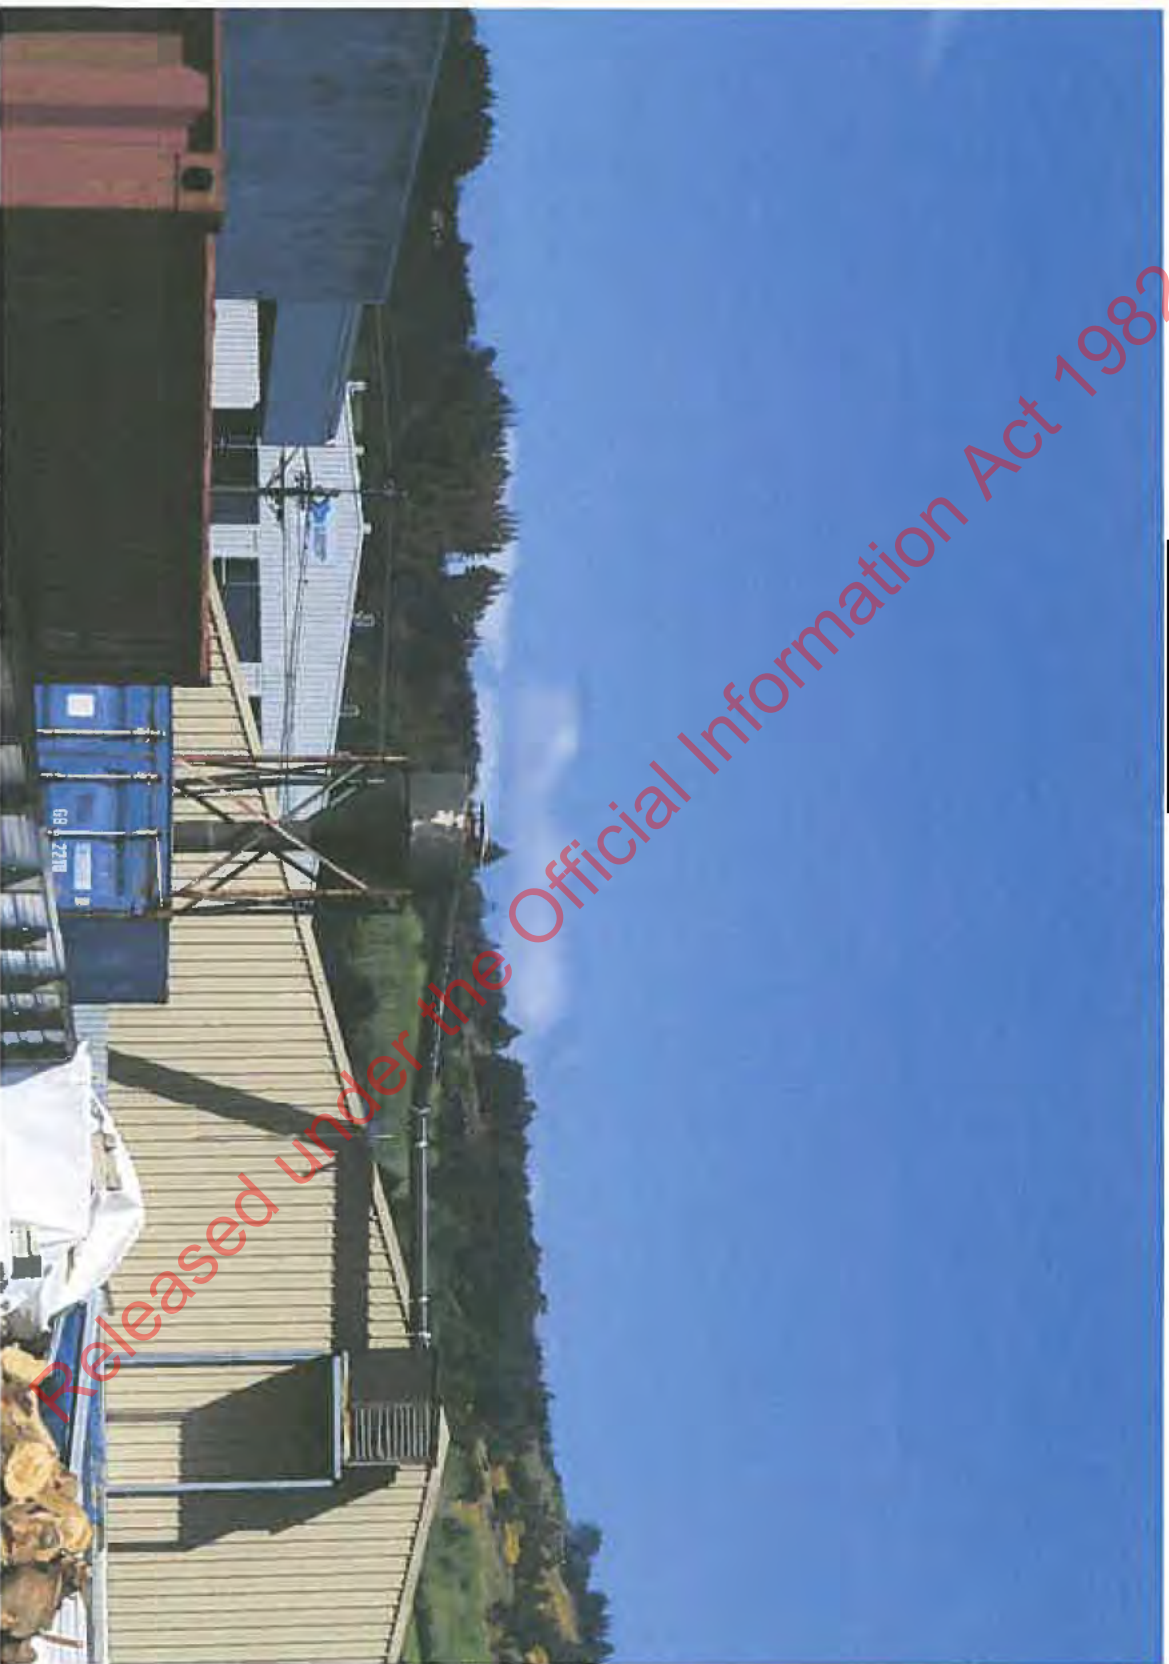
Photos 863 – 43 Coalstage Rd. Damage to property, garage destroyed.

- Photos 863 – 43 Coalstage Rd. Damage to property, garage destroyed.
- Photos 1621 Delta- 43 Coalstage Rd. Damage to car in the garage.
- Photos 1636 Delta - 43 Coalstage Rd. Spalling on concrete water tank and other plastic tanks melted down to water level.

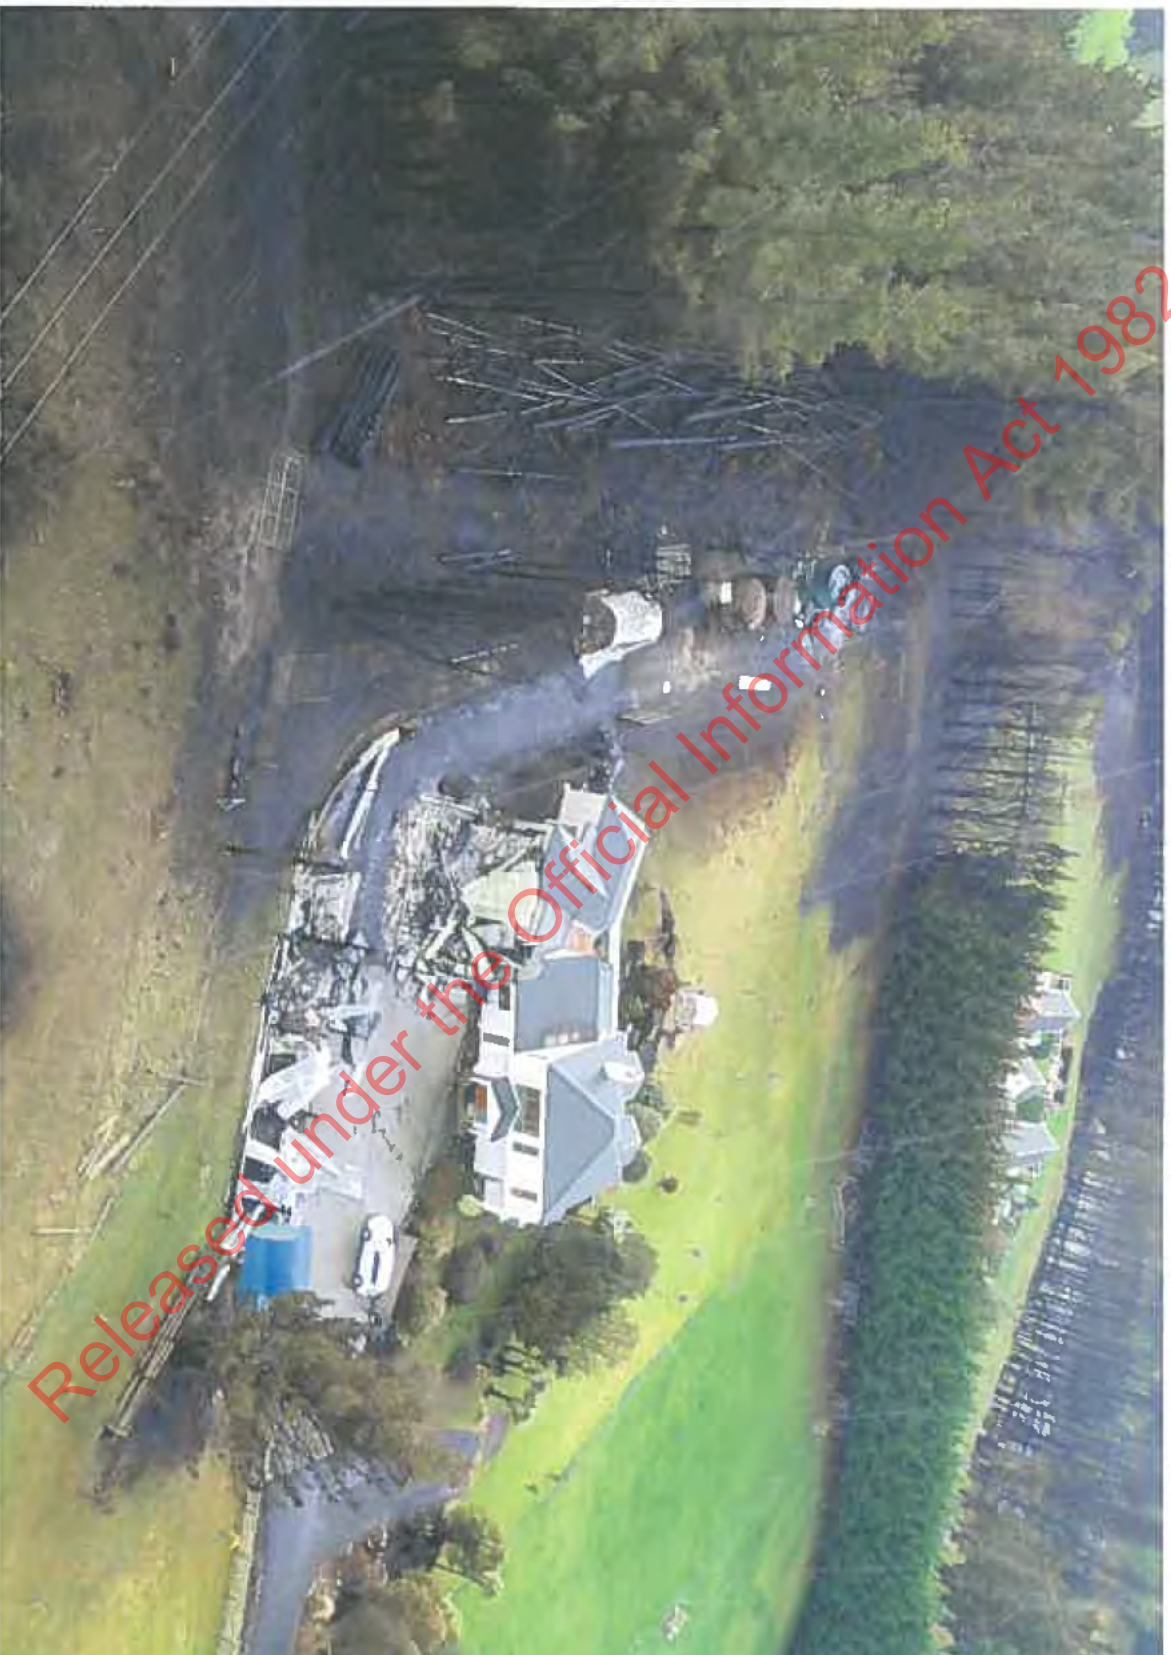
Photos 1621 Delta- 43 Coalstage Rd. Damage to car in the garage.

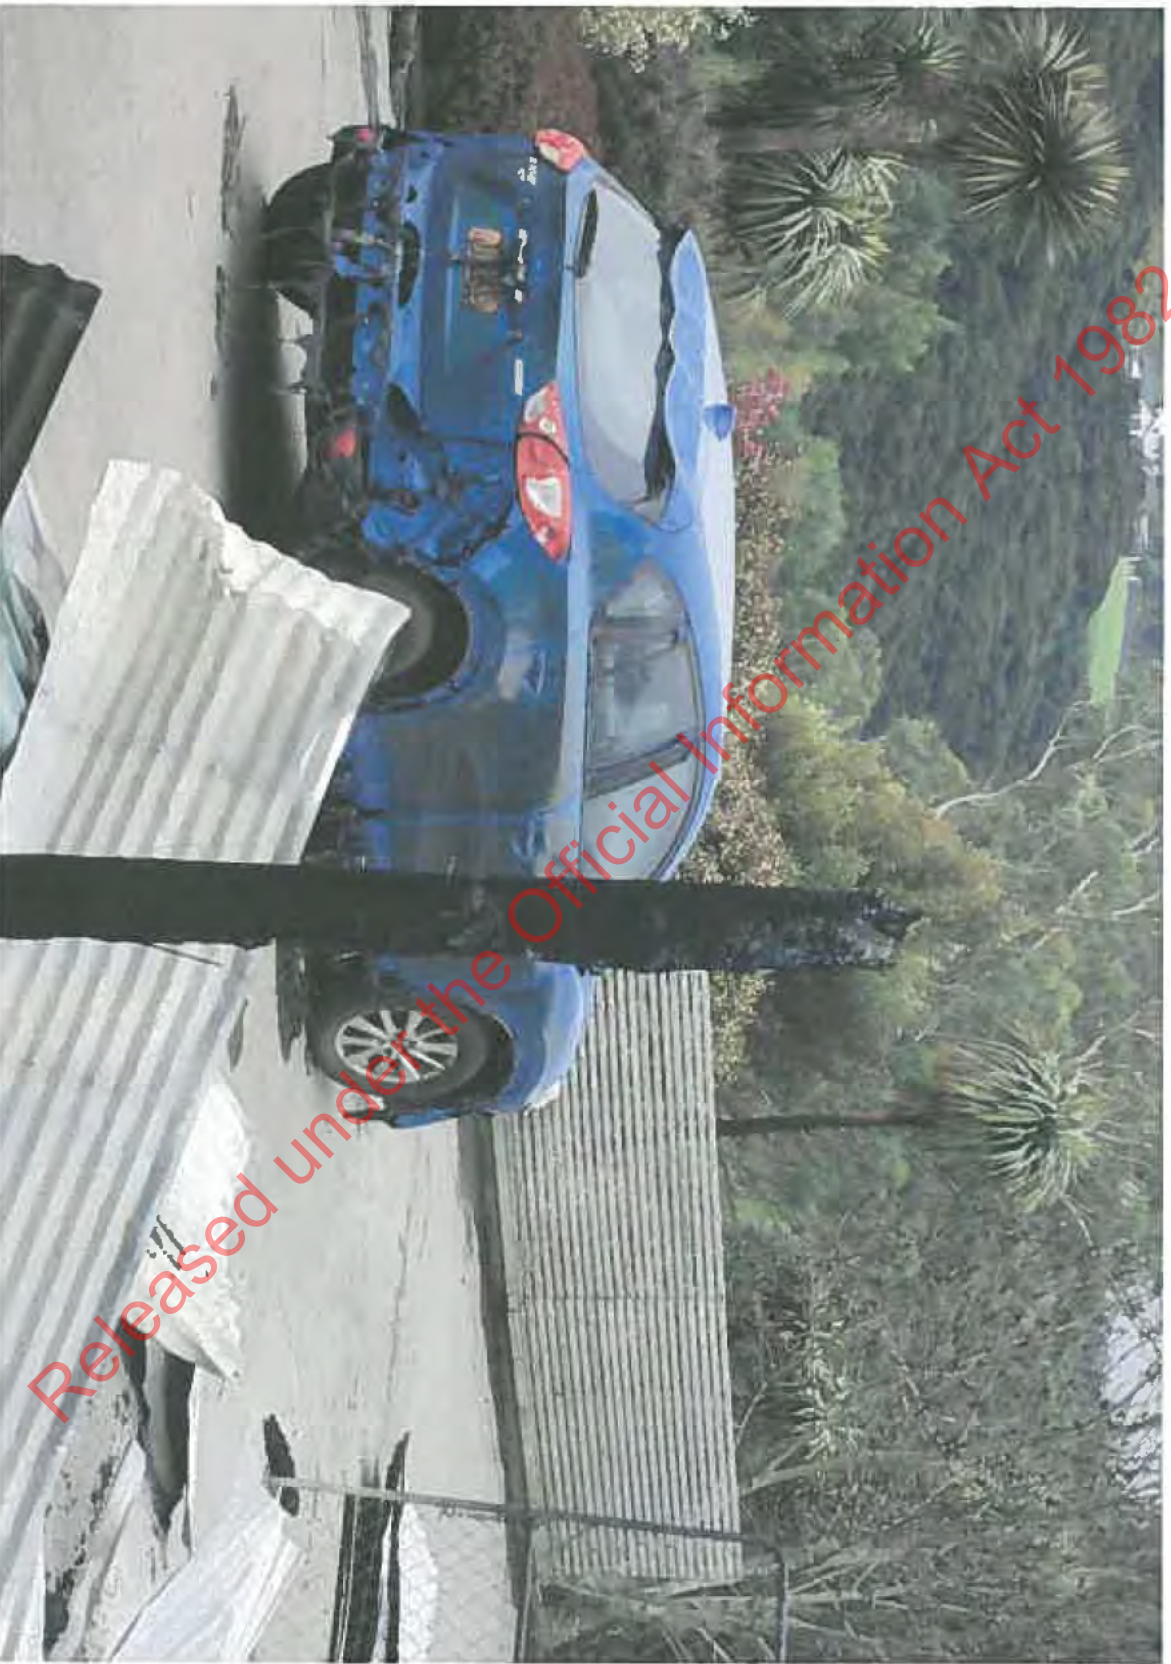
Photos 1636 Delta - 43 Coalstage Rd. Spalling on concrete water tank and other plastic tanks melted down to water level.
