POST CONSTRUCTION ROAD SAFETY AUDIT
Central Motorway Junction Cycleway
AECOM Component

Prepared for NZTA

10 March 2015

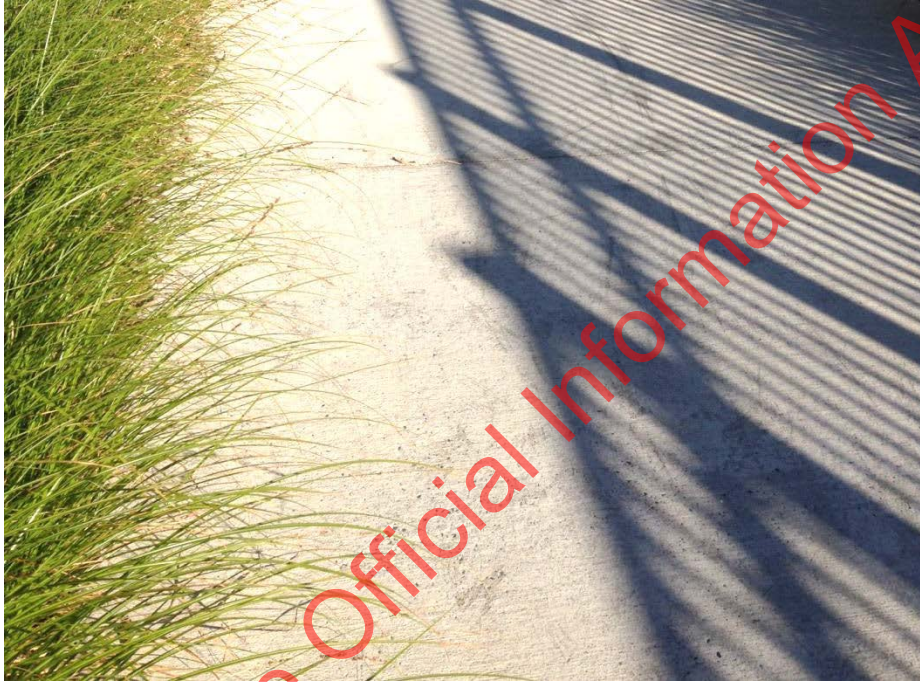
The grass vegetation planted immediately adjacent to the cycleway has grown significantly over summer months and now encroaches across into the cycleway by at least 0.5m on either side. Given the type of grass (slightly abrasive) it is not particularly pleasant to brush past and subsequently cyclists were observed to be avoiding and shying away from it. This has the effect of reducing the cycleway down to approximately 2 m in width and increases the risk of crashes between passing path users.

Figure 1: Grass encroaching over the cycleway path

Ensure the grass vegetation immediately adjacent to the path is trimmed regularly to stop encroachment and when appropriate (e.g. when the background vegetation has matured) remove the grass or replace it with a more appropriate species.

Frequency	Severity	Rating
Crashes are likely to be occasional	Death or serious injury is unlikely	The safety concern is minor
Designer response	NZTA (AT) maintenance should be able to manage vegetation growth by regular cutbacks to edge of path. This would resolve the safety concern.	
Safety engineer comment	Accept Designers Response (ADR)	
Client decision	NZTA to perform grass trimming until the end of defects liability period, i.e. September 2015 and then project will be handover to Auckland Transport for maintenance.	
Action taken	Grass trimming executed in the month of June 2015

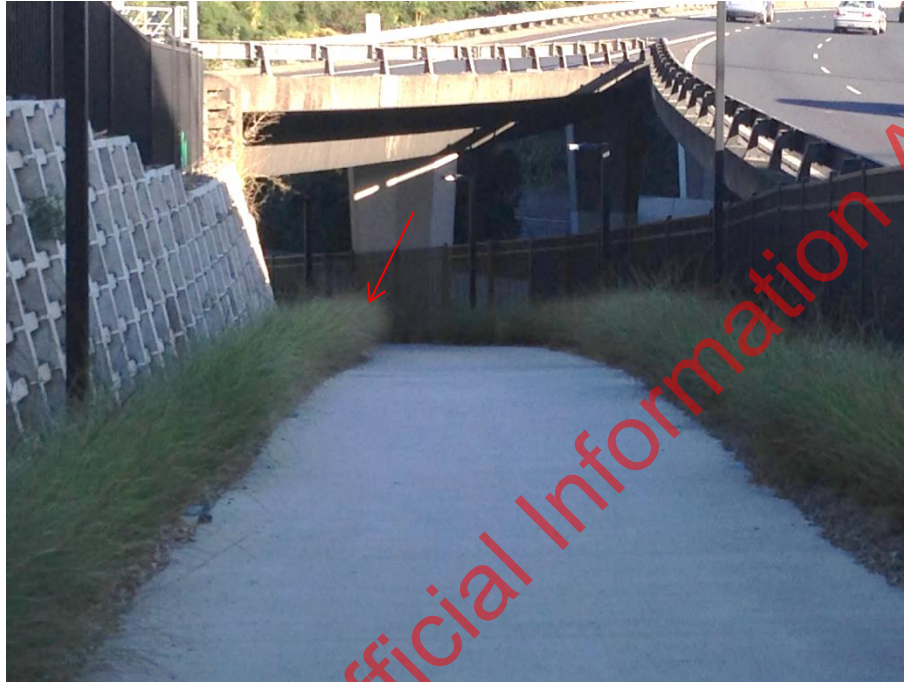
Further to 2.1 above, the SAT noted a potential forward visibility issue under the Symonds Street onramp. Northbound cyclists approaching this section (potentially at speed) will tend to shy towards the centre of the path to avoid brushing the vegetation. The same vegetation, together with the shade under the onramp, conspires to hide visibility to southbound path users heading up the hill. The grade of the path at this location (11%) also lengthens the stopping distance for down-hill cyclists. These factors combine to increase the chance of a crash between a downhill cyclist and an uphill path user.

Figure 2: Encroaching grass obscures sight distance and narrows the path

Consider installing some form of signage and/or markings immediately south (uphill) from the Symonds Street onramp underpass highlighting the need to keep left and moderate approach speed.

Frequency	Severity	Rating
Crashes are likely to be occasional	Death or serious injury is unlikely	The safety concern is minor
Designer response	NZTA (AT) maintenance should be able to manage vegetation growth by regular cutbacks to edge of path. This action would resolve the safety concern.	
Safety engineer comment	ADR	
Client decision	NZTA to perform grass trimming until the end of defects liability period, i.e. September 2015 and then project will be handover to Auckland Transport for maintenance.	
Action taken	Grass trimming executed in the month of June 2015

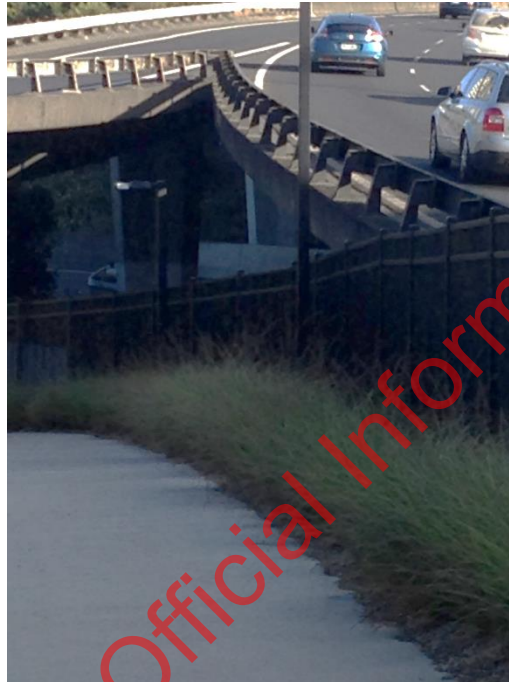
At the Symonds Street motorway onramp connection with the southern motorway the shared path descends from a level above the motorway lanes to travel underneath the onramp. At this location the nearest lane of the southern motorway is no more than 2 m away (at head height). The SAT was concerned that any debris (accidental or deliberate) from a passing vehicle would enter the shared path area at roughly head height, posing a significant hazard to a passing cyclist or pedestrian. This hazard is further exacerbated given the low non-solid side barrier at this location. The SAT was also concerned that the current barrier would not comply with NZTA's current requirements for side road protection and may not contain a heavy vehicle impact.

Figure 3: Note close proximity of motorway, potentially non-compliant barrier system and potential for fallen objects to strike path users

1. Review whether the motorway side barrier is fit for purpose
2. Provide a screen to stop debris falling (or thrown) from motorway traffic from entering the shared path area

Frequency	Severity	Rating
Crashes are likely to be infrequent	Death or serious injury is likely	The safety concern is moderate
Designer response	<ol style="list-style-type: none"> 1. Motorway side barrier is not in project scope. This concern should be referred to AMA for consideration to upgrade the bridge and edge protection. 2. This issue has been raised before in previous RSA's and the risk is no different to debris falling off a truck further down the cycleway where it is located alongside the motorway or street (eg. Beach Rd section). 	
Safety engineer comment	ADR. This issue will be considered in an area wide investigation of barrier fitness.	
Client decision	Investigate the two SAR recommendations above	
Action taken	AMA to take care of recommendation 1; the screen to catch debris falling to cyclists

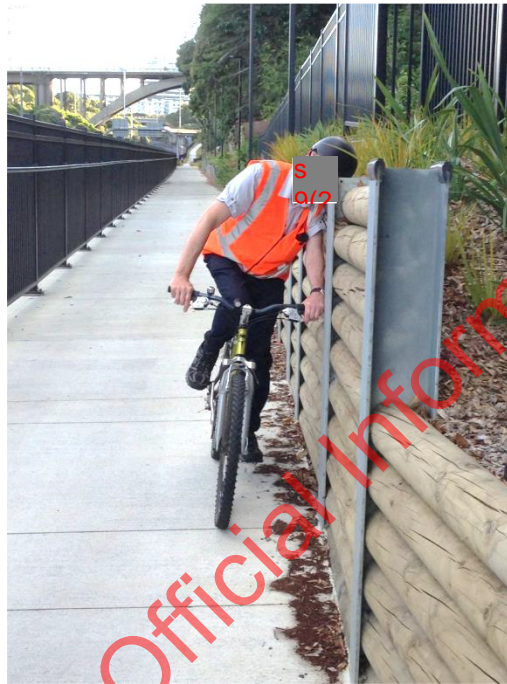
The tops of the steel 'H' pile retaining wall are exposed such that that a glancing collision with the wall could result in part of a cyclists body catching on the corners of the retaining posts. The likelihood of a crash is further increased due to the close proximity of the wall to the path (no separation zone), the local narrowing of the path (less than 2.5m) and the lack of a 'rub' rail on the retaining wall side.

The after-market hard rubber covers that have been attached to the top of the H-piles would offer no protection for the type of crash illustrated in Figure 4.

Figure 4: Exposed 'H' pile posts are a hazard for glancing collisions with the retaining wall

Encapsulate the top of the retaining wall (including the posts) in a capping beam such that any glancing blow will slide along the wall and not catch on the exposed corners of the retaining wall posts

Agree this could happen but highly unlikely. A cyclist hitting the wall by a glancing blow would more likely be thrown away from the wall and not into it at the angle shown in the photograph. However a plastic half round pipe capping could be installed. A rub rail would reduce the already narrow width causing a problem for cyclists approaching from the opposite direction. NZTA to advise if want to proceed with a specialised treatment.

ADR. The risk of this type of incident is very low.

No further action to be taken

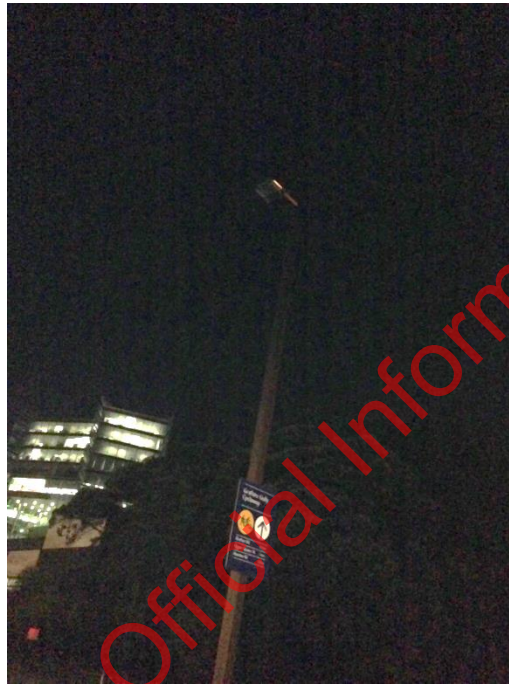
During the night inspection the SAT noted that half the streetlights on Stage 1 were not working (9 lights). On previous site visits to this stage this has also been the case, whereas the lighting on all other stages was 100% operational. Poor lighting is a possible risk to personal security and increases the chance of crashes between path users.

Figure 5: Streetlight not working

Undertake a thorough maintenance check of the lighting in Stage 1.

Frequency	Severity	Rating
Crashes are likely to be infrequent	Death or serious injury is unlikely	The safety concern is minor
Designer response	NZTA (AT) maintenance need to raise this fault with Vector Ltd as the supplier of power to the AT street lighting or advise Council Action line of the fault to resolve this issue. All lights were working at the time of handover from the Contractor and at end of defects period.	
Safety engineer comment	ADR. This is a maintenance issue.	
Client decision	NZTA to inform AT of the lighting maintenance issue which is now their responsibility	
Action taken	AT has taken responsibility of the lighting maintenance. No further action to be taken.

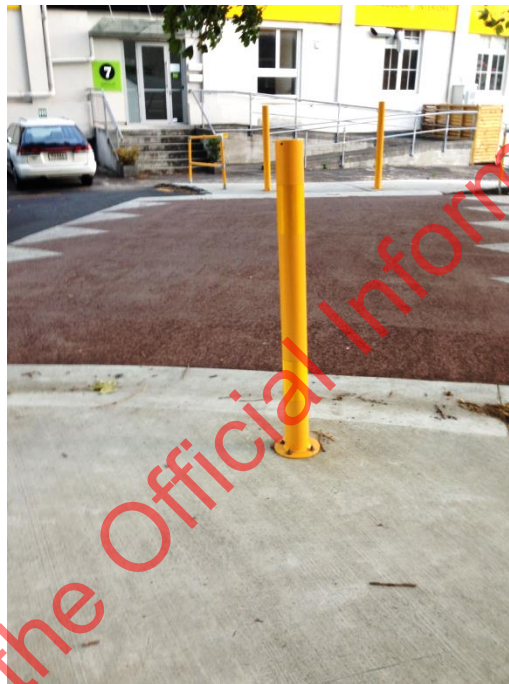
Near the Alten Road end of Stage 2 the shared path crosses Churchill Street on a raised speed table. As the raised speed table does not include zebra markings drivers of vehicles on the road have right of way. However, the shared path at this location does not have any signage or markings indicating cyclists should dismount or give way to vehicles. The SAT consider that the red colour of the table and the lack of any obvious indicators suggesting cyclists should give way (e.g. chicanes, signage, markings, hold rails, etc.) increases the risk of a cyclist crashing with a vehicle, especially given the low volume of vehicles using Churchill Street and the propensity for cyclists to grow accustomed to not having to give way.

Figure 6: Mid-block crossing across Churchill Street

Clarify whether vehicles or cyclists should have right of way at the Churchill Street speed table and mark, sign and control crossing movements appropriately

Frequency	Severity	Rating
Crashes are likely to be infrequent	Death or serious injury is likely	The safety concern is moderate
Designer response	The safety concern raised has been answered in above auditor discussion ie. <i>the shared path at this location does not have any signage or markings indicating cyclists should dismount or give way to vehicles.</i> Cyclists in this instance do not have right of way and given the speed table hence low vehicle speeds and low vehicle frequency this is not considered to be a moderate concern. Further to this sight lines are more than adequate at this location.	
Safety engineer comment	ADR. This is not a moderate risk.	
Client decision	Accepts Safety Engineer's recommendation.

Action taken No further action required
