DETAIL DESIGN ROAD SAFETY AUDIT
SH1 WAIKATO EXPRESSWAY 110 KM/H SPEED
REVIEW PROJECT TAMAHERE

PREPARED FOR WAKA KOTAHI NZ TRANSPORT AGENCY

26 October 2021

SH1 Waikato Expressway 110 km/h Speed Review Project Tamahere

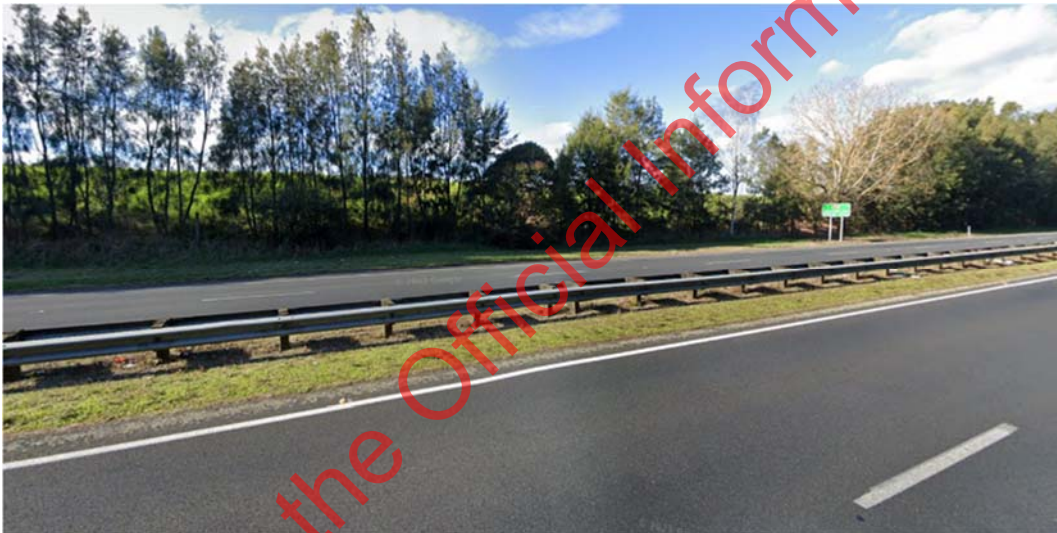
Figure 2: Median barrier (Google, 2021)

The existing back-to-back semi-rigid median barrier and semi-rigid roadside barriers are likely to have been produced and installed to NCHRP 350 TL-3 standards.

Although the barriers appear not to have received any recent strikes (as would be evidenced by replaced sections of barrier) their performance in preventing a vehicle (especially a high centre of gravity vehicle) from crossing the median into opposing traffic or crashing into the gully or road below may be questionable. The main concern is their low mounting height in relation to the road surface, particularly on the interchange bridge.

1. Replace the existing median and roadside barriers (and especially the bridge barriers) with a taller and more appropriate level of performance barrier system.

Frequency Crashes are likely to be infrequent	Severity Death or serious injury is likely	Rating The safety concern is moderate
Designer response	<p>Agree in general principles, though this is currently outside the scope of the work, and would require some specialist bridge input into the affixing replacement barriers to the bridge deck. We have sourced plans of the original bridge, and preliminary advice is that concrete barriers would not be able to be placed without considerable strengthening of the bridge, and semi-rigid TL4 barrier (eg thribeam) would be more likely to be the appropriate treatment.</p> <p>The replaced roadside barriers would be at the same offset from the edgeline, which is in the order of 2.0m – considerably less than the 3.0m RONS standard elsewhere on the Waikato Expressway.</p> <p>The median barrier currently existing with a 5.0m grassed median (with the exception of the bridge crossing itself), narrower than the desired minimum for wire rope barrier medians. It is noted that the Hamilton Section terminates with a double sided F shape concrete barrier TL4 height. A suitable treatment would likely be a double sided semi rigid barrier until the median widens to the existing</p>

Safety Engineer comment	<p>Designer response is acknowledged. It is recommended to the client that all barriers including interchange bridge barrier be replaced thereby providing safety to road users.</p>	
Client decision	<p>This work is beyond the original scope of works and requires review. If mitigation of the existing risk is required, impact on the WEX 110km/h project (schedule, time, cost) to be approved and funding allocated.</p>	
Action taken	<p>A scope change request has been developed identifying the risk with the performance of the existing barriers and potential mitigation options. Date of resolution tbc.</p>

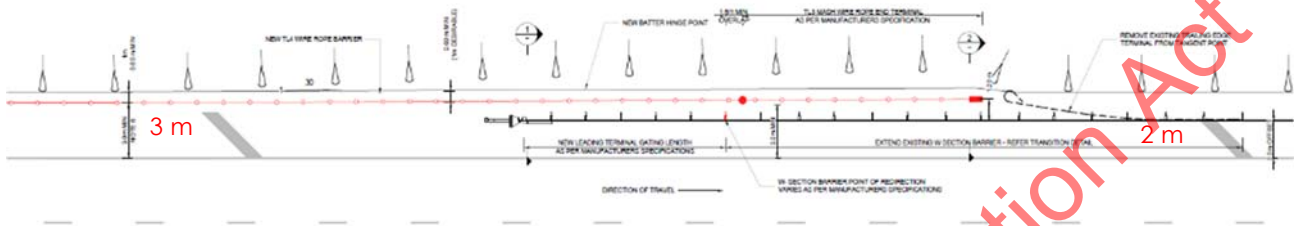
Figure 5: Flexible to semi-rigid barrier transition detail

The transition from flexible to semi-rigid barrier, which would be applied only near the northbound exit ramp, shows a 1 m lateral step from the widened shoulder width of 3 m to tie into an existing shoulder width of 2 m.

Normally the projected faces of the flexible barrier and the semi-rigid barrier would line up, i.e. be the same offset from the edge line, and the flexible barrier would deviate behind the semi-rigid barrier only locally.

Although the proposed detail appears to adopt the same performance principles as shown in the RSB7A standard drawing of Waka Kotahi, it may be worth checking that Waka Kotahi is comfortable with the proposed detail.

Designer response	Accepted. Propose to use a flared guardrail extension and terminal to widen to 3.0m rather than a lateral step. Detail updated.
Safety Engineer comment	Agree with designer's response.
Client decision	Agree with SAT and RSE
Action taken	The design has been updated to reflect the designers response.

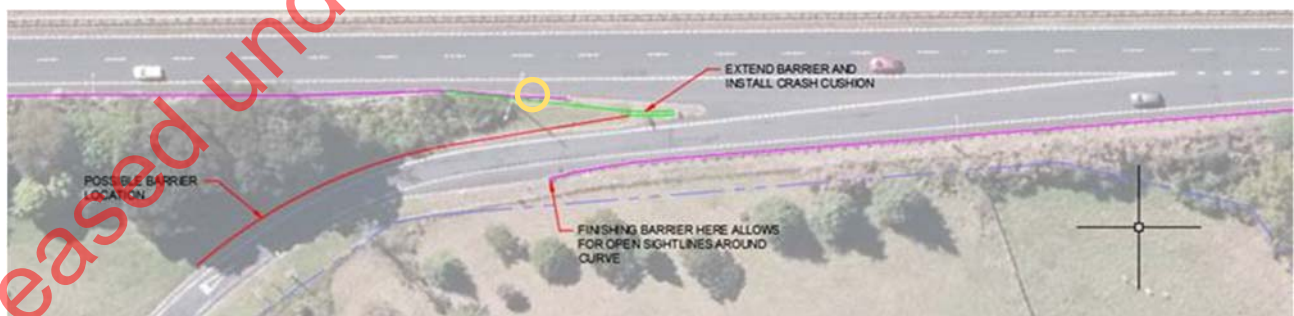
Figure 6: Proposed barriers along northbound exit ramp

The designers are contemplating providing barriers along the right-hand side of the exit ramp and connecting these to the existing barriers behind the nose with a crash cushion as indicated in Figure 6.

Refer to Section 2.1.7 concerning the proximity of the lighting column in Figure 6 (yellow circle) and Figure 7 to the proposed barrier and crash cushion.

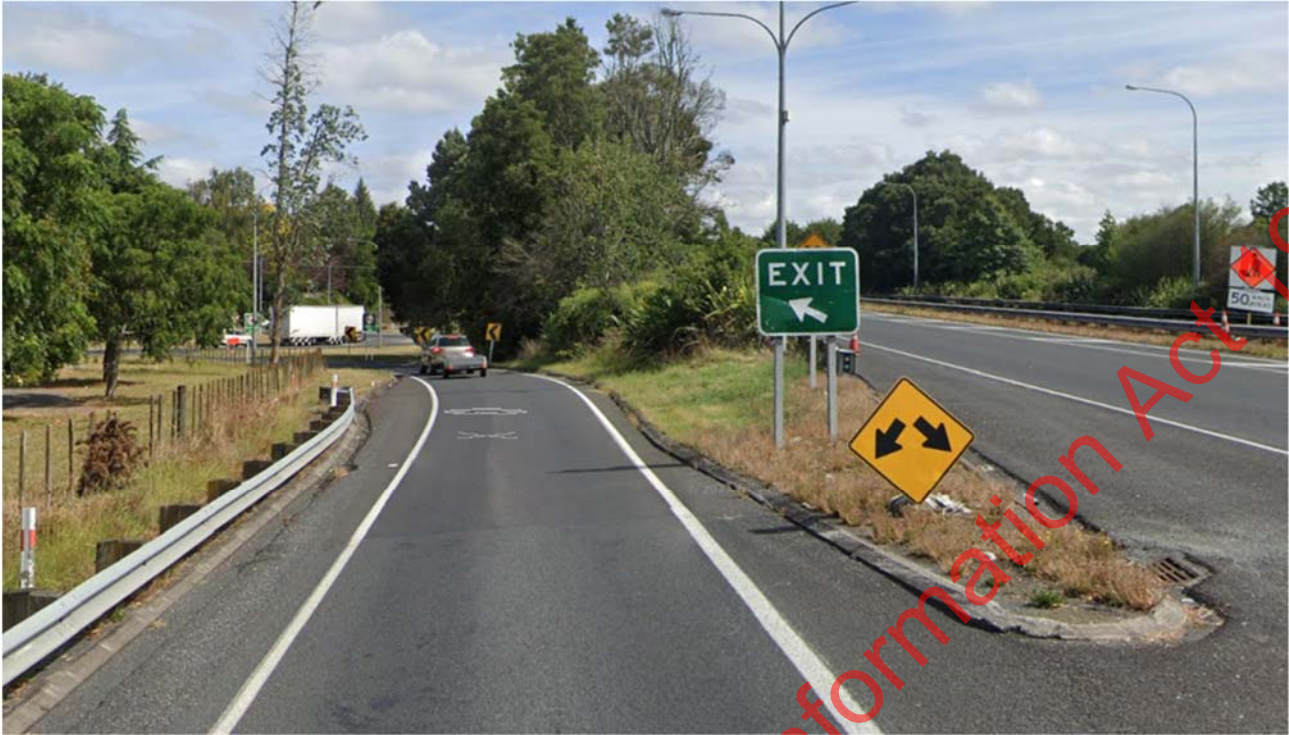
Figure 7: Trees and lighting column along northbound exit ramp (Google, 2021)

The proposal would be a positive safety improvement as there are a number of large trees next to the ramp in Figure 7.

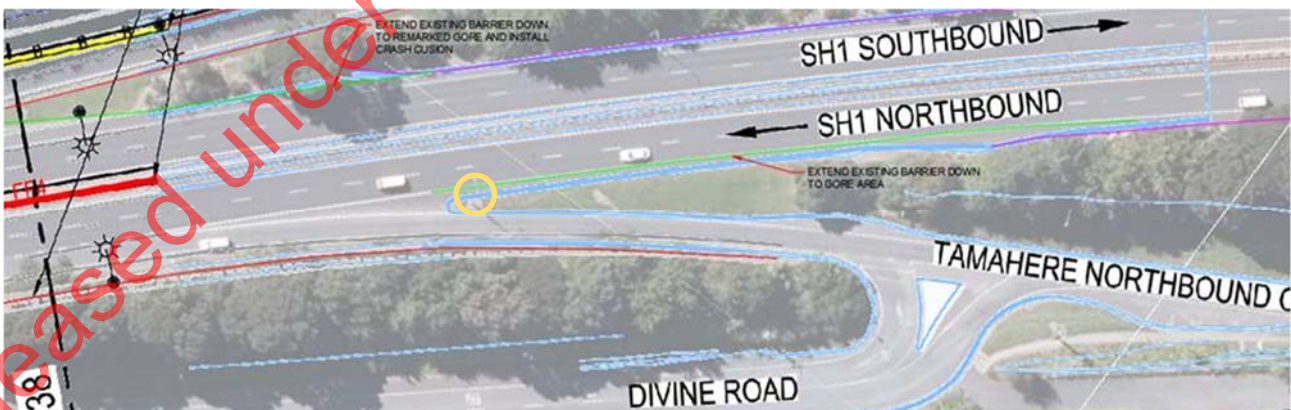
Figure 8: Proposed barriers along northbound entrance ramp

The designers are contemplating providing barriers along the left-hand side of the entrance ramp as shown in red in Figure 8 and Figure 9 and extending the existing barriers to the nose as indicated by the green line in Figure 8 and Figure 9. The southern end of the flexible barrier system already installed on the Hamilton Bypass project is shown by the yellow arrow in Figure 9.

Refer to Section 2.1.7 concerning the proximity of the lighting column in Figure 8 (yellow circle) and Figure 9 to the proposed barrier next to the expressway.

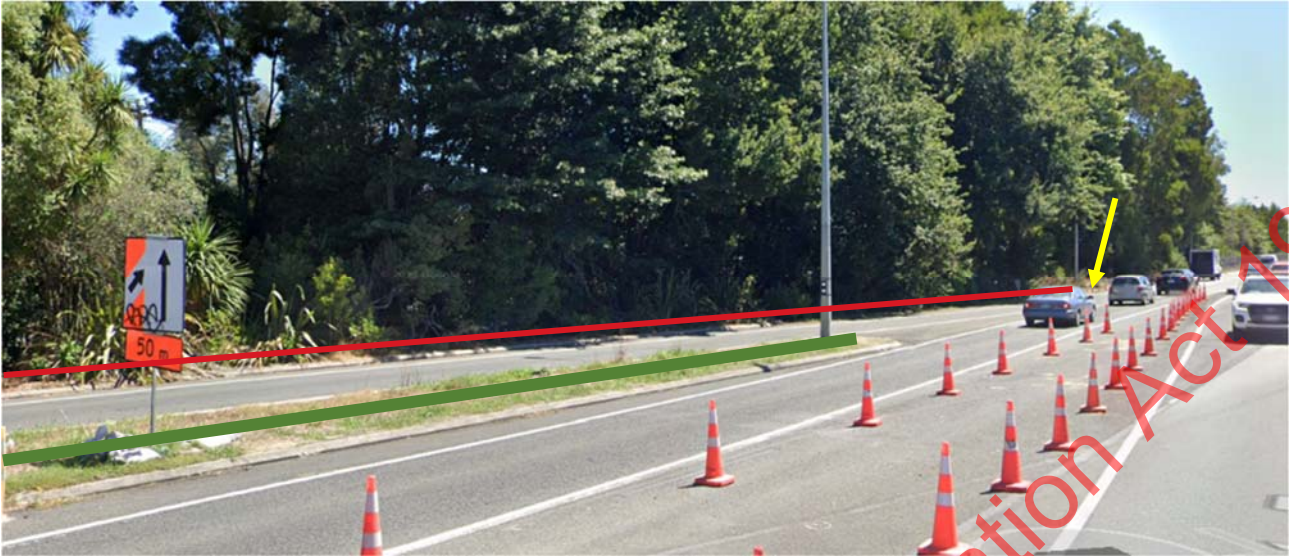
Figure 9: Trees and lighting column along northbound entrance ramp (Google, 2021)

The proposal would be a positive safety improvement as there are a number of large trees and a lighting column next to the ramp.

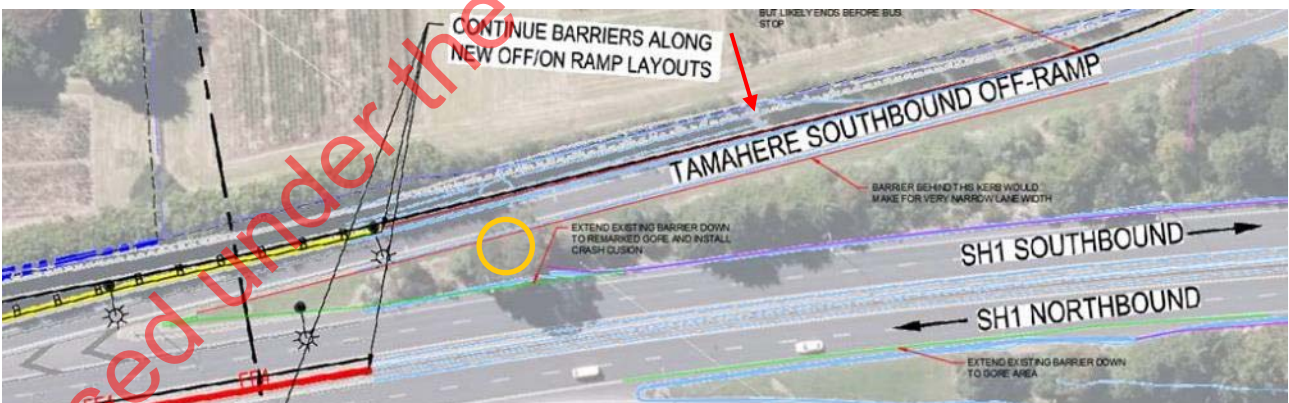
Figure 10: Proposed barriers along southbound exit ramp

The designers are contemplating providing barriers along both sides of the entrance ramp as shown in red in Figure 10 and extending the existing barriers to the nose as indicated by the green line in Figure 10.

However, the designers expressed concern that installing barriers along the exiting edge of seal on both sides of the ramp would not provide enough width (5 m to 5.5 m) for broken down vehicles to stop or for emergency vehicles to pass without significant widening of the pavement.

The barriers on both sides of the ramp probably do not need to be extended as far down the ramp as proposed. There is a farm gate about halfway down the ramp, to which access would need to be maintained. The barriers could probably end at the gate. The ramp is straight and has good sight distance along it. Speeds would be bleeding off as drivers slowed for the ramp terminal intersection. The greatest risk of a crash would be close to the nose where drivers might suddenly realize that they have reached the exit and swerve across the gore losing control and crashing into the trees on either side of the ramp.

Refer to Section 2.1.7 concerning the proximity of the lighting column in Figure 10 (yellow circle) and Figure 11 to the proposed barrier next to the expressway.

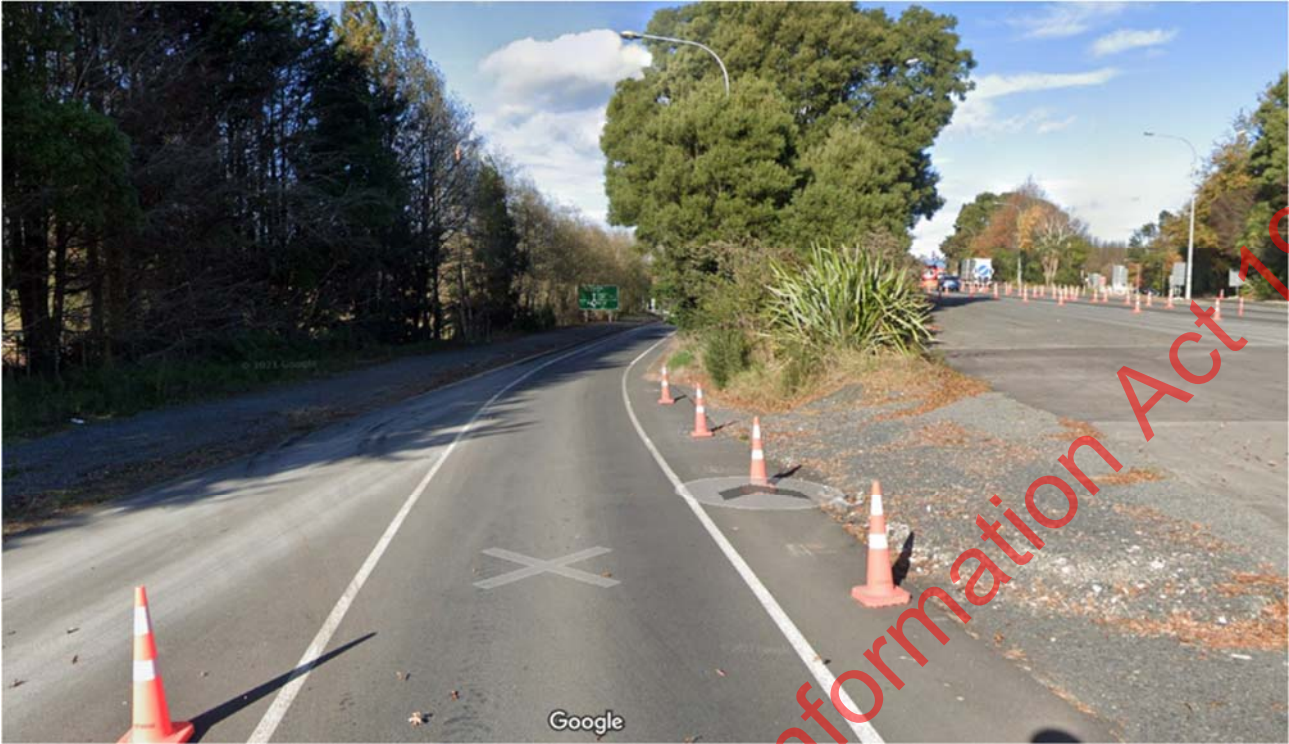
Figure 11: Trees and lighting column along southbound exit ramp (Google, 2021)

The proposal would be a positive safety improvement as there are a number of large trees next to the ramp.

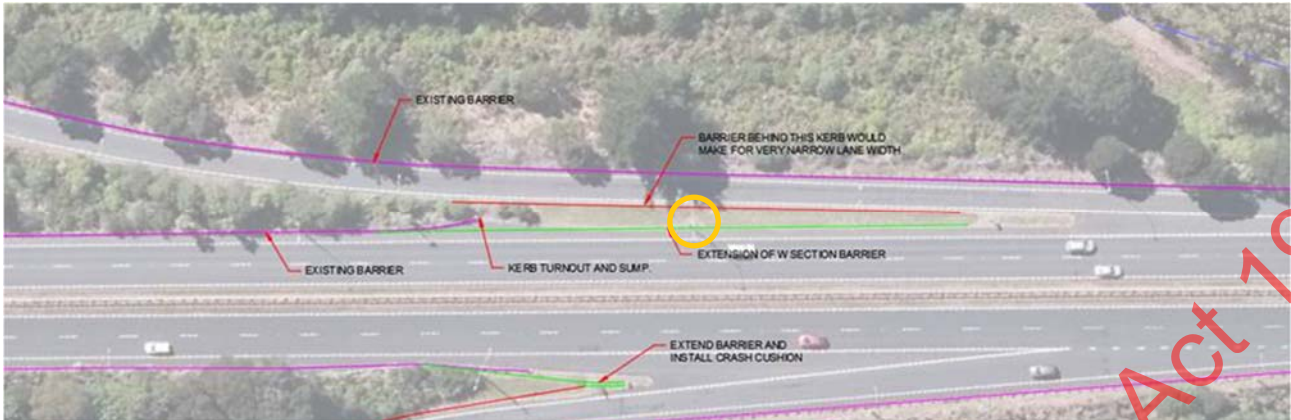
Figure 12: Proposed barriers along southbound entrance ramp

The designers are contemplating providing barriers along both sides of the entrance ramp as shown in red in Figure 12 and extending the existing barriers to the nose as indicated by the green line in Figure 12.

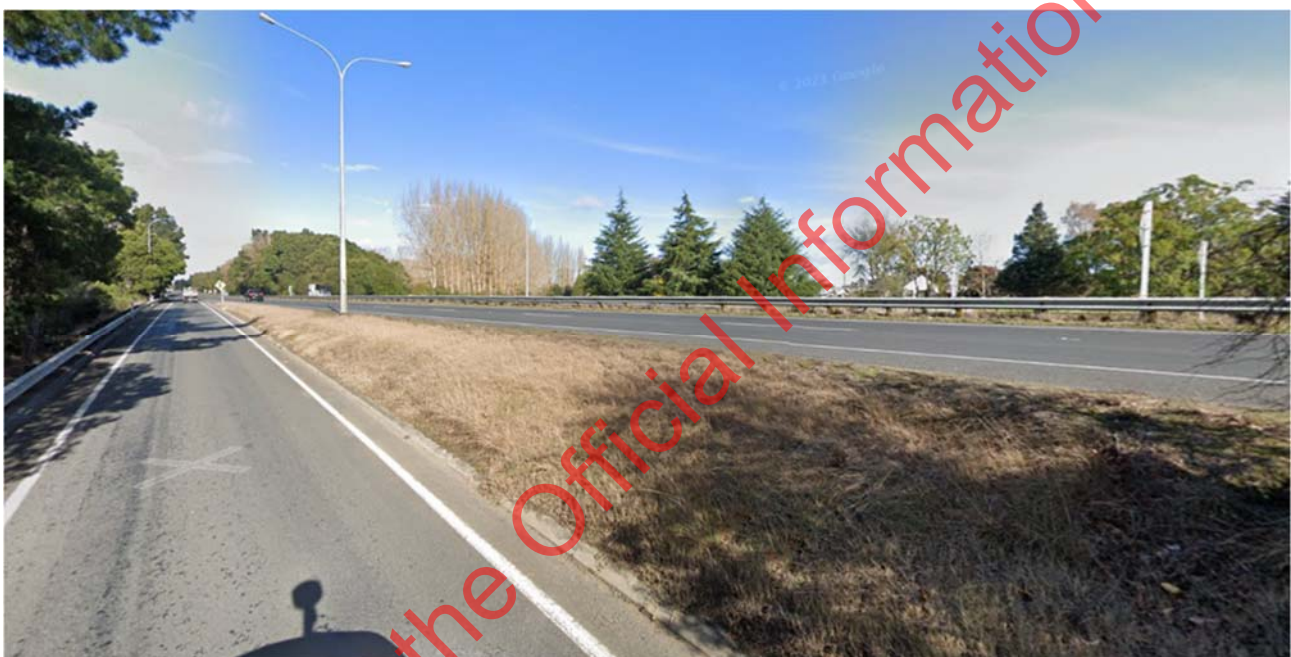
Figure 13: Lighting column near southbound entrance ramp merge

With the exception of the lighting column shown in Figure 13, there are no other significant hazards that motorists need to be protected from in the vicinity of the merge area.

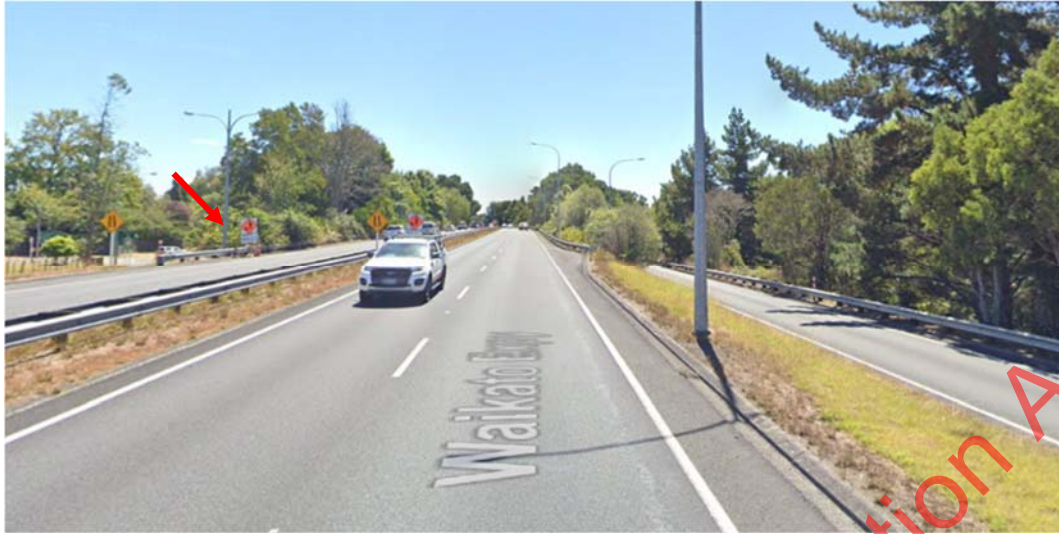
Figure 14: Lighting column close to edge of expressway (Google, 2021)

Figure 14 shows a typical lighting column close to the edge of the expressway. Some, such as the one arrowed in Figure 14 at the northbound exit ramp are behind existing barriers. Others, such as the one in the foreground of Figure 14 at the southbound entrance ramp are currently exposed.

The designers are contemplating extending the barriers on all four ramps up to the nose as described in the preceding Sections 2.1.3, 2.1.4, 2.1.5, and 2.1.6. In all cases there are one or more lighting columns that would be within the operating zone of a barrier. The performance of the existing and proposed barriers, and of the slip base lighting columns, would be unpredictable in a crash.

It is acknowledged that the installation of the roadside barriers would be a safety improvement, even if they were not installed in accordance with accepted normal operating clearances. However, consideration should be given to mitigating the departure, like using a stiffer less defluctive barrier system or replacing the lighting columns with fewer high mast lighting columns in less vulnerable positions.

1. Mitigate the consequence of the potentially narrow gap between the lighting columns and the back of the roadside barriers by using a stiffer less defluctive barrier system.
2. In conjunction with the recommendation above, specify on the cross-section edge details what minimum clearance between the lighting columns and the back of the barrier would be sought.
3. Where lighting columns might need to be relocated, specify ground-planted frangible lighting columns to replace the slip-base columns.

Frequency Crashes are likely to be occasional	Severity Death or serious injury is unlikely	Rating The safety concern is minor
Designer response	Agreed, included in plan and details.	
Safety Engineer comment	Acknowledge designer's response. It is recommended to the client that slip base light columns are the preferred option. Clearance from the proposed barrier to all light columns should be as per Waka Kotahi guidelines	
Client decision	<p>Agree with SAT and RSE.</p> <p>However, M23 Appendix A, notes the below:</p> <p>'m) For new installations, lighting columns shall be installed so that there is at least 1.5 m clearance between the closest parts of the barrier system and the lighting column. <u>In retrofit situations only</u>, this may be reduced to 1.0 m with application to, and acceptance by, the Lead Safety Advisor. <u>Lighting columns behind barriers should not be on a frangible 'slip base'</u> (for retrofit installations these should be modified to reduce the risk of being activated by a deflecting barrier).'</p> <p>Based on this requirement, ground-planted frangible lighting columns are to be specified.</p>

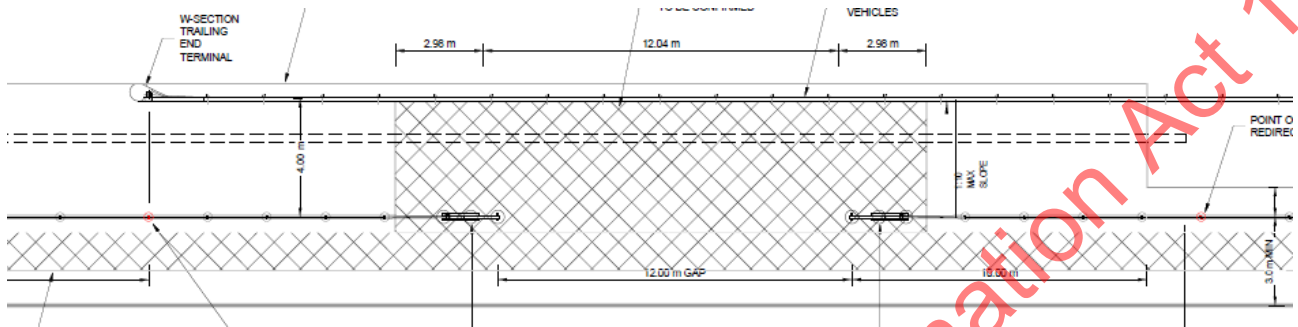
Figure 15: Maintenance access bay detail

The proposed maintenance bays, which are intended to give access to the berm in both directions, are shown in Figure 15 and Figure 16. Although the detail shows a width of 4 m, the layout indicates 3 m.

The effective width of the maintenance bay in the detail in Figure 15 would be less than the 4 m width shown when the widths of the end terminals are taken into account. There is thus unlikely to be enough width for a maintenance truck to manoeuvre into the maintenance bay from the shoulder and a portion of the through lane will likely be required for the manoeuvre. Similarly, exiting the bay might require the front of the vehicle to swing wide into the adjacent lane. This would mean blocking the through lane while manoeuvring in or out, effectively bringing all traffic in that lane to an unexpected halt. This would be unsafe, not only for the general traffic, but also for the maintenance personnel.

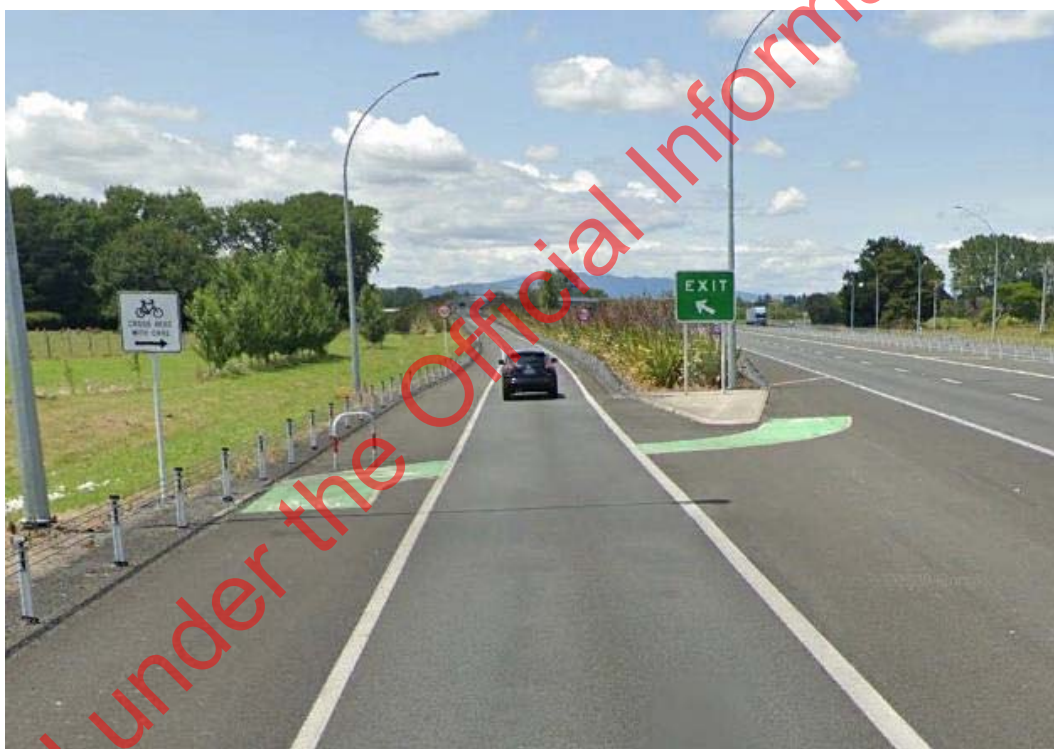
Figure 17: Exit ramp cyclist crossing at Cambridge (west) interchange (Google, 2019)

Some sections of the existing Waikato Expressway cater for cyclists in the form of painted buffer strips (e.g. Rangiriri to Ohinewai) and signed crossing points across exit and entrance ramps as shown in Figure 17 which is in an existing 110 km/h speed limit zone along the Cambridge Bypass not far from the Tamahere interchange. Such shoulder buffers and cyclist crossings are not present on the Hampton Downs section or the Tamahere section or other recently opened sections such as the Huntly Bypass.

Since the Waikato Expressway looks like a motorway, it would be reasonable to assume that some drivers would not expect to encounter cyclists in such an environment and would therefore not be looking out for cyclists.

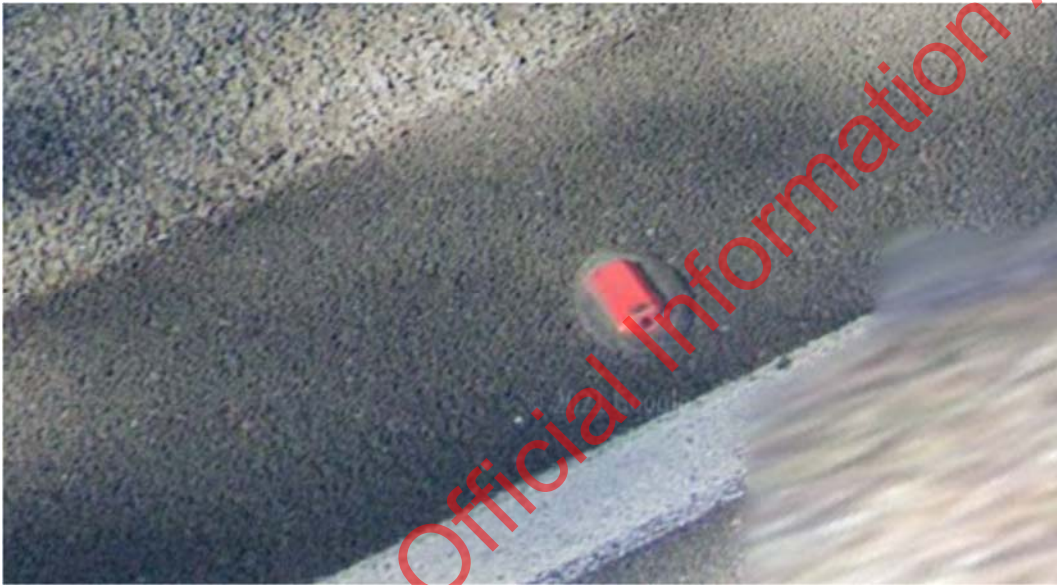
Figure 18: Existing RRPMS position in relation to edge line

The ATP markings applied on the recent Longswamp to Rangiriri project (June 2020) coincided with the RRPMS. Not only did the application cover the RRPMS in many cases, but the raised portion of the ATP also tended to mask the full effectiveness of the RRPMS reflectivity, effectively reducing the RRPMS to about half its reflective area when viewed from the low angle of a passenger vehicle.

Fortunately, it appears that the existing RRPMS along the Tamahere section are set far enough away from the existing edge line for ATP to be applied between the line of RRPMS and the edge line. However, the foregoing comment should be borne in mind when drawing up any specifications or drawings for ATP.
