DETAIL DESIGN ROAD SAFETY AUDIT
SH1 WAIKATO EXPRESSWAY 110 KM/H SPEED
REVIEW PROJECT HAMPTON DOWNS

PREPARED FOR WAKA KOTAHI NZ TRANSPORT AGENCY

29 September 2021

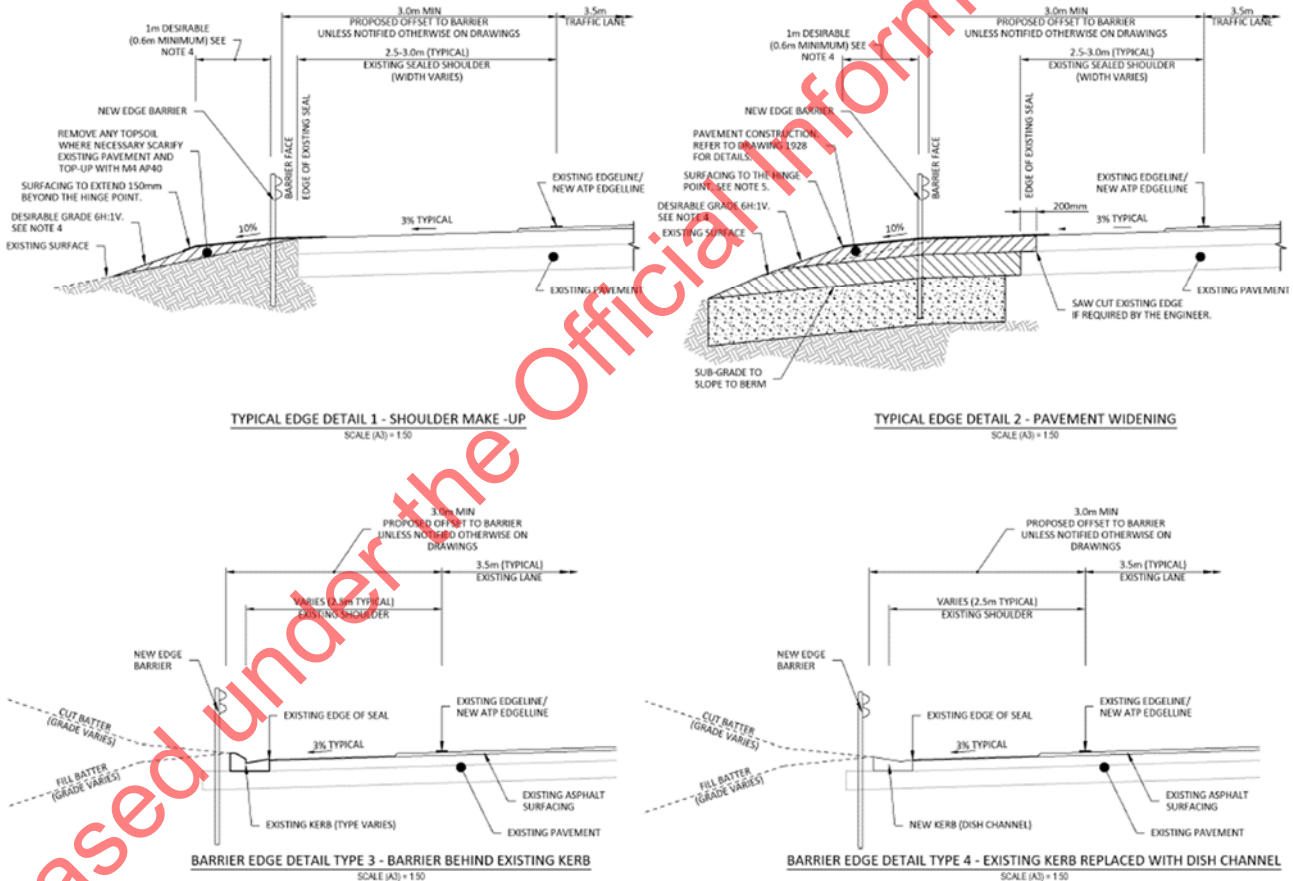
Figure 1: Proposed edge details

The design philosophy statement and the typical edge details on drawing 147130-02-1901 indicate that, although the existing shoulder next to kerbs is about 2.5 m wide, the barrier will always be installed with a 3.0 m minimum offset from the edge line. Where there are no kerbs, the seal is proposed to be widened to 3.0 m. The design philosophy statement states that, '...for 110 km/h retro fit projects is to retain existing lighting where practicable. Where existing columns are in front of or clash with new barrier, they will be relocated behind the new barrier clear of the deflection zone.' The general arrangement drawings tabulate exactly where each edge design applies. Thus, in all cases, there should be enough width for a vehicle to stop and for the passenger door to be opened.

However, the lighting columns that would need to be relocated are not identified on the drawings, thus placing the onus on the contractor to determine which ones are to be shifted. There is also no criterion shown for how close the barrier can be to the lighting column before it needs to be shifted. Theoretically, the drawings could allow the back of the barrier to touch the lighting column.

The safety concern is that the desired 3.0 m width will not eventuate if it is left to the contractor to determine which lighting columns are to be relocated, especially if the existing lighting column position is only just shy of meeting the requirements and the barrier is shifted to miss the column or to achieve the desired clearance to the lighting column. The two lighting columns, each about 40 m behind the nose of

the two exit ramps, are examples where the flare of the barriers meeting the crash cushions needs to be accounted for.

1. Show the lighting columns on the typical edge details with the minimum acceptable gap between the back of the barrier and the face of the lighting column dimensioned, and also on the general arrangement drawings, so that there can be no ambiguity concerning which lighting columns are to be relocated and which can remain in place.

Frequency Crashes are likely to be infrequent	Severity Death or serious injury is likely	Rating The safety concern is moderate
Designer response	<p>Designer agrees. The drawings now detail where columns are to be relocated. An additional edge detail has been added to the drawing set for <i>Barrier behind existing kerb – with lighting column</i>. The minimum gap between back barrier and light column is 150mm. Survey indicates there is space to accommodate barrier and 150mm gap between kerb and column in most instance. Where this is not achieved columns are shown to be relocated.</p> <p>The general arrangement plans also note the requirement for lighting to be relocated where the 150mm gap cannot be achieved.</p>	
Safety Engineer comment	<p>Agree with SAT. Designer to add lighting columns to the drawing set.</p> <p>Julian Chisnall, Team Lead Road Safety, Programme and Standards: Current best practice is to provide 1.5m between the back of the barrier system and the front face of the lighting column to mitigate the risk of an errant vehicle deflecting the barrier and striking the column. In locations where the 1.5mtr offset clearance cannot be achieved, 1mtr gap would be acceptable (but not desirable).</p>

Client decision	<p>Agree with SAT and RSE.</p> <p>Scope to include the relocation of light columns beyond the barrier deflection zone (min 1mtr gap).</p>	
Action taken	<p>The design has been updated, indicating the relocation of affected light columns</p>

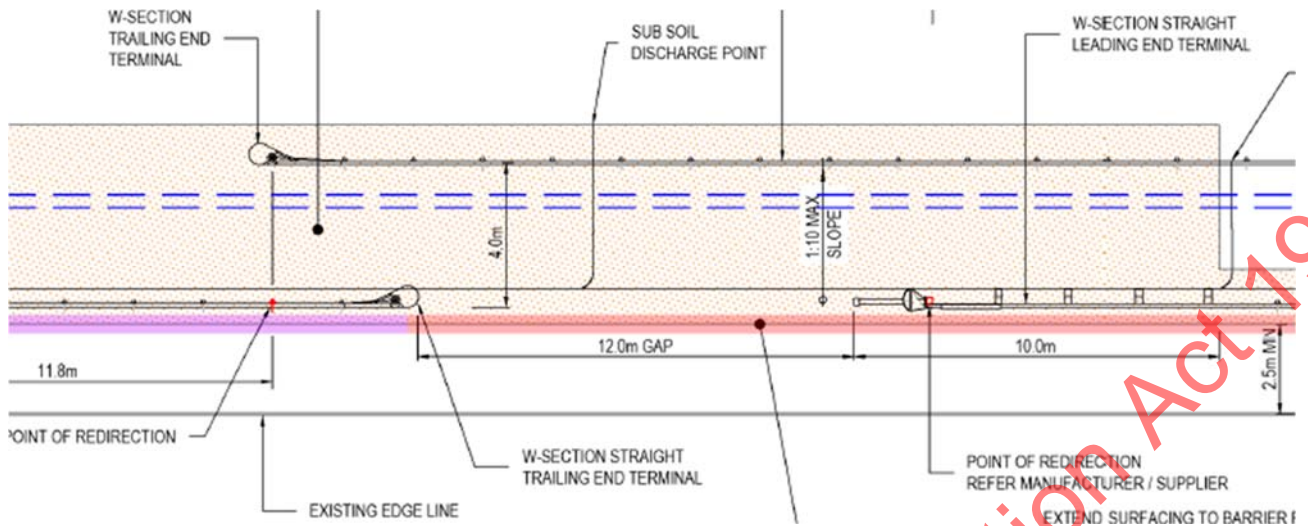
Figure 2: Maintenance access bay Type 2

The proposed Type 2 maintenance bay, which is intended to give access to the berm in both directions, is shown in Figure 2.

The effective width of the maintenance bay would be less than the 4 m width shown when the widths of the end terminals are taken into account. There is thus unlikely to be enough width for a maintenance truck to manoeuvre into the maintenance bay from the shoulder and a portion of the through lane will likely be required for the manoeuvre. Similarly, exiting the bay might require the front of the vehicle to swing wide into the adjacent lane. This would mean blocking the through lane while manoeuvring in or out, effectively bringing all traffic in that lane to an unexpected halt. This would be unsafe, not only for the general traffic, but also for the maintenance personnel.

The possibility of using a lane closure traffic management plan with attenuation vehicles was discussed. However, the risk is that a maintenance person might try to use the bay not realising that it required a special temporary traffic management plan.

Furthermore, the gap in the roadside barrier will leave any worker or vehicle in the maintenance bay exposed to the risk of a vehicle leaving the road at that point.

1. Amend the design to a disengaging overlapping barrier layout that will allow maintenance vehicle drivers to pull over onto the shoulder first and then access the maintenance bay without encroaching into the adjacent through lane, while also fully shielding the maintenance vehicle and any personnel in the maintenance bay. This may require additional access bays or alternative arrangements to service the berm.

Frequency	Severity	Rating
Crashes are likely to be infrequent	Death or serious injury is likely	The safety concern is moderate
Designer response	The Type 2 layout has been removed and replaced with a Type 1 layout. The Type 1 layout allows the vehicle to pull onto the shoulder and reverse into the maintenance bay where they are isolated from the main carriageway by w-section barrier.	
	The shoulder is widened to 3.5m on approach and departure from the maintenance bay to allow additional space to enter and exit. The 3.5m width includes a traversable dish channel to replace kerb and channel where required.	
Safety Engineer comment	Concur with SAT and Designer. Type 1 layout supplied by the designer addresses the concerns raised by SAT.

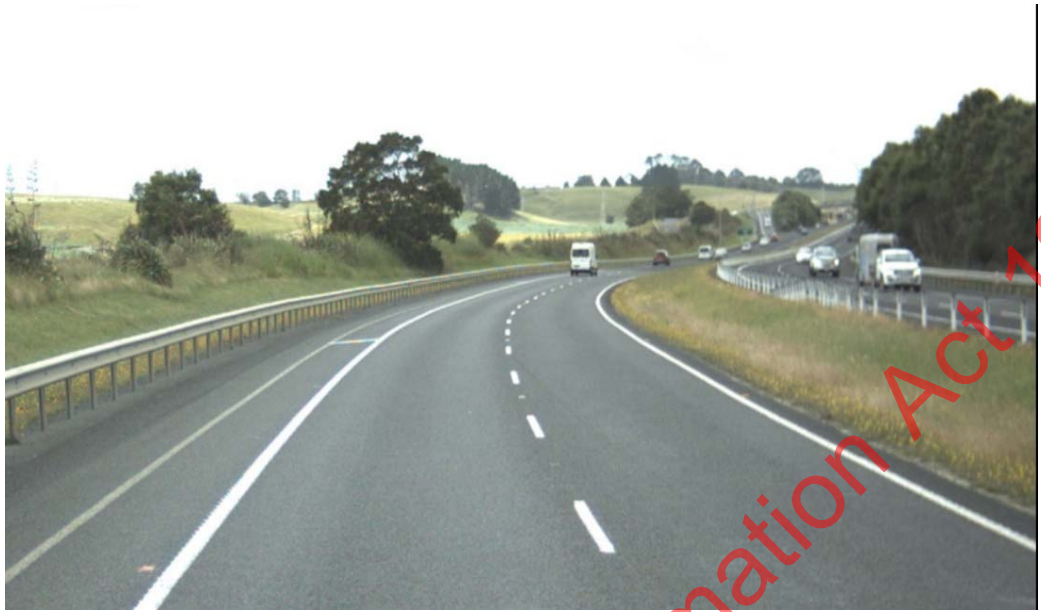
1. Consider installing median barriers wherever there is a likelihood of a rollover crash due to soft turf in the median. This recommendation should apply to the full length of the Waikato Expressway under consideration in this 110 km/h project.

Frequency	Severity	Rating
Crashes are likely to be common	Death or serious injury is unlikely	The safety concern is moderate
Designer response	The Designer acknowledges this is a risk. However, except for the short section under the interchange bridge, modification to the median is not part of the project scope.	
Safety Engineer comment	Agree with SAT.	
Client decision	Agree with Designer. Following a discussion with Principal Traffic and Safety Engineer Richard Landon-Lane on 08/12/2021, the southbound direction right-hand curve at the northern extent of the proposed 110km threshold (RS/RP 486/7.28) predominantly means any run-off road vehicles will likely veer to the left-hand-side, so the risk of a vehicle entering the right-hand side median turf is minimal. Also, the existing median barrier/turf layout is also present at other locations across the state highway network and should be reviewed at a regional/national level.

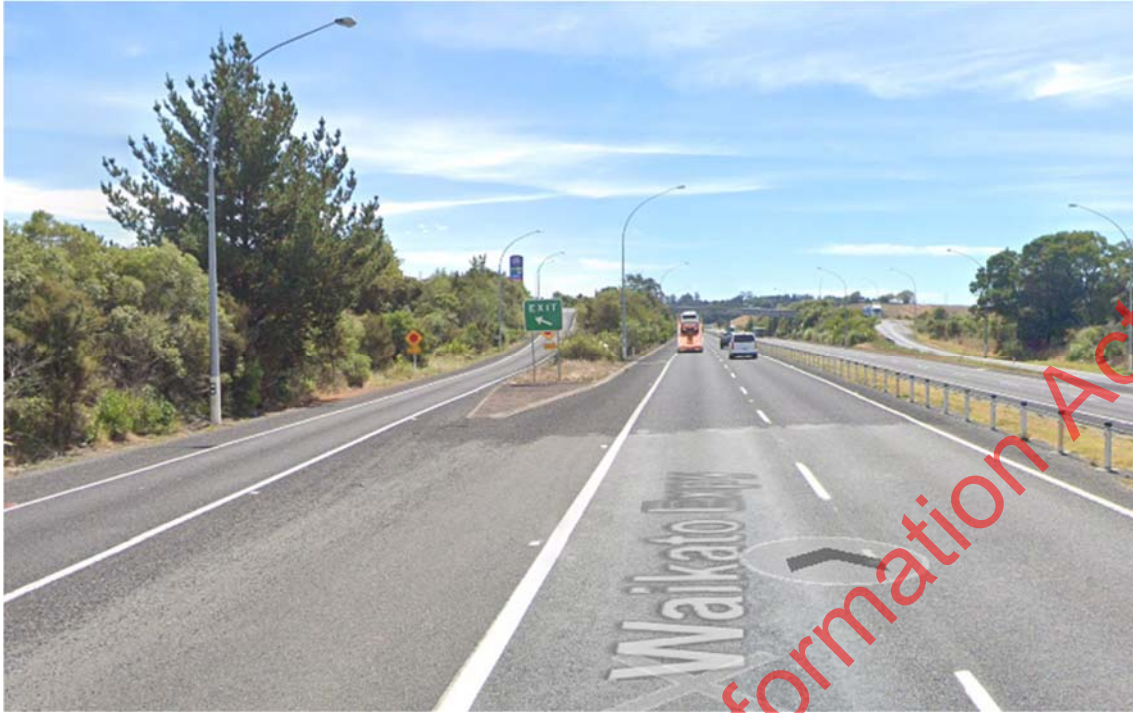
Figure 3: Hampton Downs northbound exit ramp gore and nose (Google, 2021)

The existing exit and entrance ramp gore areas have no hatching. Since there will now be crash cushions on the exit noses, thus reducing the area on and behind the noses for recovery, both exit ramps would benefit from increased visibility. It is acknowledged that the interchange is lit, but speeds will be higher.

All exit gores should be marked with diagonal chevron bars for consistency along the Waikato Expressway. Te Kauwhata, Rangiriri and Huntly interchanges are marked, but Hampton Downs and Ohinewai interchanges are not.

The drawings do not indicate how or if the exit signs on the noses are to be relocated to allow the crash cushion to be installed.

1. Mark the exit and entrance gore areas with diagonal chevron bars. Apply this to all exits on the Waikato Expressway for consistency.
2. Indicate where the exit signs are to be relocated behind the installed crash cushions.

Frequency Crashes are likely to be infrequent	Severity Death or serious injury is unlikely	Rating The safety concern is minor
Designer response	<ol style="list-style-type: none"> 1. Chevron markings have been added to the drawings for installation at the exit's. 2. Exit signs will be relocated behind the crash cushion. This will be added to the construction drawing set. 	
Safety Engineer comment	Concur with SAT and Designer.	
Client decision	Agree with SAT, Designer and RSE.	
Action taken	No further action required

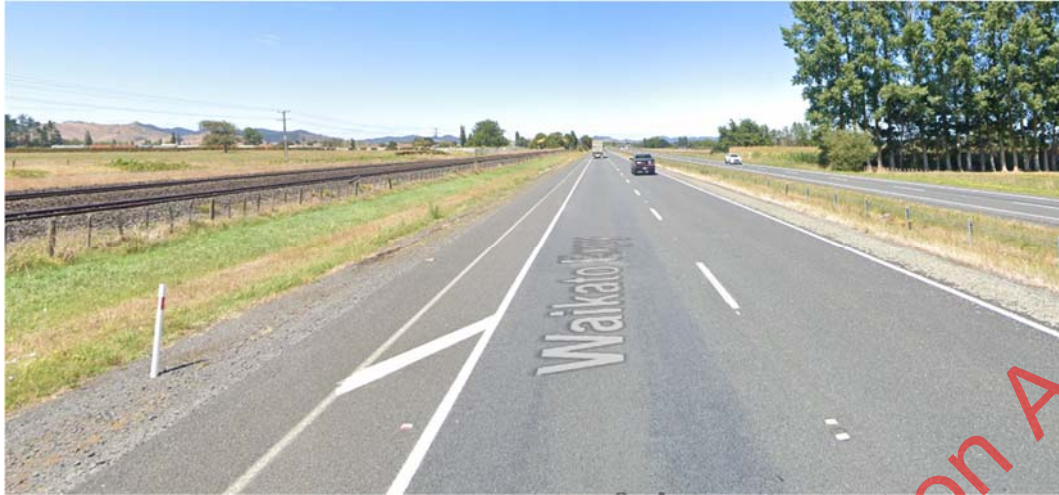
Figure 4: Existing buffer strip Rangiriri to Ohinewai (Google, 2021)

Some sections of the existing Waikato Expressway cater for cyclists in the form of painted buffer strips (e.g. Rangiriri to Ohinewai shown in Figure 4 below) and signed crossing points across exit and entrance ramps, shown in Figure 5 below. The latter is in an existing 110 km/h speed limit zone. Such shoulder buffers and cyclist crossings are not present on the Hampton Downs section or other recently opened sections such as the Huntly Bypass.

Designer response	The Designer agrees that a consistent approach would be beneficial. Cycle markings can be added if required by Waka Kotahi. Similar to the Rangiriri exits.
Safety Engineer comment	Concur with SAT and Designer. Cycle markings to be added similar to the Rangiriri exits.

Client decision	Agree with SAT, Designer and RSE. Cycle markings to be included within scope.
Action taken	Cycle markings have been added to the drawings.

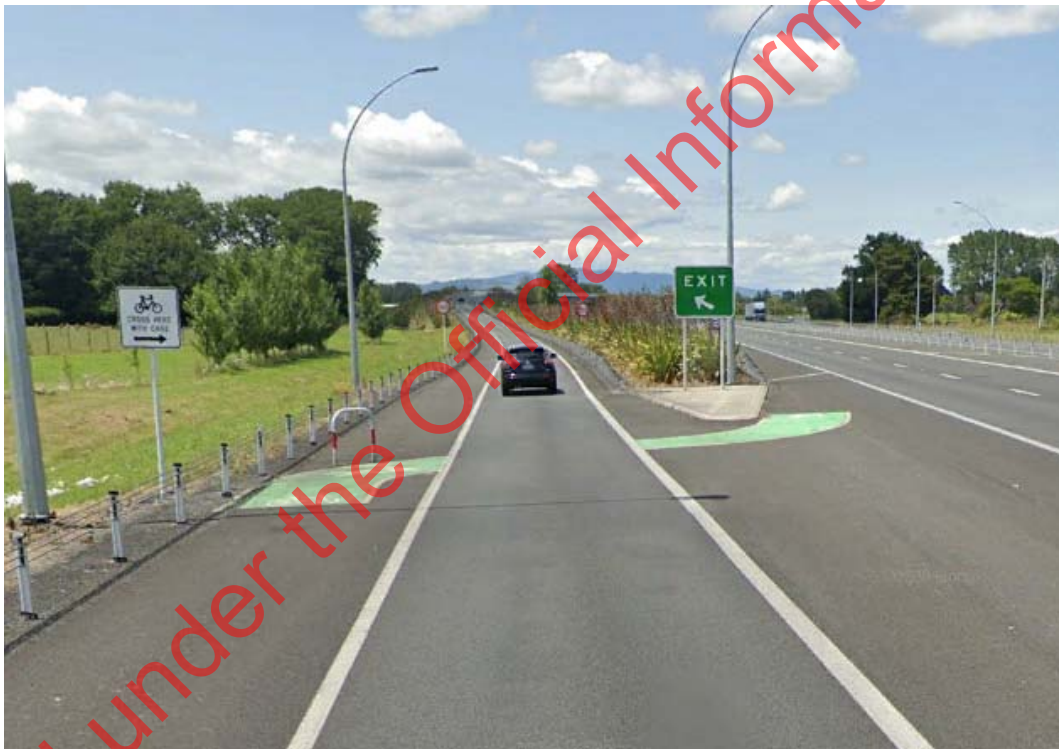
Figure 5: Exit ramp cyclist crossing at Cambridge (west) interchange (Google, 2019)

While the buffer strips and signed crossing points provide no physical protection for cyclists, the signs and markings may remind drivers to be on the lookout for cyclists. The converse *may* also be true—where the signs and markings end or are not present, drivers may think that cyclists are not allowed on the expressway.
