**SH1 WAIKATO EXPRESSWAY –
OHINEWAI**
Post-construction Road Safety Audit

26 May 2022

Prepared for:
Waka Kotahi NZ Transport Agency

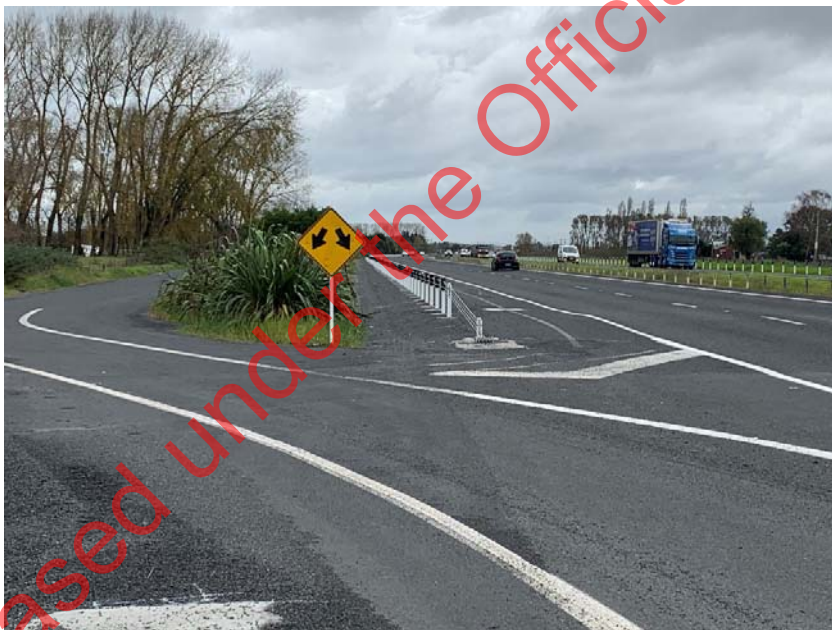
Figure 1: View looking north towards Armitage Road diverge

The current Armitage Road exit arrangement fails to protect an errant vehicle colliding with the heavily vegetated roadside berm (immediately west of the proposed roadside leading end terminal) or beyond through the exit break.

The SAT notes that the Client Decision and Designers action taken noted that an extension of the barrier down Armitage Road in combination with a crash cushion were to be installed. These assets had not been installed at the time of the audit undertaken.

It is also noted that a driver steering right of the PW-5 sign in Figure 1 could be directed into the terminal of the wire rope barrier, which could be difficult to see in poor weather conditions e.g. fog at night.

Designer response	<p>1. The Designer agrees that although this is a lower risk area and a reasonable distance from the carriageway it would improve safety if barrier was to be installed down Armitage Road. A Crash cushion was found to be difficult and costly to install at this location due to the gore geometry and need to transition to wire rope barrier. It would also be prone to costly nuisance strikes due to the gore geometry. The hazards are lower risk frangible - small shrubs or flaxes and very similar to other expressway exits with wire rope barrier and no crash cushions. Therefore, the crash cushion wasn't installed.</p> <p>2. The Designer recommends replacing the PW-5 with an MI-4 'EXIT' sign (TCD Part 10 - MOTSAM Part 3.4, Figure 3.25)</p> <div style="text-align: center;">

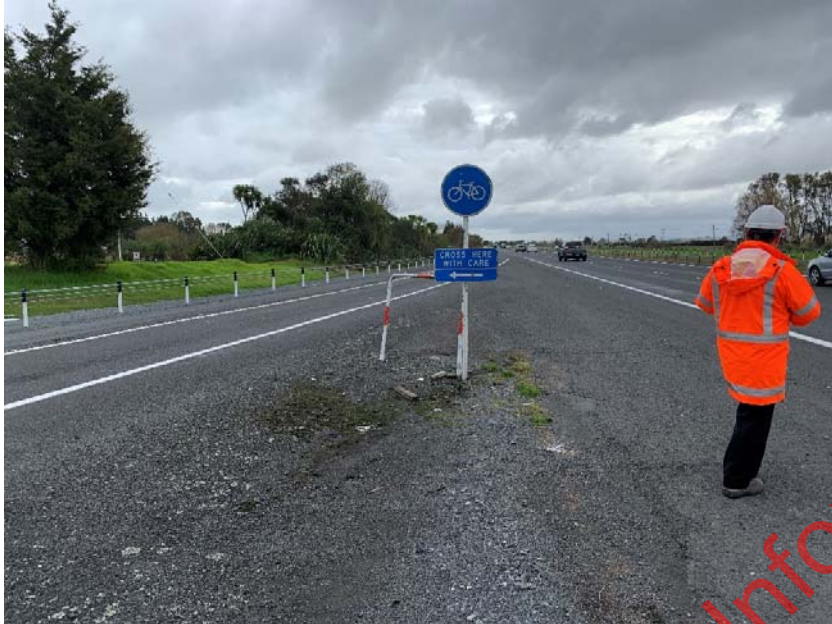
Figure 3: View looking south across Armitage Road On-ramp.

Without specific guidance, cyclists could cross at locations where it is unsafe to do so, or cross the ramp lanes at paths acutely skewed to the ramp lane resulting in longer than necessary exposure to vehicles within the lane.

Note that the pavement marking in Figure 3 is almost non-existent within the roadside sealed shoulder and gore area.

Designer response	<ol style="list-style-type: none"> 1. The Designer agrees cycle markings required remarking. This will be added to the defects list for rectification. 2. The Designer does not recommend cycle hold rails. They present a hazard and would not be well used due to the low number of cyclists and likelihood any cyclists who are on the expressway will be competent enough not to require them.
Client safety engineer comment	
Client decision	
Action taken

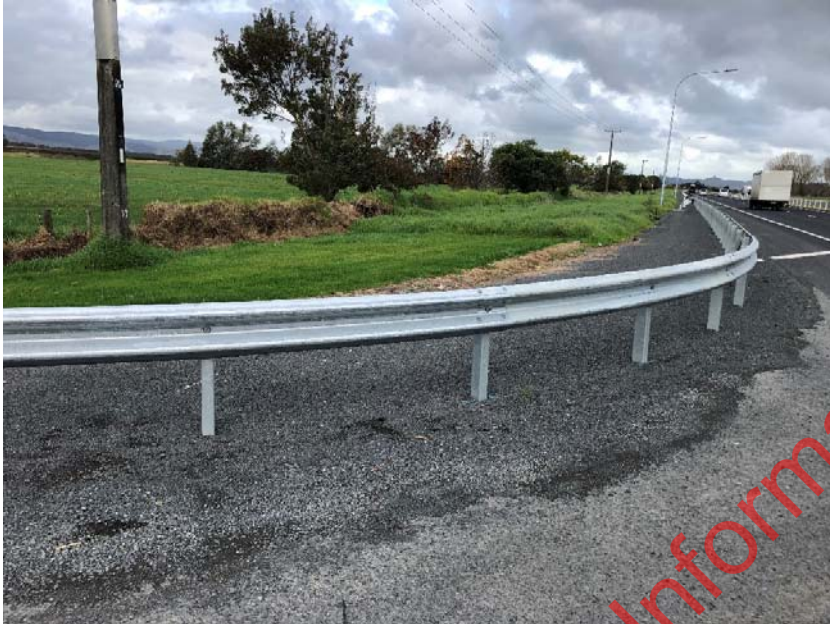
Figure 4: View looking south towards the curved terminal.

Without the shelf system in place the risk increases for an errant vehicle to vault over or penetrate the guardrail; or, in the event that the vehicle is contained by the guardrail, the resulting decelerating forces may exceed the recommended limits for occupant safety.

Note that the w-section barrier in Figure 4 is bolted to each post.

Designer response	<ol style="list-style-type: none"> 1. The Designer agrees the apex post should be on a shelf - this is on the defects list for rectification. 2. The Designer has spoken to the system manufacturer (Ingal). They have no concerns regarding barrier performance with the bottom wire rope height being 680mm and out of tolerance (570mm -10/+30mm) for this short section. 3. The Designer agrees - end terminal delineation has been added to the defects list for inclusion. W20-4 Hazard Markers will be used.
Client safety engineer comment	
Client decision	
Action taken

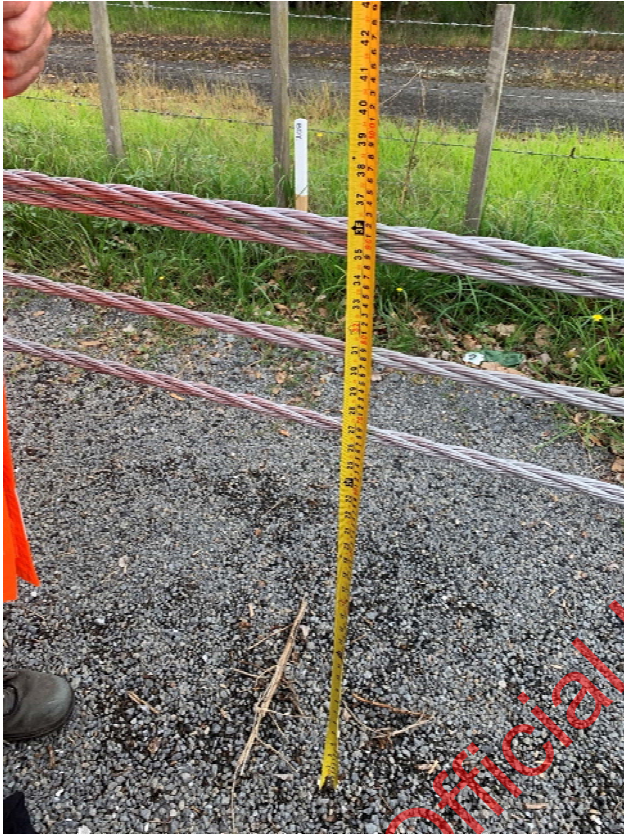
Figure 5: View depicting 680mm clearance under the bottom strand of wire

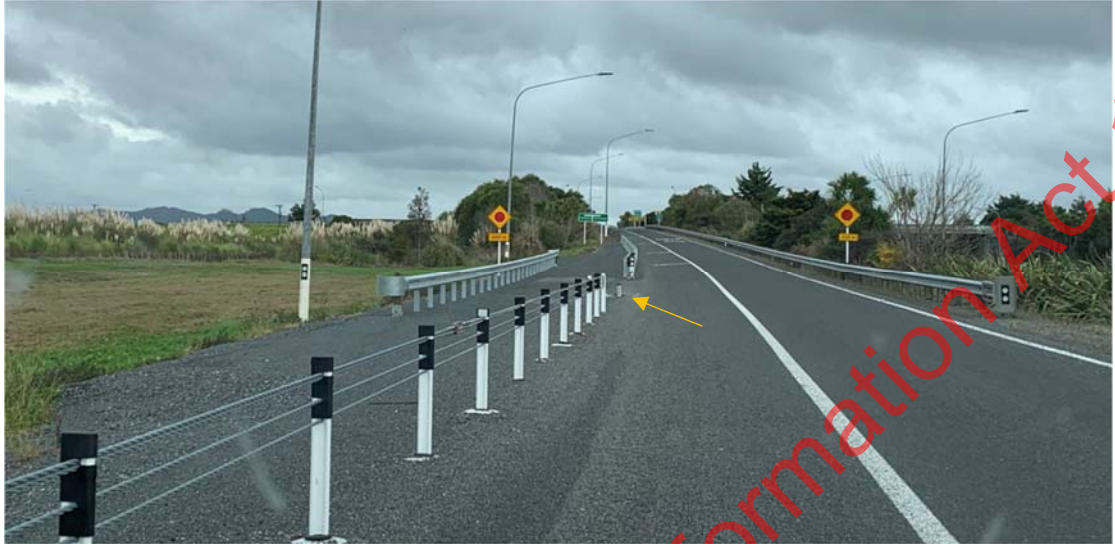
Figure 6: Maintenance bay gap in barrier

There is a risk that vehicles may inadvertently mount the terminal resulting in undercarriage damage or inadvertently pushing them into the adjacent through lane. Figure 6 illustrates how the gap can appear to be between the full height posts and how invisible the short post (yellow arrow) would be when it becomes coated in dirt.

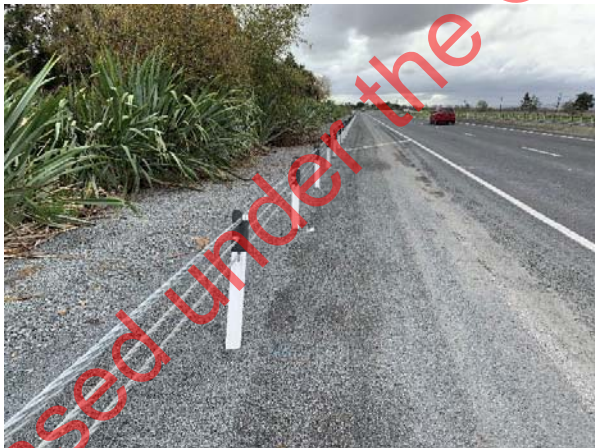
Figure 7: View looking north, north of Armitage Road on-ramp.

There are a number of instances where loose chip and/or rock was sitting on the sealed shoulder. Left in its current state, the loose material may eventually migrate onto the lane and present a loss of traction hazard for vehicles or increase the risk that these items become an airborne missile.

Note excessive sealing chip on sealed shoulder.

- 1 Sweep the shoulders to remove all loose chips and coarse aggregate.

Designer response	The Designer agrees - this is on the defects list to rectify.
Client safety engineer comment	
Client decision	
Action taken

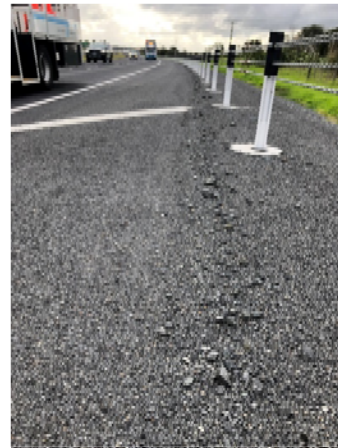
Figure 8: View looking north along the southbound lane, north of Armitage Road on-ramp.

Note the large coarse aggregate on the sealed shoulder.

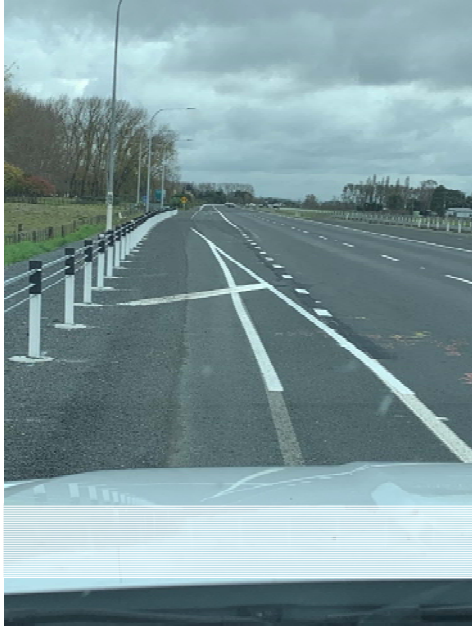
Figure 9: Note pavement marking deficiencies

1. The auxiliary lane prior to Armitage Road appears to be confusing and inconsistent. For example, a portion of the left-hand edge line is missing, and the old cycle lane buffer line has been reinstated in part (noting that the secondary buffer line beyond has not been reinstated for the remainder of the project).

Designer response	<ol style="list-style-type: none"> 1. The Designer agrees - this is on the defects list to be rectified. 2. The Designer agrees consistent and enhanced delineation would improve safety. This was not part of the project scope but could be undertaken by the NOC or by the project if the scope is extended. 3. The Designer agrees the signs are to be reinstated - This has been added to the defects list. Refer to Designers' response to 3.1.2 for cycle hold rails - we don't anticipate they will be well used and recommend leaving them out.
Client safety engineer comment	
Client decision	
Action taken

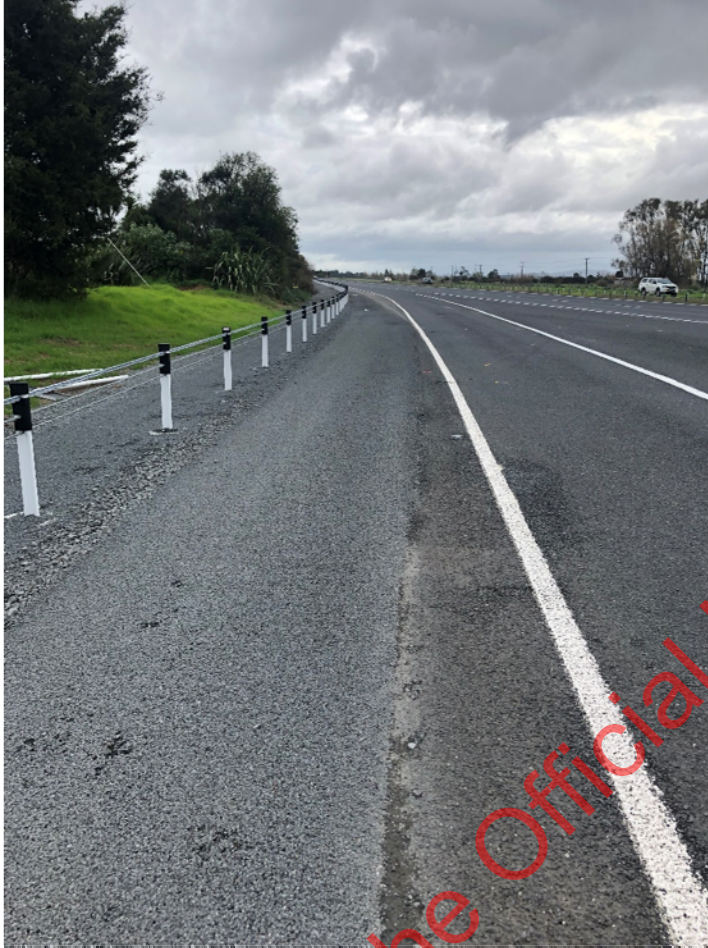
Figure 10: “Expressway” sign lying on the roadside berm

In Figure 10 the expressway sign is lying behind the barrier near the Armitage Road on-ramp.

- 3 Erect missing signs and hold rails, as necessary.
