# Detailed Design Report

<b>Project :</b>	Edgware Road (RD and SW)
<b>SCIRT Number :</b>	10944
<b>Document Number :</b>	10944-DE-GE-RP-0001
<b>Design Team :</b>	Blue
<b>Revision :</b>	1
<b>Date :</b>	29/11/2012

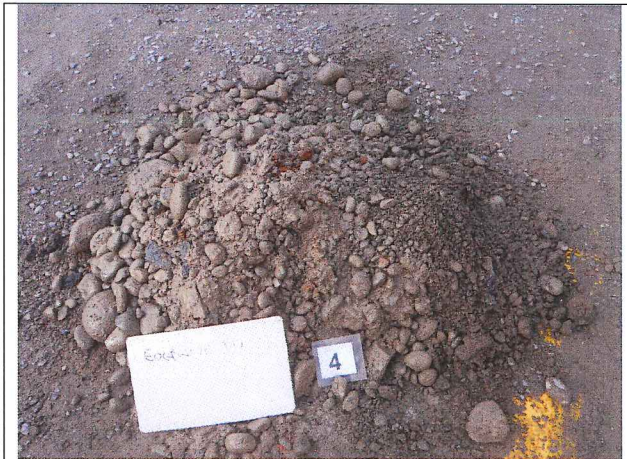
Borehole 4: Construction

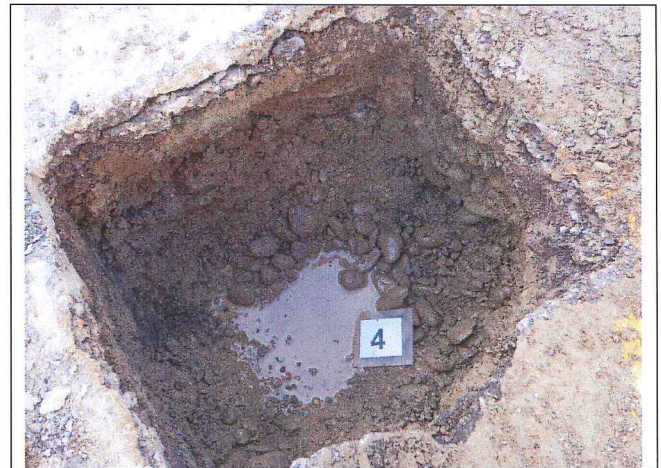
Borehole 4: Borehole

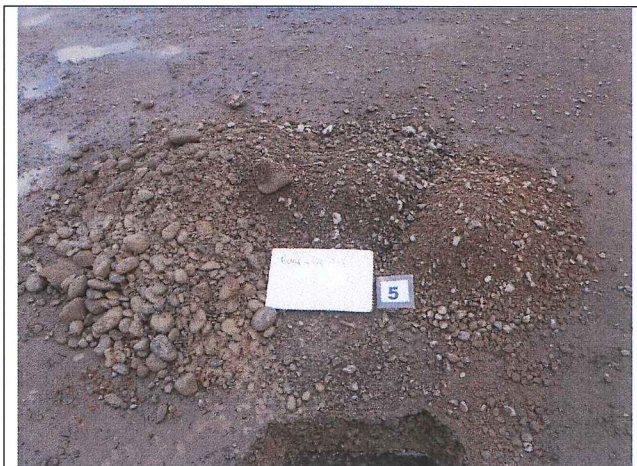
Borehole 5: Construction

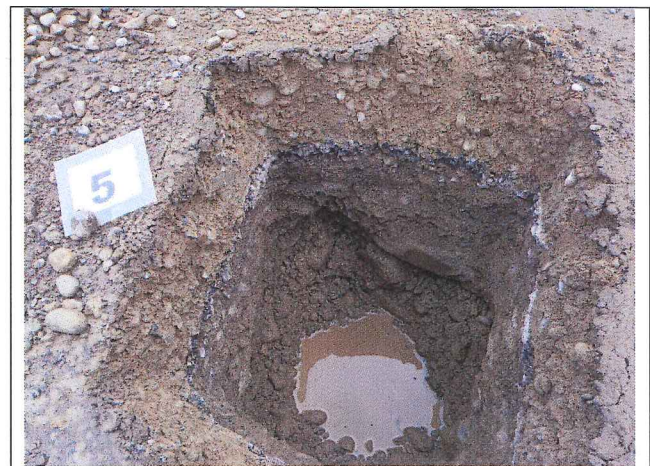
Borehole 5: Borehole

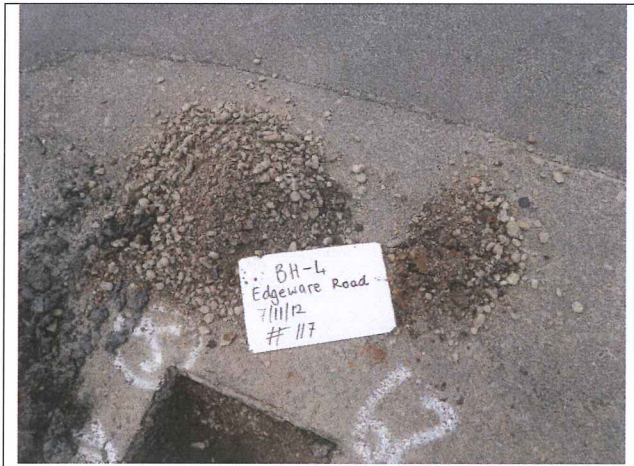
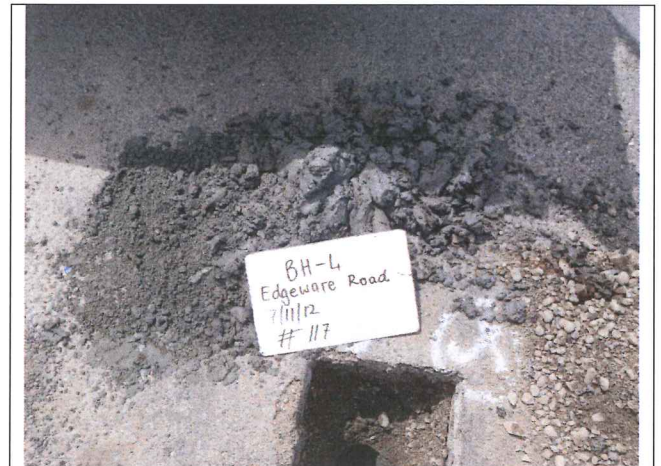
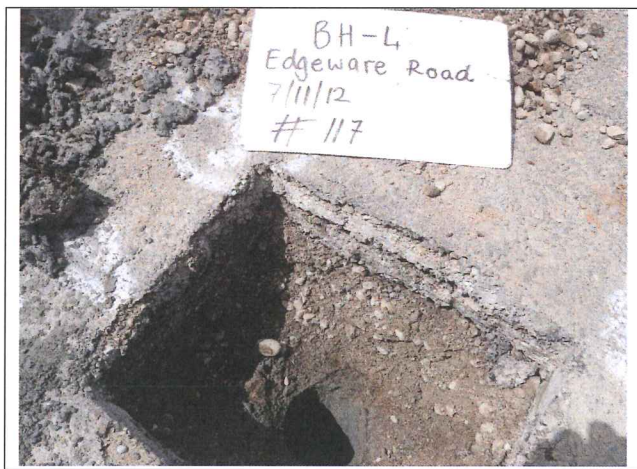
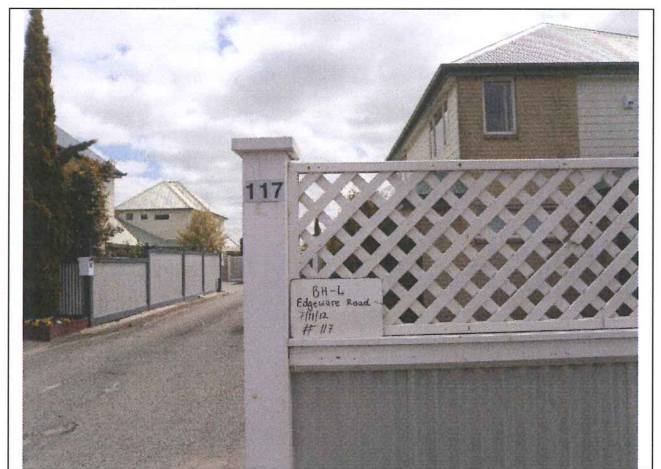
# 117 Edgware Road

Depth of Layer (mm)	Moisture Content (%)	Sand Content (%)	Silt Content (%)	Clay Content (%)	Classification / Description
0-20					Chipseal
20-200					Construction (AP40)
200-520					Construction (Pit Run)
					Water table at 460mm

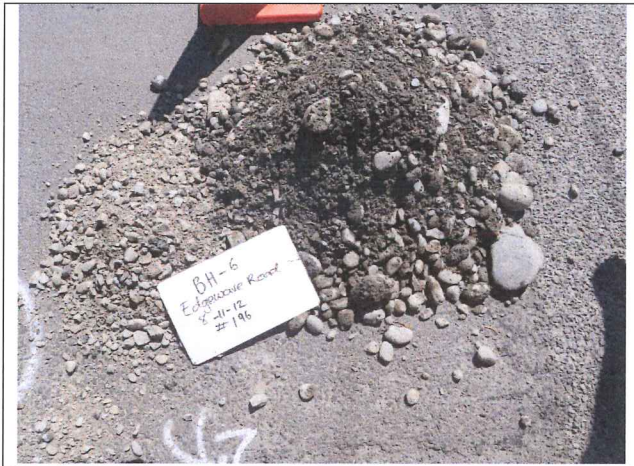
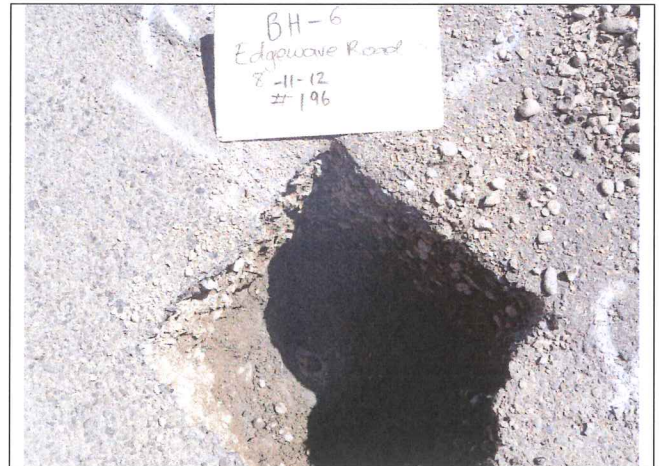
# 196 Edgware Road

Depth of Layer (mm)	Moisture Content (%)	Sand Content (%)	Silt Content (%)	Clay Content (%)	Classification / Description
0-30					Chipseal
30-150					Construction (AP40)
150-530					Construction (Pit Run)
					Water table at 420mm

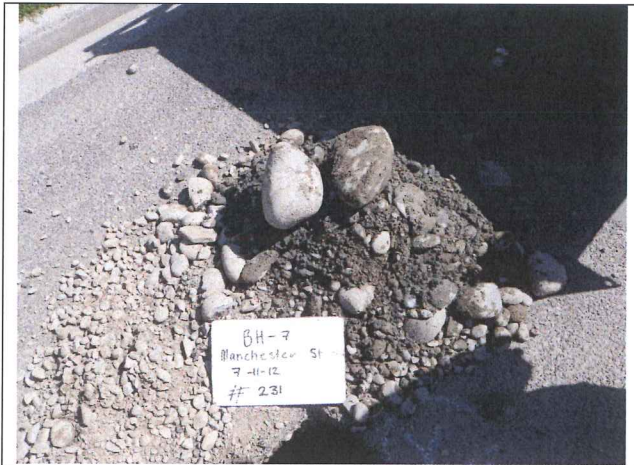
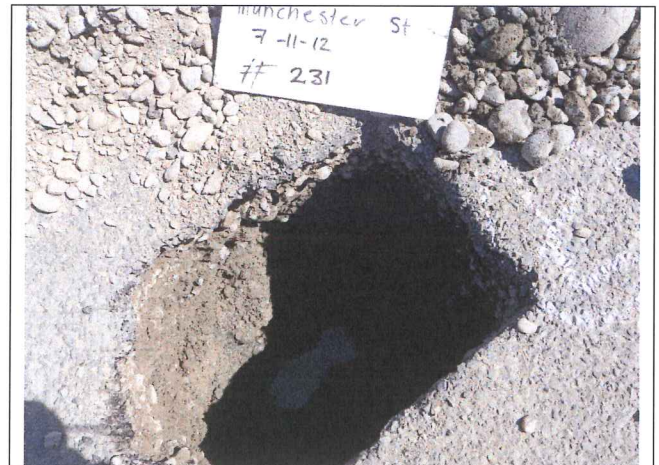
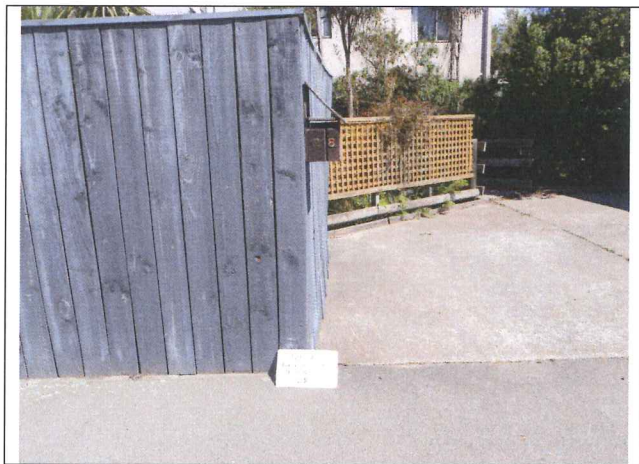
# 218 Edgware Road

Depth of Layer (mm)	Moisture Content (%)	Sand Content (%)	Silt Content (%)	Clay Content (%)	Classification / Description
0-30					Chipseal
30-160					Construction (AP40)
160-740					Construction (Pit Run)
					Water table found at 430mm

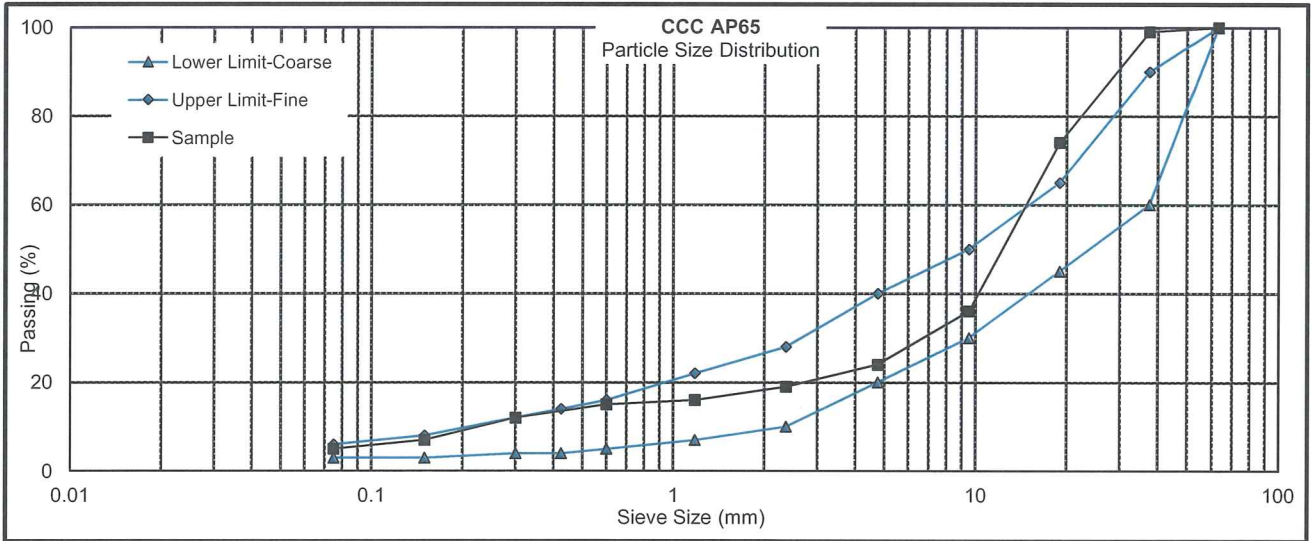
Clay Index	
Sample CI	-
Specification	<= 3

Sand Equivalent (Air Dried, Mechanical Shaking)	
Sample SE	-
Specified	>= 40

Test Methods	
Particle Size Distribution	NZS 4407 : 1991 : Test 3.8.1
Broken Faces Content of Aggregate	NZS 4407 : 1991 : Test 3.14

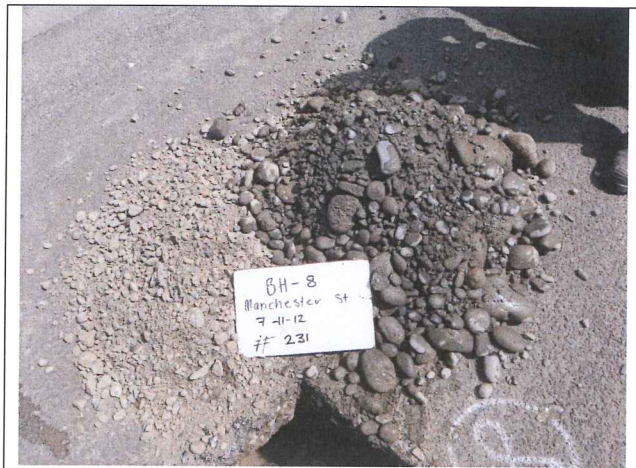
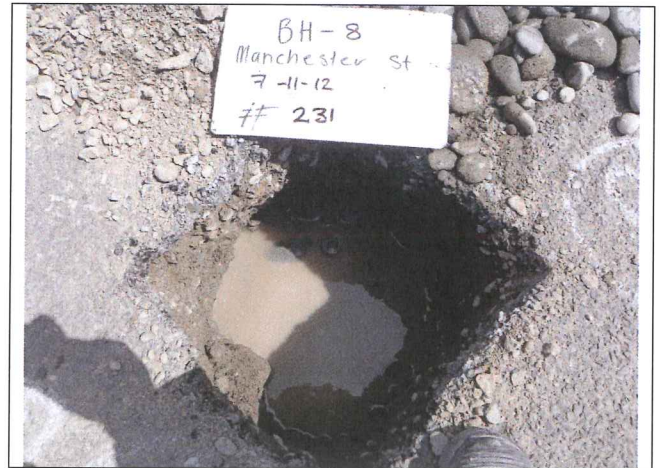
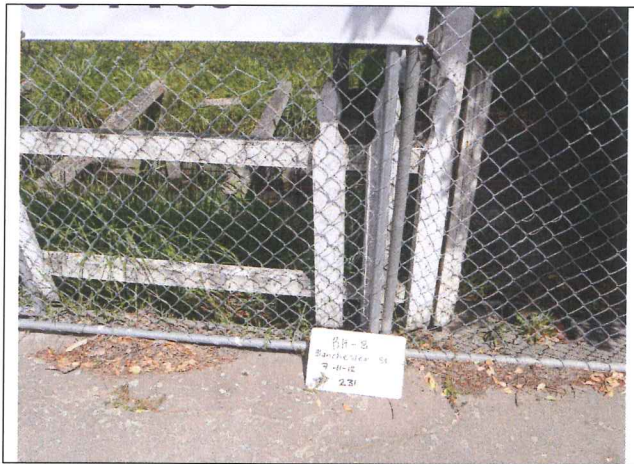
# 230 Edgware Road

Depth of Layer (mm)	Moisture Content (%)	Sand Content (%)	Silt Content (%)	Clay Content (%)	Classification / Description
0-40					Chipseal
40-170					Construction (AP40)
170-570					Construction (Pit Run)
570-1000	27	96	4	0	Sand
Water table found at 1000mm

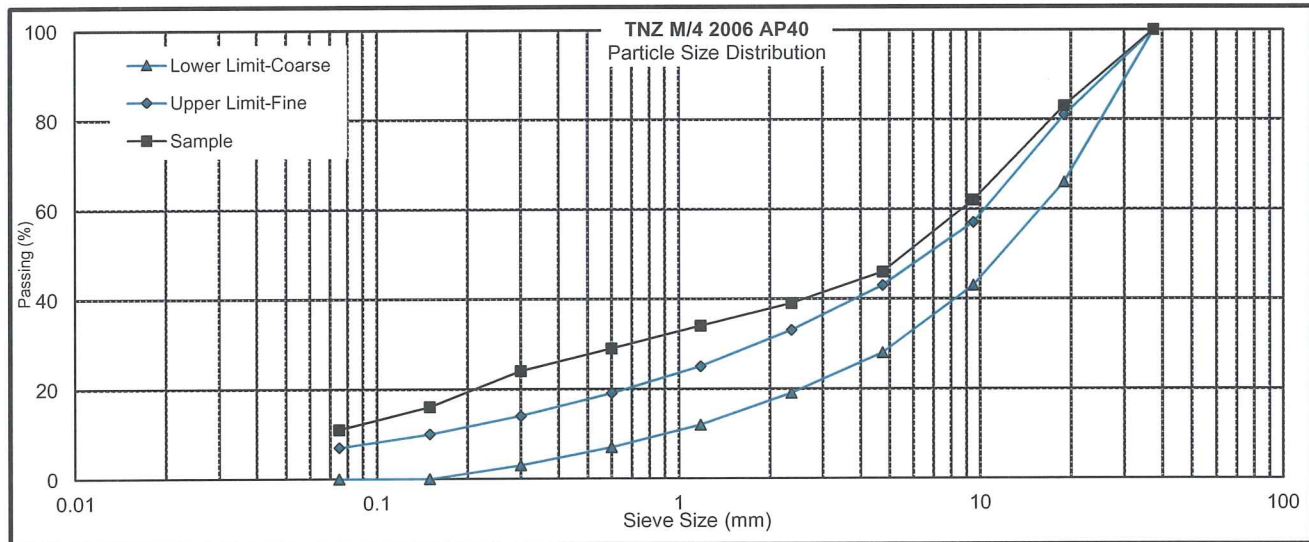
Clay Index	
Sample CI	-
Specification	<= 3

Sand Equivalent (Air Dried, Mechanical Shaking)	
Sample SE	-
Specified	>= 40

Test Methods	
Particle Size Distribution	NZS 4407 : 1991 : Test 3.8.1
Broken Faces Content of Aggregate	NZS 4407 : 1991 : Test 3.14
