Northland Rail Upgrade Detailed Design Report

Tunnel 7- Ross Hill

REFERENCE: V-581-07
PREPARED FOR: KiwiRail Holdings Ltd
REVISION: 0.1
DATE: 4 May 2020

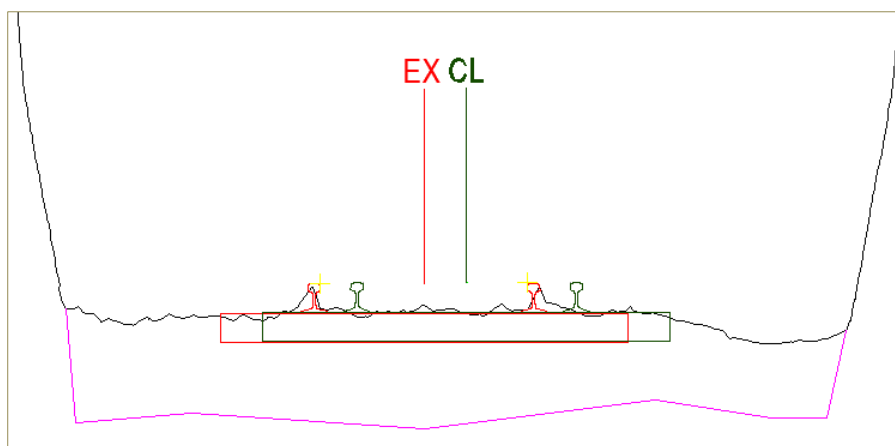
Figure 5: CH 135.464KM profile of tunnel floor relative to existing and design rail levels

The findings from the invert trenches have been transferred onto the Vitruvius design drawings and used to inform the proposed tunnel drainage solution. A typical tunnel profile including bedrock tunnel floor is shown in the figure below.

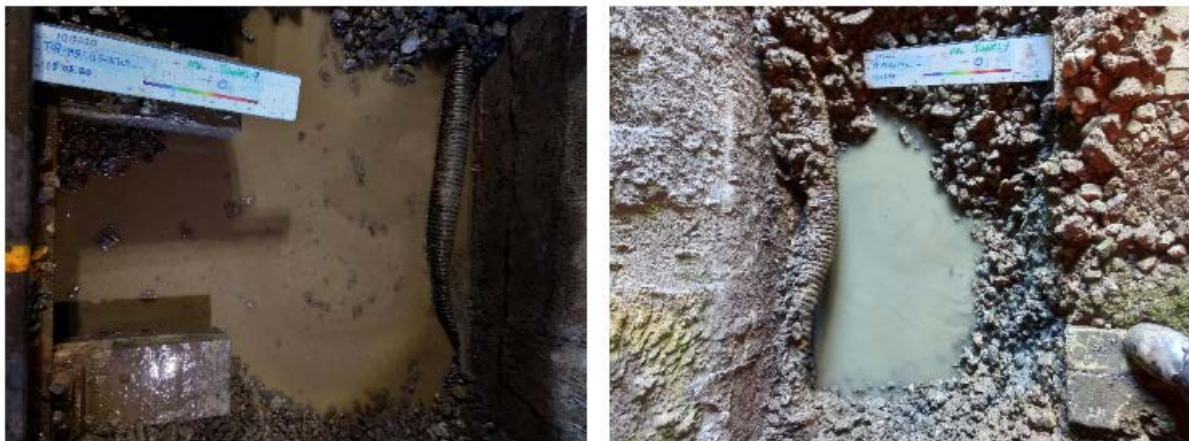
Figure 6: Photos of IT09-RHS (left) and TP01-LHS (right)

The test pit sketches and photos show the groundwater table to be within the bottom ballast layer, and that the excavations generally filled with water quickly. There was no information provided with regards to the source of the water, however it is noted that the investigations were undertaken in summer and during a particularly dry weather season, which would imply the water is from either weeping through the tunnel lining or groundwater.

The presence of a perforated subsoil drains was evident from the photos appended to the report, although these do not appear to have been included in the sketch records. From the level of the pipe relative to the ballast layer and groundwater level observed in the photos, this drainage system appears largely ineffective for ensuring a dry bottom ballast layer. The photos also show high levels of ballast contamination with fines which will have a negative effect on the track performance.

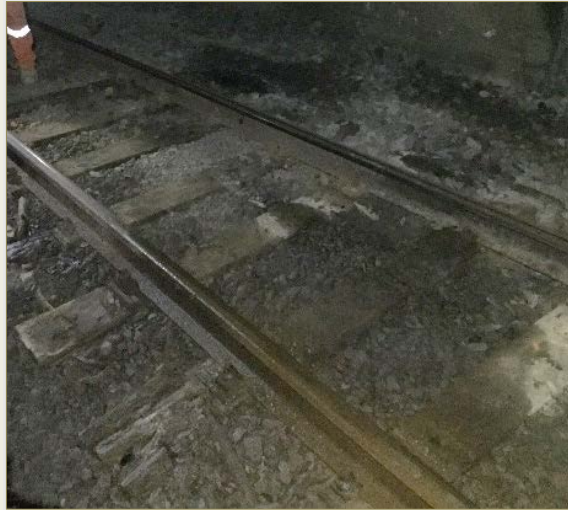
Ballast is heavily contaminated throughout with clay, with the slotted pipe protruding from the ballast in several locations (this may have been as a result of the trial pits undertaken for the NRU project).

Sleepers are damaged in such a way that indicated a derailment had occurred in the tunnel at some time. This observation was also made within the T+T Investigation report for Tunnel 7.

Track componentry was confirmed to correspond with corridor log records.

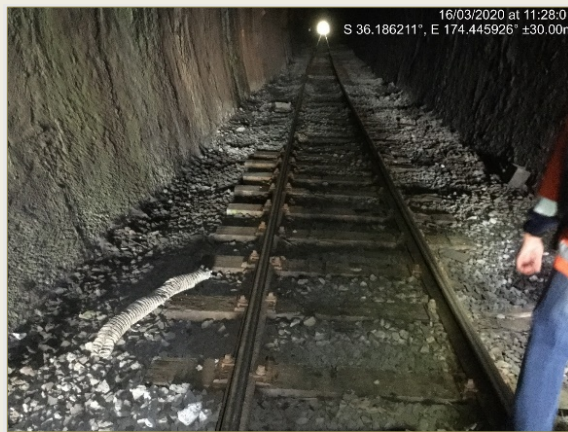
The surface of the tunnel was found to be generally uniform but in a small number of locations water was observed to be dripping from the roof of the tunnel onto the track below. These were not causing any serious concerns to the track, however they should be observed during the winter periods of high water pressure to determine if weep drains are required as per the KiwiRail standard for water ingress in tunnels.

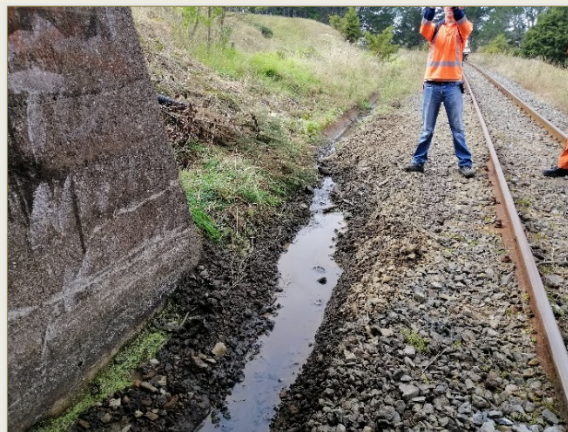
To the southeast, a small open surface drainage channel has been dug from the mouth of the tunnel to feed into a half pipe steel drainage carrier channel.

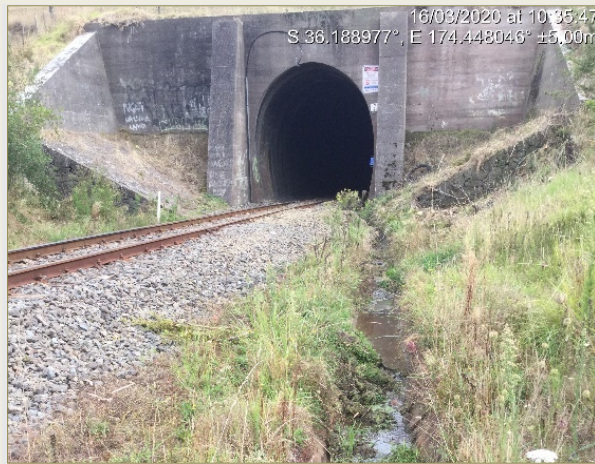
The steel channel, acting as a cess carrier drain, is flowing and appears to have had some recent maintenance.

Silt debris and vegetation remains and further maintenance is required to provide a clear channel and pathway from the tunnel.

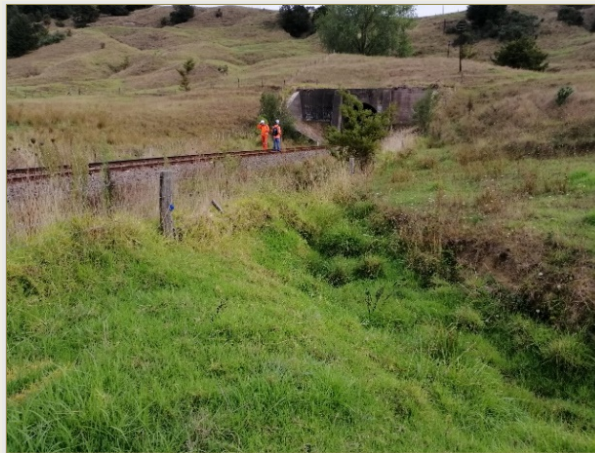
The steel channel leads away from the tunnel and track corridor to feed into a farm channel in the adjacent land.

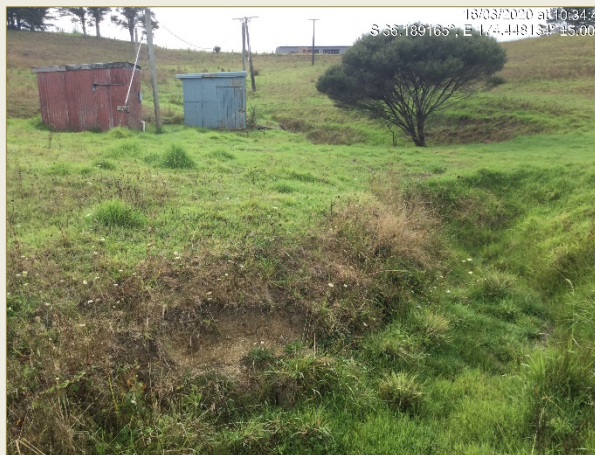
No outlet from this outfall or farm channel was visible. It is believed that the stormwater runoff from tunnel and cess drain is/has ponded here, draining down to the subsoil and crossing the railway to the west below ground. The inlet of the existing culvert (135.398km) is located in a hollow which is not connected with the farm channel.

Therefore, the drainage system requires further investigation and analysis before it can be determined functional and adequate to meet the winter, high rainfall periods.

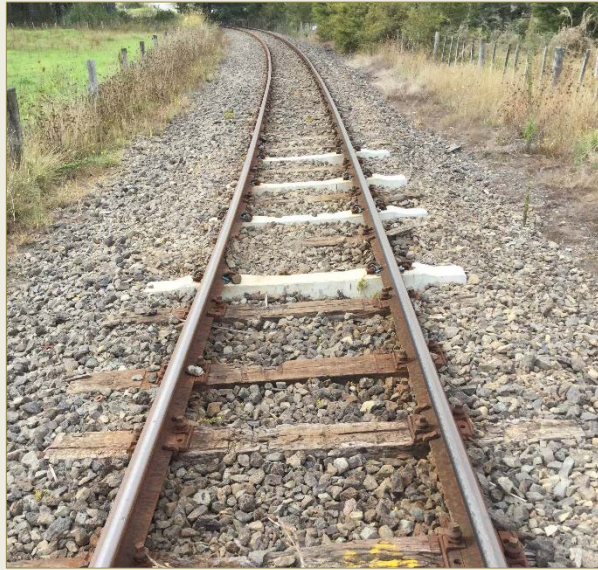
The ponding area in the eastern farm channel may be undermining the existing formation as evidence of track instability and sleeper replacement has been identified.

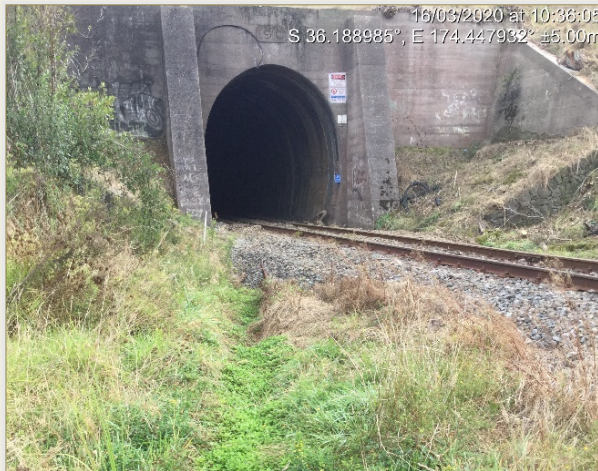
To the southwest, a small drainage channel has been dug from the mouth of the tunnel to feed into a half pipe steel drainage channel.

The steel channel leads away from the tunnel and track alignment to feed in a farm channel in the adjacent land.

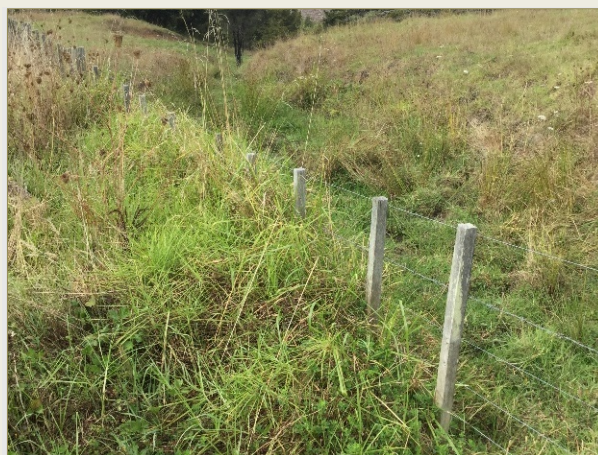
As the steel channel exits KiwiRail property, it enters a large farm channel and continues towards the southwest. From here it enters a hollow which appears to be an outlet to the culvert located at 135.398km.

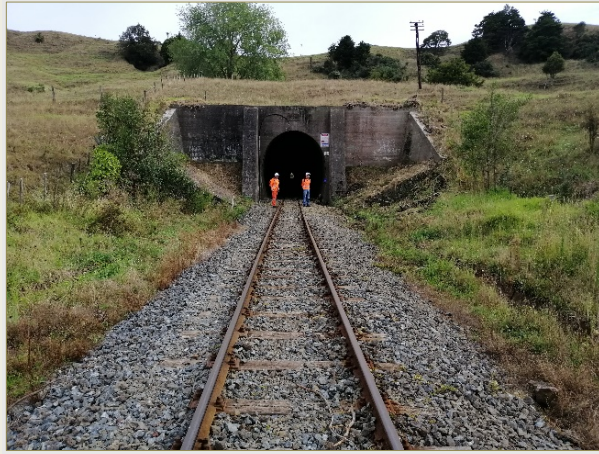
The south approach to the tunnel has been buttressed and reinforced to prevent damage to the portal wingwalls. These are not showing any signs of stress and are constructed in such a manner to allow free drainage.

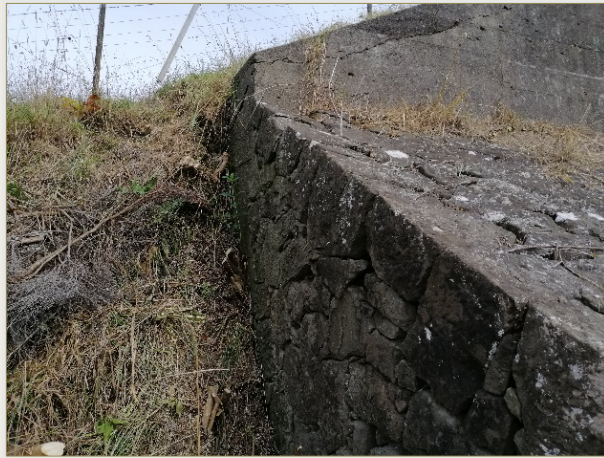
The joints of the blockwork are free draining, preventing a build up of ground water. There is no indication whether these were installed during construction of the tunnel.

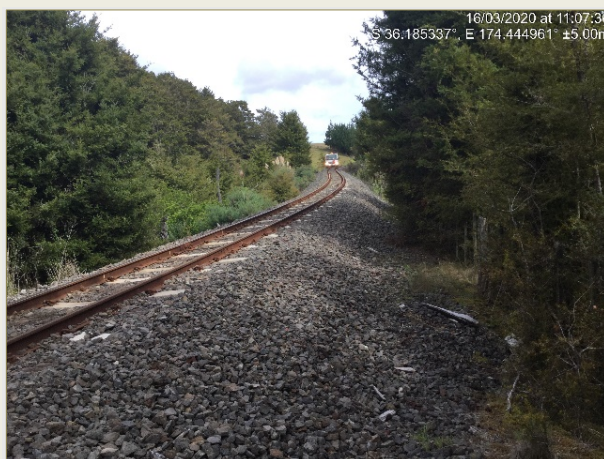
The North Portal is approached on a large embankment, with a large culvert (2258671) identified at 135.948 km and approximately 10 metres below the track.

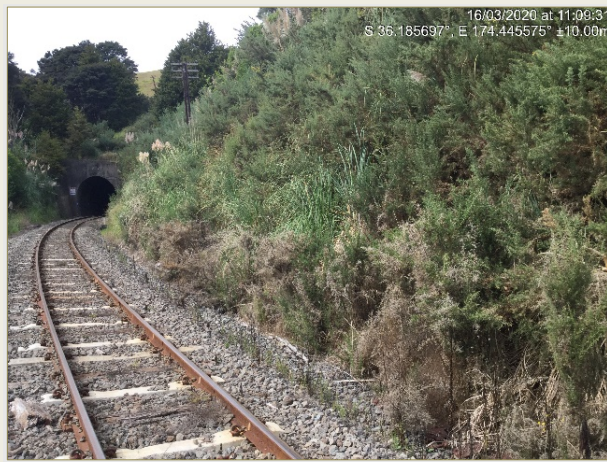
On the approach to the tunnel, the track enters a short section of cutting to the North West and embankment to the North East. The vegetation to the North West appears to reflect that the slope is damp, and water is present in the cess. However, there is little evidence of any comprehensive drainage configuration to retain or upgrade.

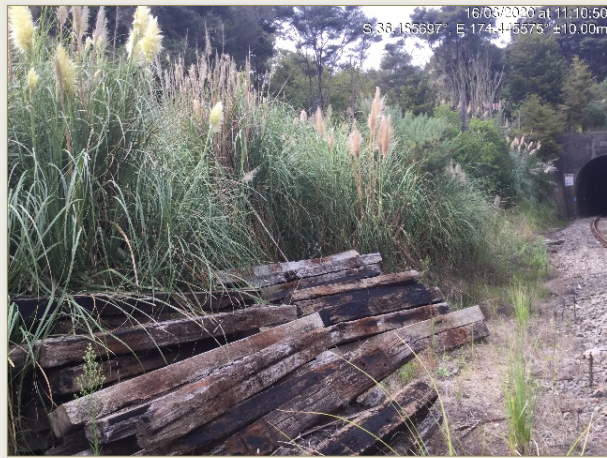
To the North East of the tunnel, the slope is gradual and covered in vegetation that thrives in damp areas. This area should be cleared back and maintained appropriately to ensure the track is free draining.

There is evidence on site of sleeper refurbishment, which has required the replacement of approximately 1 in 3 of the TPR sleepers with concrete.

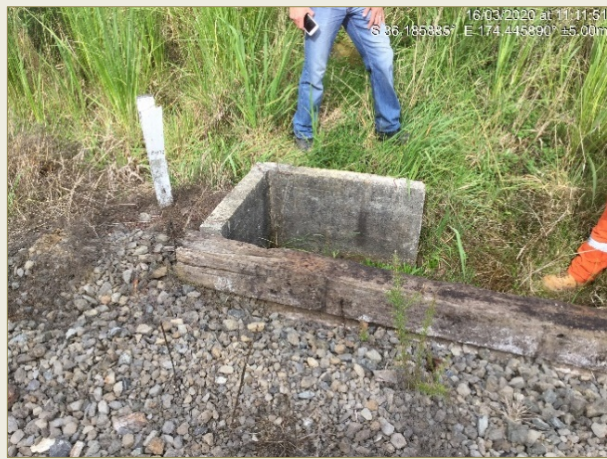
At 135.832, approximately 30m north of the tunnel a culvert has been located transporting water from the northwest face to the northeast face. The culvert was open on the North West side.

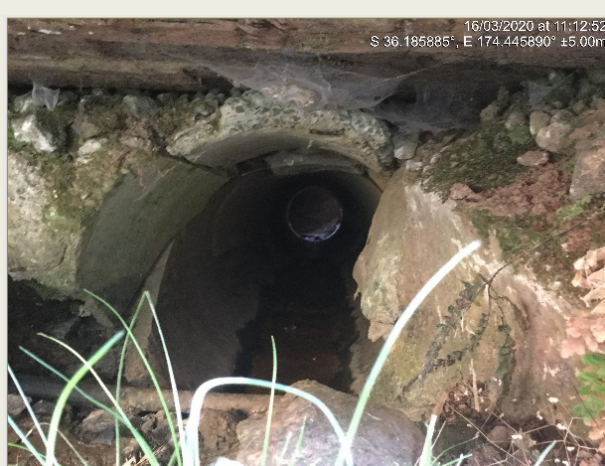
The invert of the culvert was estimated to sit approximately 1200mm below rail level and, although cracked, the pipe was clear and free draining.

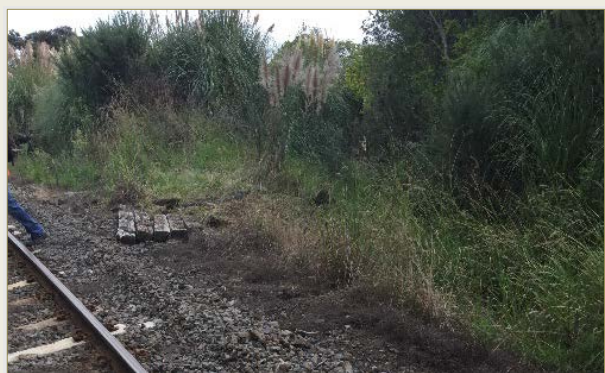
The outfall from the culvert had been covered in redundant timber sleepers to the North East. It was found to consist of a 500mm concrete pipe in a poor condition.

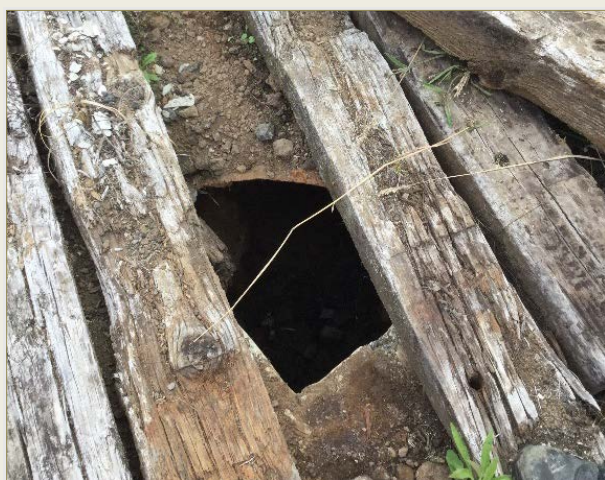
The culvert appeared to outfall into a large steel pipe toward the embankment to the North East. The outfall from the steel pipe was unable to be detected due to vegetation and a large drop at the fence line.

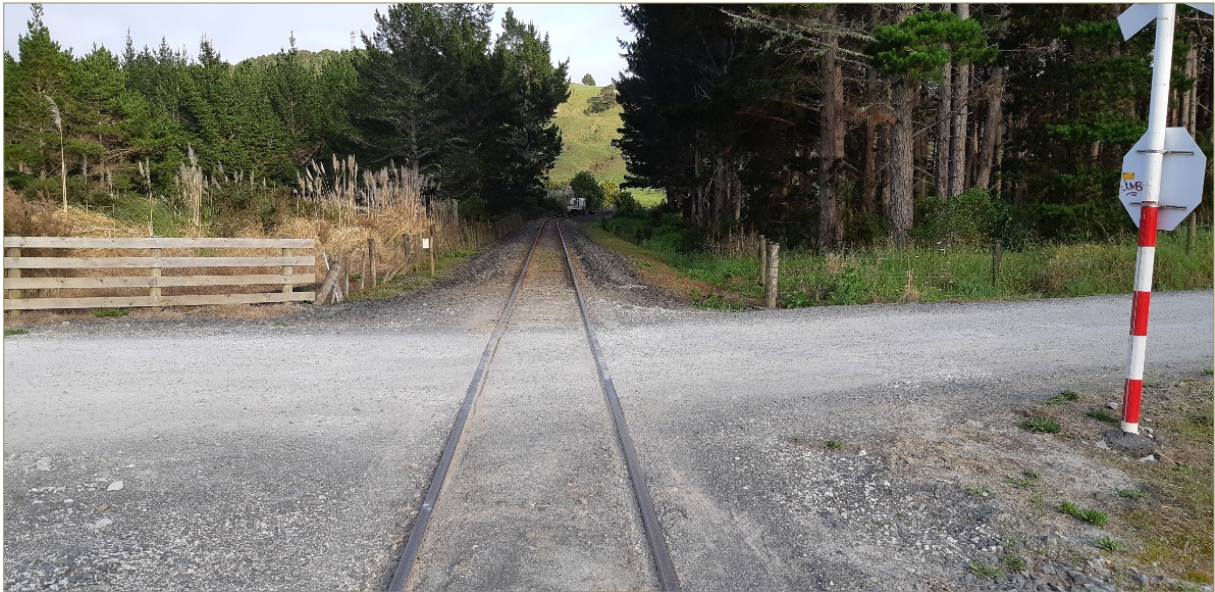
Figure 8: Level Crossing 135.150km

There is an existing level crossing located at 153.150km which was used to on-track for the site visit. The level crossing is not within the scope of the NRU upgrade project, and the realignment design extents terminate at the level crossing. It is recommended that mitigation measures are put in place during construction to ensure the rail is not damaged if this location is to be used for on and off-tracking.

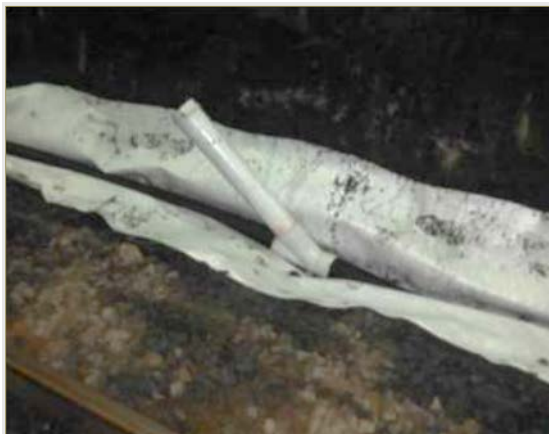
Figure 13: Example Rodding eye connection within a tunnel (Source KiwiRail C-ST-CD-4102)

The proposed design is like that shown in KiwiRail Design Standard C-ST-CD-4102 (Figure 15 below) from Caversham Tunnel on the MSL, however the wye junction will be rotated 45 degree so that it protrudes laterally towards the rodding point (i.e. refuge). If there are no refuges within 200m of the adjacent rodding location, then they shall be located on the outside of the track at the foot of the tunnel. These shall be clearly located on the tunnel lining for easy identification and accessing the future. They should not protrude above the ballast shoulder level as they could pose a trip hazard to staff or contractors walking through the tunnel.

The assumption is that tampers operate within 300mm of the running edge, leaving the central 468mm safe from damage. The end cap and access are will be maintained below the surface of the sleeper thus reducing the likelihood of damage via other activities including ballast brushes and the handling of materials.

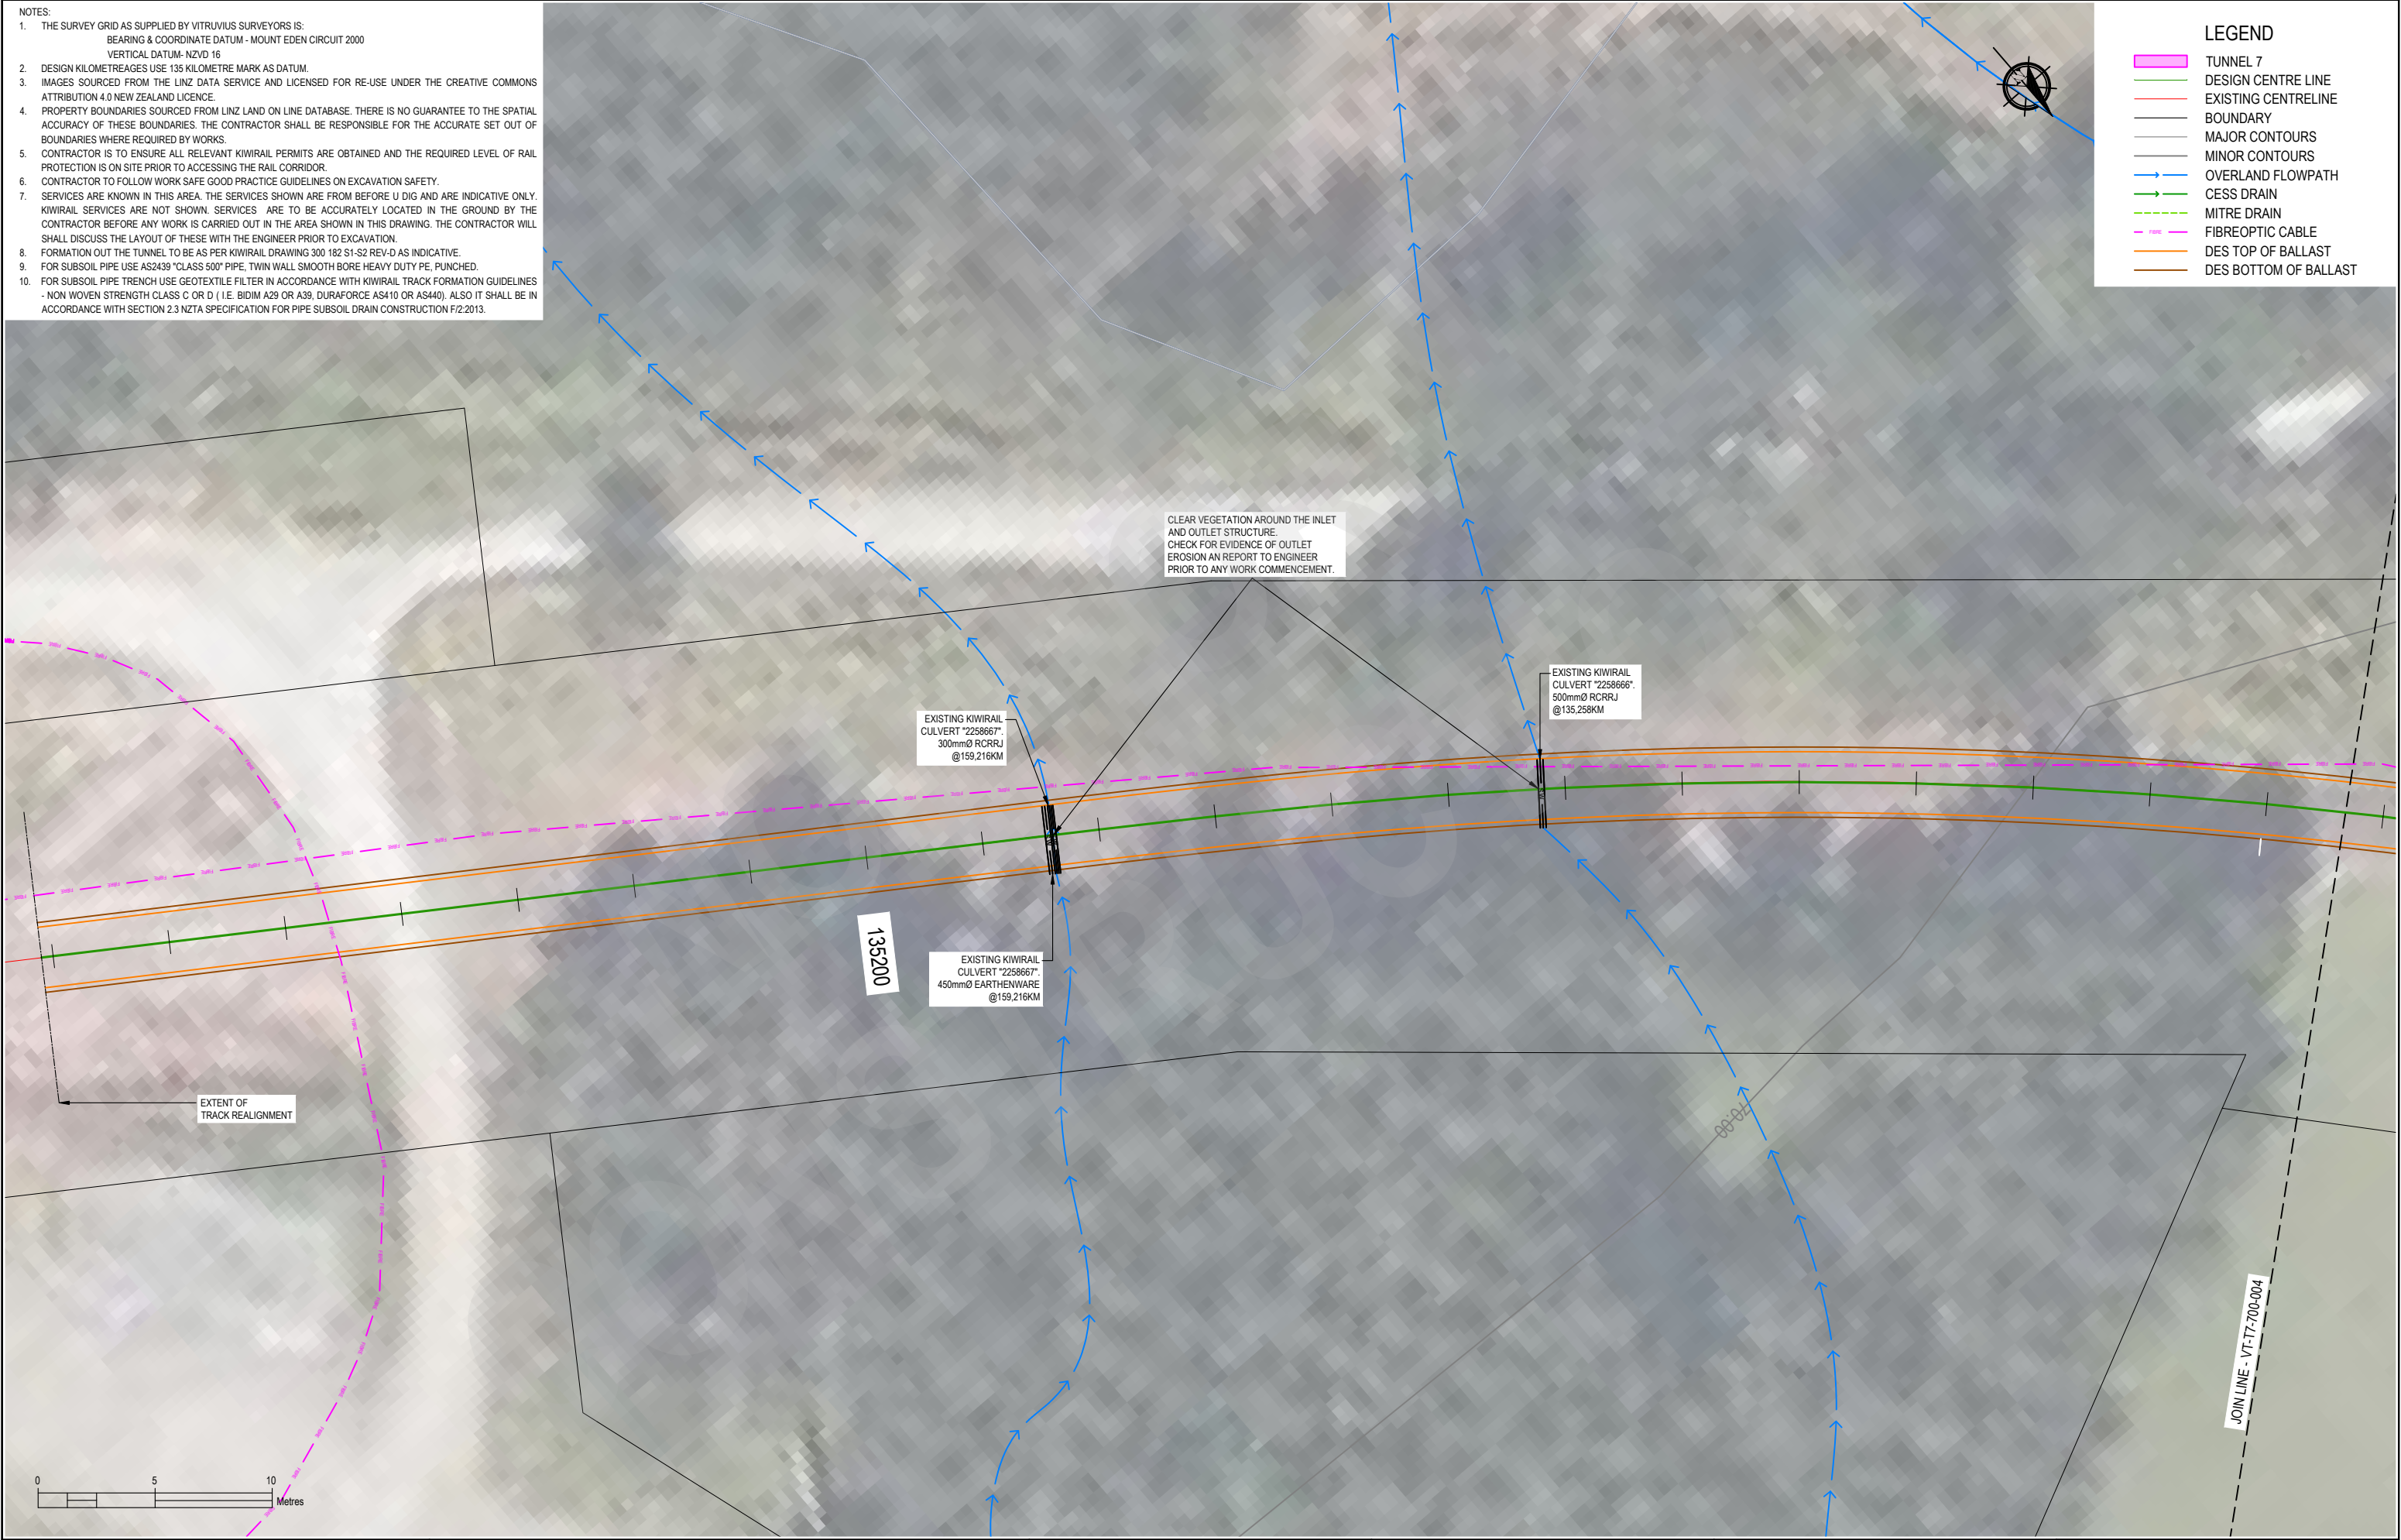
CLEAR VEGETATION AROUND THE INLET AND OUTLET STRUCTURE. CHECK FOR EVIDENCE OF OUTLET EROSION AN REPORT TO ENGINEER PRIOR TO ANY WORK COMMENCEMENT.

EXISTING KIWRIL CULVERT "2258667", 300mmØ RCRRJ @159,216KM

The south portal of the tunnel is the downhill so represents the outfall for the tunnel drainage. A culvert had been registered in Maximo as a potential outfall for the tunnel centre drain and its conditions were checked on site.
