# Traffic Crash Report - External Copy

CARD Event #:	P049501216	DOCLOC #:	220202/6922
Occurrence ID #:	156861954827	Occurred Date/Time:	01/02/2022 13:58
Location Description:	SH 26, EUREKA, WAIKATO DISTRICT 3286		
Location Type:	Point Of Impact	Side Road or Feature:	
GPS Coordinates:	-37.752445, 175.414505		
Reported By:	BCIH46

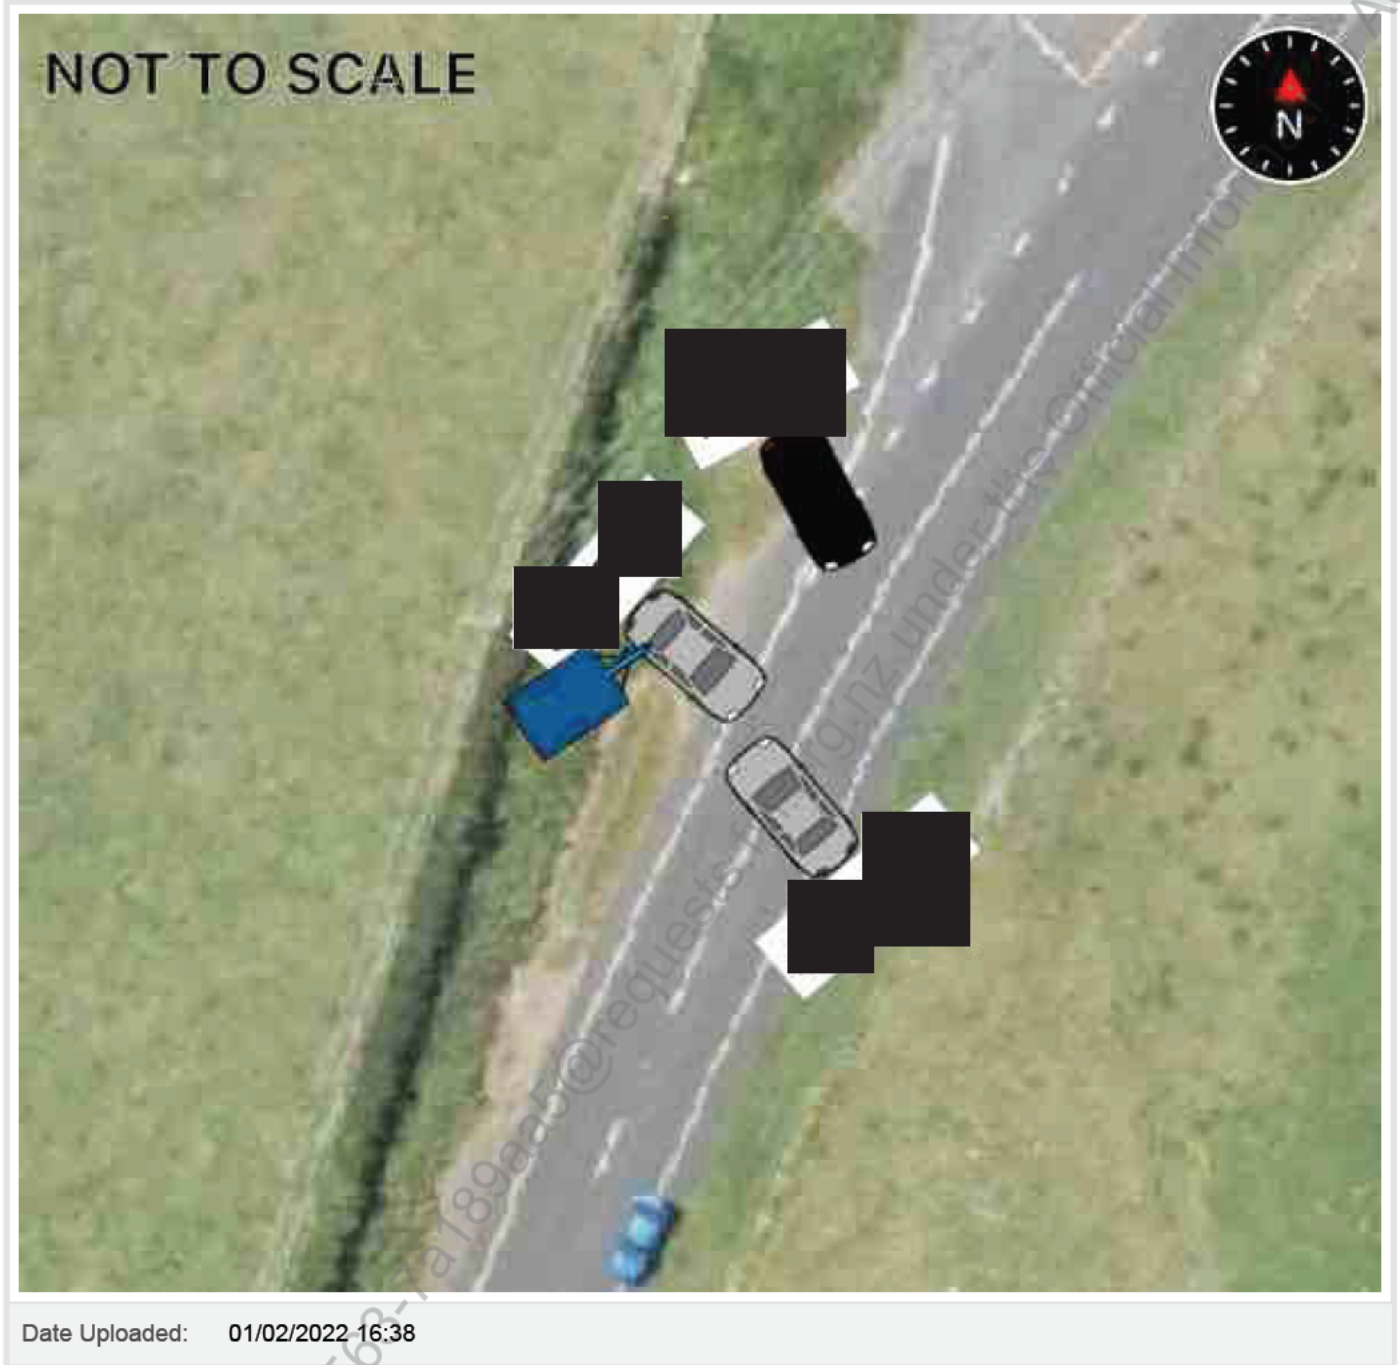
## Crash Diagram

Officer Notes:	Southbound Mitsubishi Pajero [REDACTED] has travelled along a straight section of road before crossing the centreline entering a slight left hand bend. At the same time a Northbound Toyota Soarer [REDACTED] approached the curve. An offset head on crash has occurred in the northbound lane forcing the Toyota to rotate to rest into the intersection of Hinton Road. The Mitsubishi continued and a second head on crash has occurred with a Ford Ranger [REDACTED] towing a jetski that was following the Toyota. The Mitsubishi has rotated and flipped onto its passenger side. The single occupant was able to self extricate before the Mitsubishi caught fire. The driver and rear right passenger in the Toyota died of their injuries at the scene. The male passenger received moderate injuries. The driver of the Ford received moderate injuries. The driver of the Mitsubishi received moderate injuries.
