From: Richard Griffiths <richardg@nrc.govt.nz>
Sent: Tuesday, 15 October 2024 5:52 pm
To: Colin Dall <colind@nrc.govt.nz>
Subject: RE: Aluminium monitoring/ testing

Internal series report on the causes of fish kill in the Aka Aka-Otaua area

As a result of a significant fish kill event in July 2020 in the Aka Aka-Otaua drainage area, a detailed assessment of the potential causes of this event and previous similar events has been prepared with some recommendations for further investigation and management.

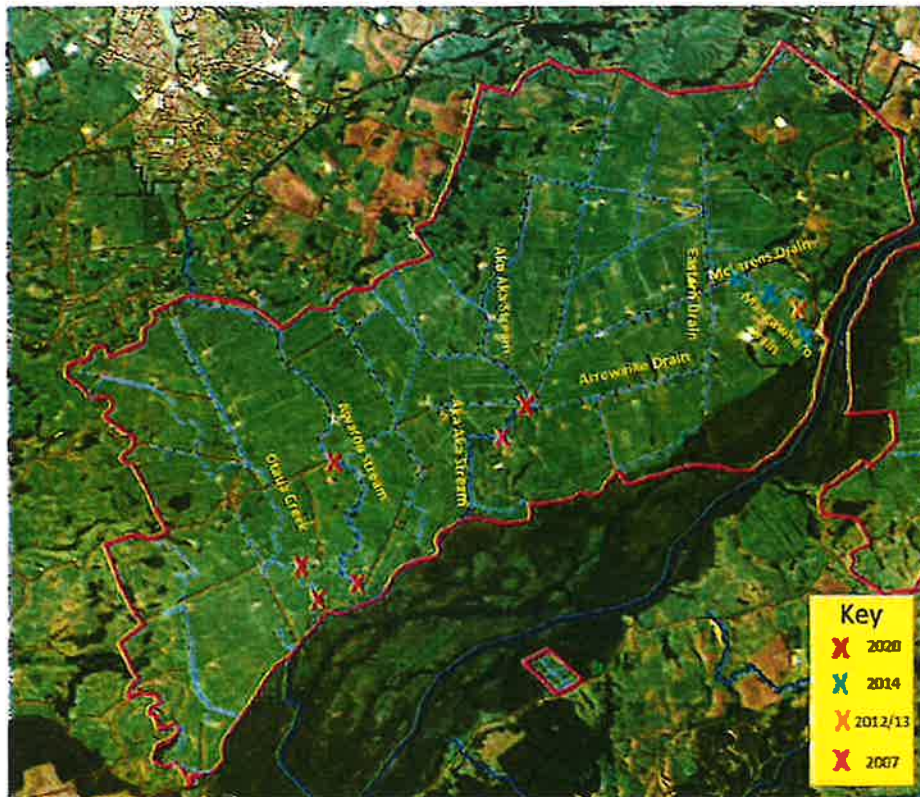
Figure 1 - Fish kill areas identified within the Aka Aka Otatau drainage area over the period 2007 to 2020.

Dead fish were observed at five out of the eight sites visited, with the majority of dead fish found at 89 Crouch Rd on the Awaroa Stream (refer to Figure 1). This was likely due to these catchments being tidally influenced and recent rain events increasing flow throughout the catchments, causing fish to either be pulled out into the mainstem of the Waikato River or washed up on the stream banks. Fish at the Awaroa Stream were observed to have varying levels of decomposition, suggesting that this occurrence has been happening over an extended period of time. There were goldfish found still alive with mouths gaping, stuck on top of a macrophyte bed indicating significant stress (Williams, 2020).

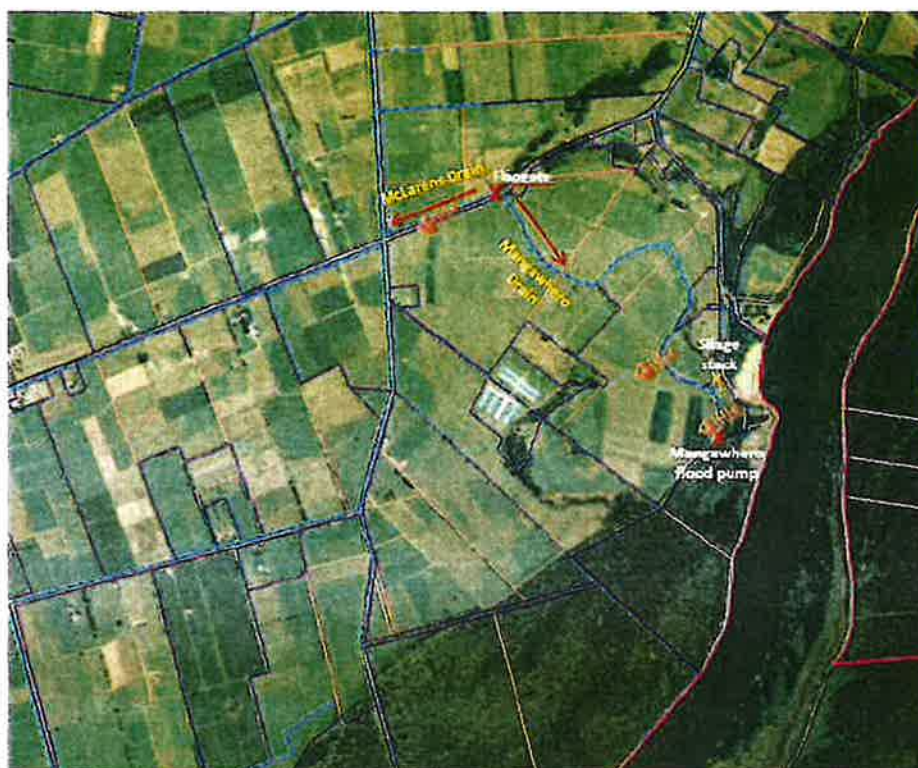
Figure 2 - Aerial photo showing location of fish kill, WRC managed drains (blue dashed lines) and Mangawhero Pump. Red arrows show direction of stream flow.

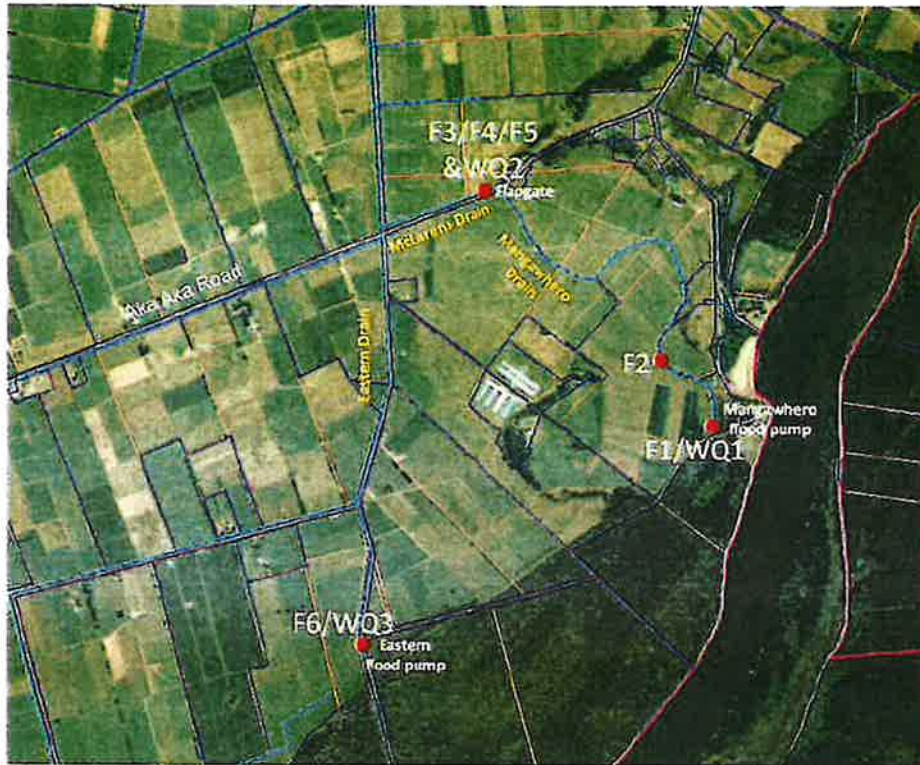
Figure 3 - Locations of water quality sampling sites (WQ1-3) and field meter measurement sites (F1-6) during initial investigation on 24 to 25 June 2014.

On the 24 June 2014, field meter measurements of dissolved oxygen (DO), electrical conductivity (EC) and temperature were recorded at sites F1 (Mangawhero drain flood pump station), F2 (Mangawhero drain adjacent to a stockpile of silage) and F3 (McLarens drain flapgate). A grab sample of water was also taken at WQ1 (Mangawhero drain flood pump station) for water quality analysis of a suite of water quality determinands including pH, EC, ammoniacal nitrogen, BOD, and sulphate. Further field measurements of DO, EC and temperature were recorded on 25 June 2020 at sites F4 & F5 (both at the McLarens drain flapgate but before and after the bed sediment was disturbed) and at site F6 (Eastern drain flood pump station). A grab sample of water was also taken at WQ2 (McLarens drain flapgate) and WQ3 (Eastern drain flood pump station) for water quality analysis of a suite of water quality determinands including pH, EC, ammoniacal nitrogen, BOD, and sulphate. The locations of the sampling sites are provided in Figure 3.

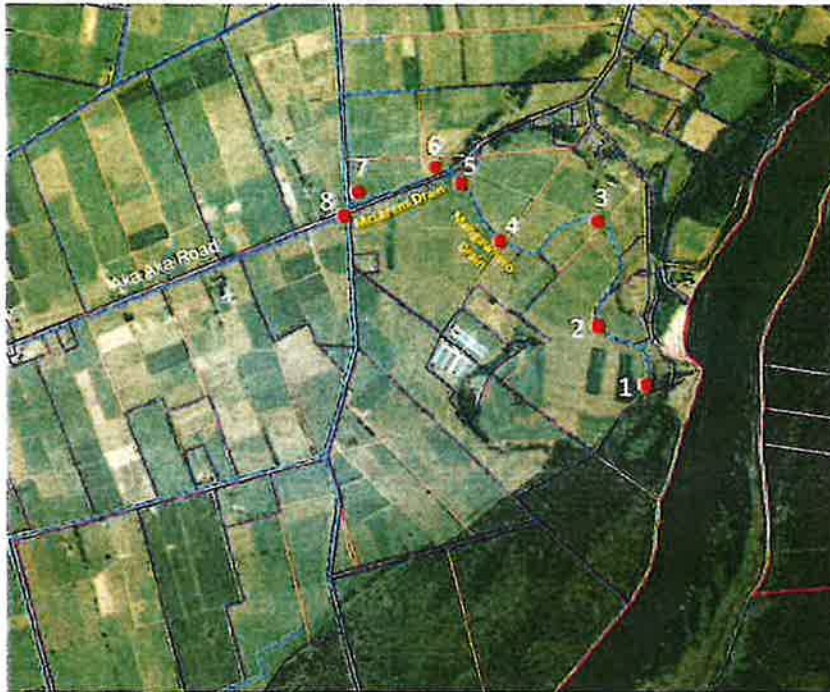
Figure 4 - pH and temperature monitoring sites 1 to 8 from 13 August 2014 to 6 September 2015 (note site 8 was sampled only once over this period).

Temperatures ranged from as low as approximately 11 degrees in June to up to 23 degrees in December (refer to Appendix A for specific values). The pH ranged from as low as 3.06 to as high as 9.38 (refer to Appendix A for specific values). With reference to Figure 6 it is evident that the pH was varying significantly from winter to summer over the two-year period of monitoring

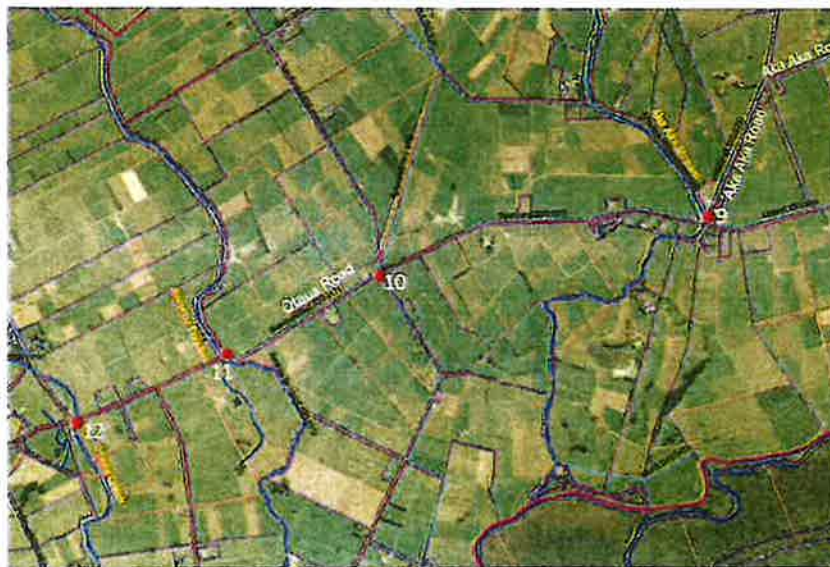
Figure 5 - pH and temperature monitoring sites 9 to 12 from 13 August 2014 to 6 September 2015.

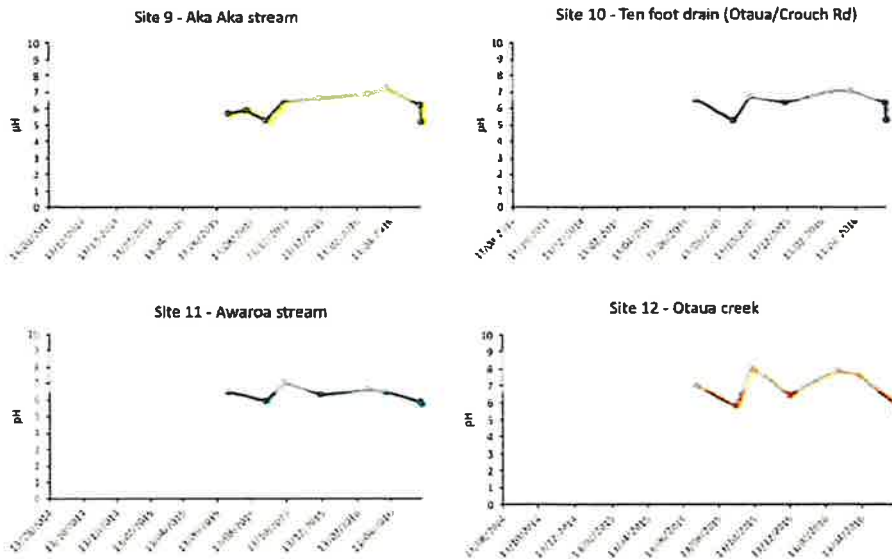
Figure 7 - pH results for sites 8 to 12 recorded August 2014 to June 2016.

The pH results recorded in the Aka Aka stream, Ten foot drain, Awaroa stream and Otatau creek (Figure 7) over the more limited monitoring period of July 2015 to June 2016 also indicate a lower pH over the winter period but with a less severe drop in pH. The pH variation for these sites provides additional evidence that water quality was impacted over an extensive area during this period.

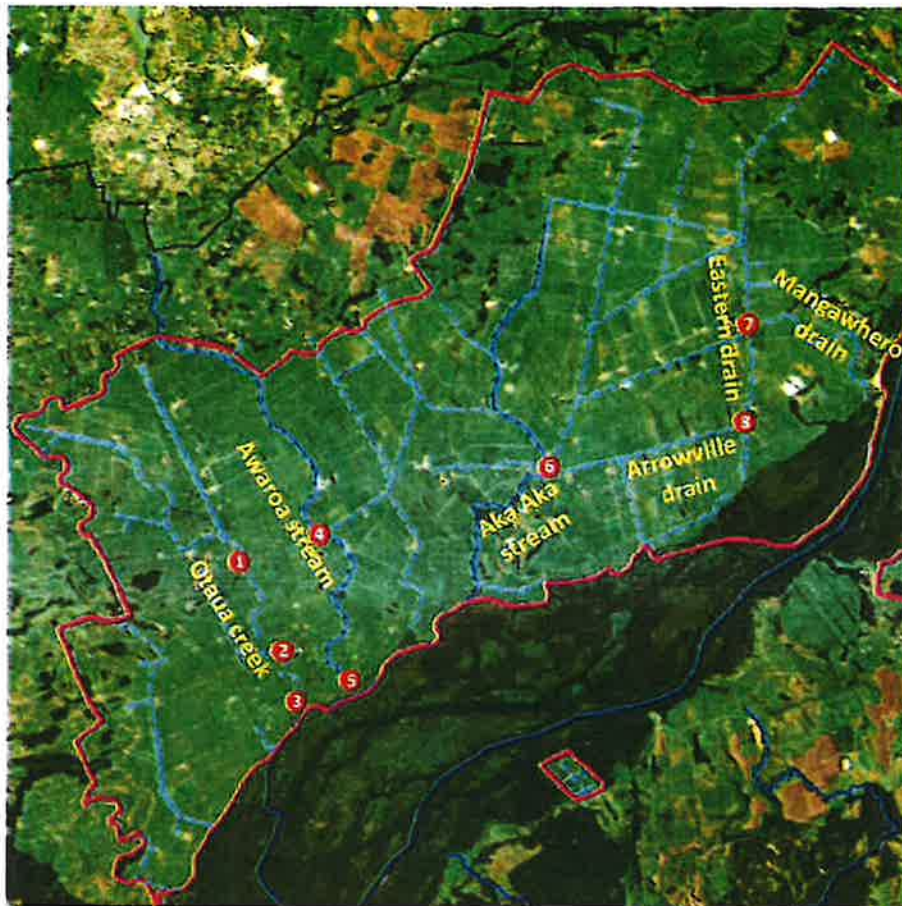
Figure 8 - Locations of water quality sampling sites and field meter measurement sites July to August 2020.

Water quality samples were also collected for laboratory analysis from sites 1 and 6 (Otaua creek and Aka Aka stream respectively) on the 21 July 2020 and again on the 11 August 2020 at which time a Data Sonde (YSI EXO2) was deployed at site 6 for continuous monitoring of pH, temperature, electrical conductivity, turbidity, dissolved oxygen and chlorophyll (refer to Appendix B for Sonde and probe serial numbers).

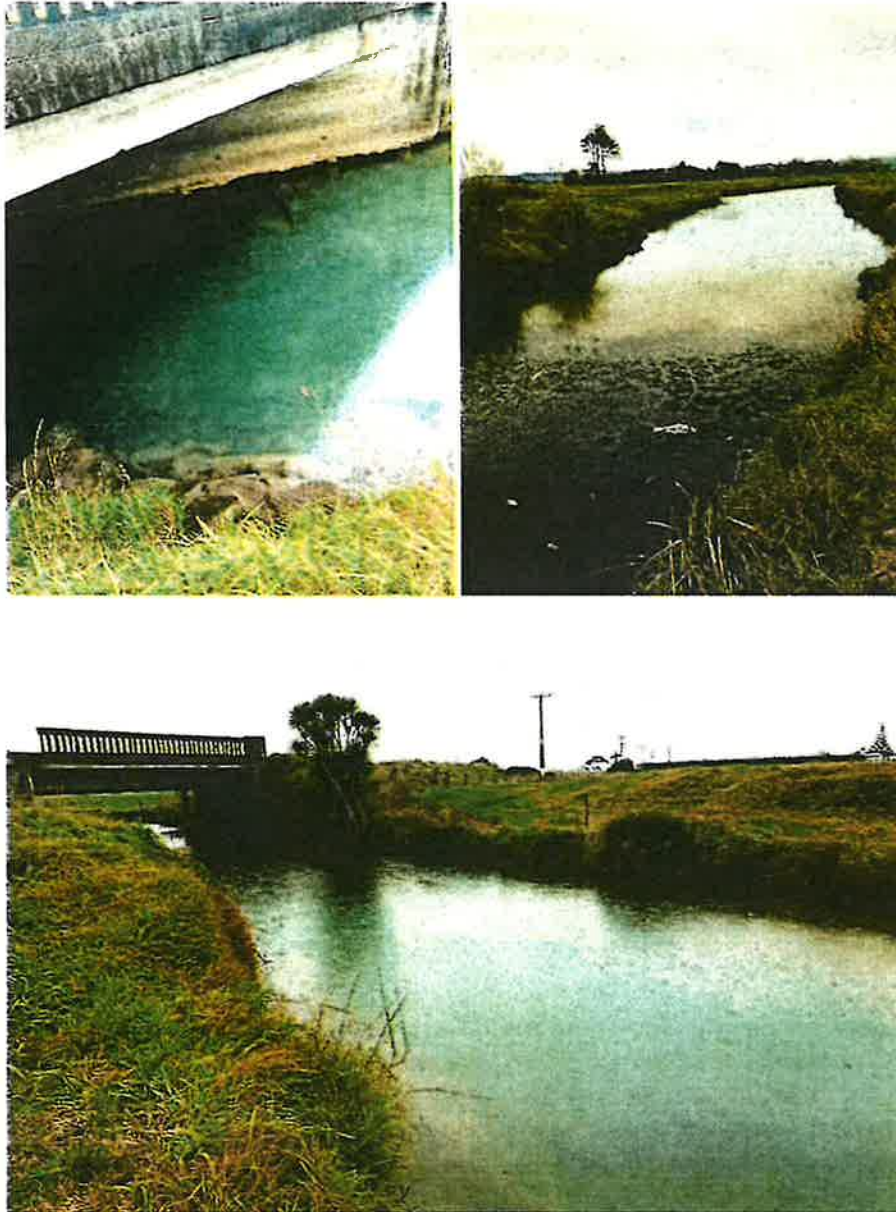
Figure 9 - Water clarity at Otatau Creek (Site 1, top left), dead fish (Awaroa Site 5, top right) and water clarity at Awaroa stream (site 4, bottom).

Water clarity at all sites was extremely high, with the bottom of the stream bed visible at most sites (Figure 9). This is an extremely uncommon occurrence for this area as streams and drains in this area typically have a high suspended sediment load and high turbidity. Landowners at the sites visited remarked that they had never seen it so clear before (Williams, 2020).

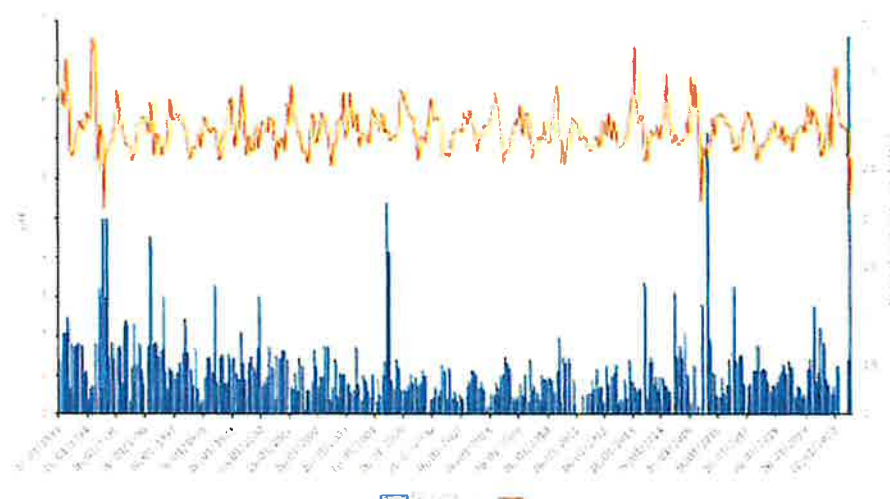
Figure 12 - pH and black disk water clarity levels recorded in the Awaroa stream from 1993 to 2020.

higher sediment runoff during heavy rainfall events in winter. However, while increased water clarity has not always coincided with a drop in pH, the most significant seasonal variations in pH recorded in 1994, 2013, 2015 and 2020 align with the most significant increases in water clarity with 2020 featuring the largest drop in pH over the winter period and the largest increase in water clarity.

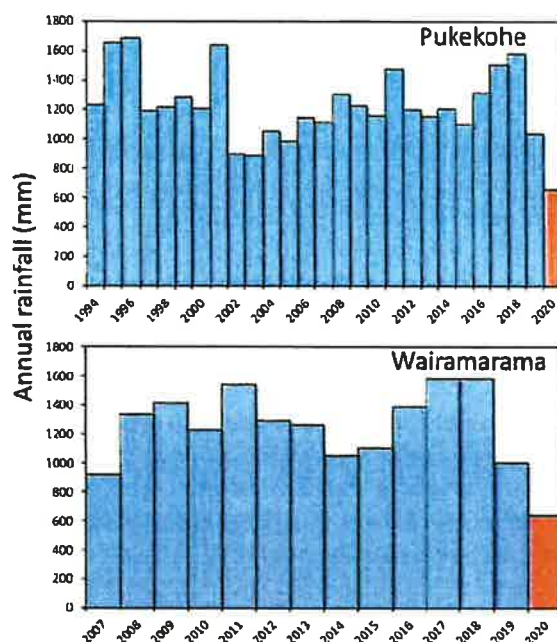
Figure 14 - Annual rainfalls recorded at the Pukekohe and Wairamarama rainfall monitoring stations (2020 total represents year to date to end of August).

The total rainfall of approximately 650 mm for 2020 for the period up to the end of August (orange bar in Figure 13) indicates that the annual total for this year is likely to fall within a low range of 1000 to 1100 mm when the mean monthly rainfalls (refer to Figure 14) for September through to December are added.

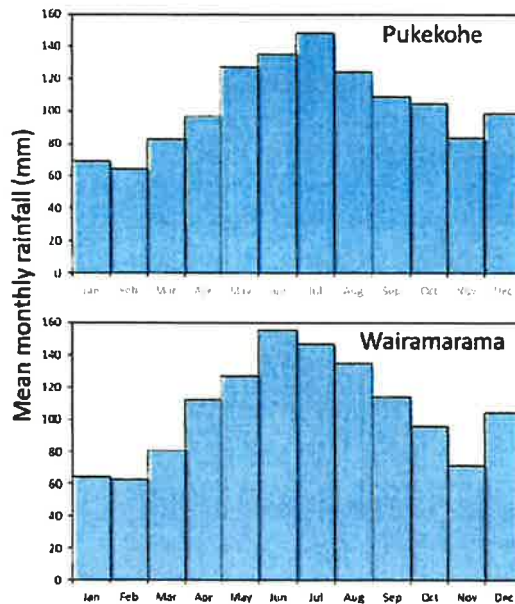
Figure 15 - Mean monthly rainfalls recorded at the Pukekohe and Wairamarama rainfall monitoring stations.

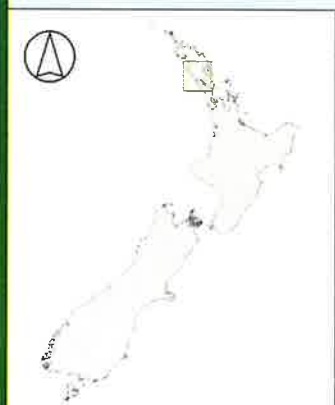
Kaipara District - Soils

AK	HKA	KRE	OA	PN	RPAH	TP	YWH	YCI
AKH	KB	KT	OAH	PN1	RU	TRS	WD	YCH
AP	KBH	KTH	OG	POS	RUH	TT	WR	YK
APH	KBe	MA	OH	PZ	RV	TTH	WRH	YKH
AR	KM	ME	OMH	RA	Rv	TU	WRH	YN
AU	KN	MEH	OH	RAH	TC	TUH	WRH	YNH
AUH	KNH	MF	OPH	RAJ	TEA	WA	WT	YP
AUS	KNH	MFFH	OT	RL	TEK	WAH	WTH	YPH
C1	KNH	MD	PELH	RLH	TES	WGS	YU	YR
C4	KD	MRH	PD	RLA	TEFS	WE	YQ	YU
CS	KP	MRH	PD	RLAH	TN	YF	YCH	YU
H	KPY	MT	PES	RP	TNH	WFFH	YD	Dark rock
HK	KRE	MV	PEH	RPH	TNAH	WK	YGH	
HKH	KRA	MVH	PM	RPA	TO	WKA	YGH

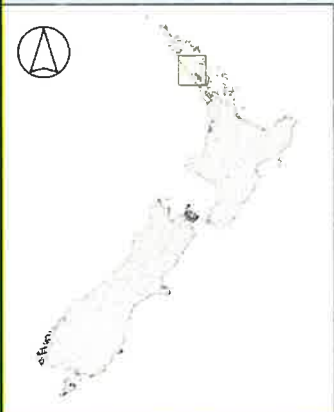
Kaipara District - Slope Class

- Flat to gently undulating (0 - 3 degrees)
- Undulating (4 - 7 degrees)
- Rolling (8 - 15 degrees)
- Strongly rolling (16 - 20 degrees)
- Moderately steep (21 - 25 degrees)
- Steep (26 - 35 degrees)
- Very steep (> 35 degrees)
- Town
