**Resource Consent Application**  
**Assessment of Environmental Effects**  
**Discharge of Wastewater into Land**

# Resource Consent Application Assessment of Environmental Effects

## Discharge of Wastewater into Land

### Te Pirangi Developments

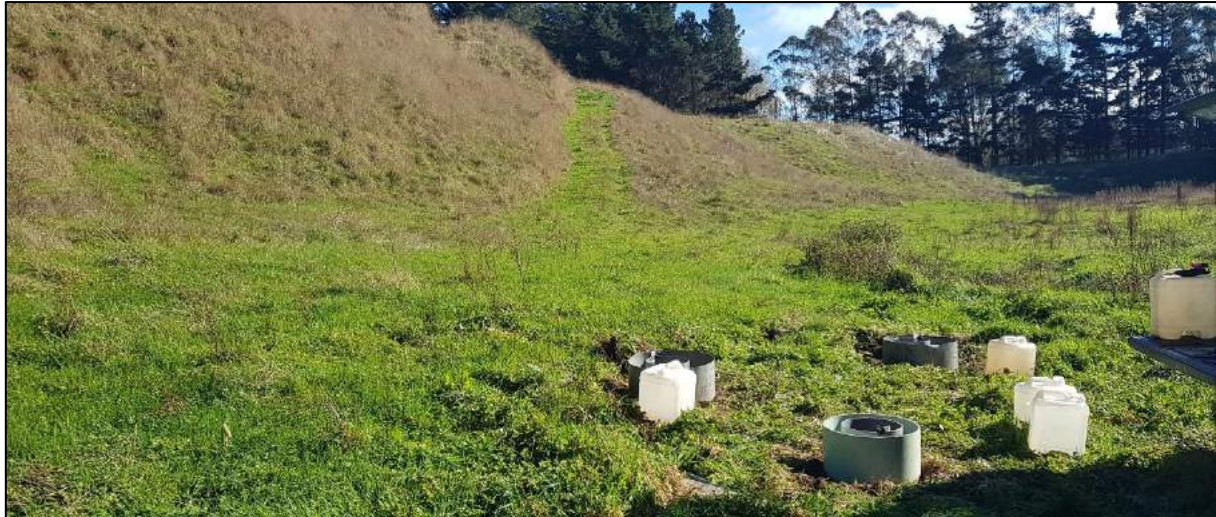
**Figure 0.5: Photo Taken from Lot 14 and Looking North-West Towards Lots 16, 17 and 19.**

Figure 0.5 shows the expected overland flow path along the foot of the terrace towards the north-west as discussed in Section 0.
