Upper Hutt City Council

**Silverstream Bridge Seismic
Strengthening**

Final Report

July 2007

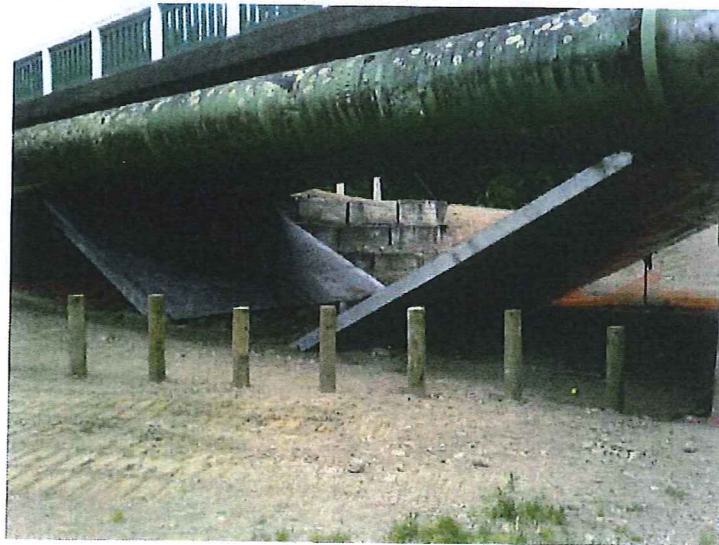
To mitigate the impact of the prestressed bars on water flow during a flood event and to prove to the Regional Council the appropriateness of the solution, the hydraulic model of the Hutt River at the site was modified and rerun. The effect of different debris "blockage" scenarios (within the strengthened span) were considered by modelling and the final design incorporated a lowered ground level (within the end span) to ensure the effect of the exposed bars and debris would be negligible. In addition the bars were enclosed in continuous shield to minimise the possibility of debris "catching" between rows and compounding the blockage. Final agreement to the proposal was obtained from Regional Council after a meeting on site to discuss the issue and solution while viewing the actual area / site it would be located.

Modelling of the river in flood and various debris blockage scenarios were considered to support the resource consent application with the final solution detailed to ensure the effect on water level in a flood event was negligible.

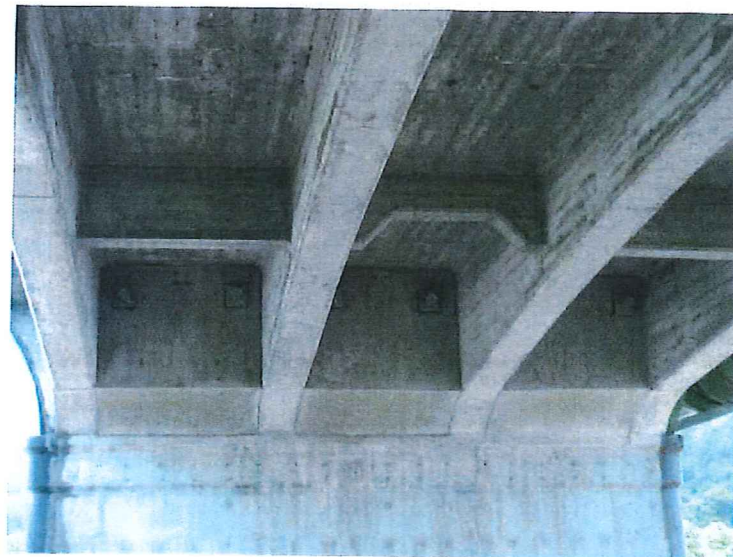
To overcome the construction joint at midspan it proposed that the bridge be tied together across this joint so the bridge would seismically respond as one structure. The linkage bars would be detailed to allow normal temperature expansion and contraction to take place.

Self-compacting concrete was used to strengthen the diaphragms and abutment where the post tension bars were required and access for pouring and compacting was difficult. This was a great success and ensured the integrity of the final product in place.

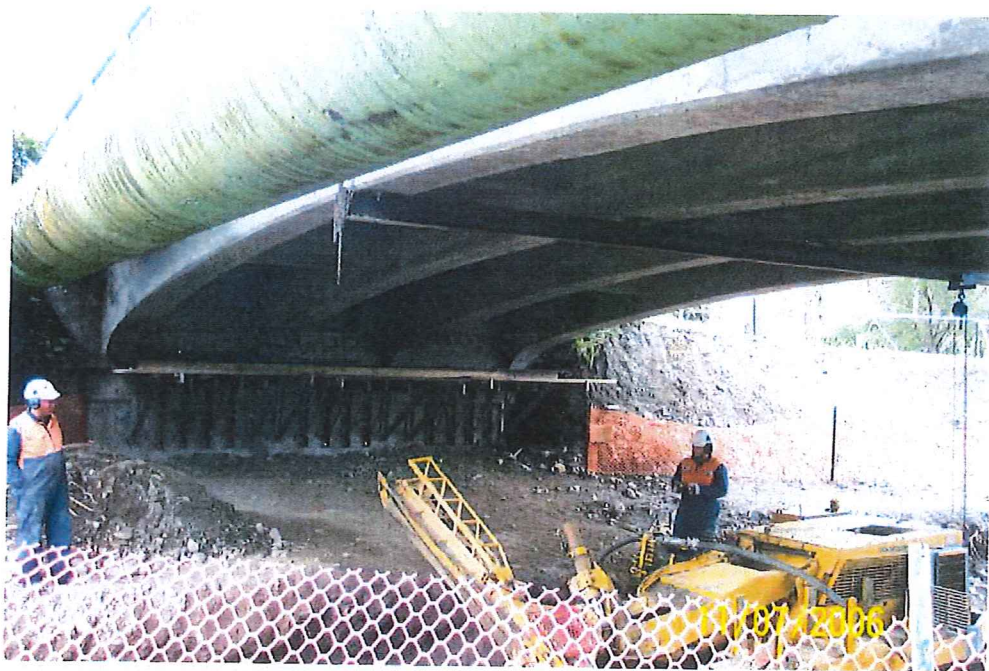
Construction was carried out over the late summer and winter of 2006 and finished early in 2007. Progress was slower than originally envisaged due to numerous southerly storms that hit the region over that period and also some difficulties in drilling the initially rock anchors.
