Table IEP-1 Initial Evaluation Procedure Step 1

Location	386 Fergusson Drive Building A	Building Name	Fig Tree Café
Site visit By	Benedicto	Date	26/07/12
Process By	AZL	Date	18/08/12

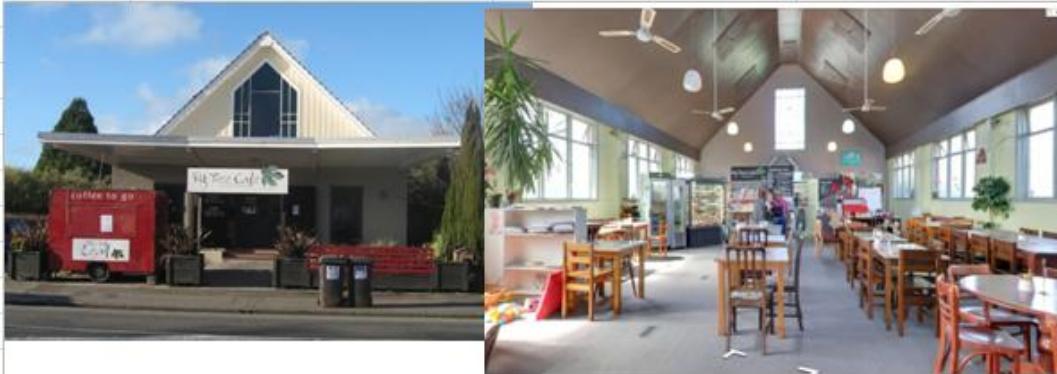
1.1 Photos (Attached Sufficient Photos to Describe Building)

1. The building seems to be a single storey light timber framed building with concrete tile roof and brick veneers
2. It is free standing
3. The building is used as a cafe shop and a hall. The building hall is very spacious and has got skillion roof. In transverse direction, the bracing elements are spaced far away. The roof diaphragm capacity is critical, apart from the lateral load resisting system in transverse direction.
