PETONE TO NGAURANGA CYCLEWAY

GEOTECHNICAL INVESTIGATION

# Drillhole Core Logs and Photographs

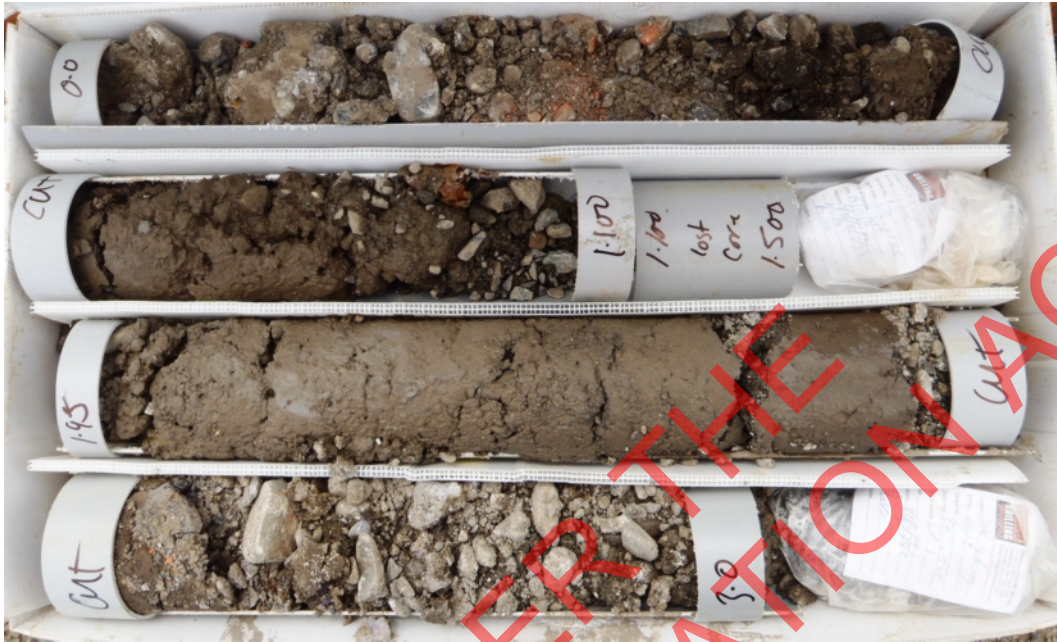
HOLE IDENTIFICATION  
DH02

**Box: 1 of 3 - Depth: 0.00m to 3.45m of 7.50m**

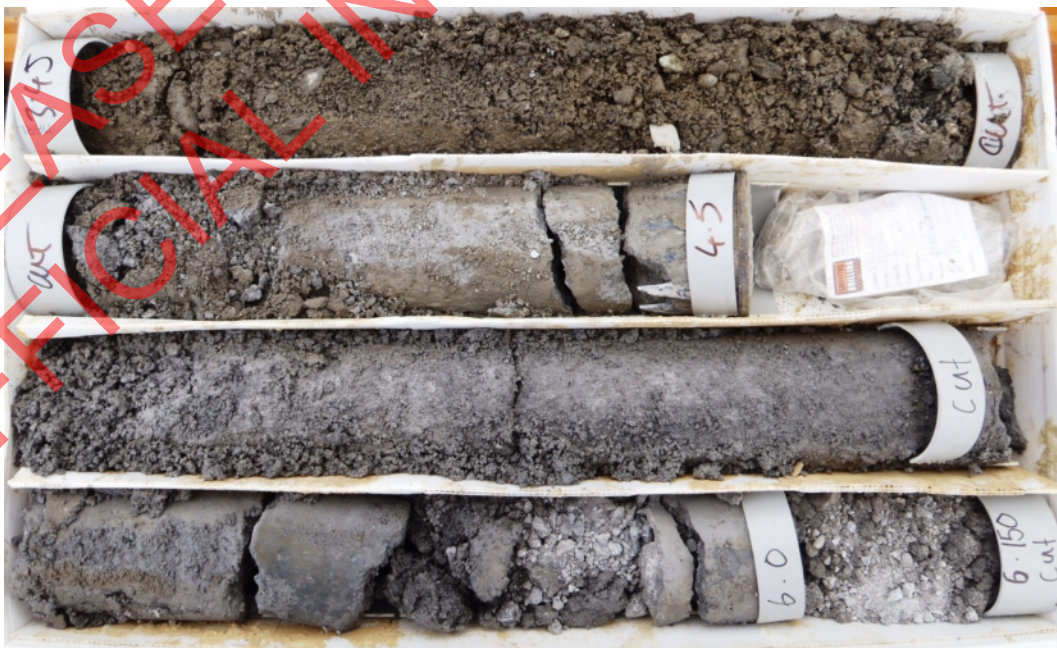
**Box: 2 of 3 - Depth: 3.45m to 6.15m of 7.50m**

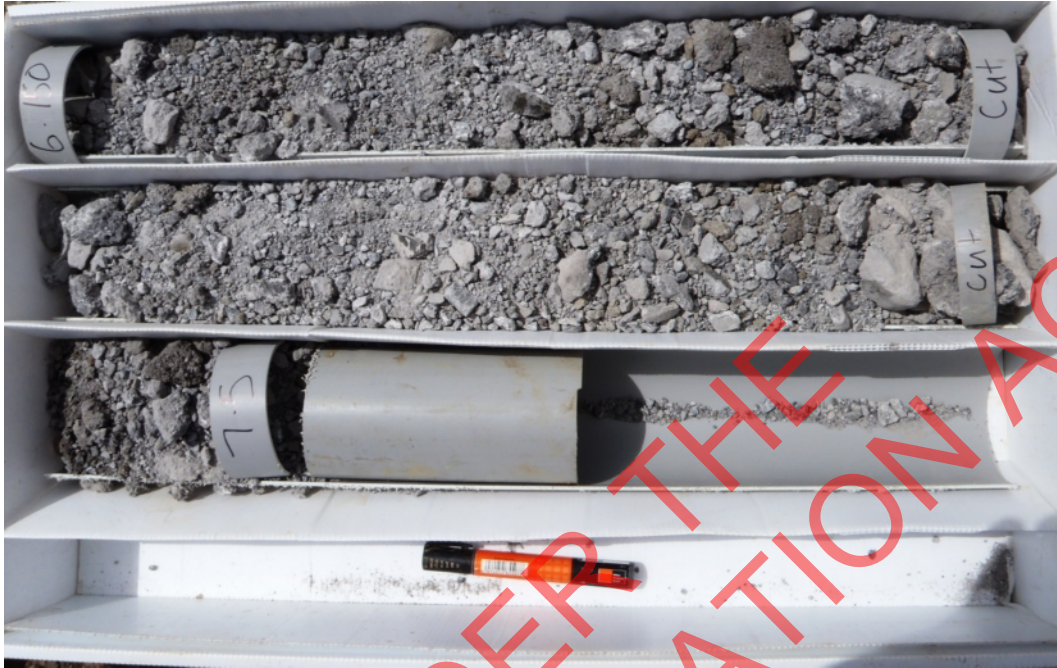
**Box: 3 of 3 - Depth: 6.15m to 7.50m of 7.50m**  
Date Drilled 19/12/2013 to 19/12/2013 - Date Photographed: 19/12/2013

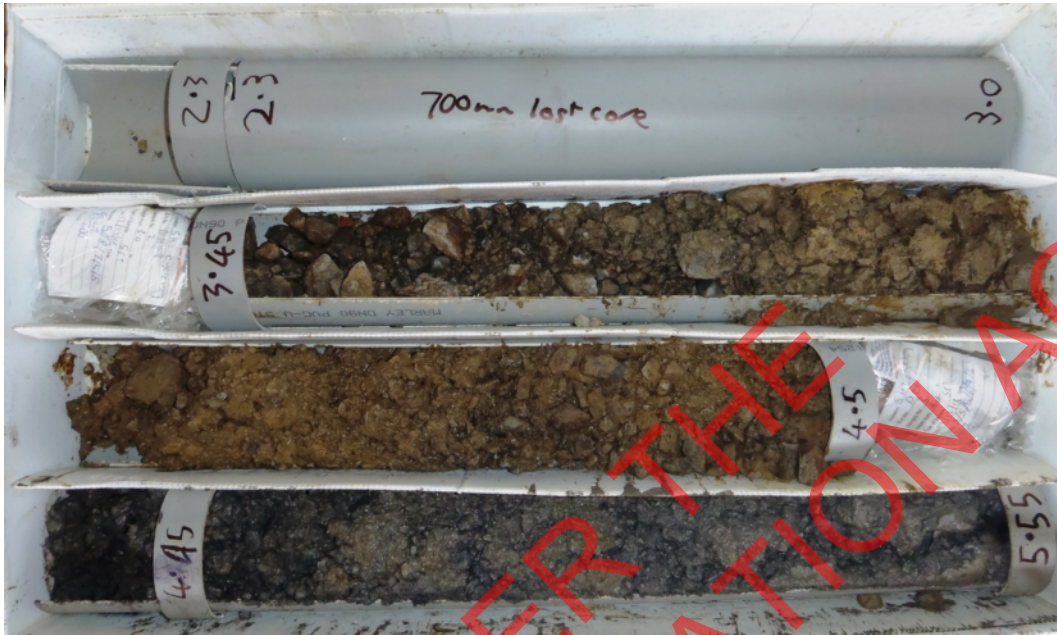
**Box: 1 of 3 - Depth: 2.30m to 5.55m of 10.50m**  
Date Drilled 12/12/2013 to 13/12/2013 - Date Photographed: 18/12/2013

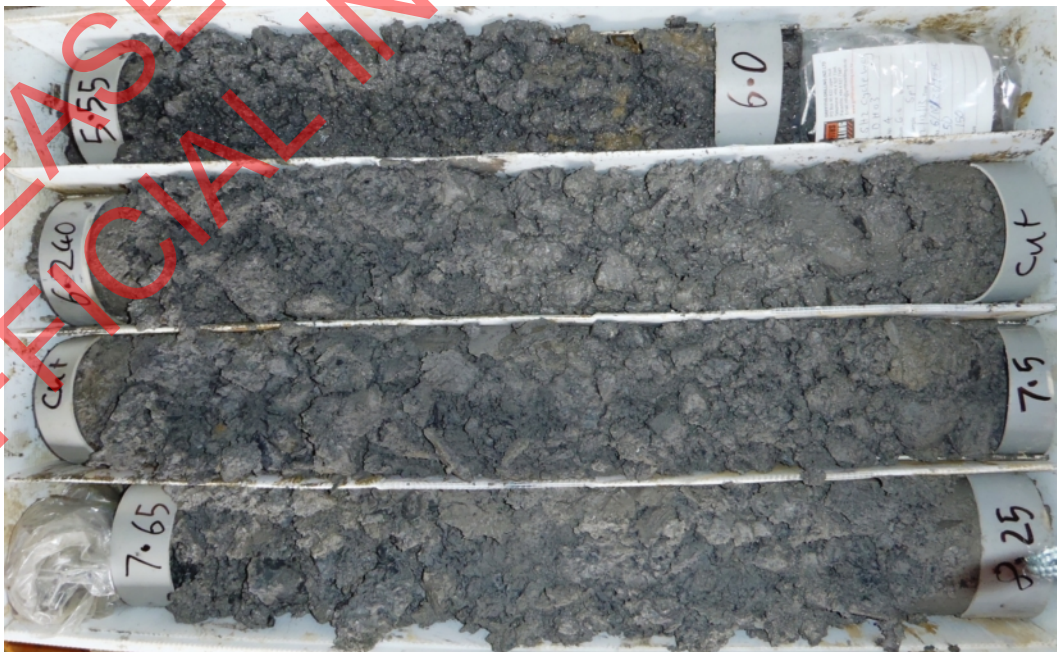
**Box: 2 of 3 - Depth: 5.55m to 8.25m of 10.50m**  
Date Drilled 12/12/2013 to 13/12/2013 - Date Photographed: 18/12/2013

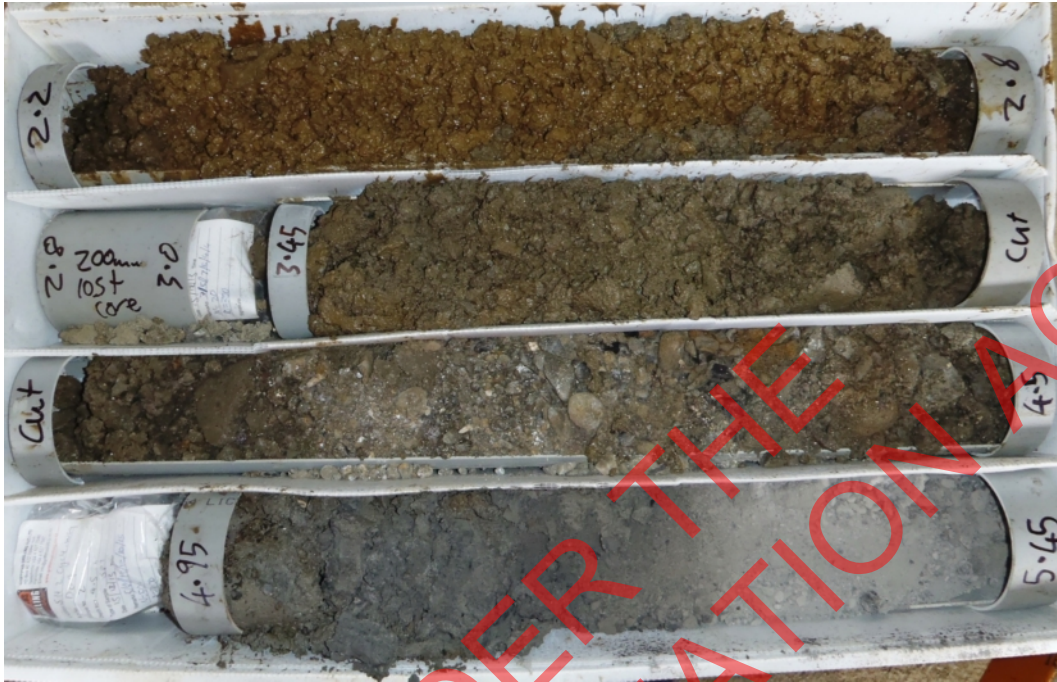
**Box: 1 of 3 - Depth: 2.20m to 5.45m of 8.10m**

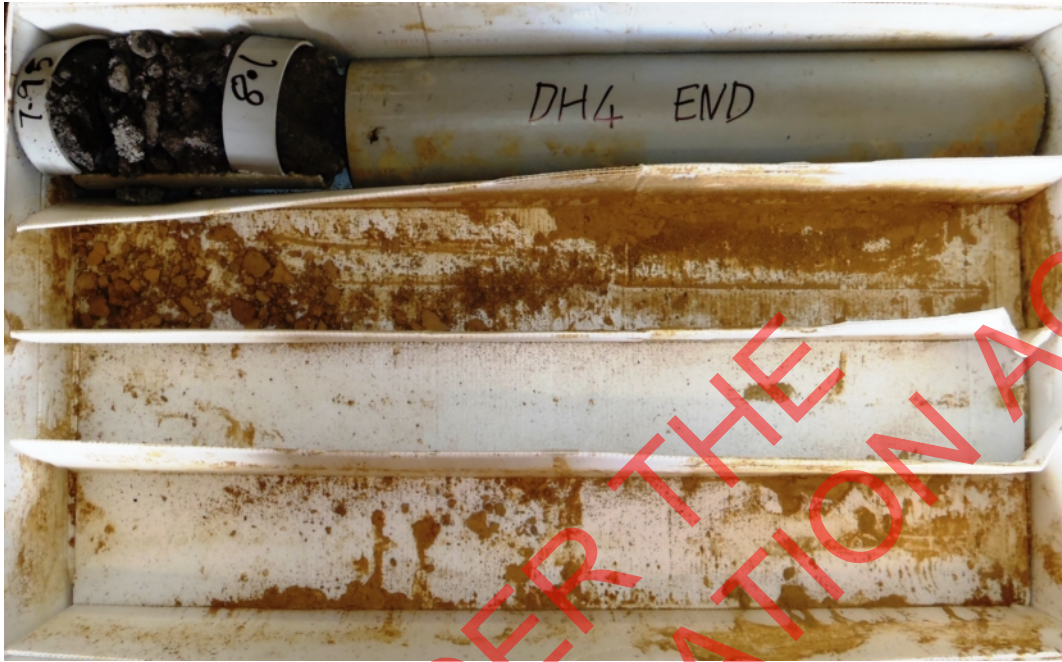
**Box: 3 of 3 - Depth: 7.95m to 8.10m of 8.10m**

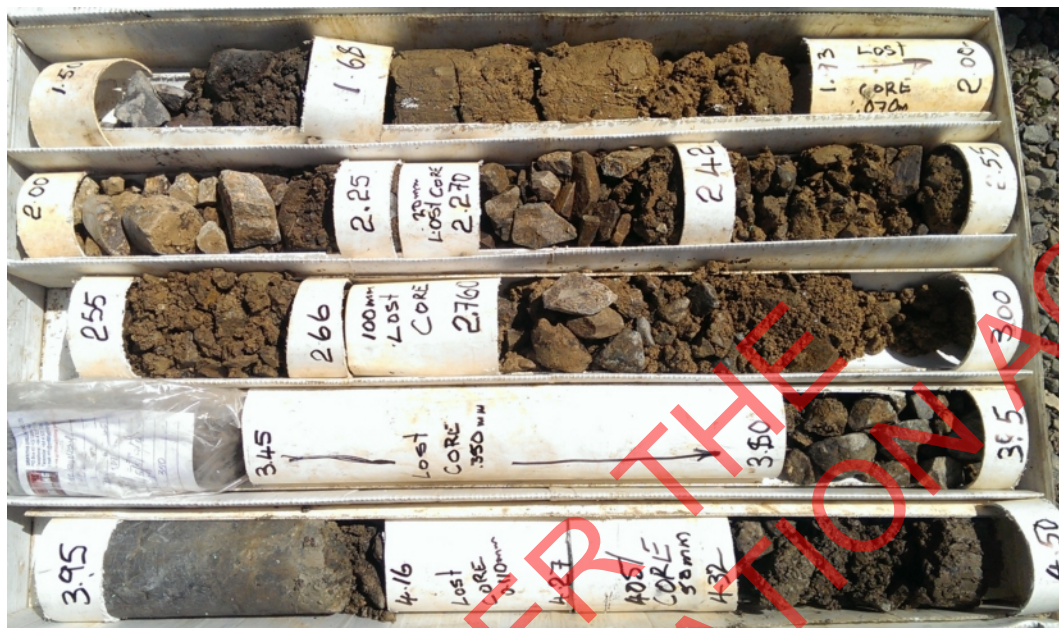
HOLE IDENTIFICATION	DH06
---------------------	------

**Box: 1 of 3 - Depth: 1.50m to 4.50m of of 13.50m**  
 Date Drilled 19/02/2014 to 21/02/2014

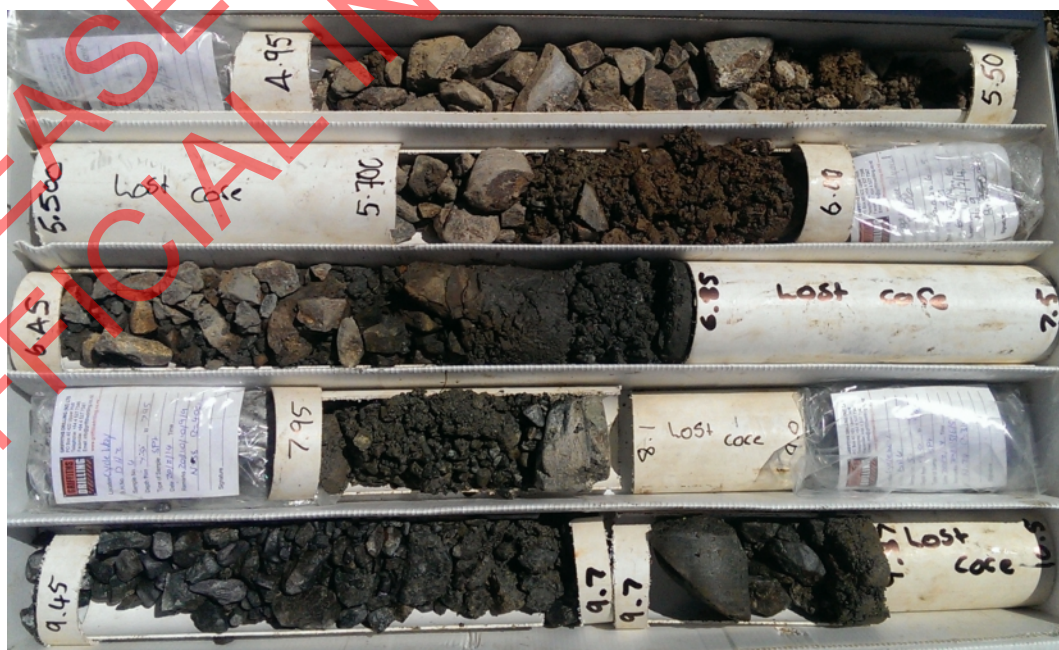
**Box: 2 of 3 - Depth: 4.50m to 10.50m of of 13.50m**  
 Date Drilled 19/02/2014 to 21/02/2014

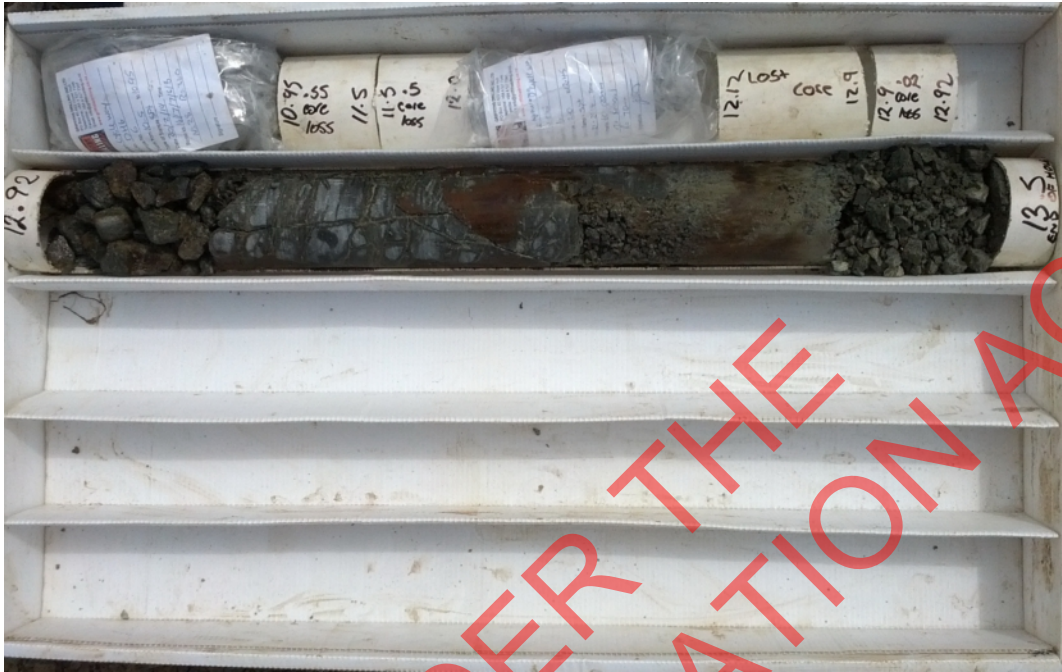
**Box: 3 of 3 - Depth: 10.50m to 13.50m of of 13.50m**  
Date Drilled 19/02/2014 to 21/02/2014
