Stage 1 Site Evaluation New School Hawkes Bay

This report is compiled by The Property Group Limited for The Ministry of Education and forms part the site selection process for a new school in Hawkes Bay.

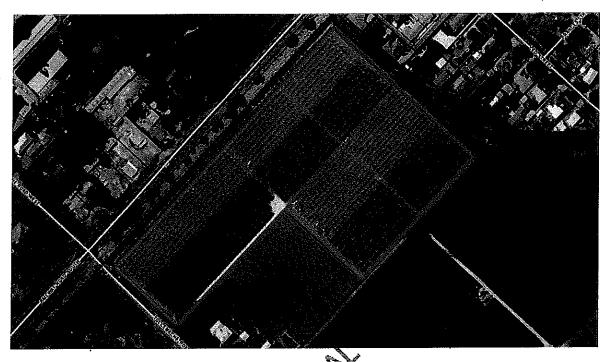
Site 7: 16 Railway Road S, Longlands

All of the site is located within the defined catchment area as per Appendix A. GREEN.

The total area of the site is 3.83 hectares. The surrounding properties are similar agricultural uses. **GREEN**

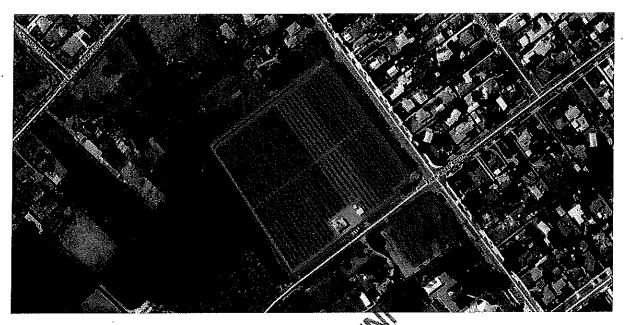
Site 11: 829 Park Road South, Hastings

All of the site is located within the defined catchment as as per Appendix A. GREEN.

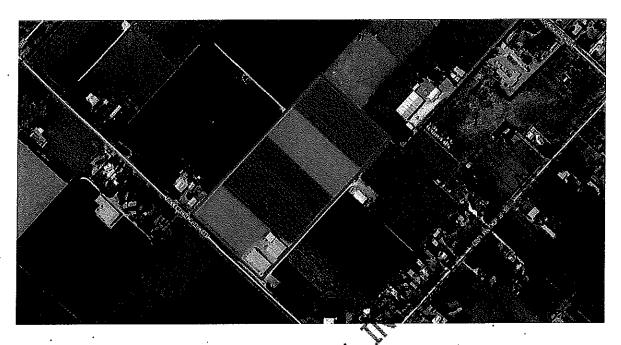
Site 12: 53 Tollemanche Road East, Longlands

All of the site is located within the defined catch entrarea as per Appendix A. GREEN.

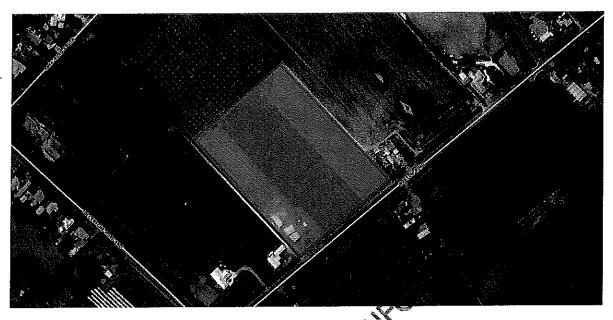
Site 21: 945 Norton Road, Hastings

All of the site is located within the defined catchmen as as per Appendix A: GREEN.

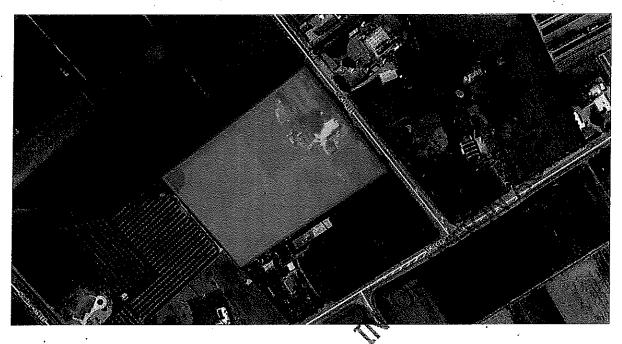
Site 28: 1289 Ada Street, Parkvale

The entire site is located within the defined care need as per Appendix A. GREEN.

The site has road frontage along its entire north eastern boundary. The regular shape of the site RELEASED UNDER THE OFFICIAL INFORMATION ACT and length of this boundary provide sufficient access to the site. There is no provision for offsite parking in the area. GREEN.

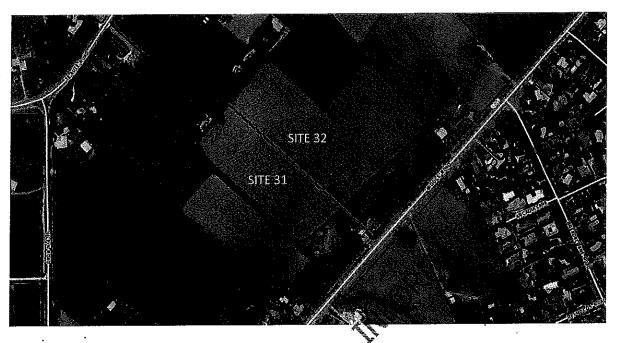
Sites 32&33: 122 Middle Road, Havelock North

The entire site is located within the defined catchinent area as per Appendix A. GREEN.

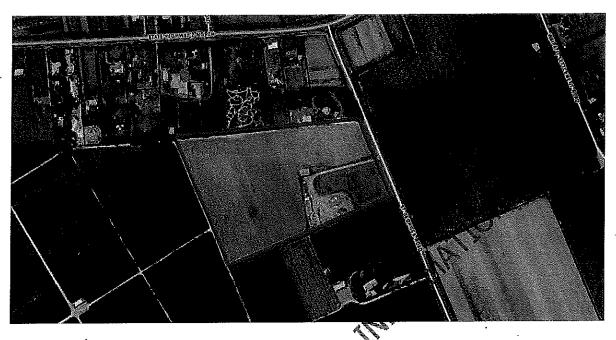
Site 44: 22 St Georges Road, Hastings

All of the site is located within the defined catchine area as per Appendix A. GREEN.

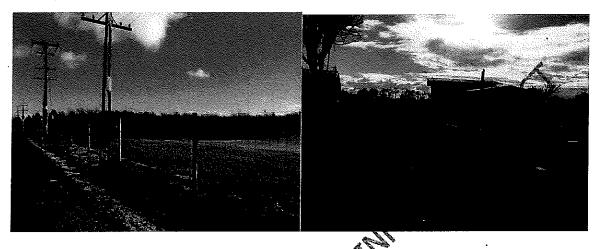
7. Site 21

Sites 21 is located at 945 Norton Road, Hastings. The site accommodates established trees over the majority of the site. There is a dwelling and other improvements located on the site.
