Appendix A Scheme Estimates

Project estimate: Entire Route

Project name: Glen Innes to Tamaki Drive Shared Path

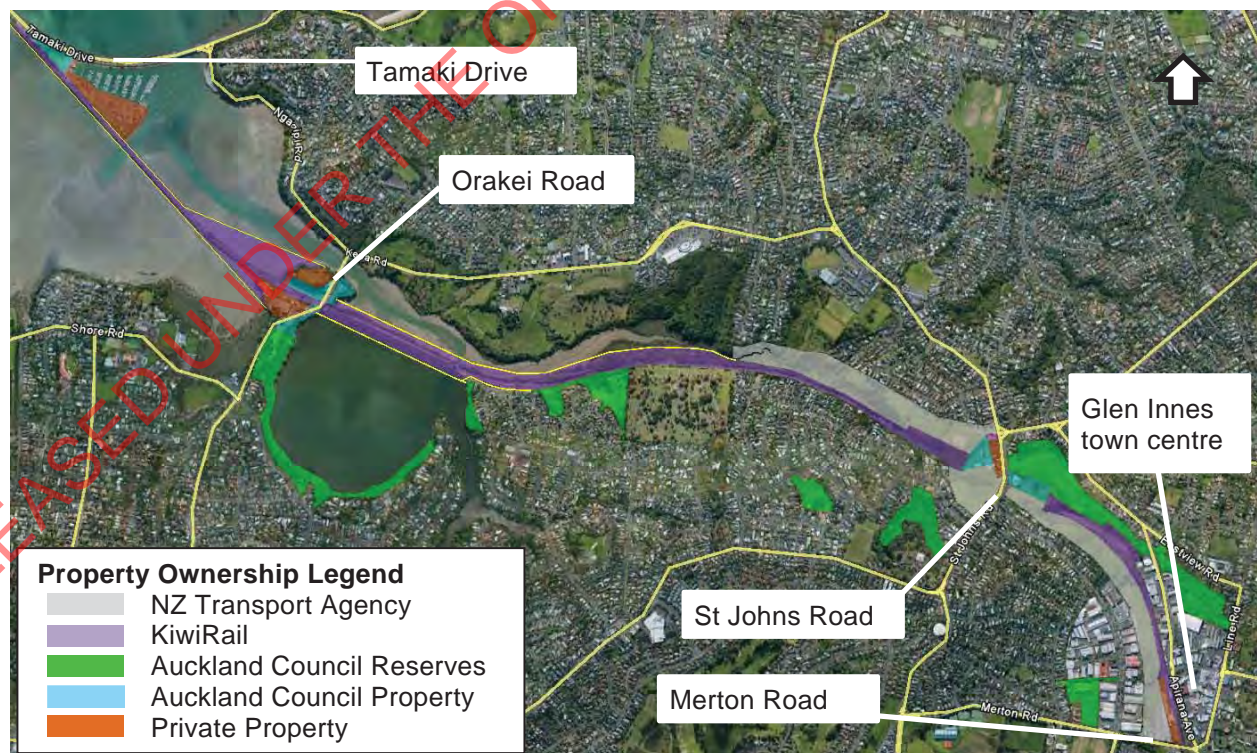
Figure 3-1 : Route land ownership.

The land ownership along the route is shown below in Figure 3-1. The route will cross a combination of NZ Transport Agency (NZTA), KiwiRail, and Auckland Council reserves / property. All agencies will need to work collaboratively to achieve the best outcomes for the project.

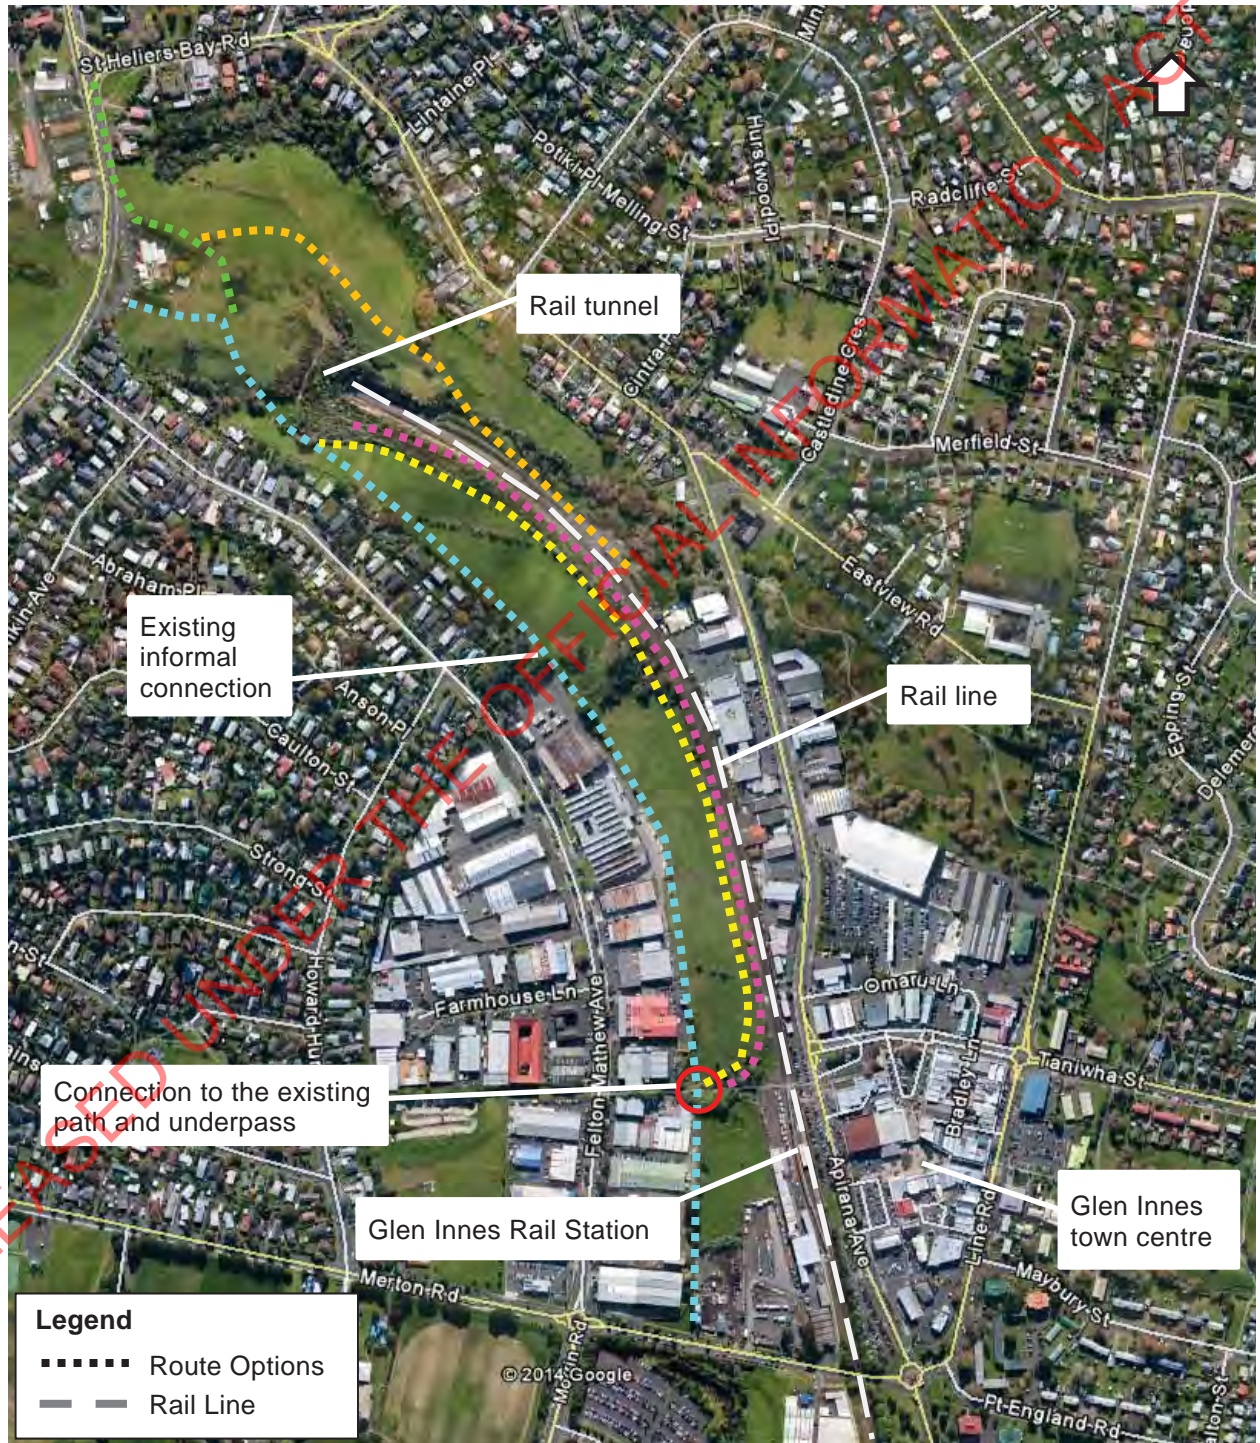
Figure 4-1 : Route options investigated along Section 1

Figure 4-1 shows the route options considered. In assessing these options it was considered critical that the connection to the underpass and Felton Mathew Avenue was as far west as possible. This helps to future proof by allowing as much length as possible for bridge ramps should a rail over bridge be required to replace the existing underpass in the future.

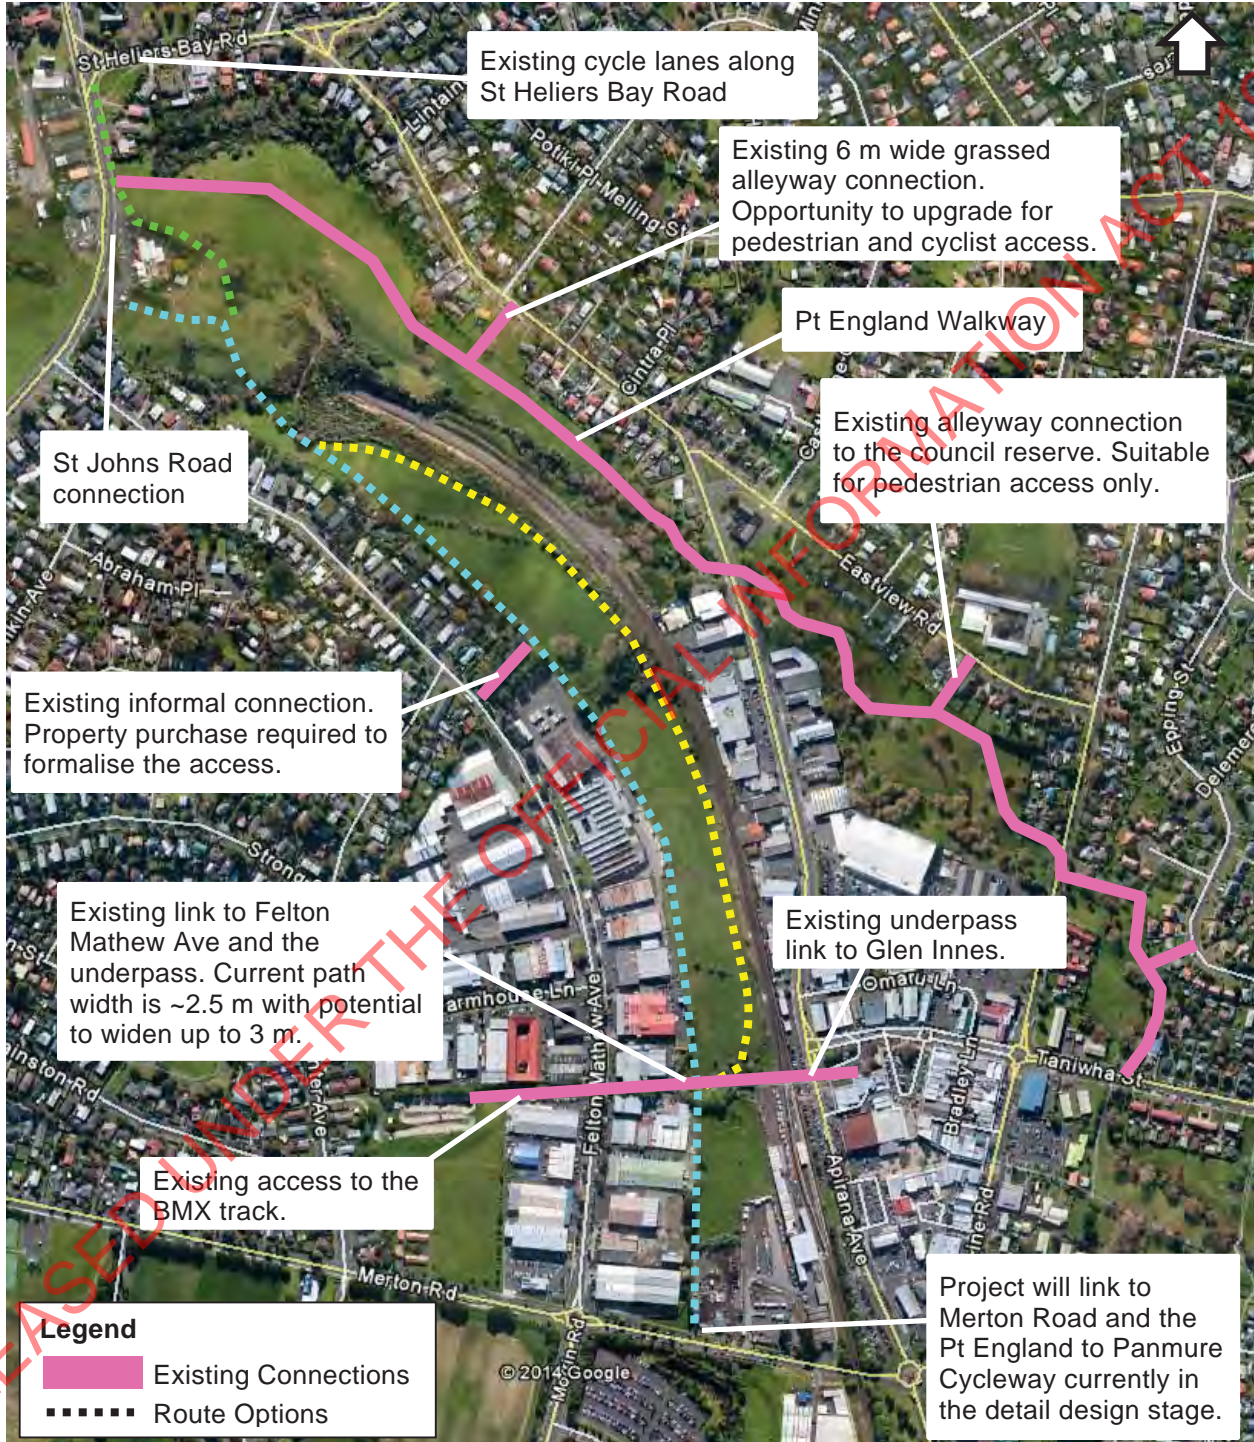
Figure 4-2 : Section 1 route connectivity

This section of the route has good connectivity options with a mix of pedestrian and cycle access as identified in Figure 4-2.

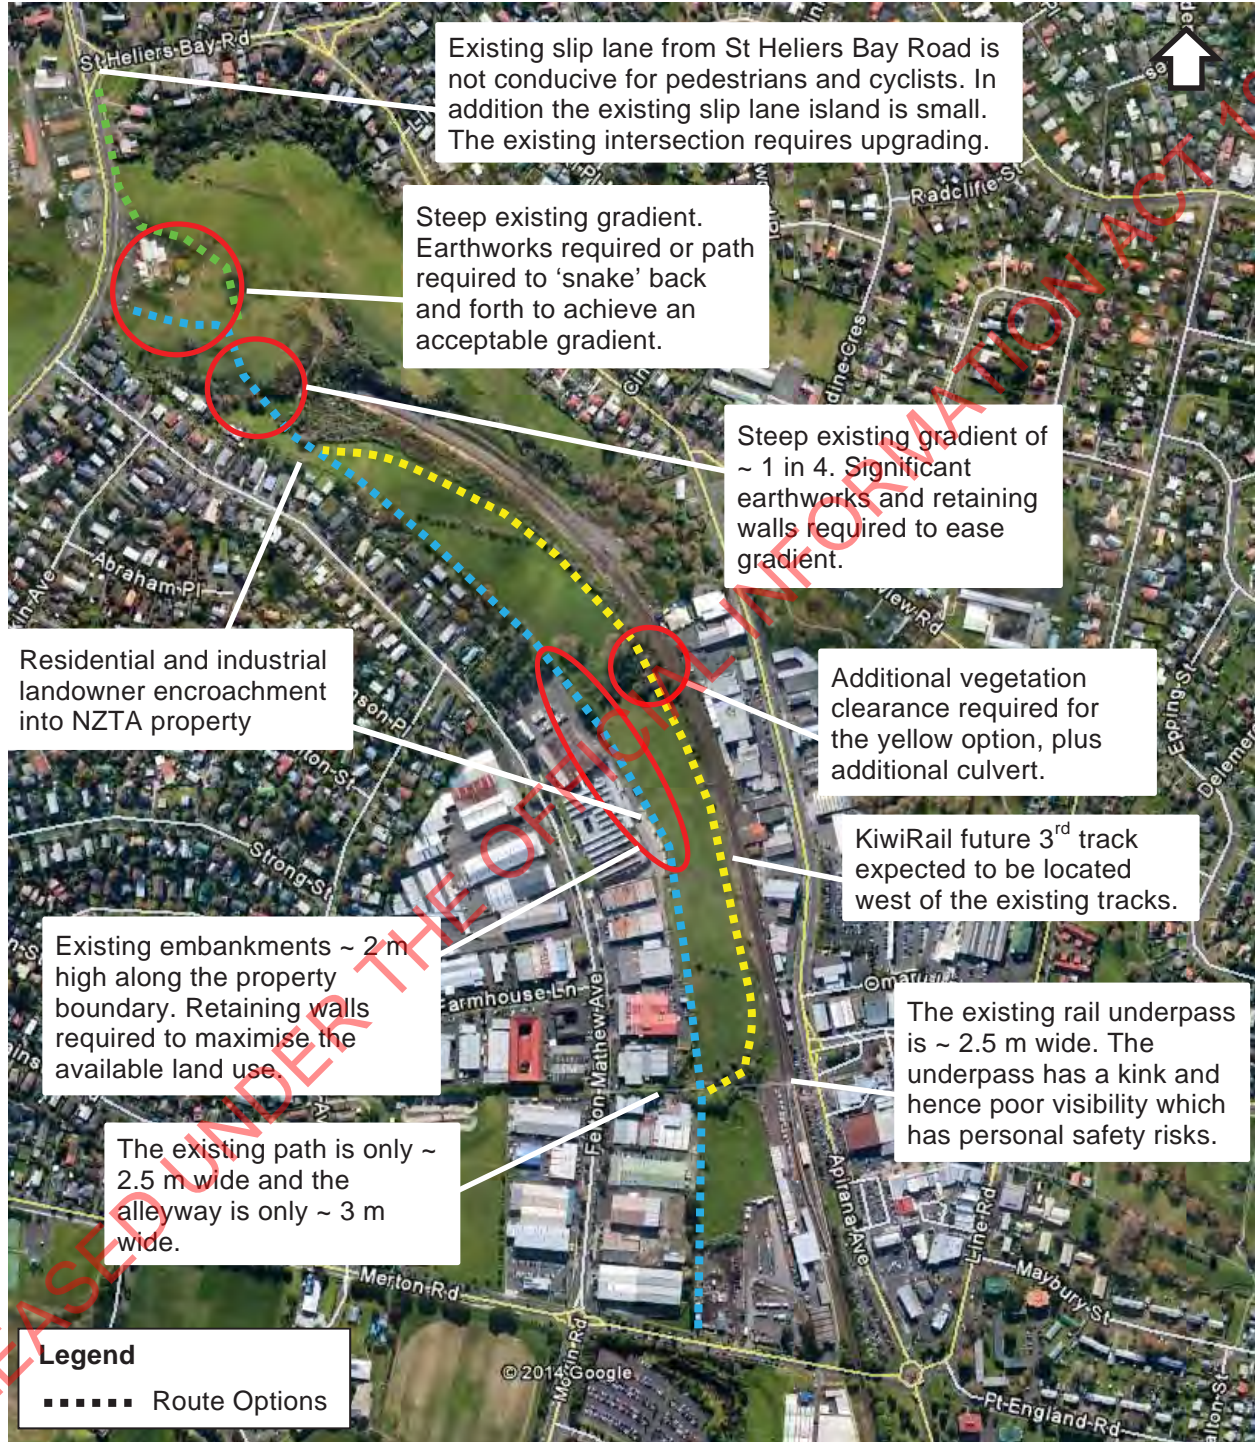
Figure 4-3 : Section 1 route constraints

The main challenge for Section 1 will be to minimise the steep gradients, particularly near to St Johns Road. The constraints for Section 1 are summarised in Figure 4-3.

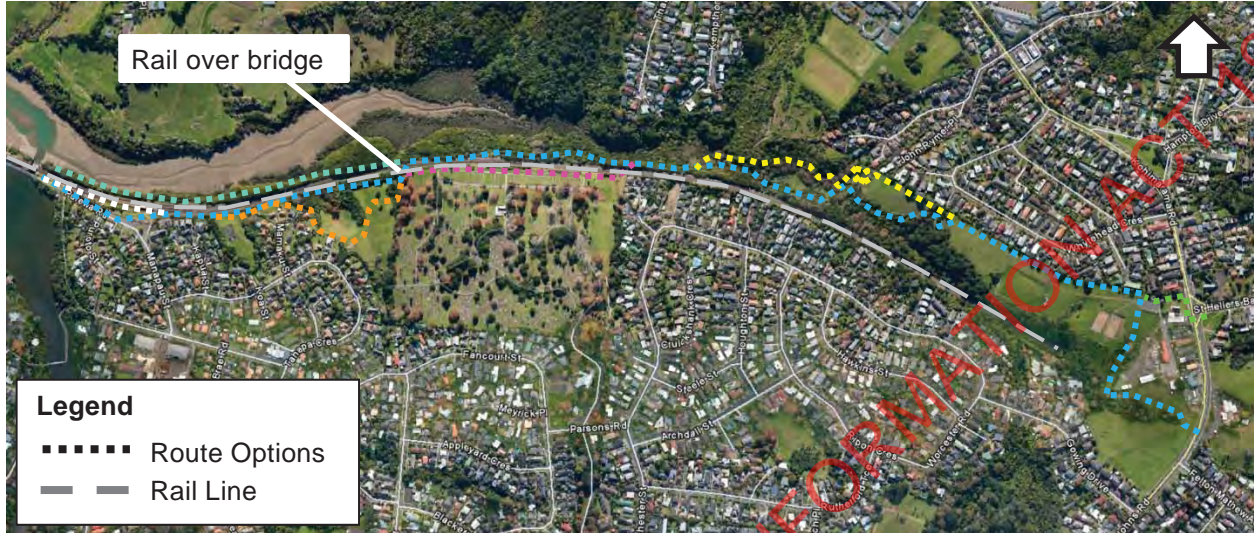
Figure 5-1: Route options investigated along Section 2

Figure 5-1 shows the route options considered.

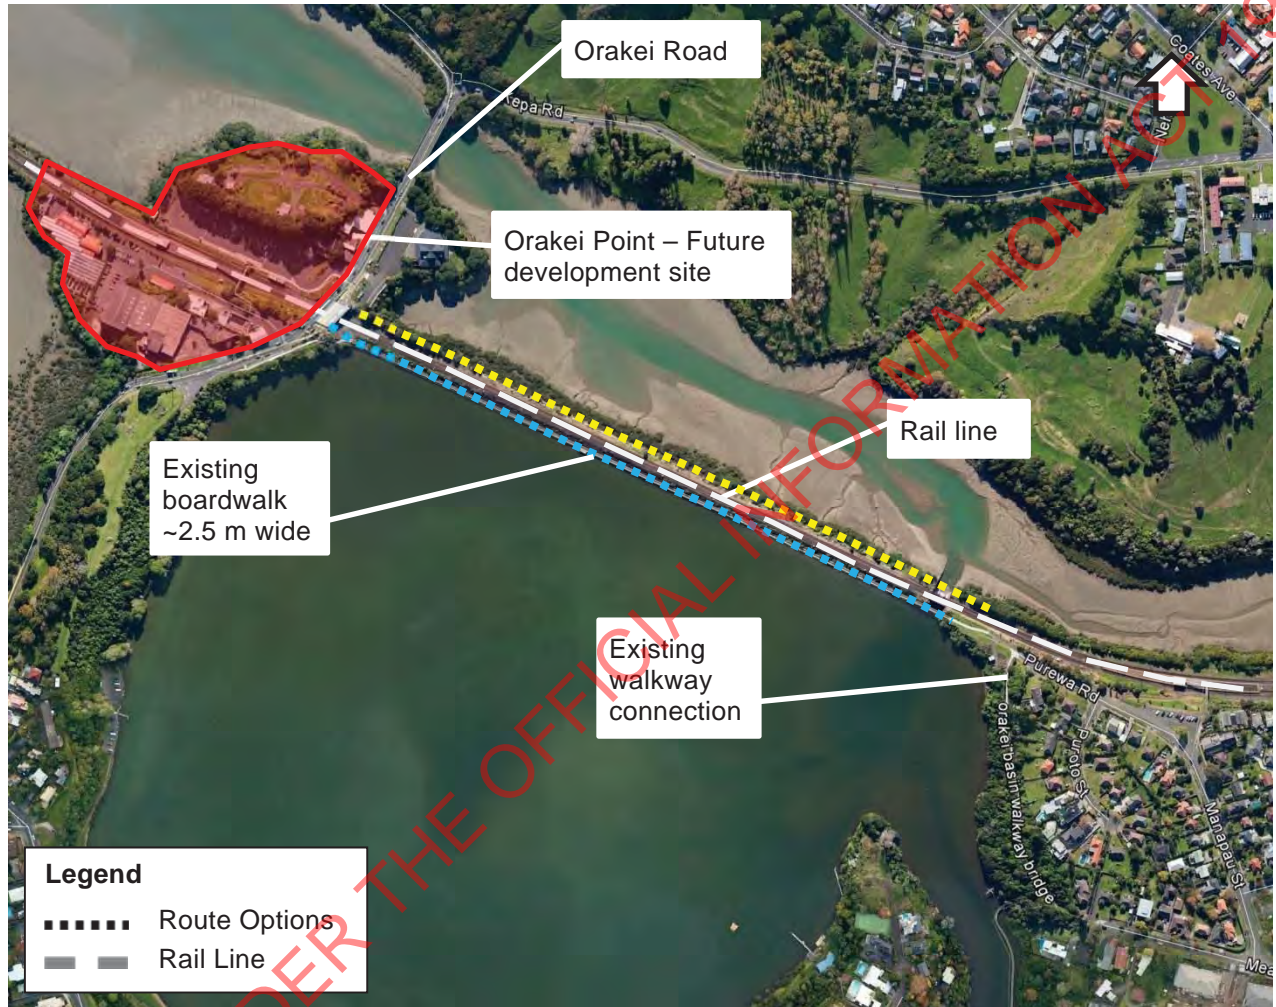
Figure 6-1 : Route options investigated along Section 3

Figure 6-1 shows the route options considered. For this section there are only two possible options which are to widen the existing boardwalk or to provide a new structure on the north side of the rail line.

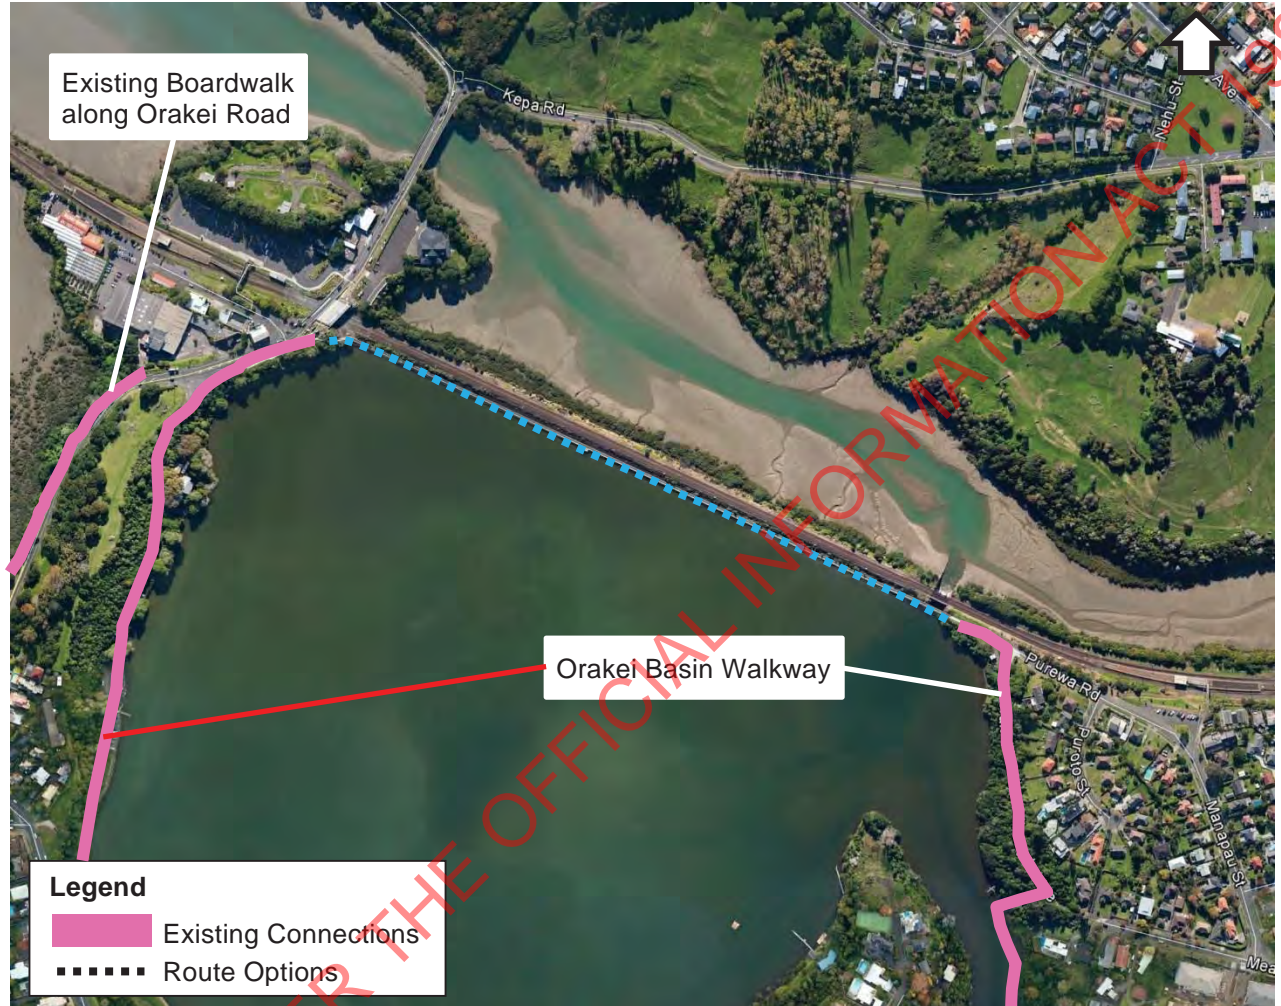
Figure 6-2 : Section 3 route connectivity

This section of the route has connectivity options at either end of the section with mainly pedestrian access as identified in Figure 6-2. Sections of the Orakei Basin walkway through reserves could be upgraded to accommodate cyclists.

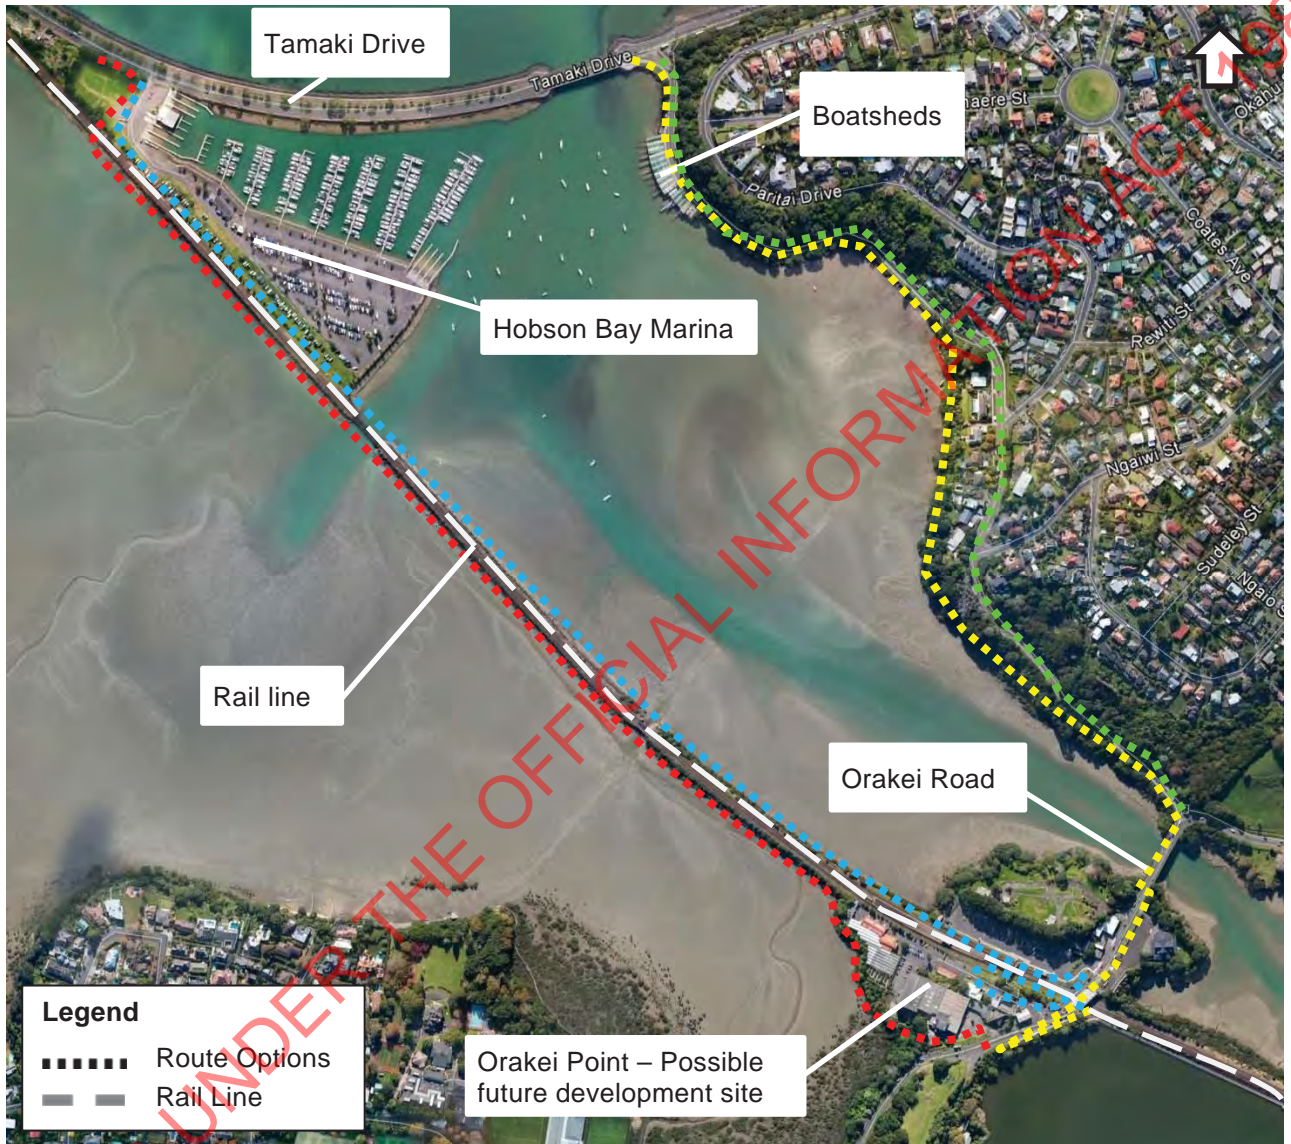
Figure 7-1 : Route options investigated along Section 4

Figure 7-1 shows the route options considered.

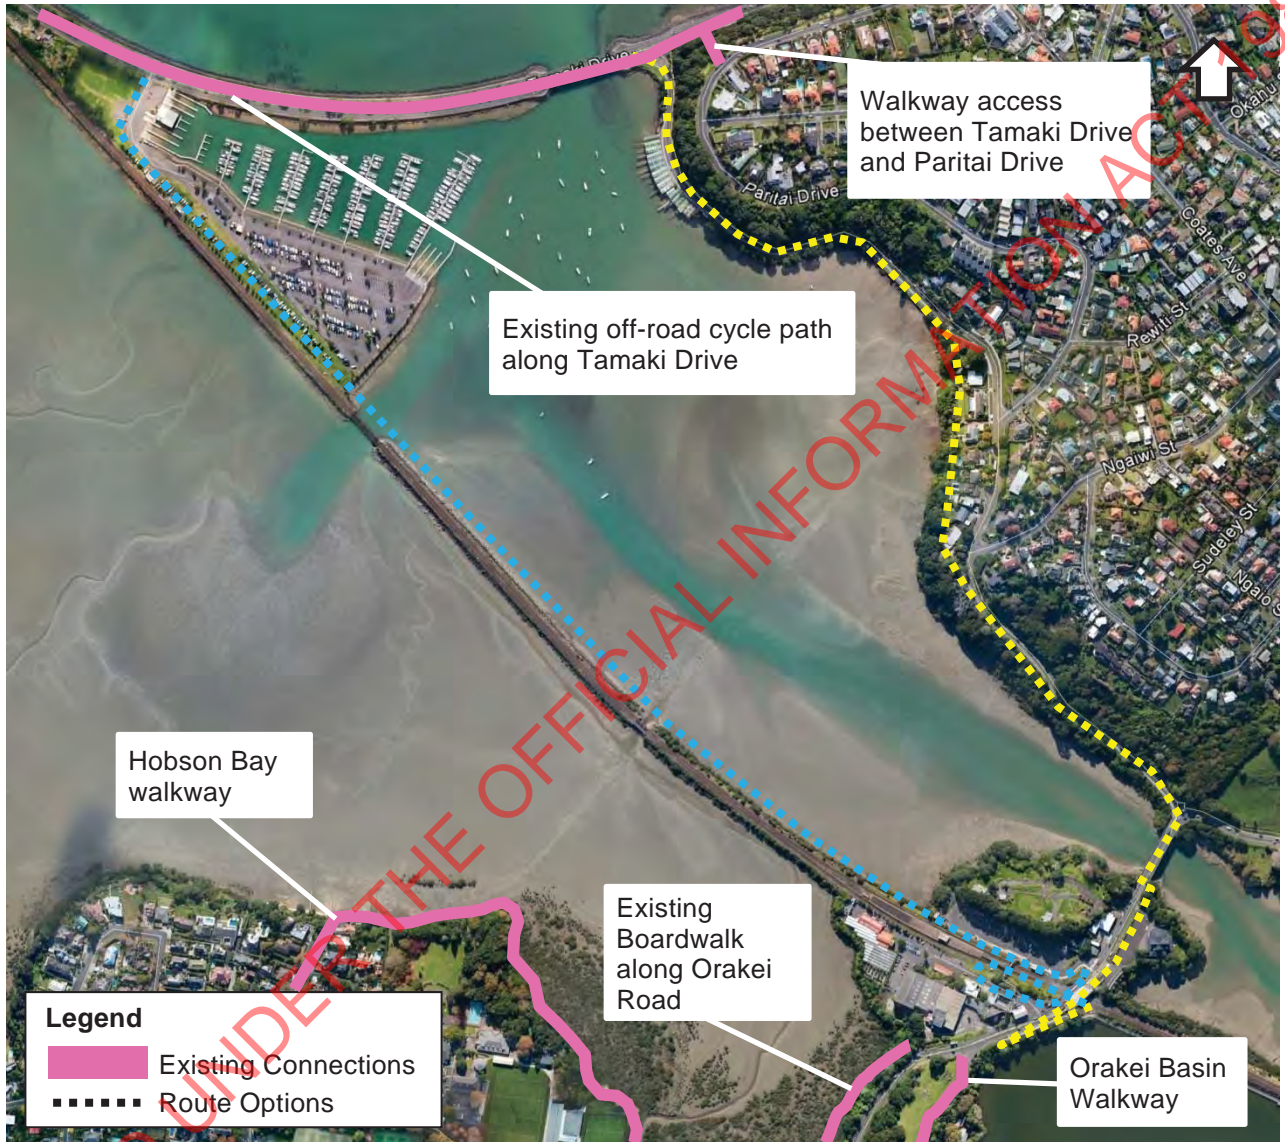
Figure 7-2 : Section 4 route connectivity

This section of the route has two connections at the southern end with mainly pedestrian access as identified in Figure 7-2. However the Orakei Basin walkway through the reserve section could be upgraded to accommodate cyclists. The route connects to Tamaki Drive where there is an existing shared path.

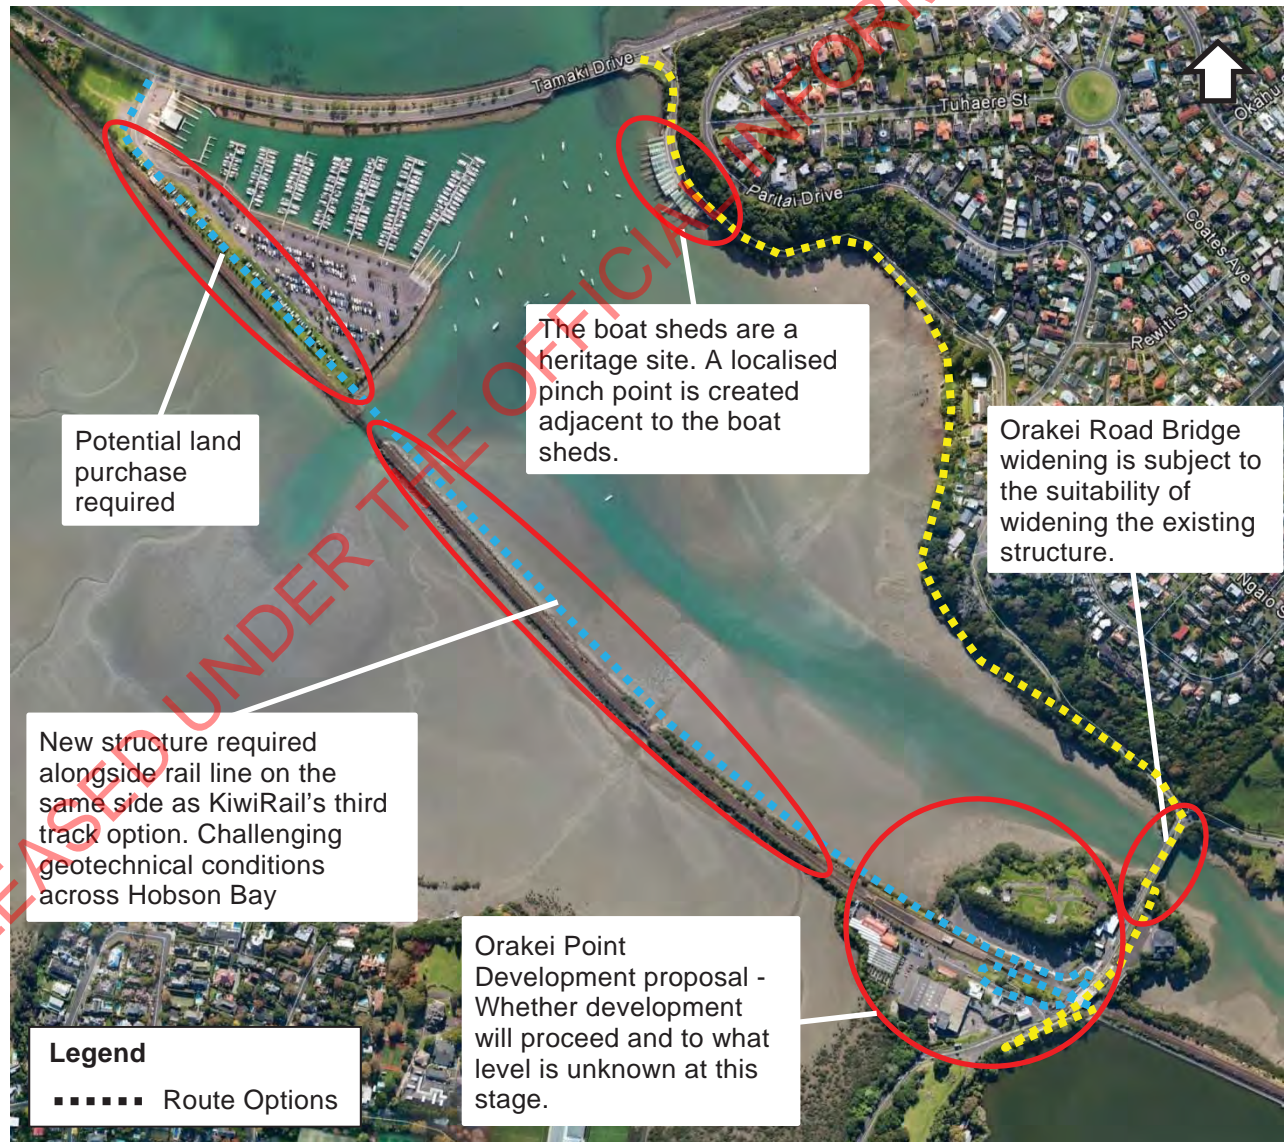
Figure 7-3 : Section 4 route constraints

The constraints for Section 4 are summarised in Figure 7-3.

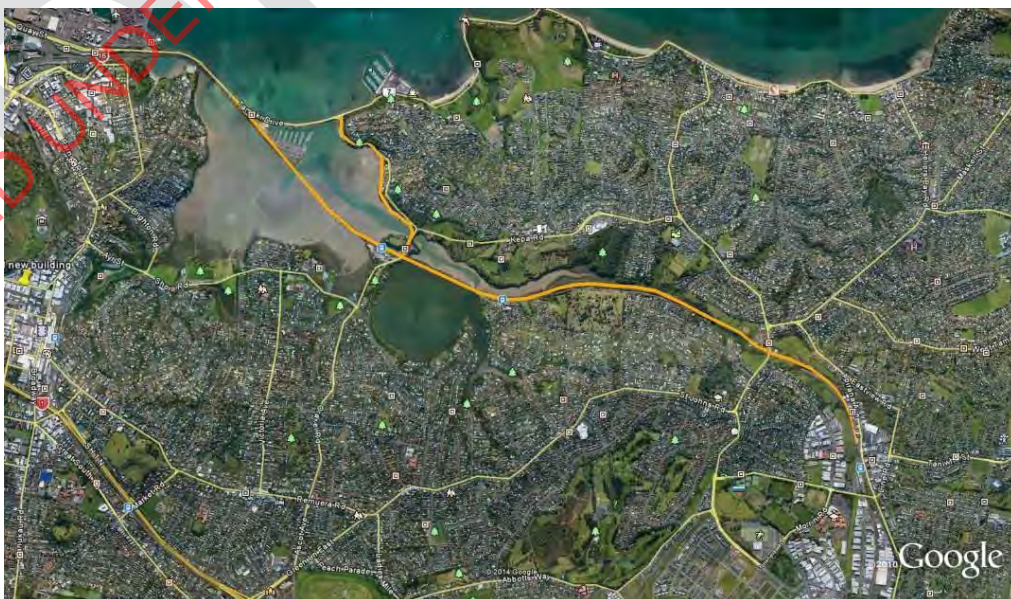
Image 2-1: Aerial map of indicative route and project area (image sourced from Google Maps)

The Project will link Glen Innes to Tamaki Drive via a 7.5 kilometre generally 3.0 metre wide shared path. The Project will provide a continuous walking and cycling facility between the city centre and the eastern suburbs, consistent with AT's integrated multi-modal transport vision. While the final Project route is still to be determined, Image 2-1 shows an indicative route and the general project area.

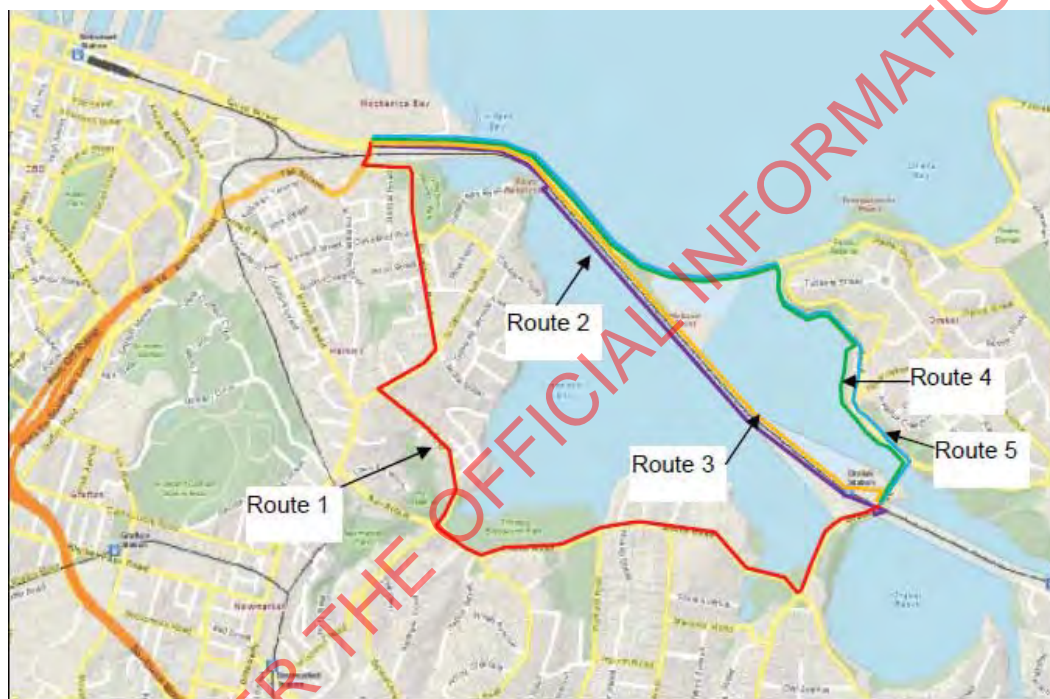
Figure 2 Proposed routes connecting Tamaki Drive to Orakei Station

A feasibility report entitled *Hobson Bay Shared Path – Project Feasibility Report* dated 17 October 2012 was prepared by Beca Carter Hollings and Ferner Ltd (Beca), which assessed the feasibility of the various routes in Section 1 that would connect Tamaki Drive to Orakei Station. Five routes were proposed in the Project Feasibility Report (PFR) as shown in Figure 2. Route 1 was discounted by AT. Routes 2 to 5 which involve development over Hobson Bay or along Ngapipi Road will be considered for this PGAR and have outlined further in Section 5 of this report.

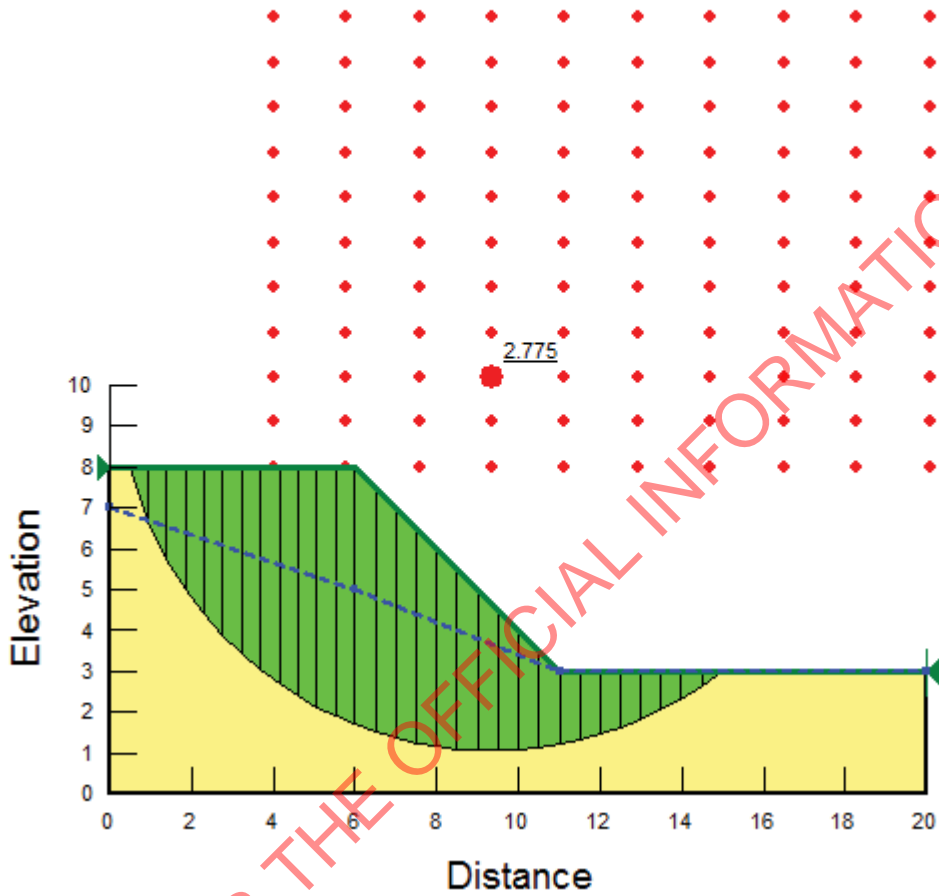
1H:1V slope
Static Case
Short term undrained conditions
Undrained shear strength, $c = 40$ kPa

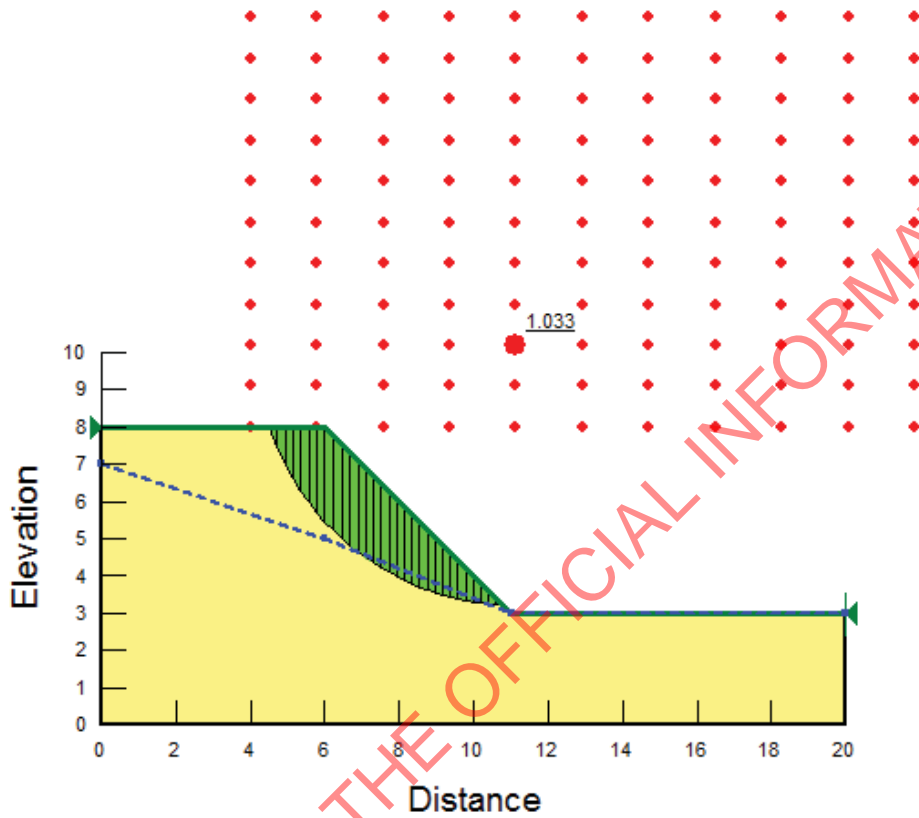
1H:1V slope
Static Case
Long term drained conditions
Drained cohesion, $c' = 4$ kPa
Drained Friction angle, $\Phi' = 25$ degrees

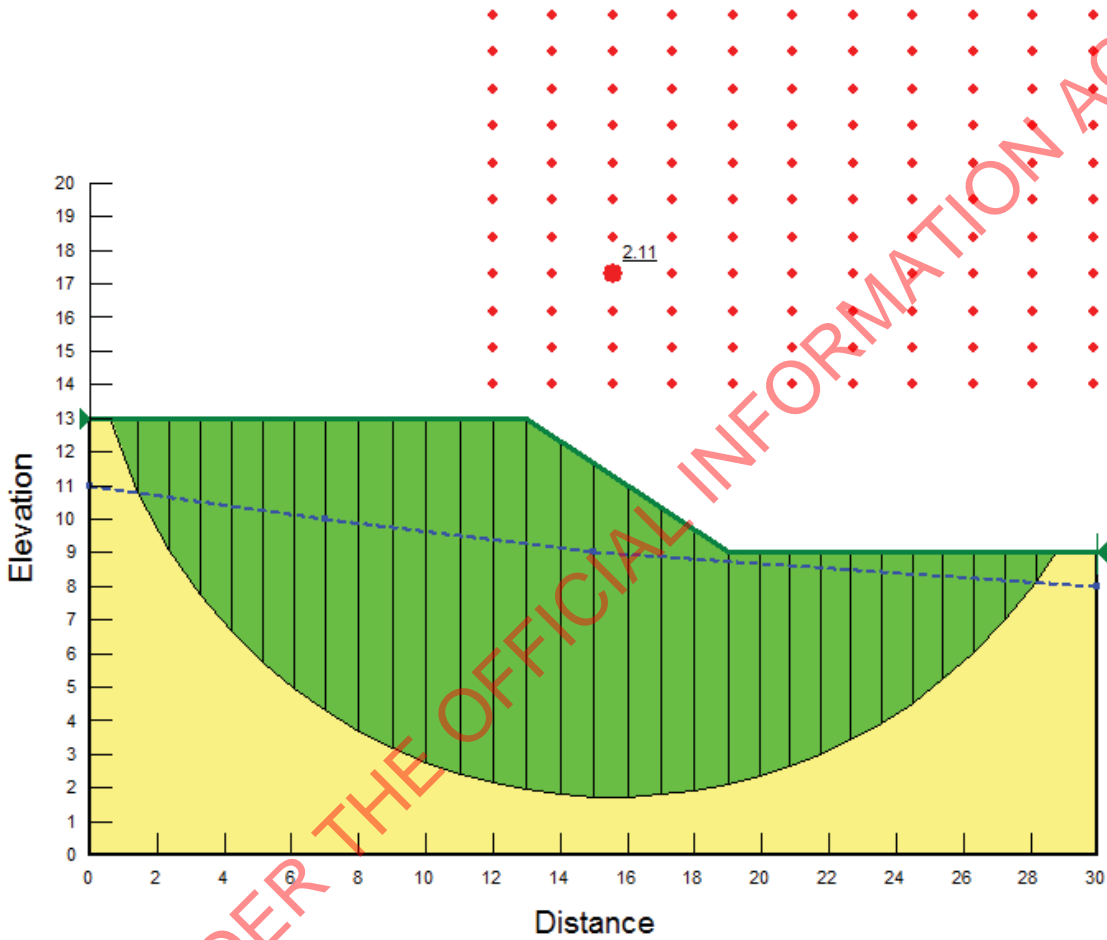
1.5H:1V slope
Seismic case (maximum considered earthquake)
Short term undrained conditions
Undrained shear strength = 40 kPa

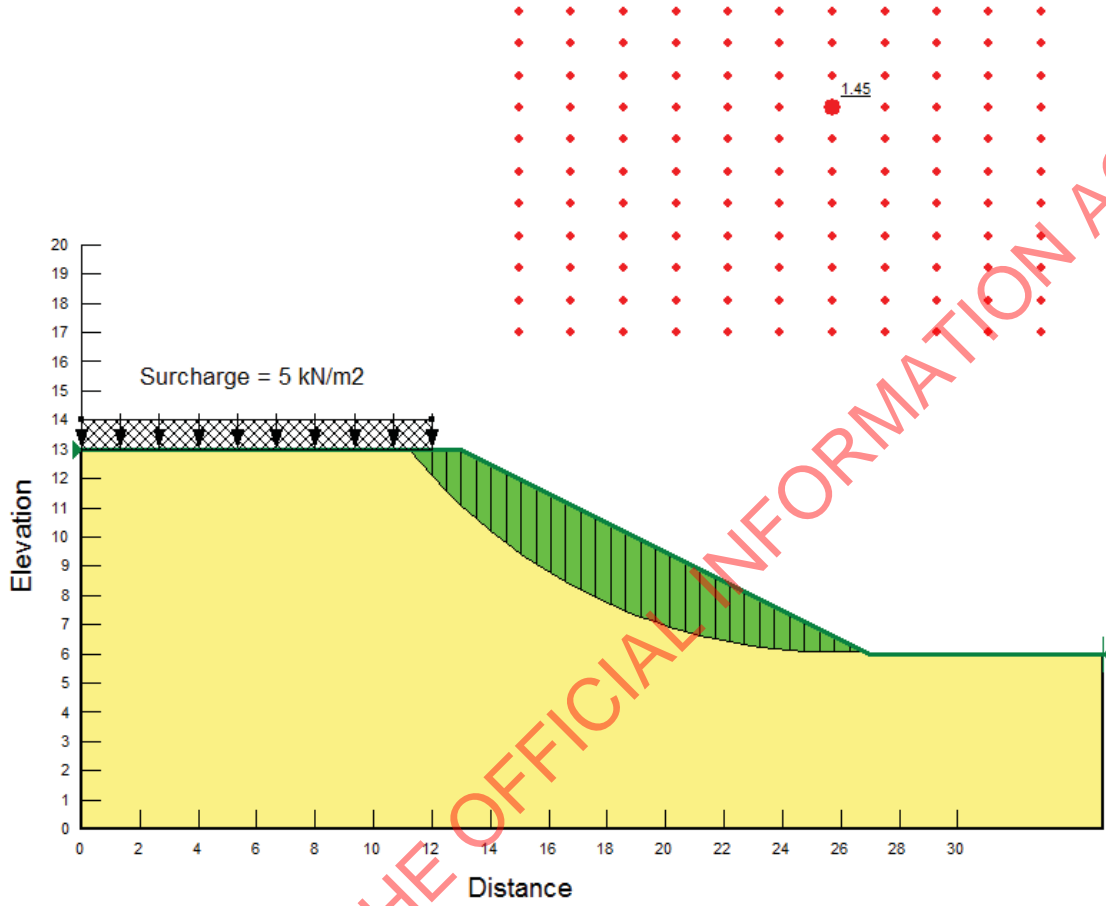
2H:1V slope
Static case
Long term drained conditions
Drained cohesion, $c' = 4 \text{ kPa}$
Drained angle of friction, $\phi' = 25 \text{ degrees}$

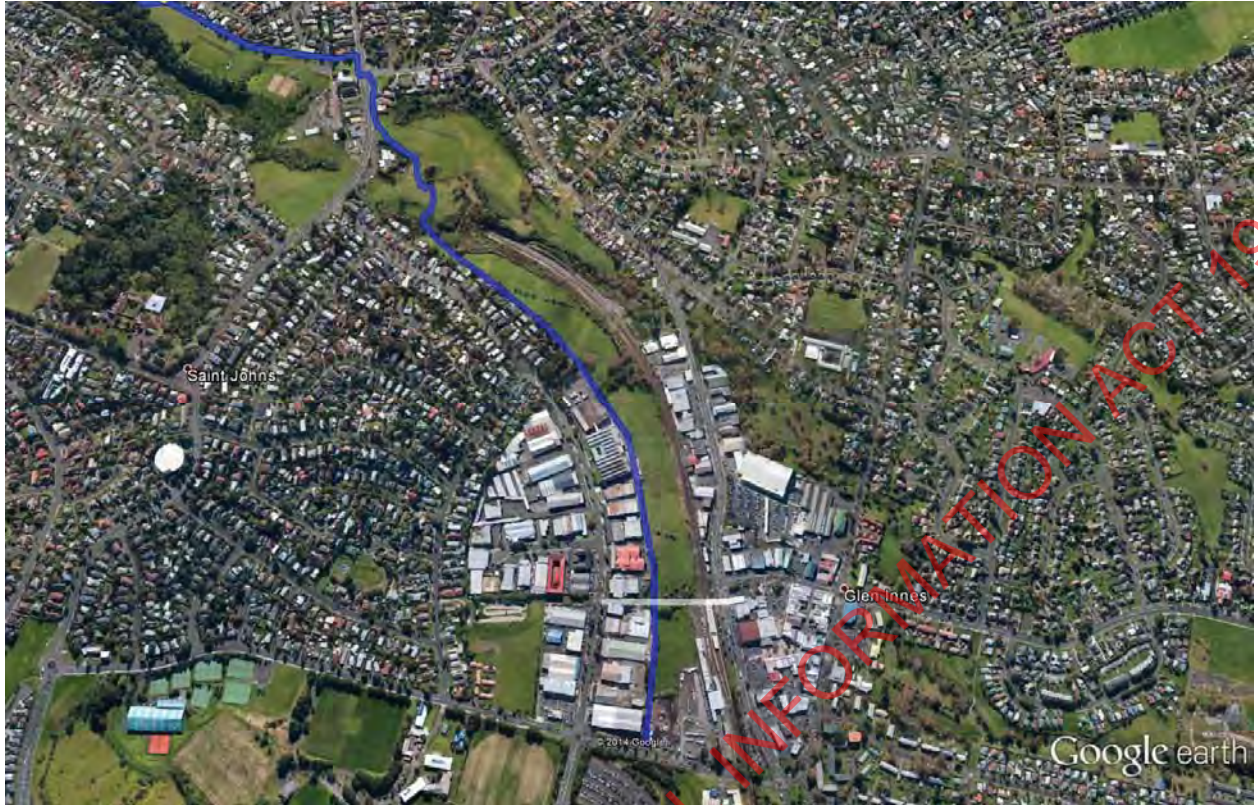
Figure 1-2: Section One

For ease of discussion, this Report splits the route into three sections. Section one extends from Merton Road to St Johns Road and is shown in Figure 1-2. Section two extends from St Johns Road to Orakei Road and is shown in Figure 1-3. Finally Section three extends from Orakei Road across (or around) Hobson Bay to Tamaki Drive as shown in Figure 1-4.

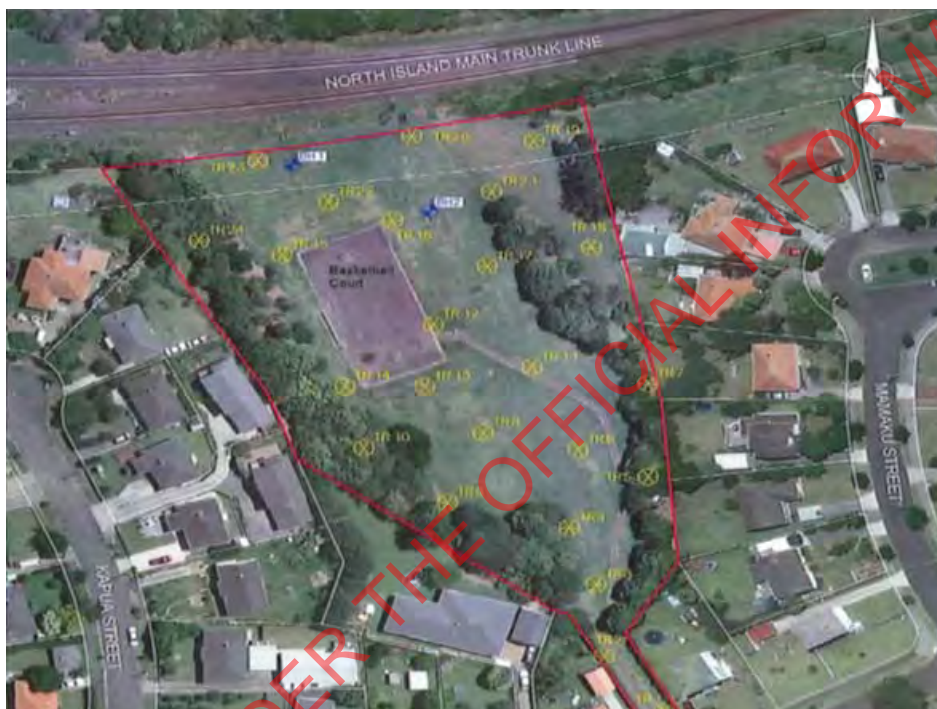
Figure 2-1: Sampling Locations (Tonkin and Taylor, 2012)

Tonkin and Taylor analysed 24 surface soil samples and one groundwater sample, the locations of which are shown in Figure 2-1. Soil samples were analysed for metals, polycyclic aromatic hydrocarbons (PAHs), and asbestos containing material (ACM). None of the samples tested detected ACM.

Sample TR 14 returned a mercury concentration elevated above the proposed Air, Land and Water Plan (PLAWP) and samples TR 2, TR 8 and TR 17 exceeded the Auckland Council Tier 1 and PALWP criteria for Benzo a pyrene equivalents (BaP eq). All results recorded were below the National Environmental Standard for Assessing and Managing Contaminated Land (NES), recreation and park maintenance workers soil contaminant standard.

It is therefore concluded that while there is some risk to human health from the elevated contaminant levels within the western end of the Tahape Reserve these concentrations are likely to be below the NES commercial/industrial guidelines and therefore the risk to construction workers who will install the proposed shared path will be minimal if appropriate site controls are implemented.
