Appendix A Scheme Estimates

Project estimate: Entire Route

Project name: Glen Innes to Tamaki Drive Shared Path

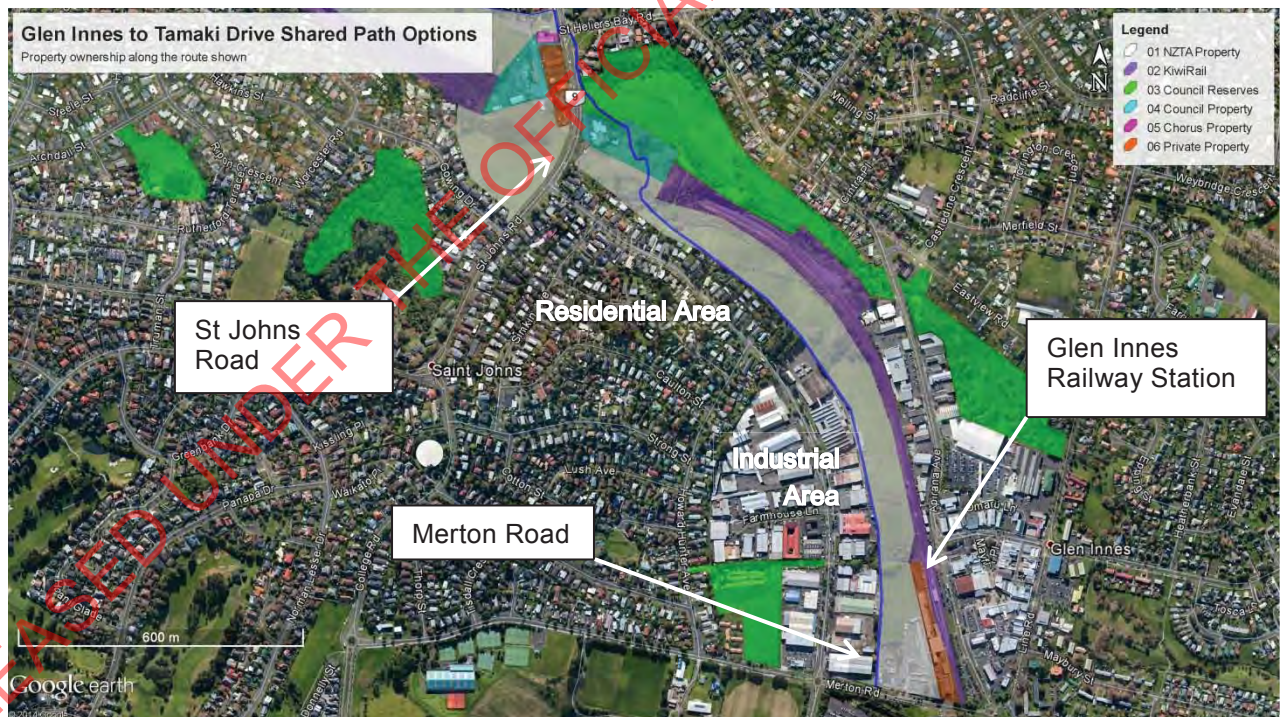
Figure 1-1: Glen Innes to Tamaki Drive Shared Path Route – Section 1 (blue line).

Section 1 begins at Merton Road between a landscape supplies yard and a supermarket. As the path continues north it runs directly adjacent to an industrial area (<10 m to the west) which extends for the first 750 m of the alignment. The adjacent land then changes to a residential area for the remainder of Section 1. Glen Innes Railway Station is also in close proximity to the start of Section 1 (approximately 100 m to the east) and runs adjacent to the railway line within a KiwiRail-owned corridor, typically 50 to 100 m to the east. The industrial area has been built up with fill to obtain the same level as Felton Mathew Road before the ground slopes down through the reserve to the railway line below.

Figure 1-1 shows Section 1 of the proposed Shared Path, which extends from Merton Road to St Johns Road, in Glen Innes.

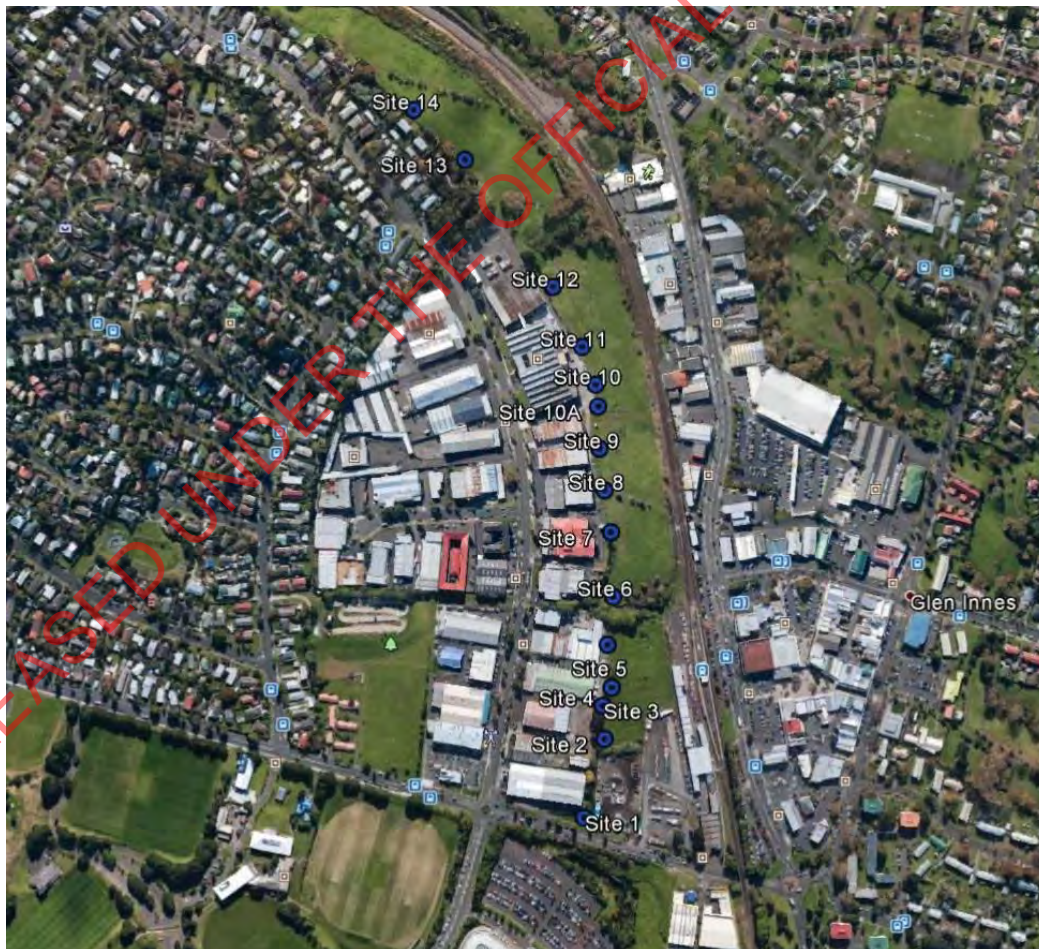
Figure 2-1: Soil sampling locations along Section One of the Glen Innes to Tamaki Drive Shared Path Route.

Soil sampling was undertaken at 15 locations along the Section 1 of the Shared Path route. The majority of these sampling points were located adjacent to the industrial area, with just two of the 15 sites adjacent to the residential area. The locations of the soil sampling sites are shown in Figure 2-1.

Soil sampling was undertaken on the 2nd October 2014. Soil samples were collected at depths of i) approximately 500 mm bgl for all 15 sites, and ii) 1 m bgl for 10 of the sites directly adjacent to the highest density areas of industrial activity, using a 50 mm hand auger. Soil samples were taken in accordance with standard MWH environmental monitoring procedures and were consistent with the Ministry for the Environment (MFE) Contaminated Land Management Guidelines No. 5 Site Investigation and Analysis of Soils (Revised 2011), as required under the NES. A service location company undertook an electromagnetic induction (EMI) and ground penetrating radar (GPR) survey during drilling to ensure any potential underground services were avoided.

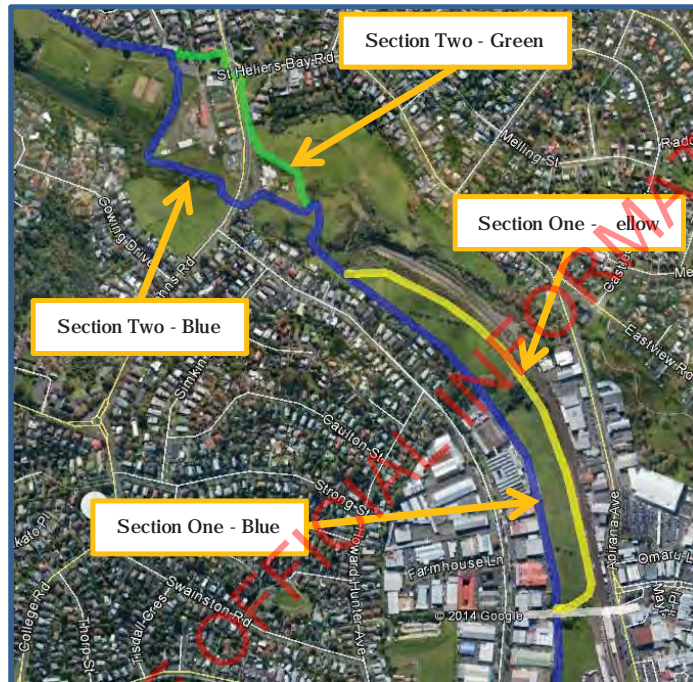
Figure 2 1: Route Options for MCA

For the purposes of the workshop only Section One of the project (Merton Road to St Johns Road) was analysed. Because there are two options to cross St Johns Road the MCA was carried out to the termination of the two options. Therefore the MCA process was carried out for the four options shown in Figure 2-1 below:

- MCA Section One - Blue vs Yellow Route (From Glen Innes Station to prior to St Johns Road)
- MCA Section Two - Blue vs Green Route (Crossing St Johns Road)

For Section One the Blue route was rated higher than the yellow route and for Section Two the Green Route was higher than the Blue Route. Therefore, it is recommended that the Blue route is continued with for Section One at the Glen Innes end of the route and the Green Route for Section Two where the route crosses St Johns Road.
