## **DRAFT REPORT**

# **Old Mangere Bridge Superstructure and Pier Crosshead Beam Capacity Peer Review**

A UfW 2016

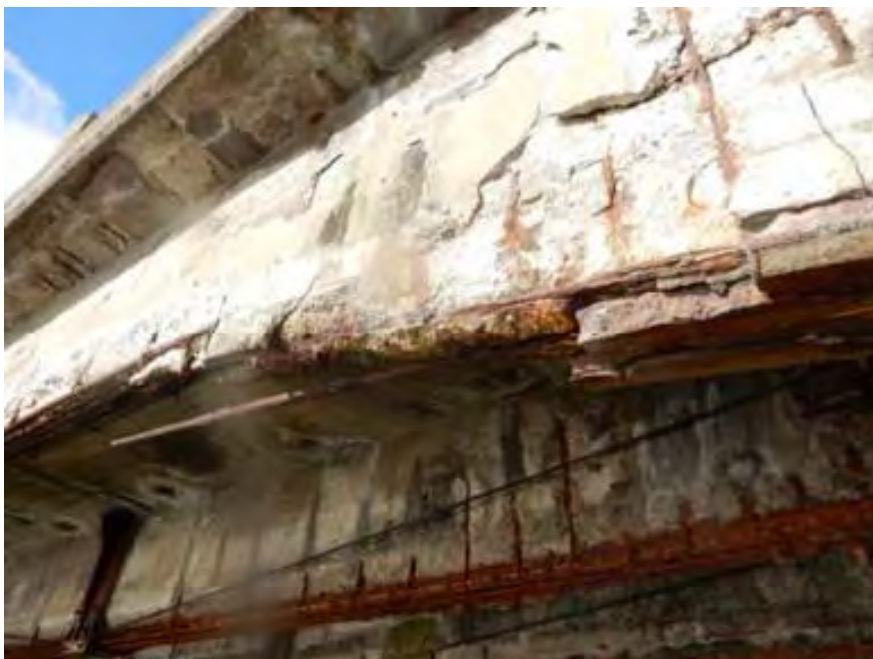
Figure 1: Photo from principal inspection report showing extensive edge girder spalling.

- The full girder cross section was assumed to contribute to the girder dead load. 40mm cover from each side face and 100mm from the bottom face was assumed to have spalled when calculating girder capacity. This assumption was based on the photos from the Principal Inspection report such as that in Figure 1 which shows extensive edge girder spalling.

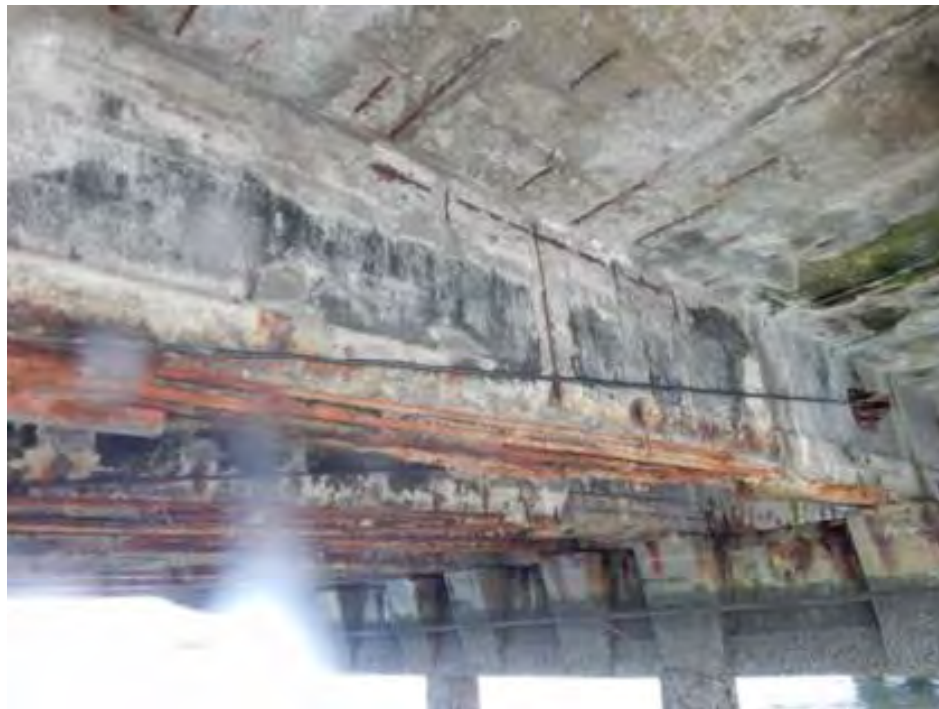
Figure 2: Photo from principal inspection report showing extensive spalling of internal girder.

- The full girder cross section was assumed to contribute to the girder dead load. 40mm cover from each side face and 100mm from the bottom face was assumed to have spalled when calculating girder capacity. This assumption was based on the photos from the Principal Inspection report such as that in Figure 2 which shows extensive internal girder spalling.

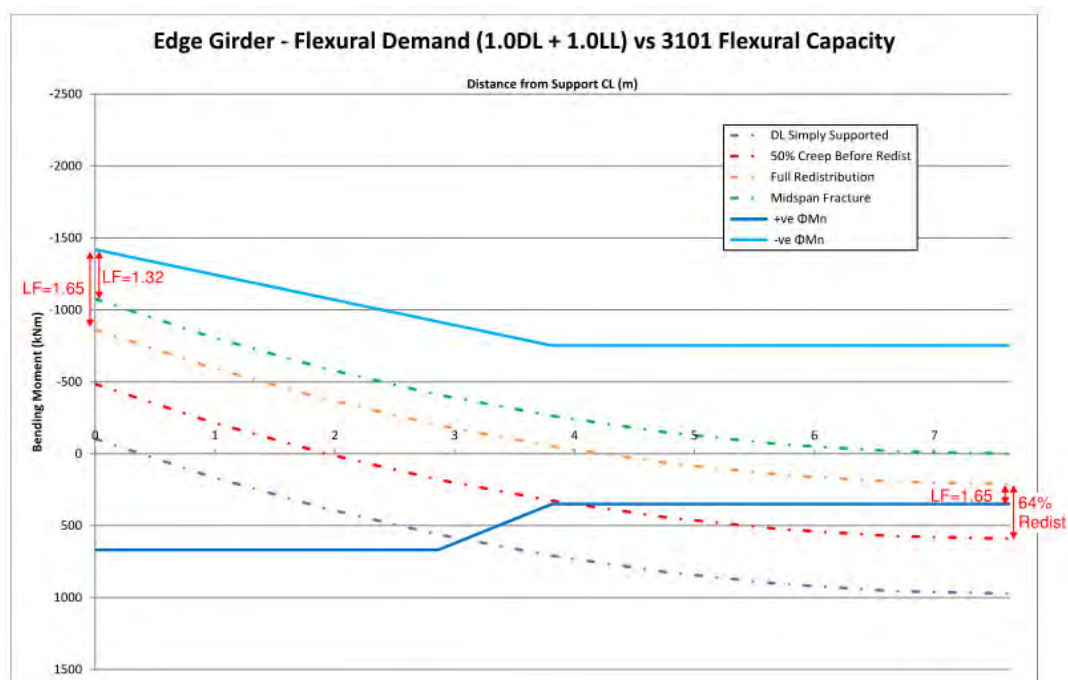
Figure 3: Comparison between flexural demand and flexural capacity for edge girder.

The external girder was checked for flexural capacity to NZS3101. A comparison between the flexural demand and flexural capacity along half the span of the girder is shown in Figure 3. For the demands calculated assuming the dead load was applied to simply supported girders it was found that the midspan flexure demand was 177% greater than the capacity and as shown in Figure 3 this would require a very large amount of moment redistribution. When the demands were recalculated assuming '50% creep' the midspan flexure demand was 69% greater than the capacity. With 64% redistribution of the midspan moment an overall load factor of 1.65 under DL + LL is obtained both at midspan and over the pier.

Because the moment redistribution required for midspan flexure is greater than the code allowable limit there may be a risk of rupture of the tension reinforcement at midspan. In this case each half of the girder would then act as a cantilever. As shown in Figure 3 even if this occurred there is still a DL + LL load factor of 1.32 for end hog flexure, thus the structure should not have a collapse mechanism in flexure. Note that as detailed below for the edge girder it is expected that the section is capable of significant ductile curvature and rupture of the tension reinforcement is therefore considered to be a relatively low risk.

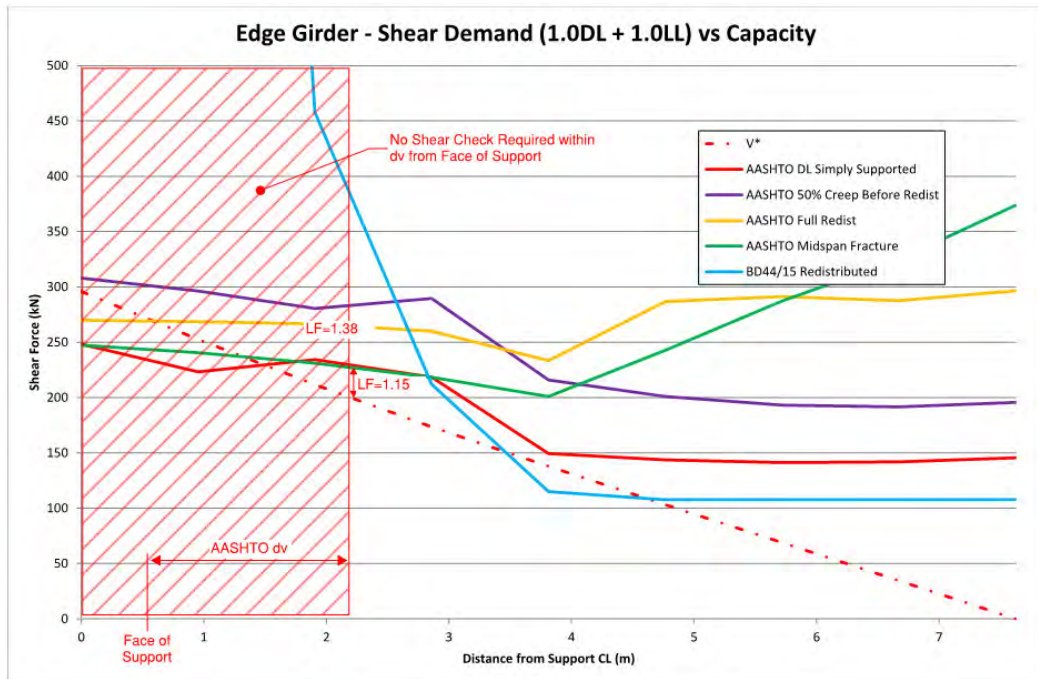
Figure 4: Comparison between shear demand and shear capacity for edge girder.

The girder capacity in shear is compared to the shear demands in Figure 4. For modified compression field theory the flexural demand affects the shear capacity. Therefore the shear capacity to AASHTO was calculated three times, once assuming the flexural demands from the '50% creep' case, once assuming the flexural demands after redistribution of the midspan bending moment had occurred and once based on the demands after fracture of the midspan tensile reinforcement. A DL + LL load factor against shear failure of 1.15 was obtained assuming fracture of the midspan tensile reinforcement or 1.38 assuming no fracture. The shear capacity to BD44/15 was found to be less than the shear demand.

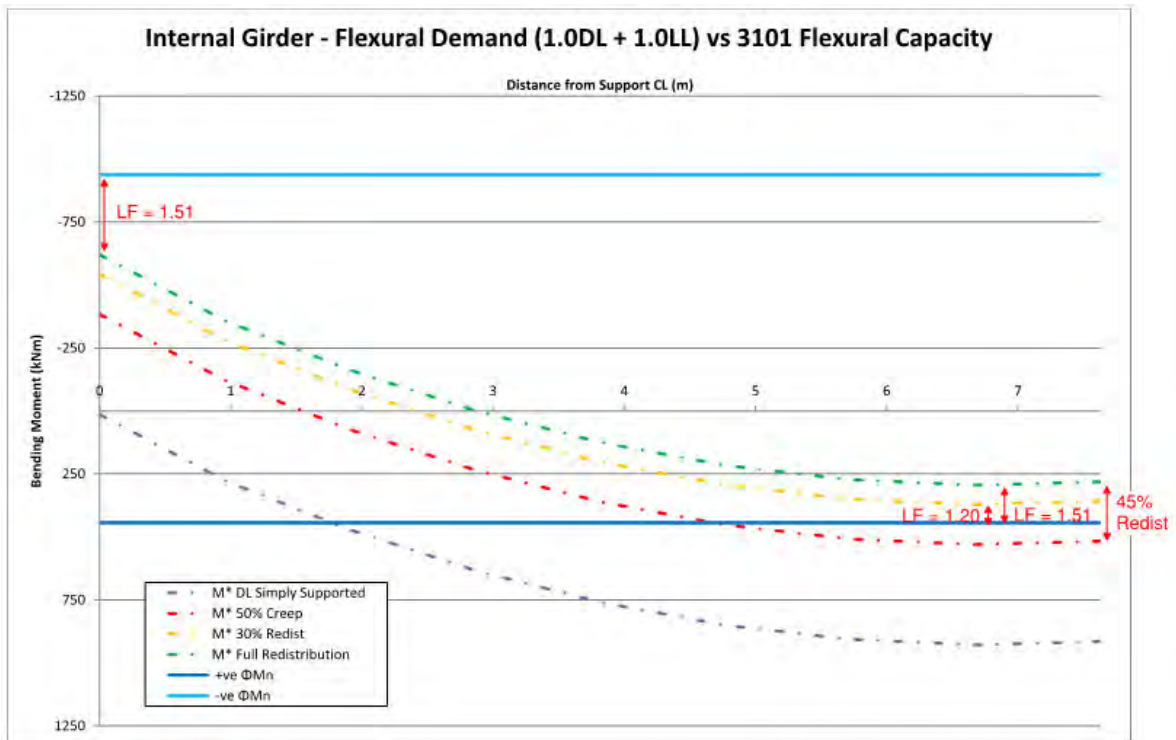
Figure 5: Comparison between flexural demand and flexural capacity for critical internal girder.

The critical internal girder was checked for flexural capacity to NZS3101. A comparison between the flexural capacity and demand along half the span of the girder is shown in Figure 5.

For the '50% creep' case with a redistribution of 30% allowed by NZS3101, a midspan DL+LL load factor of 1.20 is obtained. With full redistribution so the load factor at the support and midspan are equal, a load factor of 1.51 is obtained and redistribution of 45% of the midspan moment is required.

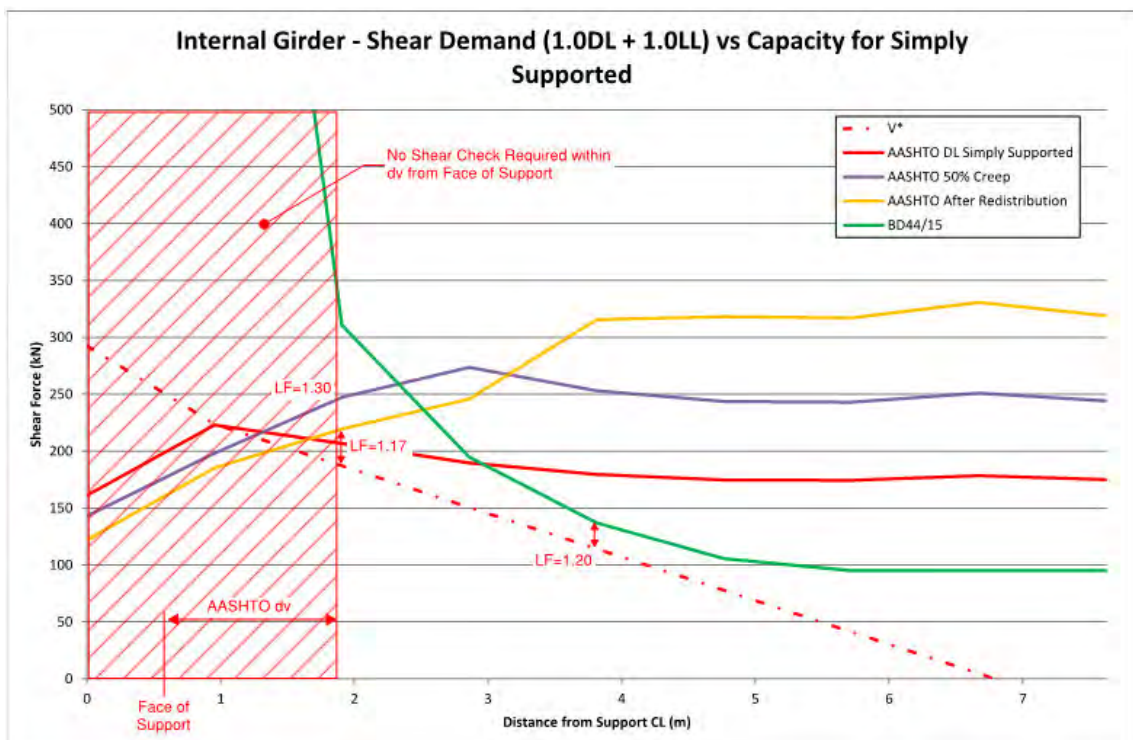
Figure 6: Comparison between shear demand and shear capacity for critical internal girder.

The girder capacity in shear is compared to the shear demands in Figure 6. For modified compression field theory the flexural demand affects the shear capacity. Therefore the shear capacity to AASHTO was calculated once based on the demands prior to moment redistribution and once based on the redistributed demands. A DL+LL load factor against shear failure of 1.30 was obtained assuming no moment redistribution had occurred and 1.17 after moment redistribution. When the shear capacity was calculated to BD44/15 a DL+LL load factor of 1.20 was obtained.

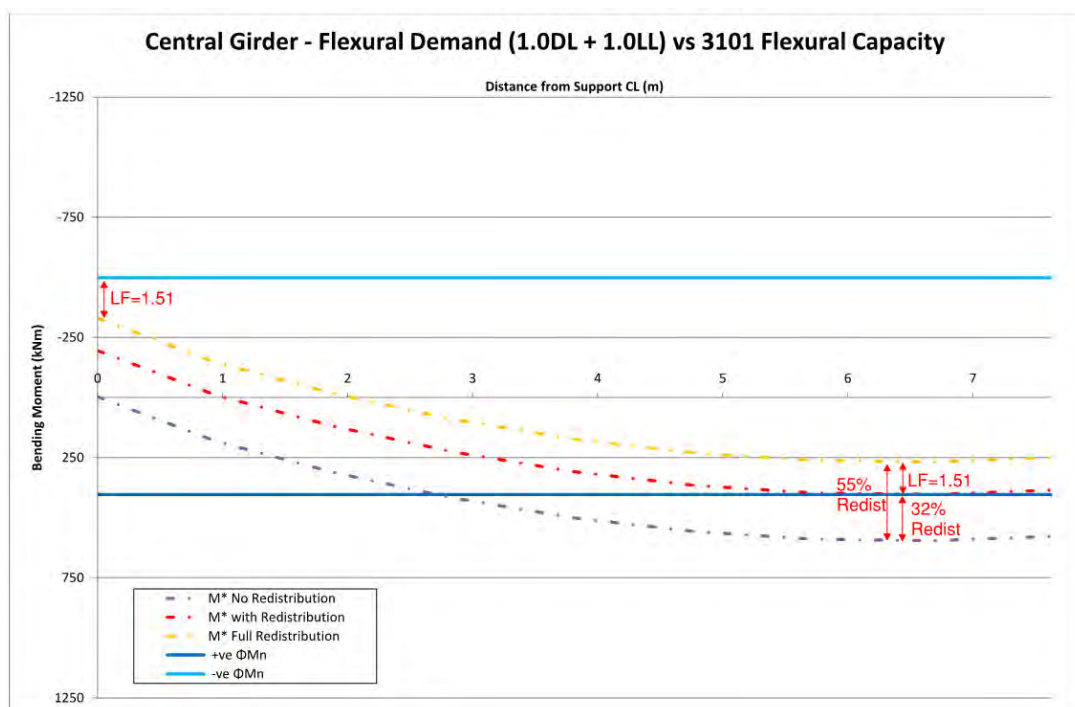
Figure 7: Comparison between flexural demand and flexural capacity for central girder.

After full moment redistribution of 55% there is a DL+LL load factor of 1.51 against failure due to negative flexure over the pier or positive moment at midspan. This girder was also found to be less critical than the other internal girders for shear.
