Housing New Zealand Corporation Retest 1 Methamphetamine Assessment

Site Assessment Date	29 th June 2017
Sample Team	s 9(2)(a)
Report Author	
Report Checked by	
Key Technical Person	
Property Reference	HSS0034158
Works Order	WO1611788

Housing New Zealand Corporation Post-remediation Methamphetamine Assessment

Housing New Zealand Corporation Initial Methamphetamine Assessment

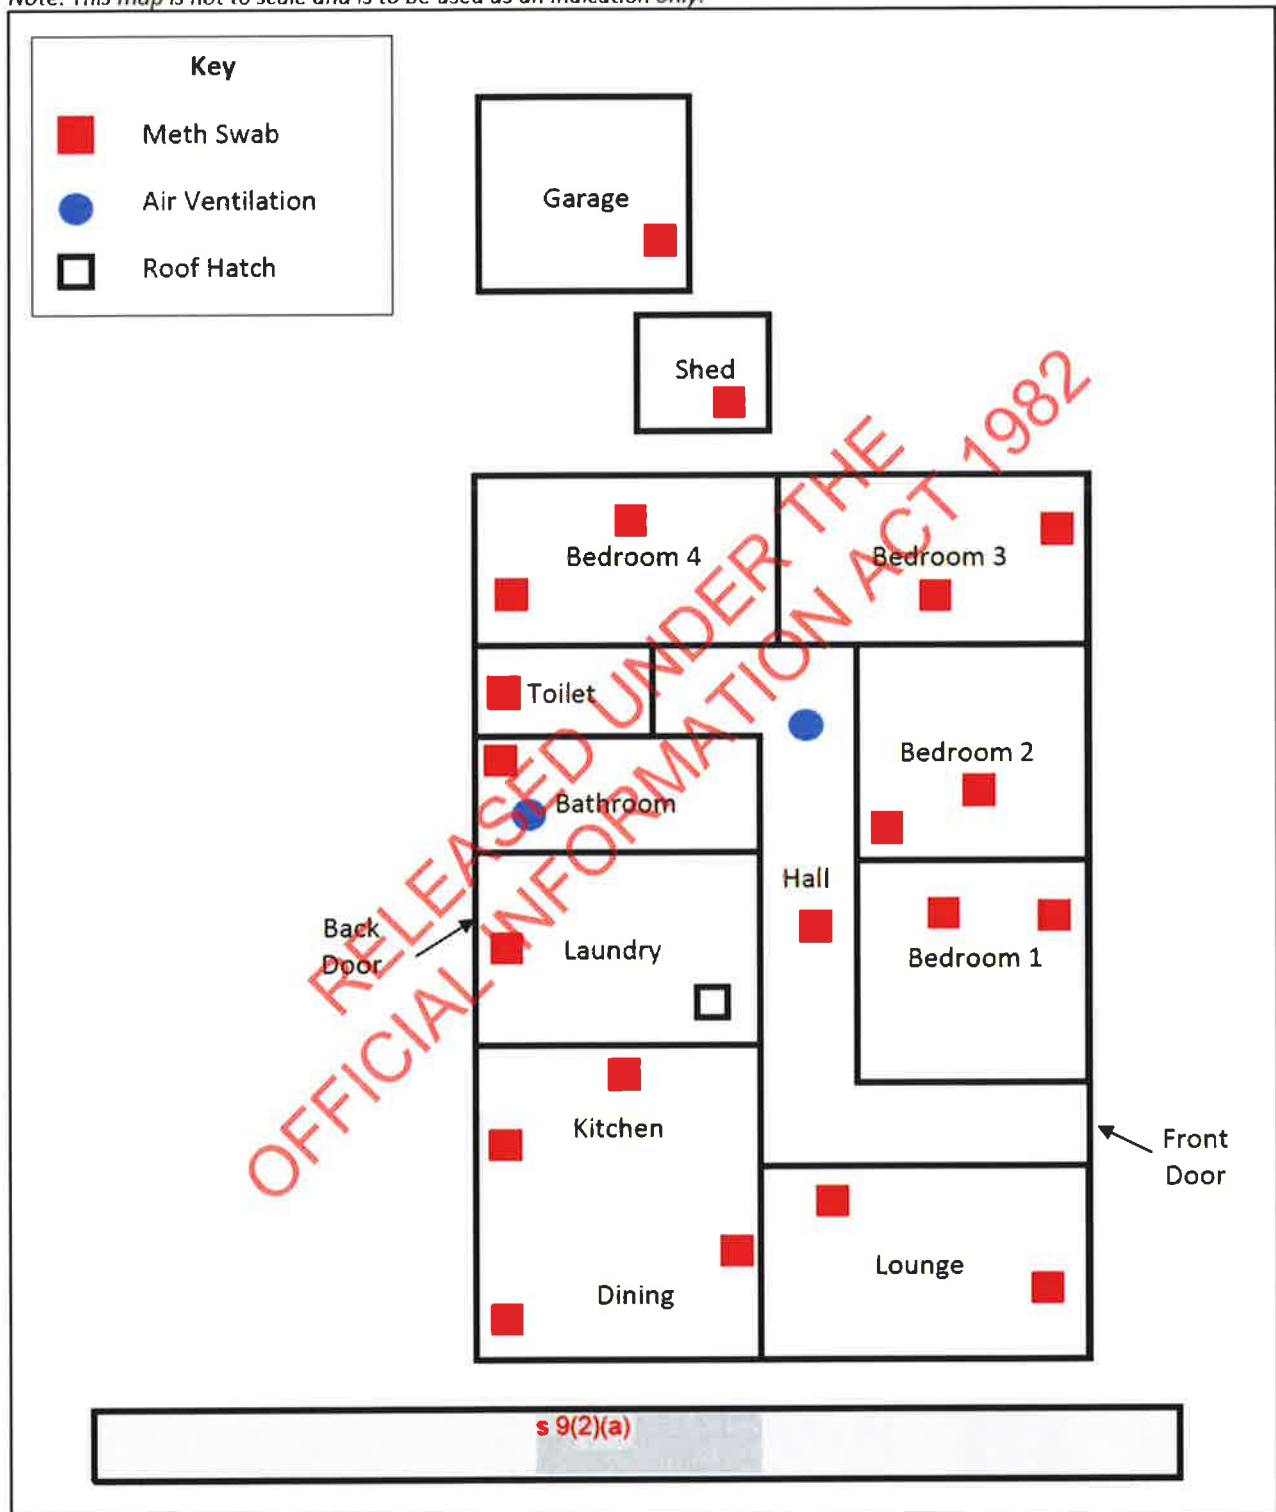
Figure 1 Site Map Showing Sample Locations

The following is a map indicating where samples were collected from.

Note: This map is not to scale and is to be used as an indication only.

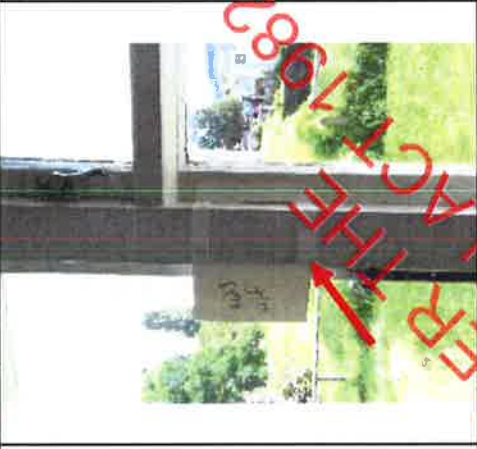
<p>Photo 11: Bedroom 3 Window Frame – 4.3µg/100cm²</p>

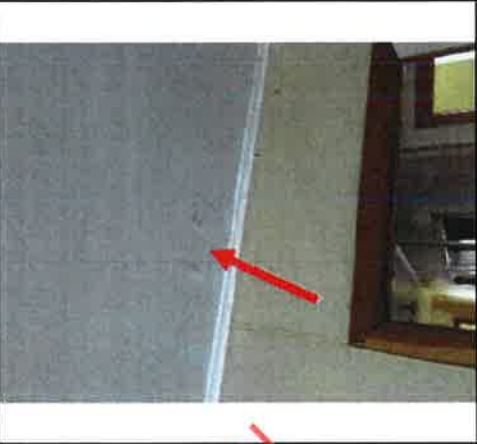
<p>Photo 12: Bedroom 3 Ceiling – 1.95µg/100cm²</p>

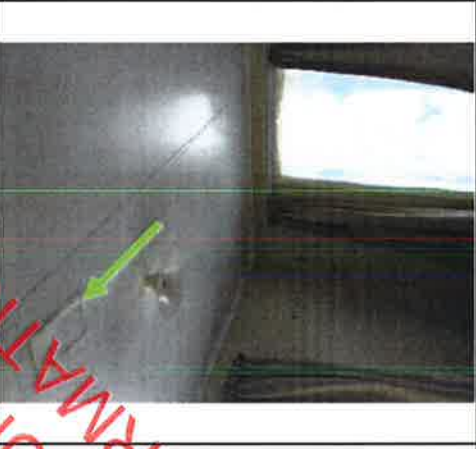
<p>Photo 15: Bedroom 4 Ceiling – 1.04µg/100cm²</p>

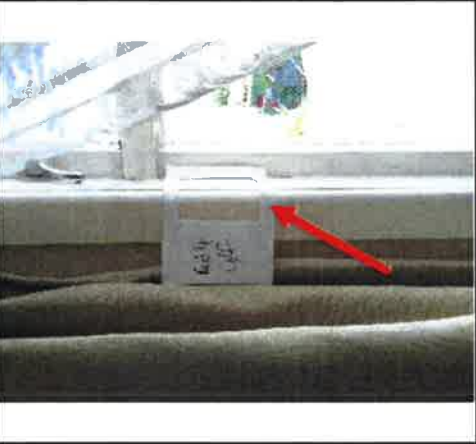
<p>Photo 16: Bedroom 4 Window Frame – 4.7µg/100cm²</p>

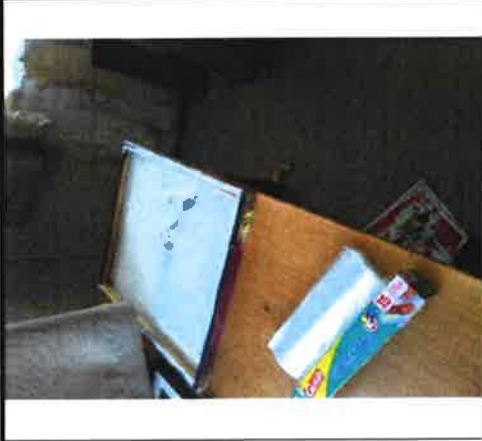
<p>Photo 17: Bedroom 4 Drug Paraphernalia</p>	<p>Photo 18: Dining Room</p>	<p>Photo 19: Dining Room Window Frame – 8.4µg/100cm²</p>	<p>Photo 20: Dining Room Wall – 13.4µg/100cm²</p>

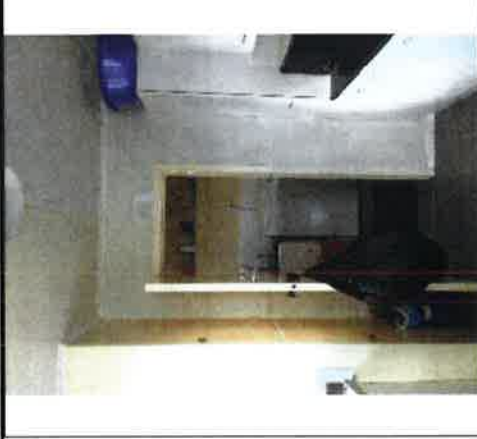
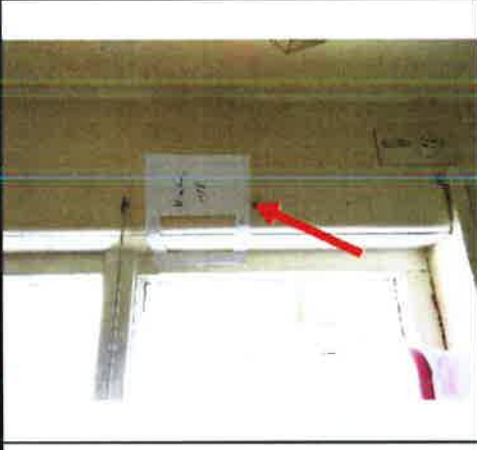
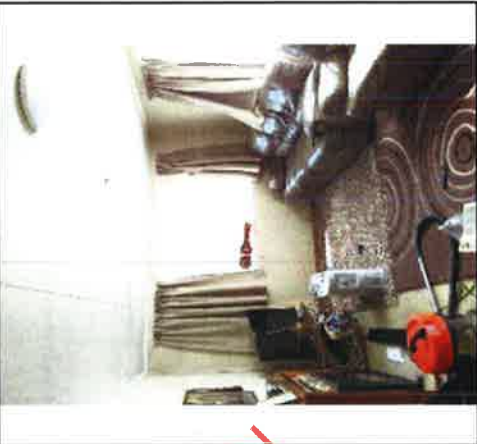
<p>Photo 21: Hall</p>	<p>Photo 22: Hall Ceiling – 1.73µg/100cm²</p>	<p>Photo 23: Laundry</p>	<p>Photo 24: Laundry Back Door – 9.2µg/100cm²</p>

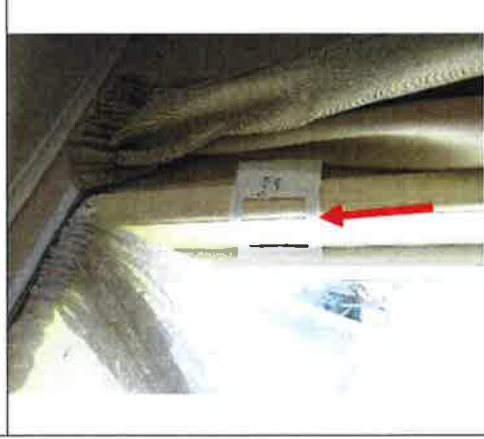
<p>Photo 25: Kitchen</p>	<p>Photo 26: Kitchen Window Frame – 9.5µg/100cm²</p>	<p>Photo 27: Kitchen Wall – 1.03µg/100cm²</p>	<p>Photo 28: Lounge</p>

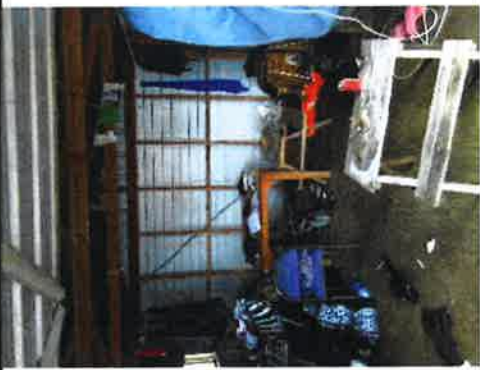
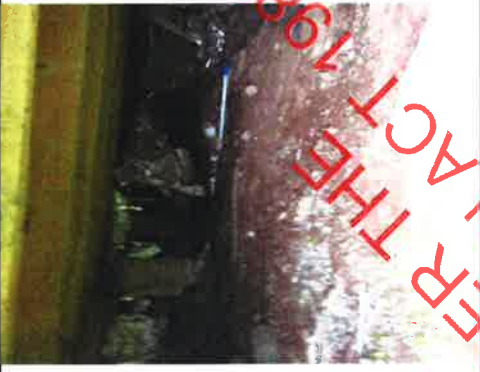
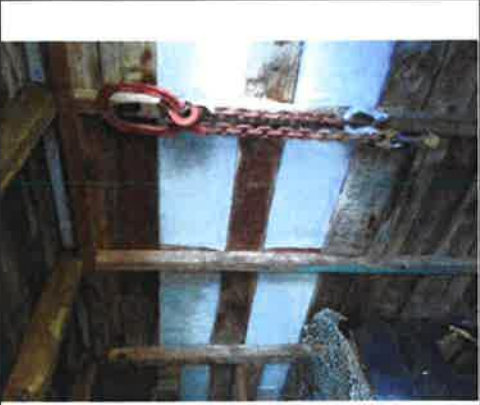
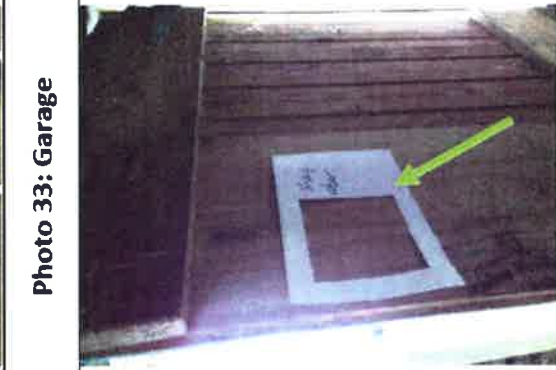
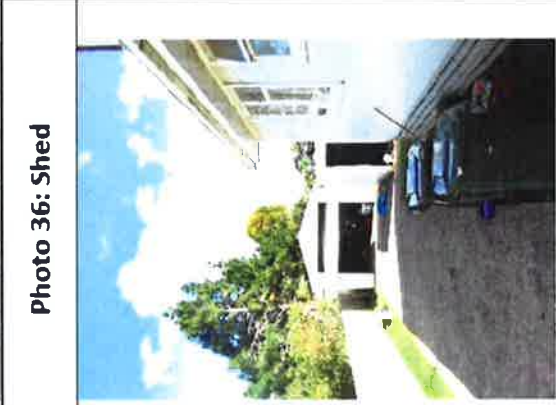
<p>Photo 33: Garage</p>	<p>Photo 34: Garage Side Door – 0.24µg/100cm²</p>	<p>Photo 35: Underfloor Space</p>	<p>Photo 36: Shed</p>
<p>Photo 37: Shed Door – <0.02µg/100cm²</p>	<p>Photo 38: Ceiling Space</p>	<p>Photo 39: Exterior</p>	<p>Photo 40: Driveway</p>
