To	Peter Murray - DCE Information and Knowledge Services
Cc	Preserving the Nation's Memory Governance Board Rob Stevens, Project Director Rosie Perez, Project Manager
From	Liana Lloyd-Simpson, Senior Project Manager
Date	15 February 2018
Subject	PtNM Project: Board Action Item AP118 Climate Change Impact

**Preserving the Nation's Memory**  
**10 Mulgrave Street**  
**Hazard Assessment**

## 10 Mulgrave Street Hazard Assessment

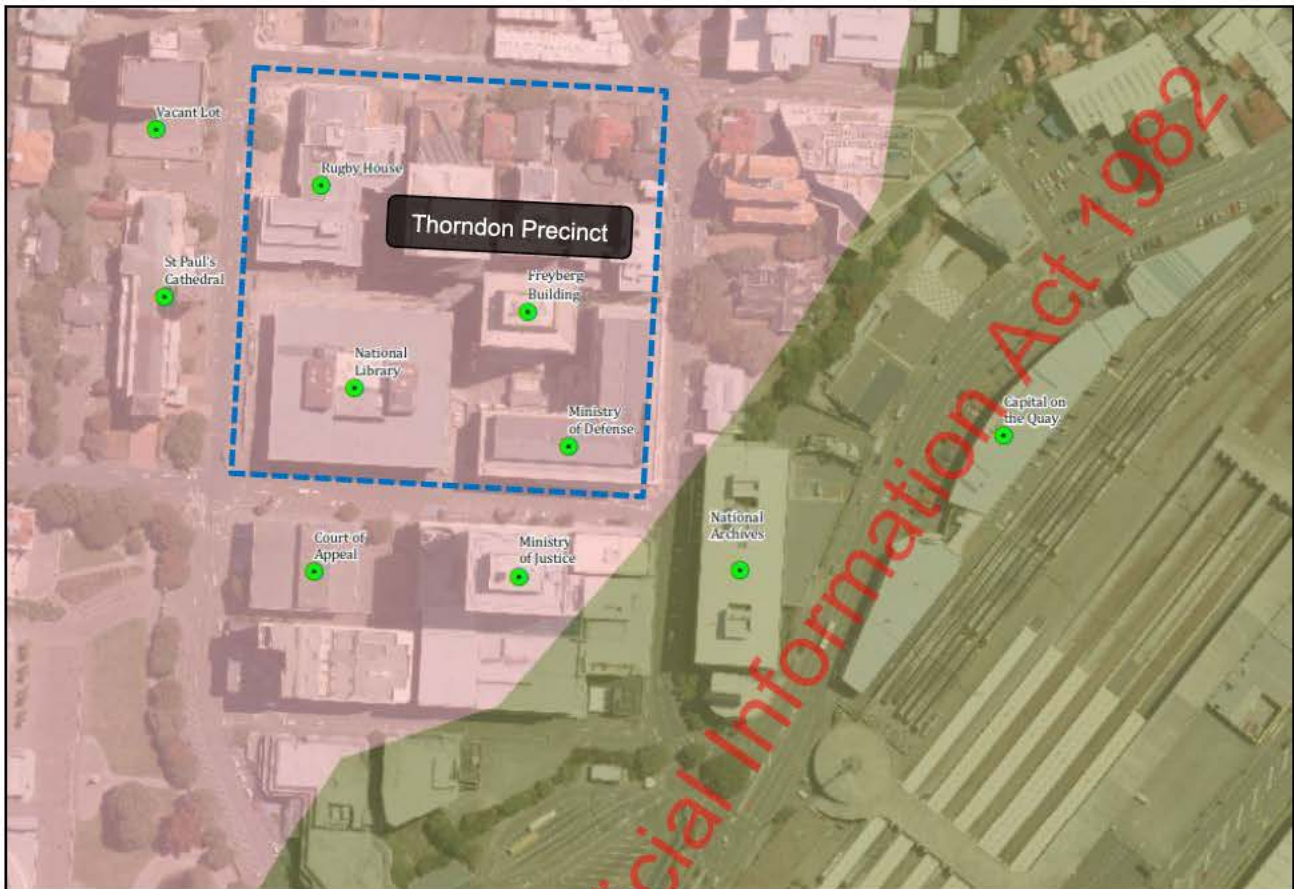
**Illustration 2** Geology of Thorndon Area (IGNS, 2000)

The third geological unit in the vicinity of the Archives New Zealand are alluvial deposits of the Whiteman Formation (DSIR, 1974). These deposits comprise gravels, sands, silts and peat and are preserved as a terrace. The edge of this alluvial terrace is likely to account for the elevation difference between Mulgrave Street and Thorndon Quay and marks the historical shoreline prior to reclamation of the land further east.

- Notes*
1. This map was originally 1:250,000 scale and does not depict the marginal marine deposits shown in the IGNS 1996 1:50,000 map.
  2. Due to the scale of this map (1:250,000) the boundary of these units should be considered to be accurate to  $\pm 250$  m.

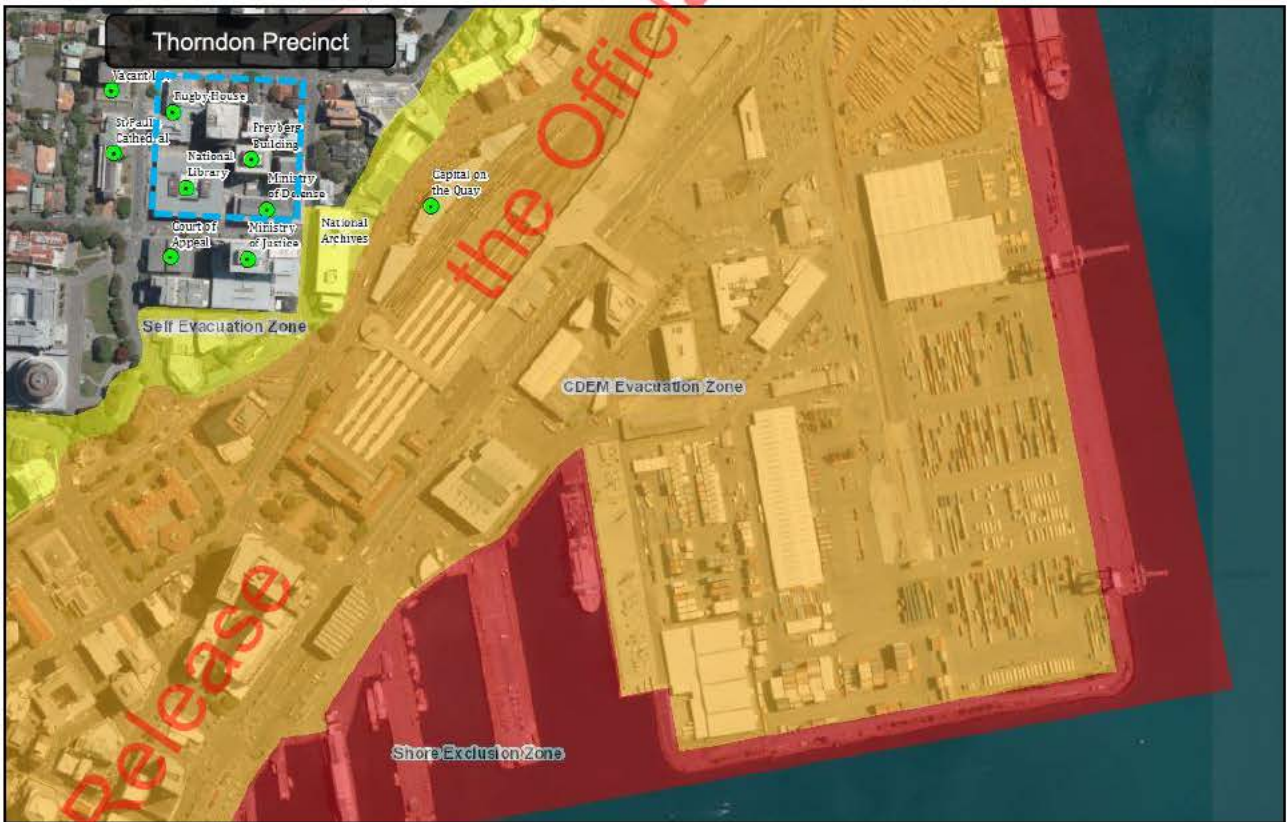
**Illustration 6** Tsunami Evacuation Zones (WREM, 2017)

Indicative evacuation zones for tsunami hazards have been mapped for the Wellington Region (GWRC, 2010). These zones correspond to different threat levels and are characterised into red (shore exclusion zone), orange (CDEM evacuation zone) and yellow (self evacuation zone) zones.

The Thorndon Quay side of the Archives New Zealand building is more exposed to tsunami hazards due to the lower elevation. This is where the loading bays to the archive storage area are located. The Thorndon Precinct has a very low exposure to tsunami hazards as it is located outside of the tsunami evacuation zones.

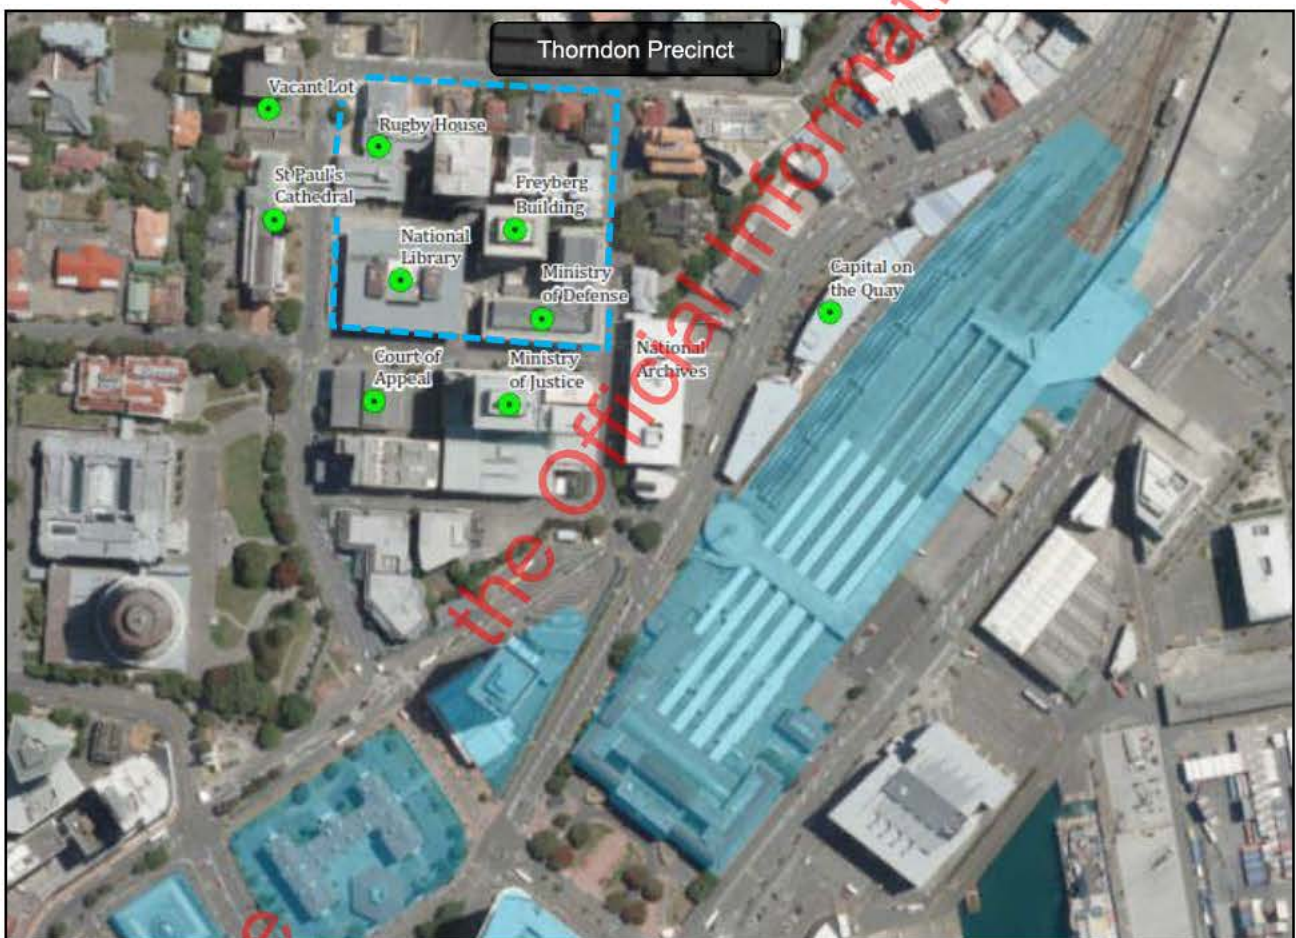
Illustration 7 Flooding Hazards

Greater Wellington Regional Council have produced flood hazard maps (GWRC, 2016). These maps indicate that there are a number of low lying areas in the vicinity of the Archives New Zealand that are exposed to flooding hazards, see Illustration 7. These areas, including the train station and associated rail yard opposite the Archives New Zealand facility, are mapped to have 2% probability of a flood occurring within any given year which is classed as a 'high likelihood' area (GWRC, 2016). Predicted flooding depths for specific sites are based on factors such as the wider catchment area, land use and storm water services and would require detailed assessment.

Although these maps do not present the Archives New Zealand facility as being exposed to flood risk, the low-lying elevation on the Thorndon Quay is consistent with the railway yard (2 m above mean sea level). Given this it is reasonable to expect that flooding hazards can also be expected across Thornden Quay and along the base of the Archives New Zealand facility. This is of particular importance for the loading bay area and the basement levels of the building. It is noted that the loading bays are 1.2 – 1.5 m above the road level and hence have a greater level of protection. The basement level is potentially exposed to flooding if the flooding extends from the rail yards across Thorndon Quay, but the likelihood is low based on the flood hazard maps.

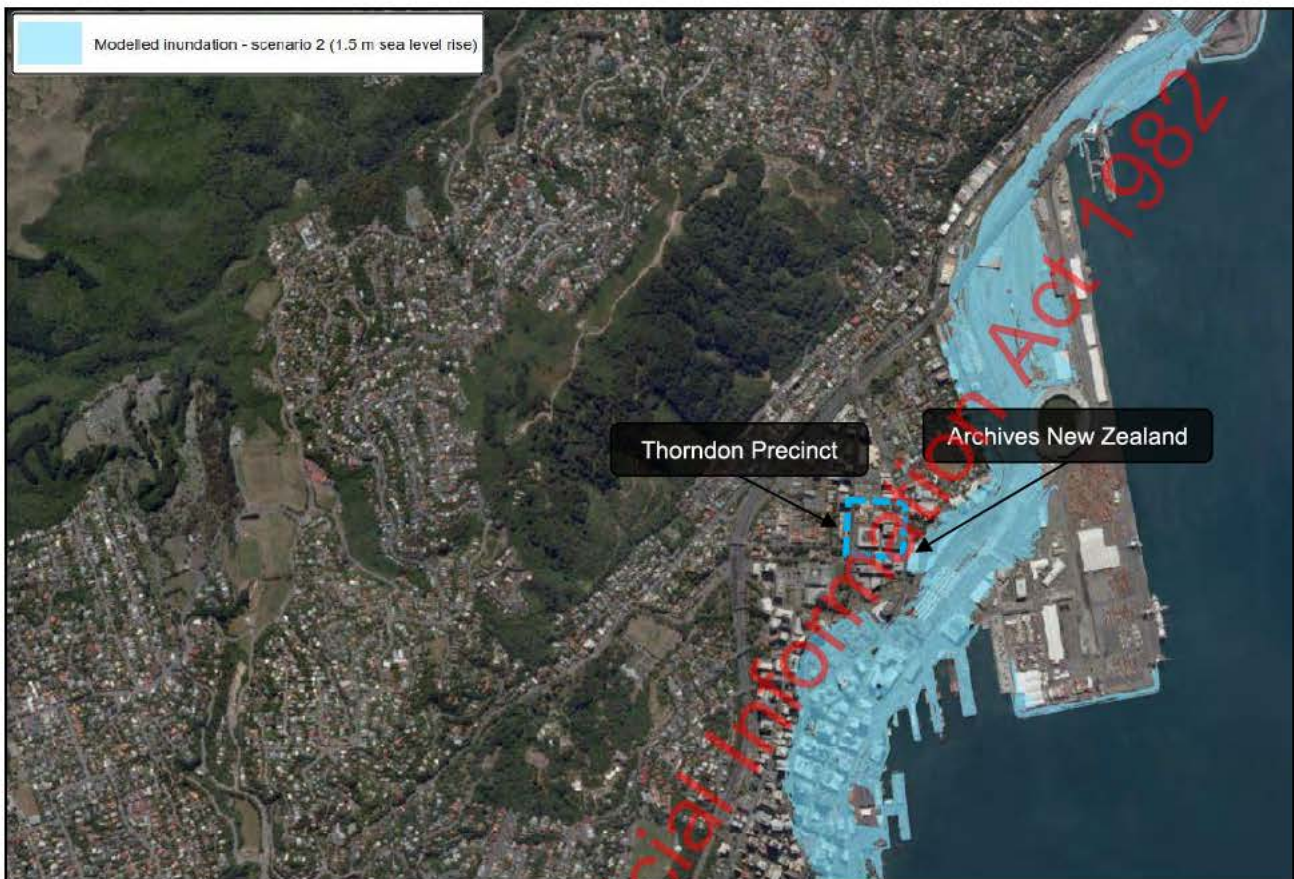
The Thorndon Quay side of the Archives New Zealand facility is on reasonably low lying ground. While the facility is 300 m from the existing Wellington Harbour coastline, with a number of buildings and infrastructure located in between, a 1.5 m rise in sea levels will cause this low lying area to be inundated (Illustration 8) (T+T, 2013). However, considering the area expected to be inundated is part of Wellington's business hub, it is possible that mitigation techniques such as sea walls will be employed and thus, limit inundation. The Thorndon Precinct is not modelled to be inundated with a 1.5 m rise in sea levels, however will have a higher exposure to storm surge and coastal inundation hazards (Illustration 8).

Illustration 8 1.5m sea level rise modelled scenario assuming no mitigation (i.e. sea walls) (from T+T, June 2013).

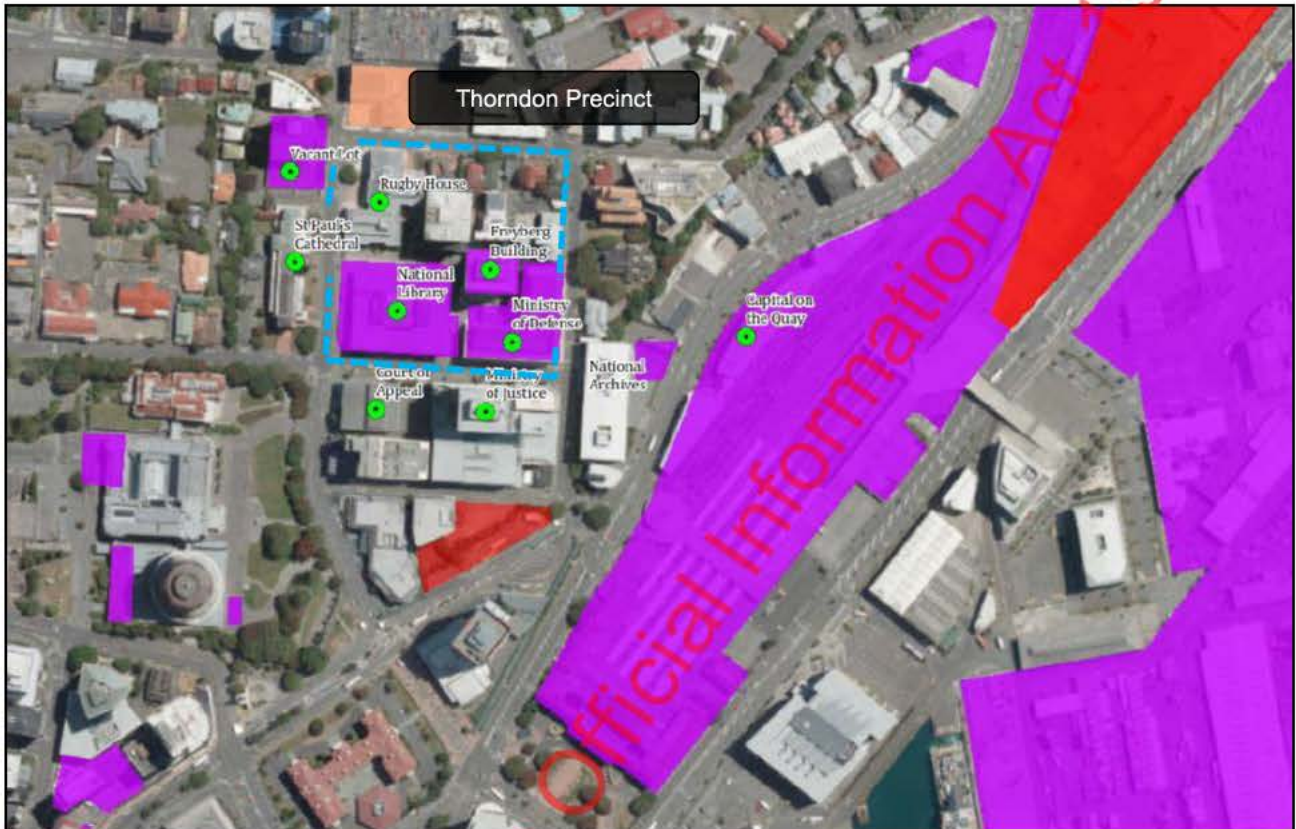
Illustration 9 Thorndon HAIL sites

The Archives New Zealand facility is registered as a site with a verified history of hazardous activity or industry, cited to have storage tanks for fuel, chemicals or liquid waste. However, a report was produced in 2009 confirming that fuel storage tanks have been removed from the site (MWH, 2009). The report details soil validation testing following the removal of two fuel storage tanks and identified that a sample retrieved from the tank site returned chemical concentrations above MfE guidelines. The report detailed that the contamination was contained within concrete bunding and no significant risks were identified.

A number of other buildings in the near vicinity are also registered and cited to have storage tanks for fuel, chemicals or liquid waste. These are Defence House, the Freyberg Building, the National Library, the vacant lot at 61 Molesworth Street and the Ministry of Justice building at 32 Aitken Street (see Illustration 9). There is limited information regarding whether the tanks noted are still in operation or have been removed and whether any contamination has been confirmed.

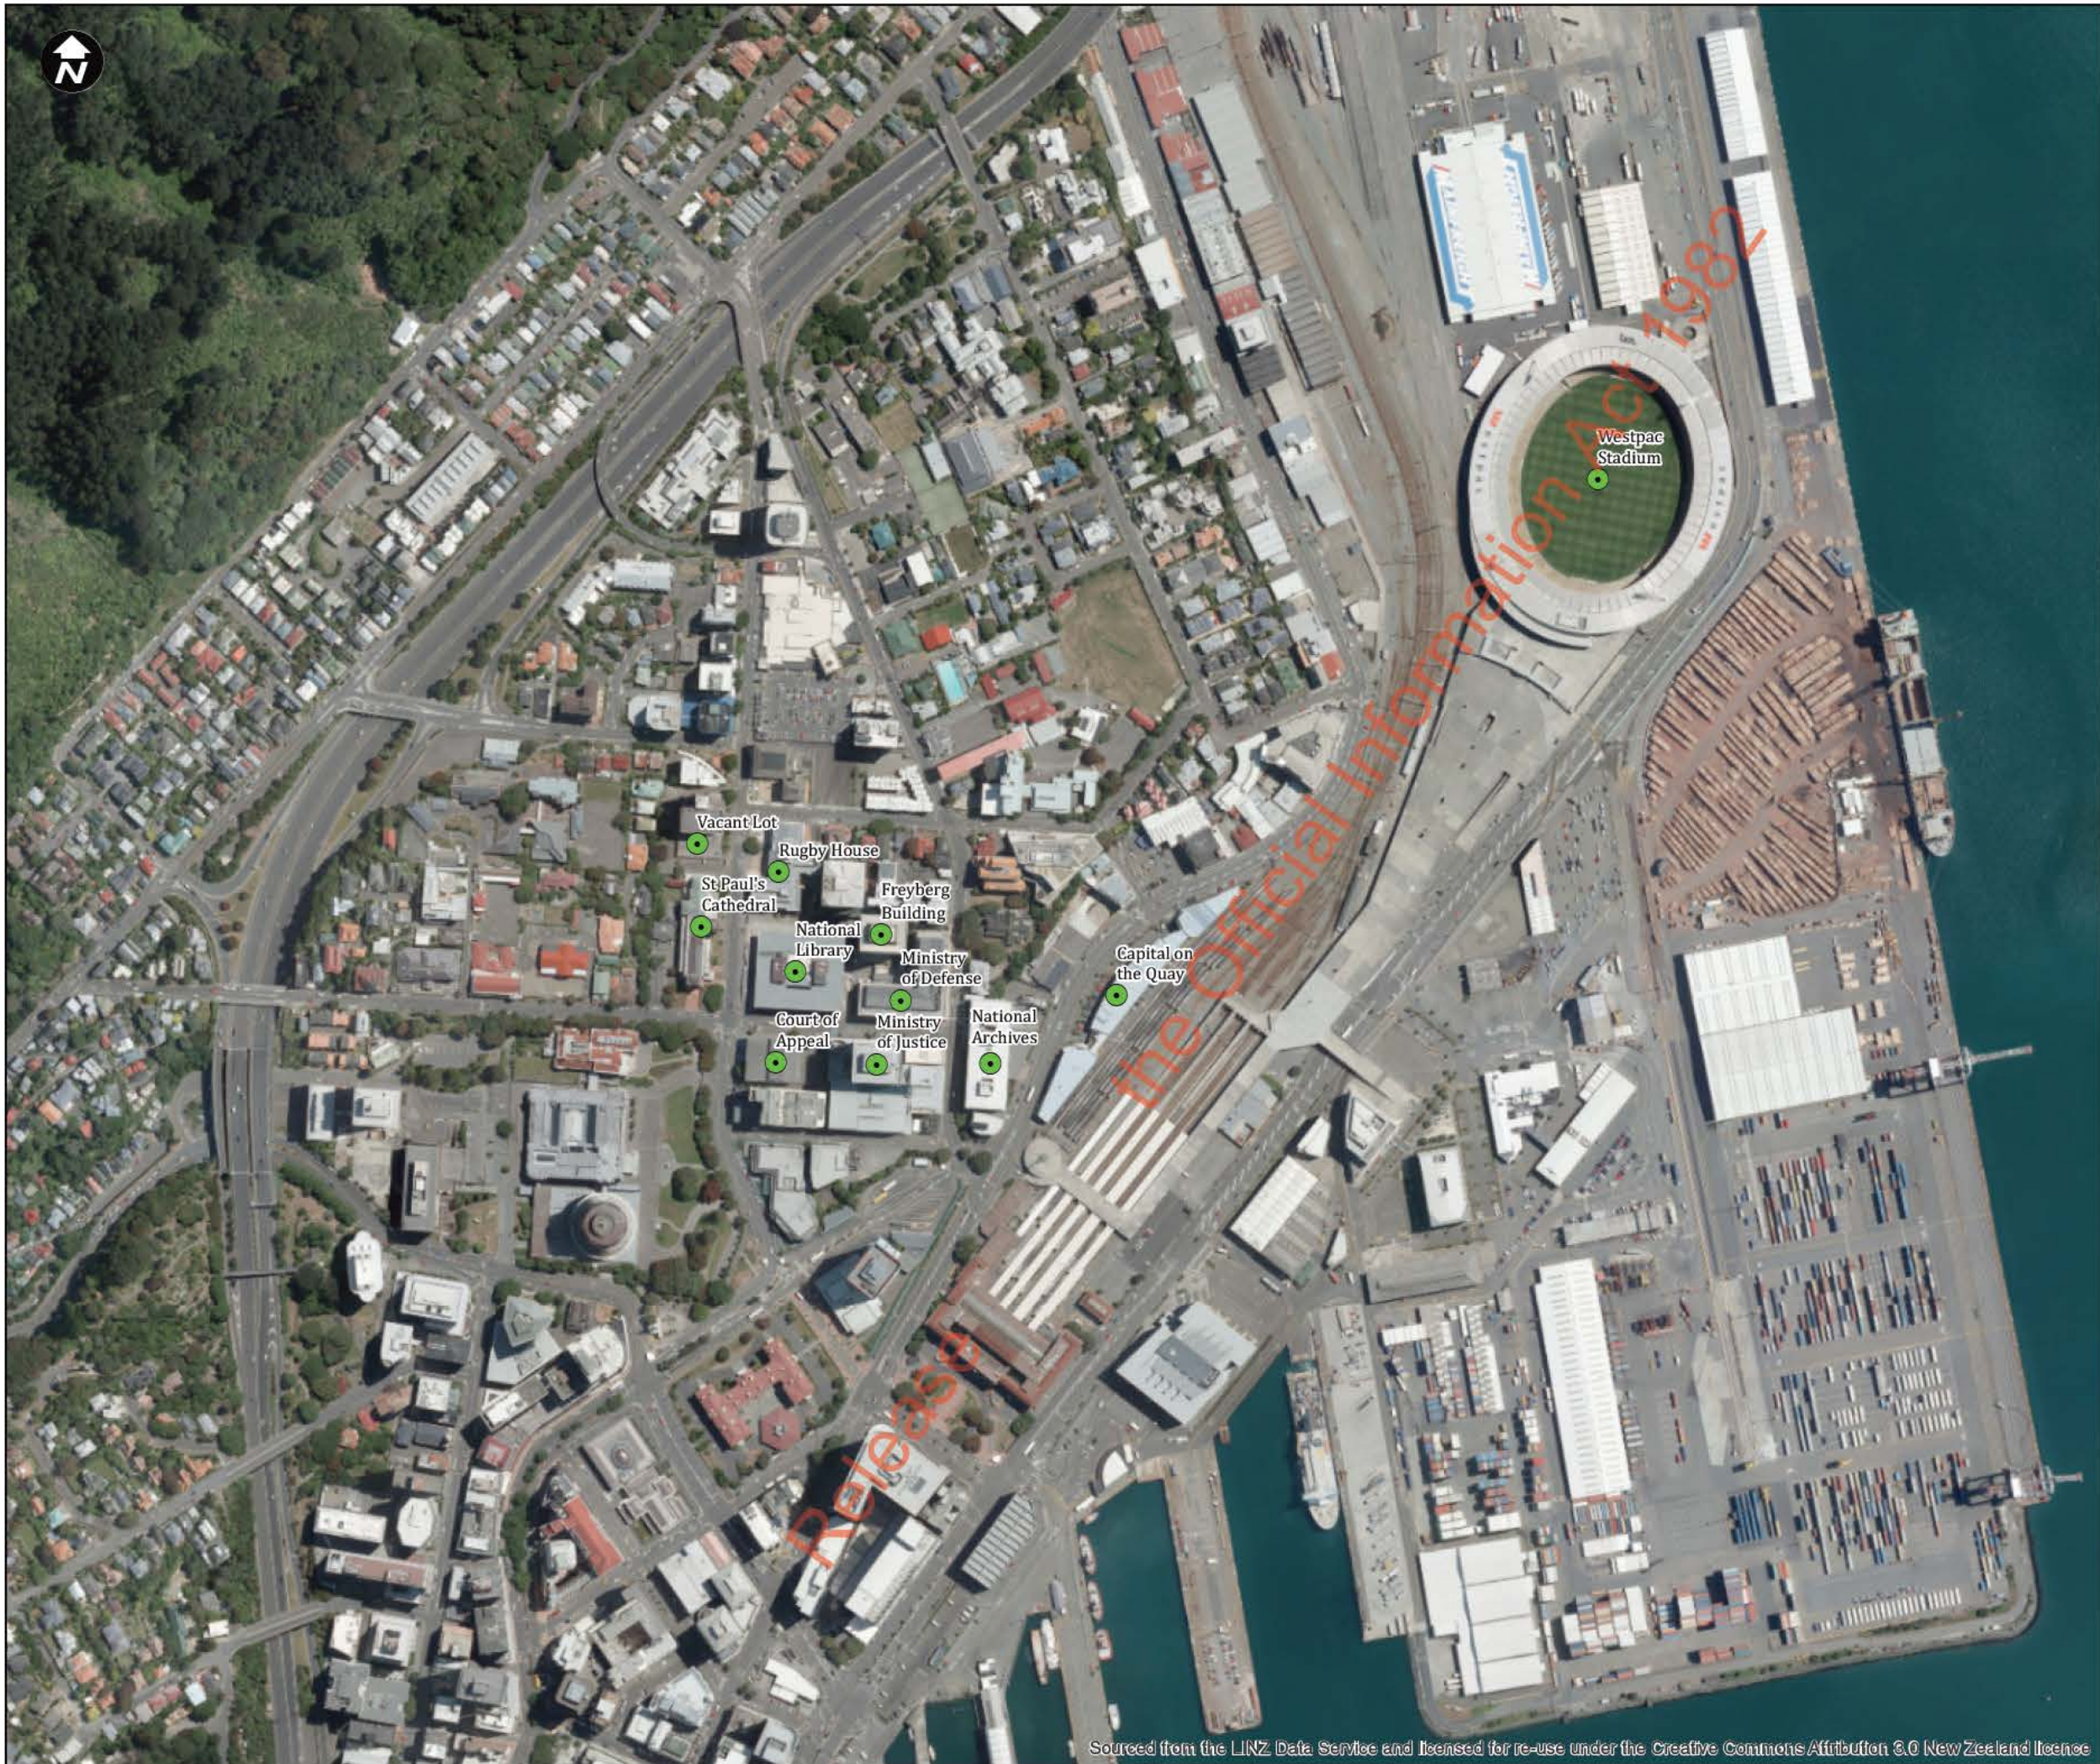
Date: Sept 2017	Project No: 5-C3448.00	Figure: 1
--------------------	---------------------------	--------------

The Archives New Zealand is located in close proximity to an area described as the 'Thorndon Precinct'. This area encompasses the National Library and a number of other Government occupied buildings such as the Ministry of Defence and the Ministry of Justice, see Figure 1.

An overview of the potential exposure to liquefaction hazards has been undertaken by reviewing geotechnical information available for the Archives New Zealand and the surrounding area. Intrusive geotechnical information was predominantly retrieved from our records, the Wellington City Council archives and public databases. Historical geotechnical logs were reviewed for the following buildings (Figure 1):
