NORTH HEAD TUNNELS INVESTIGATION REPORT

North Head Tunnels Investigation Report

By David Veart
Auckland Conservancy Historic Resource Series No. 15
Department of Conservation
Auckland Conservancy
Private Bag 68908
Newton
Auckland

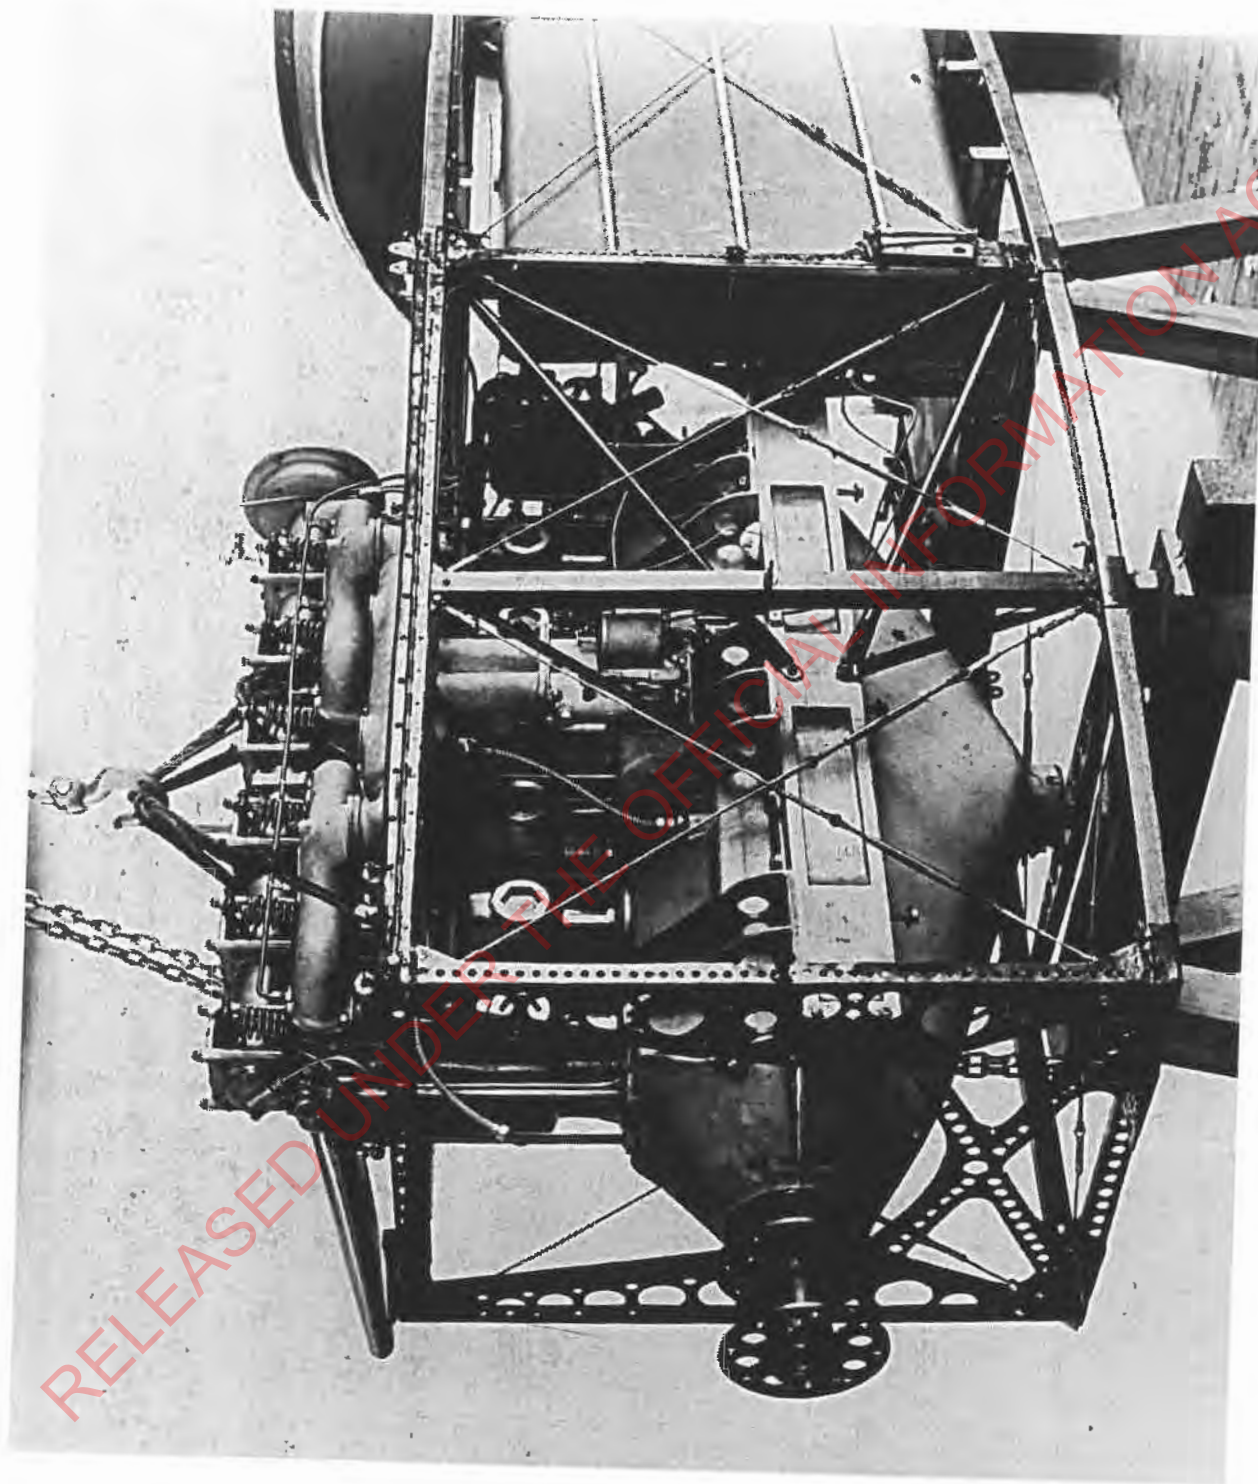
Figure 5: The 125 hp Hall-Scott aero engine

At the time of the government assessment of the flying school assets, the engines were examined and valued and a detailed report was made. In this report the three 125 hp Hall-Scott 6 cylinder water cooled engines are listed. They are described as in good order although rather old (ODF 7735/1 1368). In another part of the report the relative values of the engines are discussed by the assessors suggesting that the three engines were worth £300, £250 and £200 respectively (ODF 7735/1 1362). Presumably the £200 engine is the one damaged in the earlier accident with the £300 engine possibly from Boeing 'G', Mallard, the least used of the aircraft.

The three engines, originally from the Boeings, were purchased and are listed in a report on the aero engines held by the Defence Department in March 1926. At this time the engines are listed as '2 unserviceable awaiting overhaul, 1 incomplete' (ODF 7735/1 1329). Presumably the incomplete engine was the one damaged in the earlier accident.

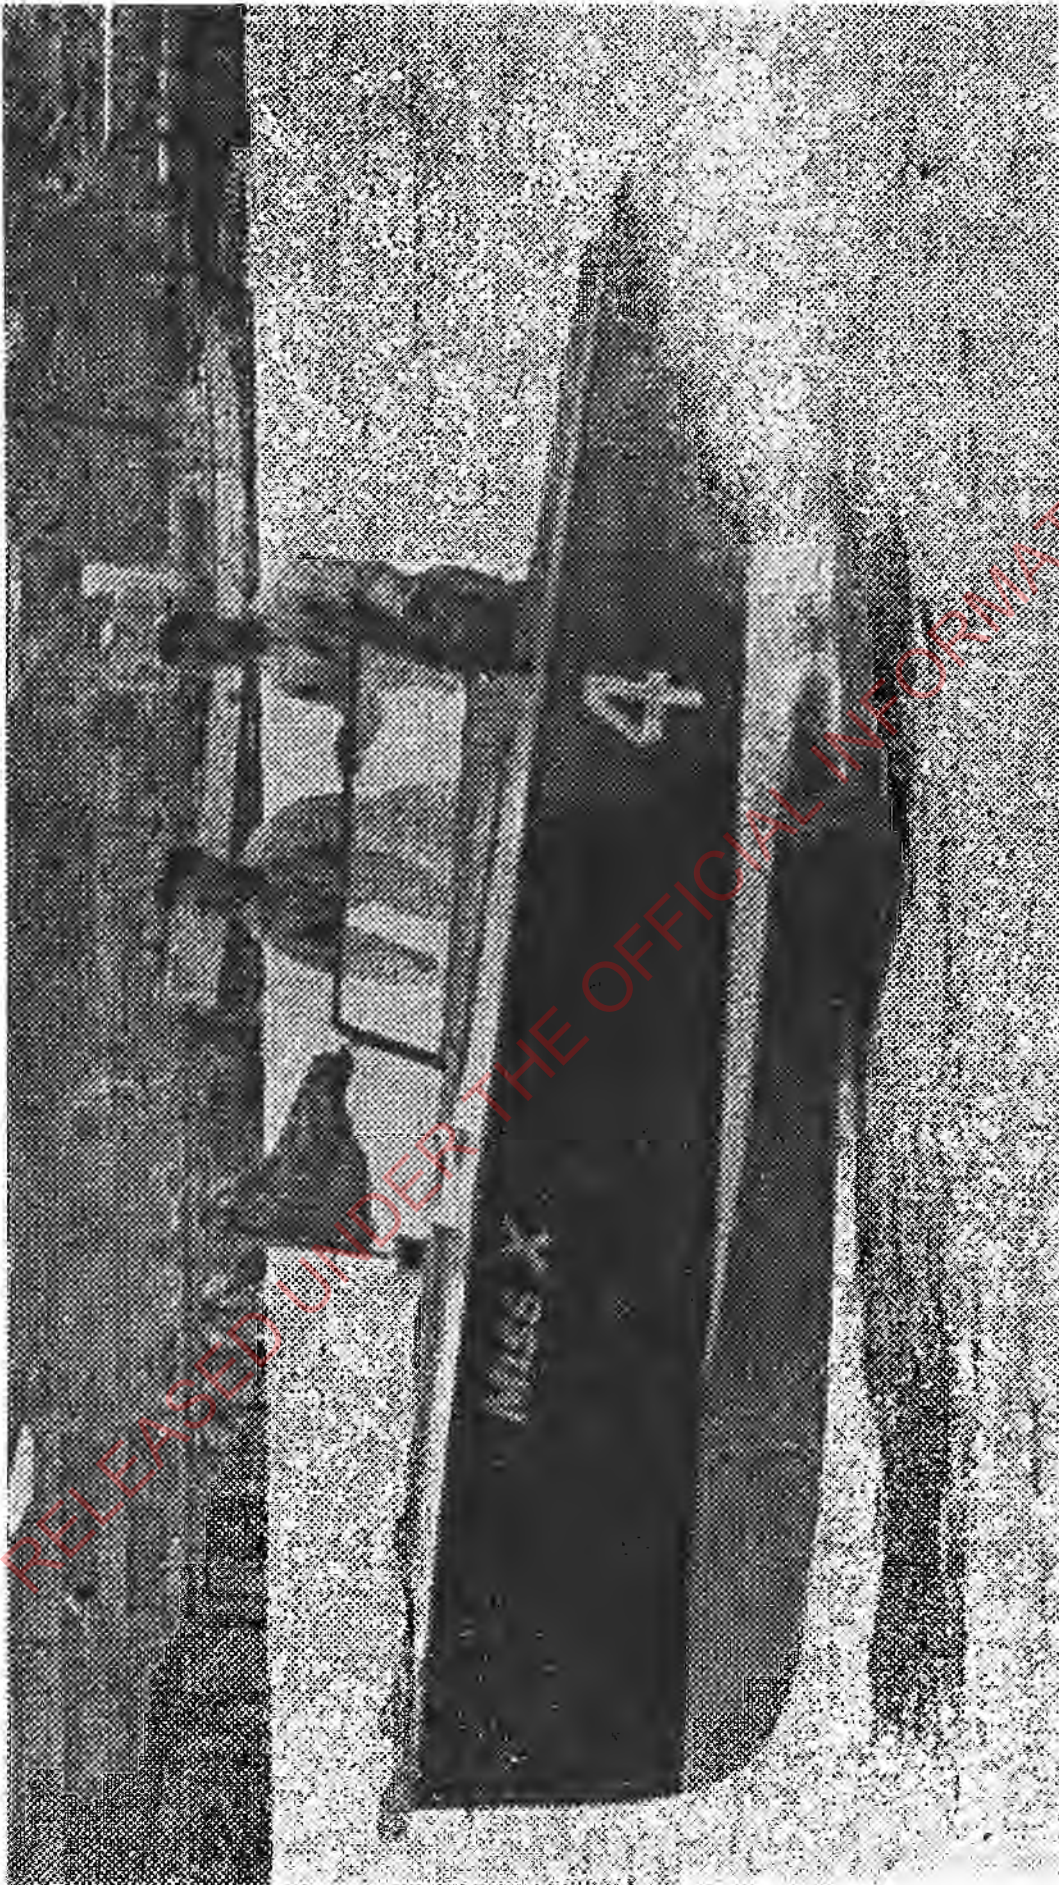
Figure 6: The Racing Powerboat "Miss X" (New Zealand Herald 20th June 1927)

WELL-KNOWN AUCKLAND SPEED BOAT BURNED TO WATER'S EDGE AT ORAKEL.
A recent photograph of the Miss X, owned by Mr. R. M. Hoyes, which was totally destroyed
by fire yesterday afternoon.

In April 1927 'Miss X' broke a prop shaft and in May suffered a minor fire (*NZ Aquatic* 25 May 1927: 17). However in June 1927 she caught fire off Orakei Wharf and was totally destroyed. The burnt out remains were towed ashore by a fishing boat (*NZ Herald* 20 June 1927) (Fig. 6). The *New Zealand Aquatic* suggested that there may have been a slight possibility of salvaging the motor, although this was believed to be so extensively damaged 'as to be not worth the trouble' (22 June 1927: 3).

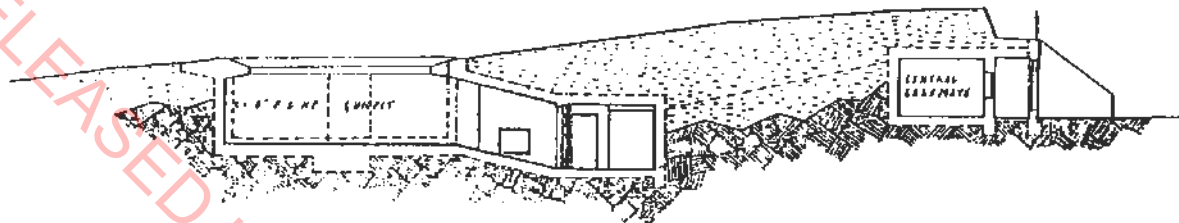
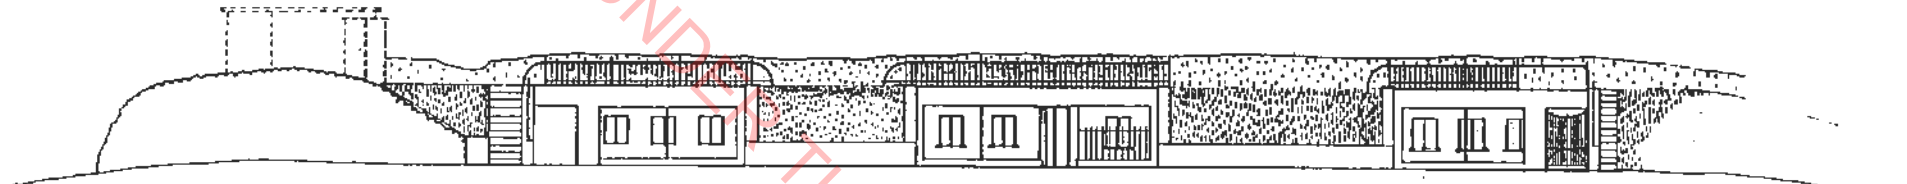
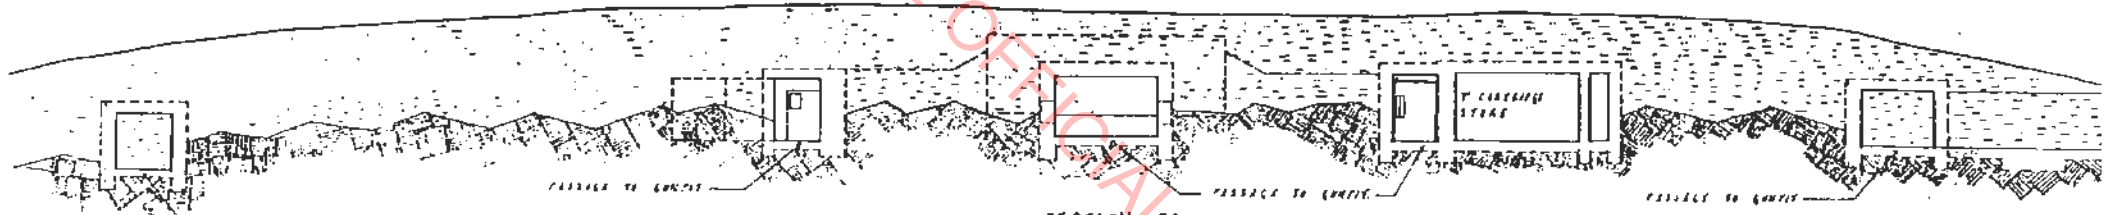
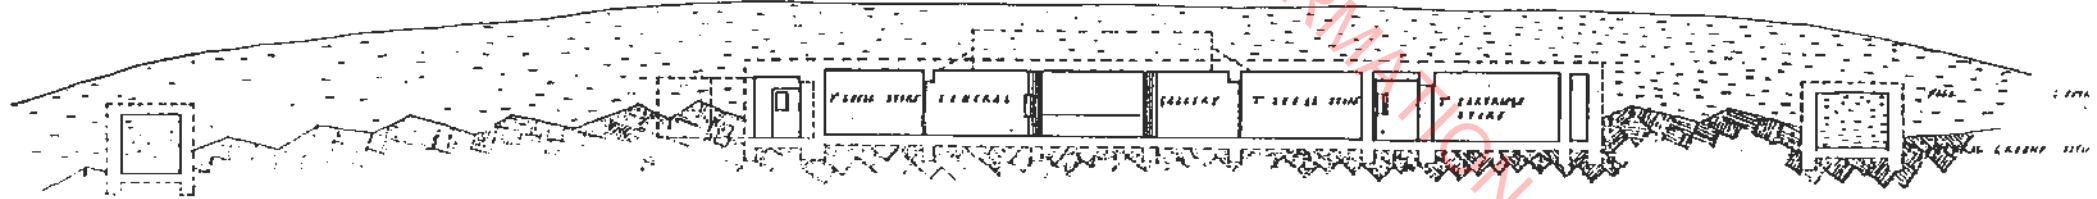
Figure 15: Plan of the summit battery, 1992. Treadwell.

SECTION AA

WEST ELEVATION

SECTION BB

SECTION CC

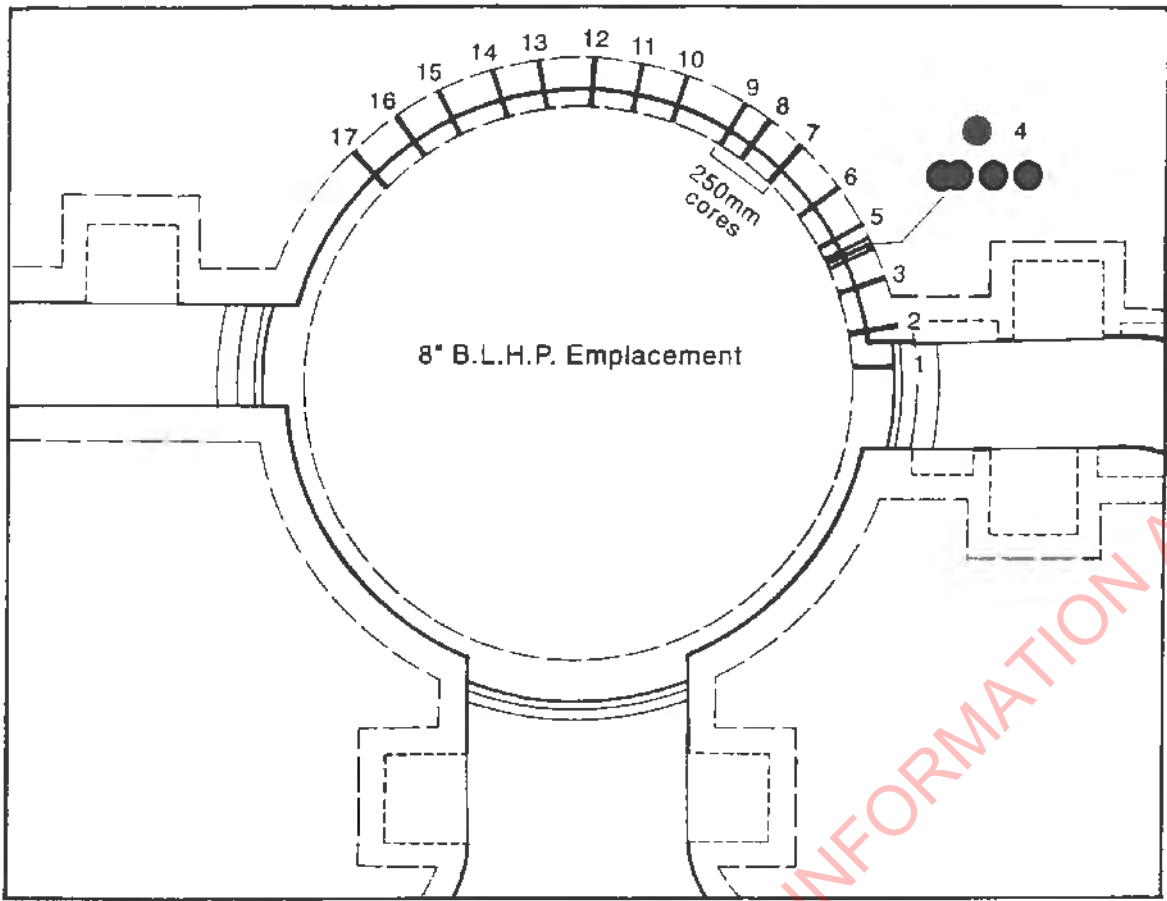
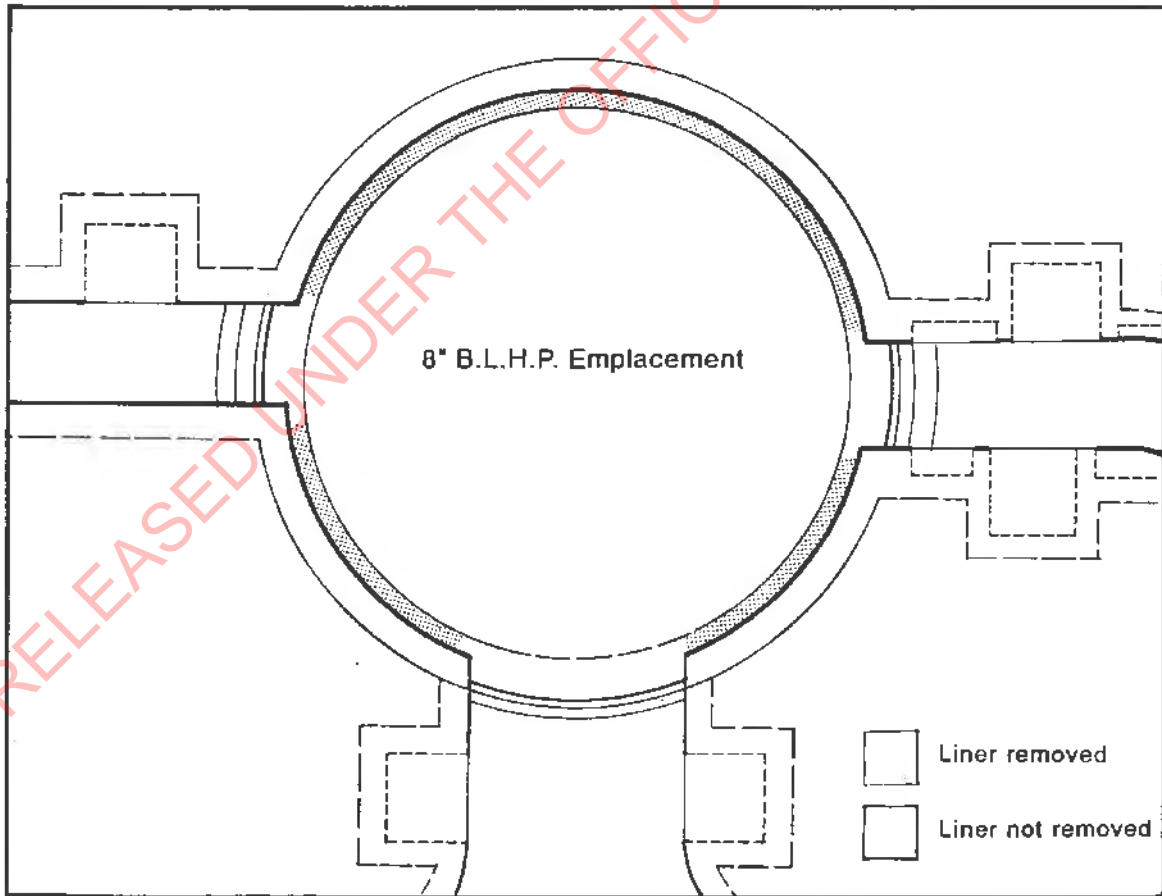
Figure 17: Work completed at summit 8 inch gunpit

The material consisted of plaster approximately 60 mm thick and then a very loose mixture of aggregate and cement which became progressively looser the deeper it got. At approximately 310 mm the concrete was so loose that the core fell apart. The material used to build the gun pit wall consisted of a sharp red chip, similar to 'McCallums Chip', a material from a quarry on McCallums Island and still used today - water rolled red pebbles, crushed shell, scoria and basalt.

Two other cores were taken approximately 1 m apart (7 and 9 in Fig. 17). These revealed the same white painted surface beneath the water tank wall. The concrete beneath this was also consistent with the 19th century concrete.

Holes drilled in gunpit wall

These were that the loose material reported by the army drilling team was in fact 19th century concrete which the cores showed became very loose, little more than rubble fill, at approximately 300 mm into the old wall. The use of a pneumatic drill by the army would have loosened the old concrete even more. This damage had been compounded because the army drill had become jammed and another drill had been used to free the original machine. This appears in turn to have disturbed the loose concrete and helped create the air space detected by the radar. The reason that the army drilling team reported that 'at 8 feet resistance to drilling stopped', was that they had gone right through the gun pit wall and out the other side. A generic drawing for these gunpits still exists. '1570-1, Emplacement for eight-inch thirteen-ton BLR gun' (copy held DOC Auckland). This shows the gun pit wall as being 6 ft thick, with the apron as 2 ft thick. It appears that the drillers went right through the main wall of the pit and then through the apron and then into the loose fill outside.

The '1 foot' thickness of 'reinforced concrete' recorded in the army report was in fact the watertank wall together with the small thickness of the 19th century concrete. The use of a core drill allowed us to distinguish these differences whereas the pneumatic drill used by the army had simply broken them up.

On 13th July the western side of the water tank was removed. The three known entrances were left blocked at the request of the Navy for security reasons (Fig. 17). The removal of the wall on this side was more difficult as it was found that the 'rammer tubes' had not been blocked off prior to the pouring of the water tank wall. Rammer tubes are the ceramic pipes set into the wall of the gunpit into which the gunners could insert the long handled rammers and swabs used to load the gun. Without the rammer tubes there would not be enough space to manipulate these unwieldy tools.

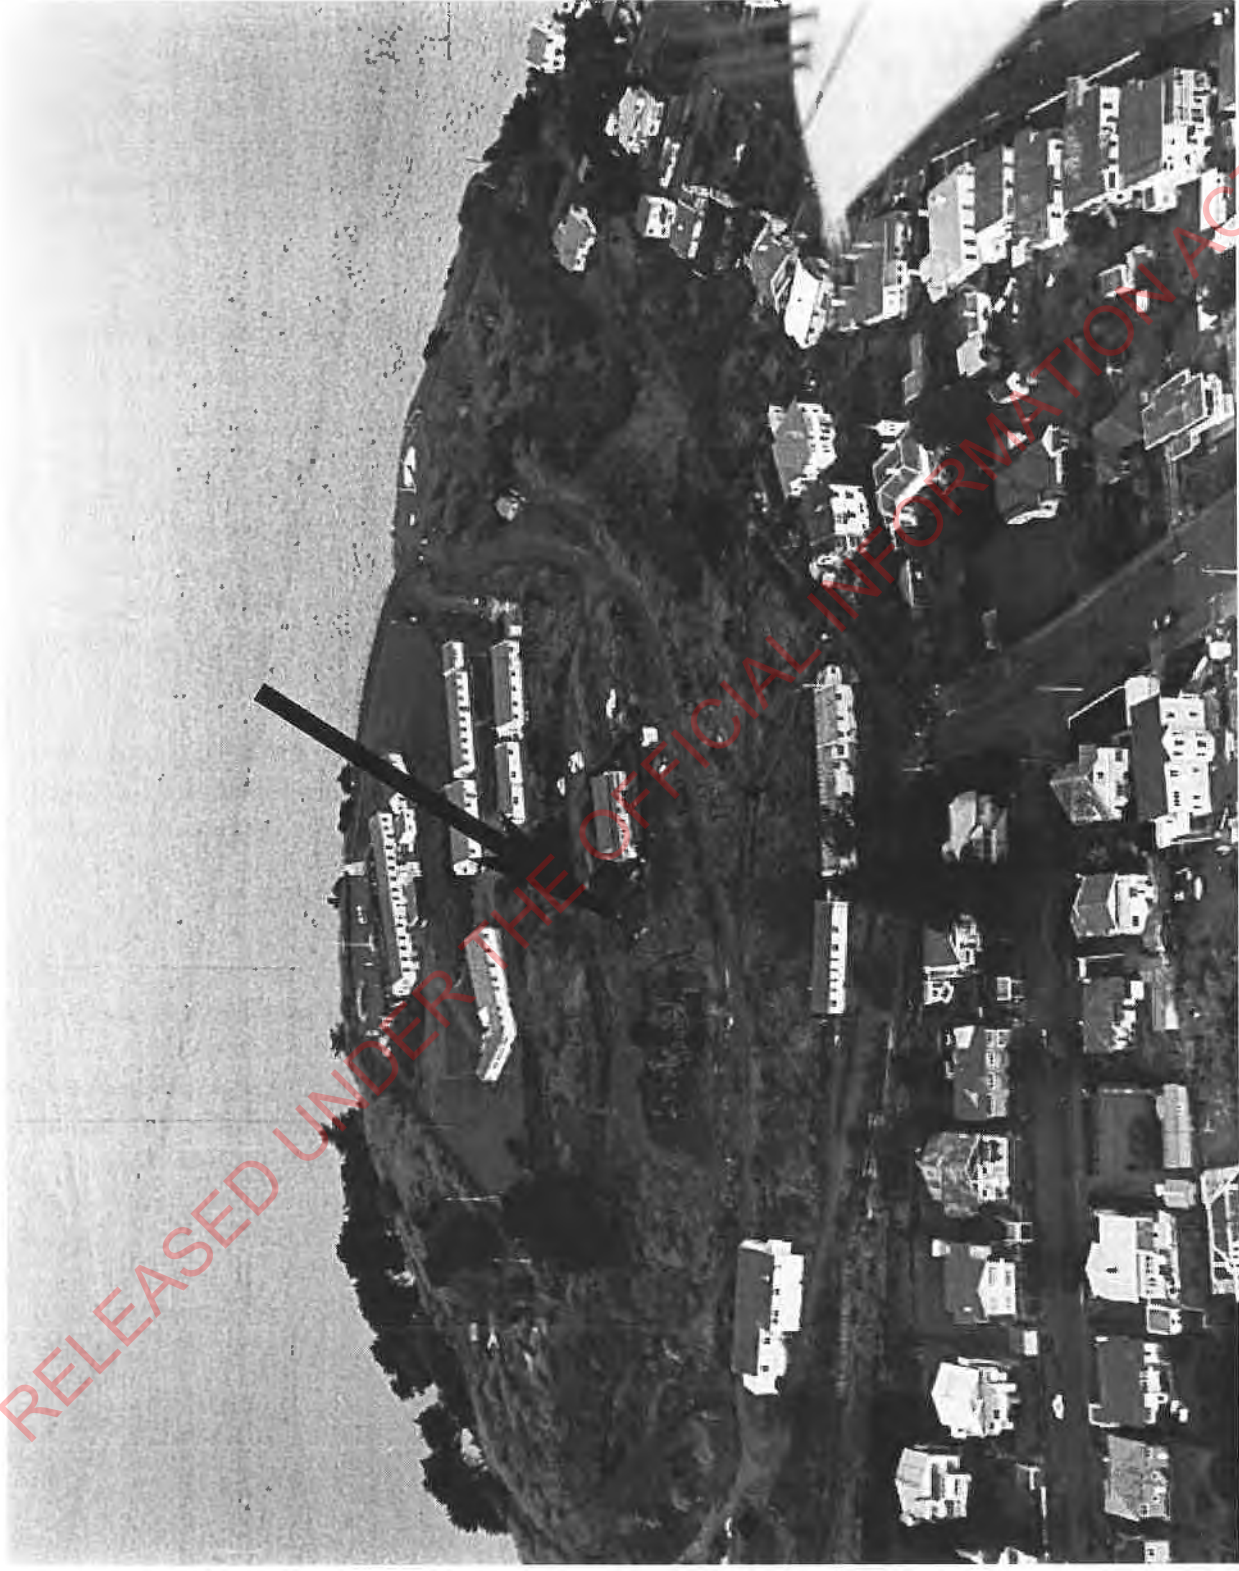
Figure 19: The structure on the western slope.

There was no indication of any structure or tunnels in any of the trenches. A number of intercutting rubbish pits were found in the trenches dug, probably from a barracks once located to the south. The material found consisted of bottles, old cans and from the lowest level a black and white pot lid from a tooth-paste container. Production of these ended in about 1914 (Dale 1977: 18), a date which fits the earlier period in which the barracks was in use. Also found was a slab of concrete approximately 1.5 x 0.5 x 0.3 m. It was not clear if this had come from the structure visible in the photographs.

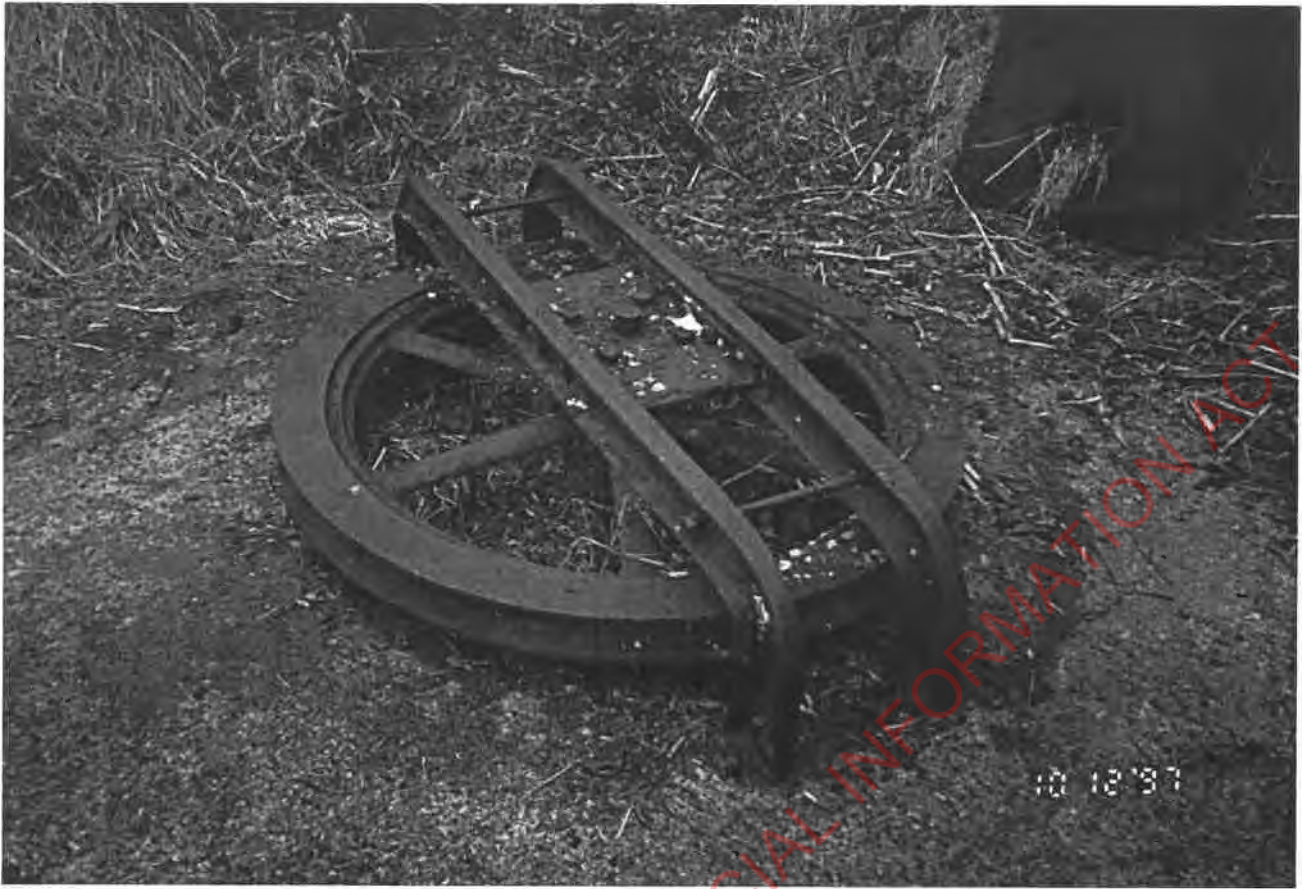
Figure 21: The incline wheel set into the rear of the upper road on the line of the tramway

The excavation was done with the same machine used to excavate the western slope. The result was not an entrance, but not simply a partly destroyed tramway either. After the machine removed a deposit of approximately 2 m of loose soil, a large iron pulley wheel was exposed. This was firmly set in concrete (Fig. 21). This was the top of the tramway from the 1893 period described in the documents. The depression in the hillside from the earlier tramway continued above the pulley wheel indicating the original extent of the feature. The area had been used as a rubbish dump and wedged in the pulley itself was a celluloid 1914 calendar issued by Tudehope's Ltd 'The Busy Drapers and Milliners' of Symonds St, Auckland (Fig. 22). Immediately above the wheel in the fill was a stoneware Grey & Menzies bottle manufactured by Govancroft of Scotland, a pottery started in 1913 (Godden 1988: 282). This bottle has a top for fitting a crown cap, a feature of these bottles from about 1920 (Tasker 1989: 68). In association with this was an 'Alva' Codd aerated water bottle manufactured by A. Alexander of London. This has a 'spun lip', a feature common on Codd bottles in the period 1915 to 1920 (Tasker 1989: 31). At the top of the deposit was a brown glass ABC beer bottle dated 1939. This suggests a progressive filling of the cut in the hill from about the time of the First World War until the beginning of the Second.

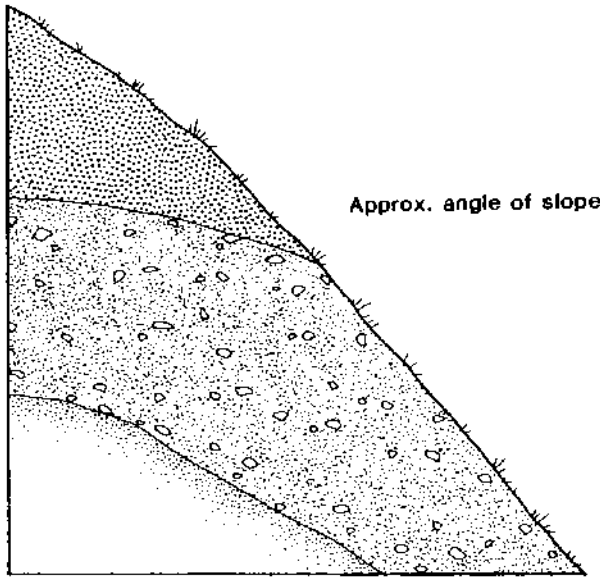
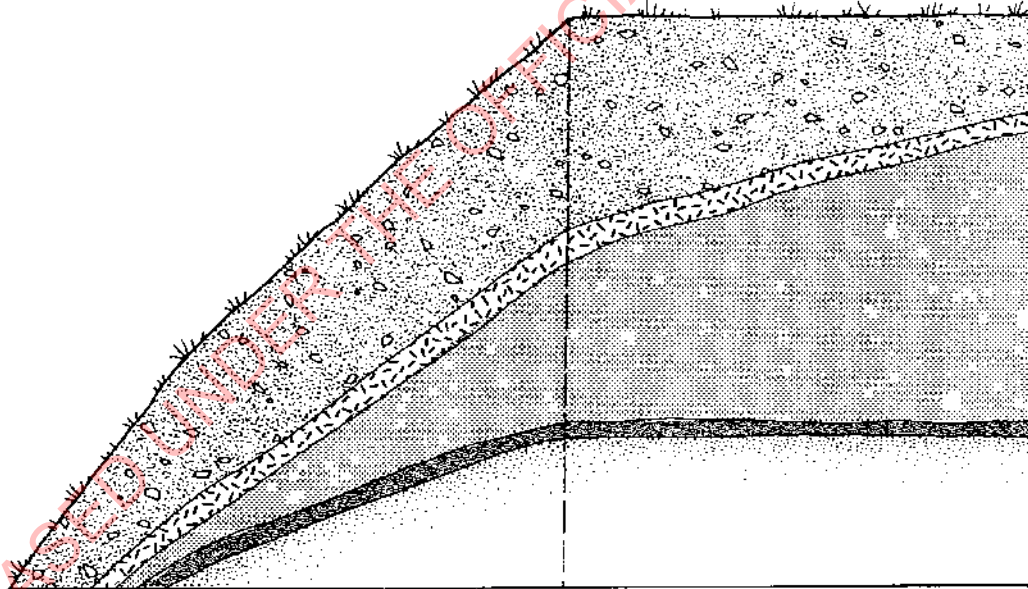
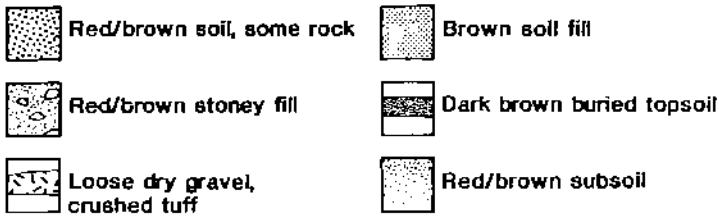
Figure 25: Cross sections of Site 5

The site was excavated by machine to a depth of 3 m. The cross section was similar to that seen at site 5. There were a number of fill layers, again with signs of the individual lenses possibly created by the dumping of loads of soil from the nearby tunnelling. A buried topsoil layer was excavated at a depth of 2.1 m with the

undisturbed natural soil layers below it. A 40 cm length of railway iron, presumably an offcut from the tunnel roof reinforcing, was found. This was probably the material found by the magnetometer. There was no sign of any structure having ever existed in this area.

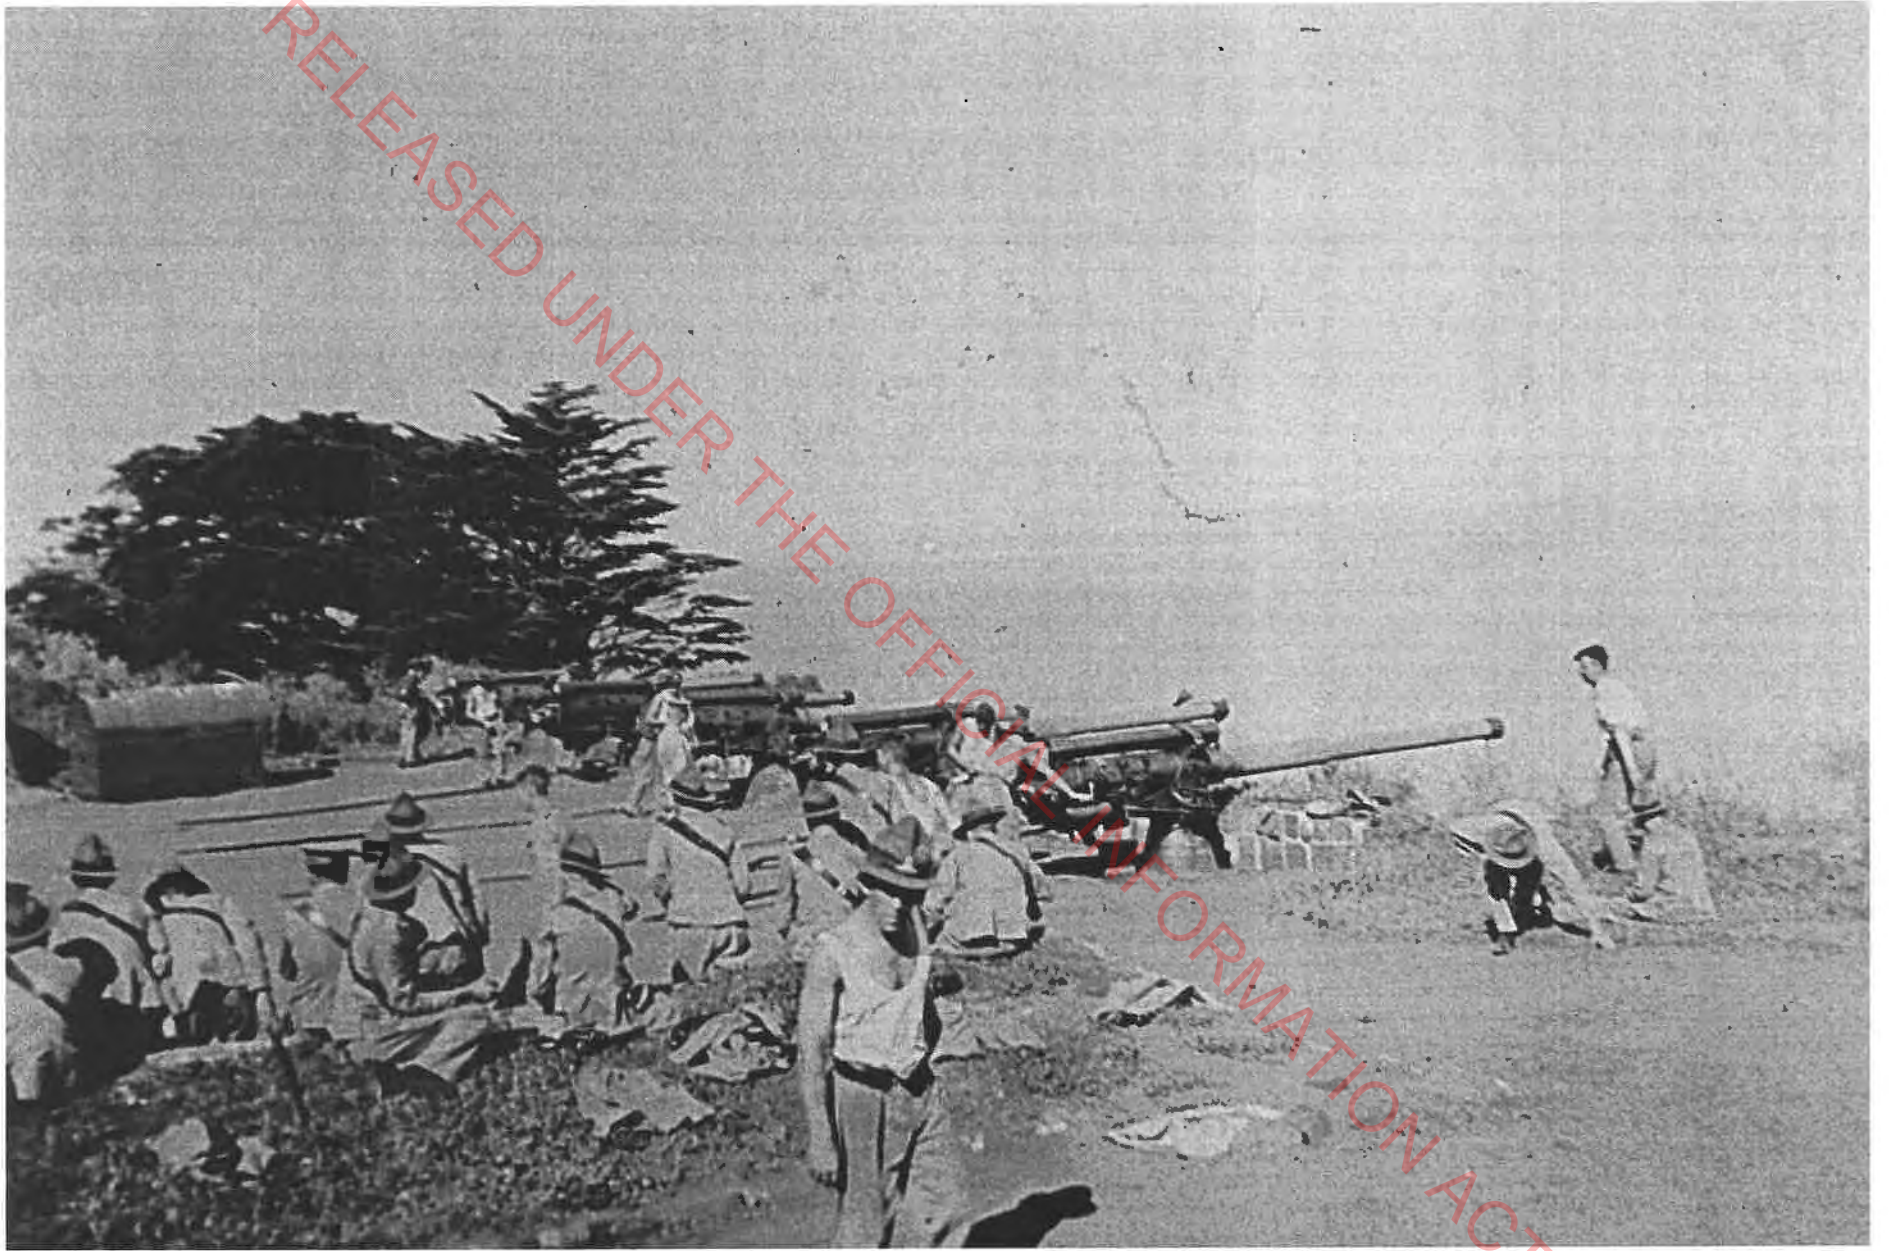
Figure 26: The 4 inch naval gun saluting battery on the tennis court by South Battery, during Territorial training in 1937. Photograph W. Ruffell collection.

Archival information indicated that there had been a battery of 6 saluting guns mounted on concrete slabs located here during the 1930s (Fig. 26). The magnetometer survey had shown some anomalies in this area and it was not clear whether the concrete slabs were the cause of this. For this reason the site was excavated and it was found that the reinforced concrete slabs were built directly on top of the undisturbed rock and soil. The conclusion reached was that the concrete bases of the old saluting battery were the cause of the magnetometer anomalies and that there were no other subsurface structures in the area examined.
