**THE EFFICACY OF BRUSH-ON REMEDIAL
TREATMENTS ON RADIATA PINE FRAMING
42-MONTH REPORT – September 2012**

Dave Page, Ian Simpson, Jackie van der Waals and Tripti Singh

Date: November 2012

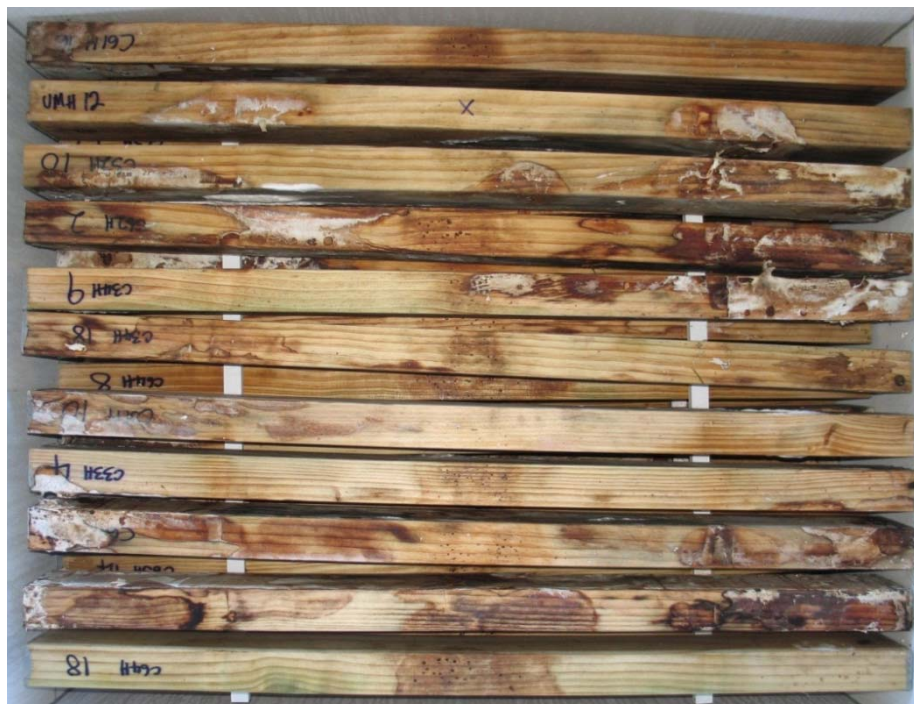
Figure 1 – Decay on copper naphthenate treated samples after 159 weeks exposure, HMC tank 1, layer 5, (2nd from top). Extensive decay mycelium on the samples including on treated surfaces, still active and progressive.

Decay mycelium was becoming established on the untreated surfaces of samples within six months of installation in the exposure stacks, generally spreading from the area originally infected by the decay feeder blocks. This progressed steadily, particularly on the untreated samples and those treated on only one edge. After 12 months mycelium spreading onto surfaces treated with copper naphthenate in the HMC tanks was recorded. Mycelium development on copper naphthenate treated surfaces in the HMC tanks continued throughout the trial although decay of the underlying wood was usually slow to develop (Figure 1).

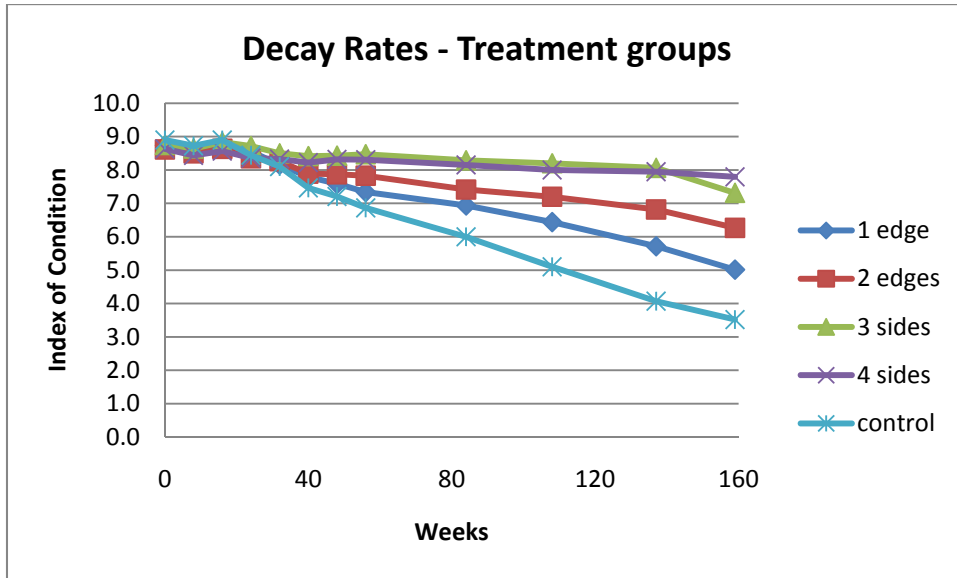
Figure 3 - Changes in the “Index of Condition”, regardless of the preservative used or the exposure conditions, as the trial progressed.

If the type of preservative used and exposure conditions are ignored, there were only minor changes in average decay ratings and MOE for samples treated on four surfaces, throughout the trial period (Figures 3 and 4). For samples treated on two edges and one face average ratings were similar to the samples treated on four sides until the last assessment when decay ratings declined more rapidly. From the outset, MOE for these samples was generally lower than for samples treated on four sides but changes over the first 137 weeks mirrored those for the samples treated on all four sides. Over the last six months exposure MOE declined more rapidly in the samples treated on three sides.

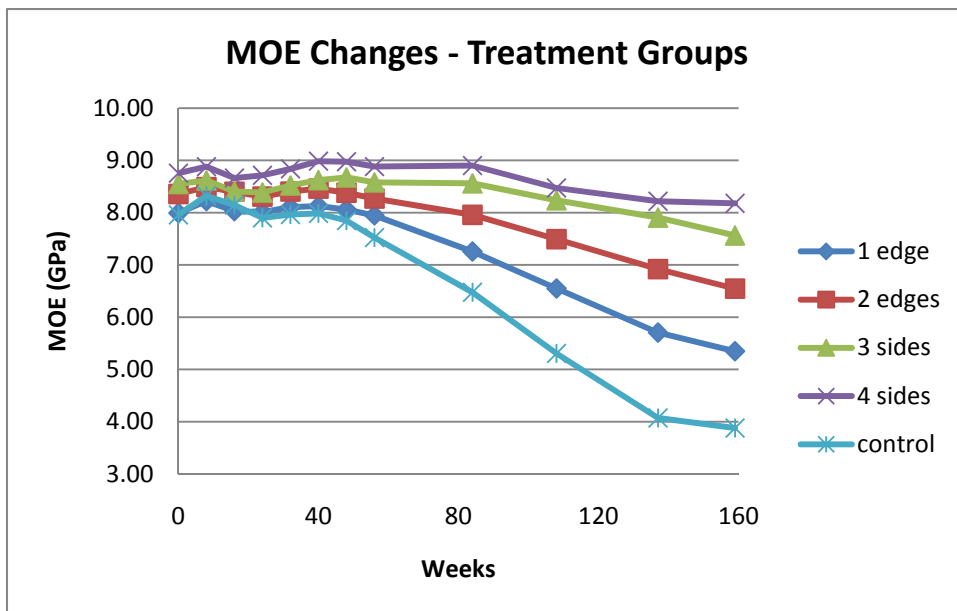
Figure 4 - The modulus of elasticity (MOE) regardless of the preservative used or the exposure conditions, as the trial progressed.

There was a steady decline in decay ratings for samples treated on one edge or on two edges from the 16-week assessment until the end of the trial. By the 159-week assessment the samples treated on one edge had an Index of Condition below 5.0. This point had been reached by untreated control samples after 108 weeks. The decline in average MOE for the “one edge” and “two edge” treated groups did not begin to show up until the 40-week assessment. Since then it has continued steadily with the “one edge” treatment groups losing strength more rapidly than the “two edge” treatment groups.

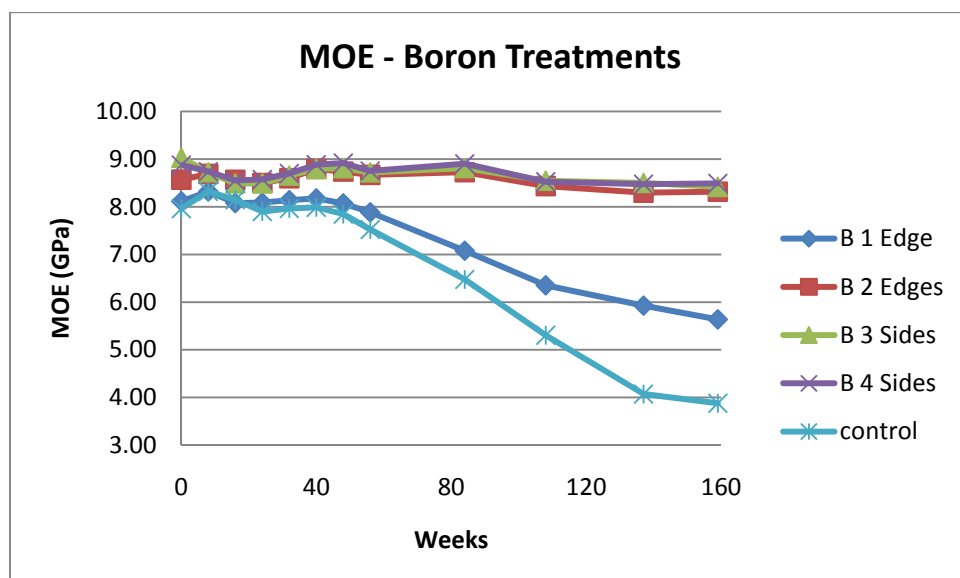
Figure 6 - The modulus of elasticity (MOE) for boron treated samples, combined HMC and LMC data.

The boron treated groups were quite different (Figure 6). The MOE for all except the “one edge” treatment groups changed very little throughout the trial. The MOE for the “one edge” treatment groups declined steadily from the 40-week assessment until the end of the trial.

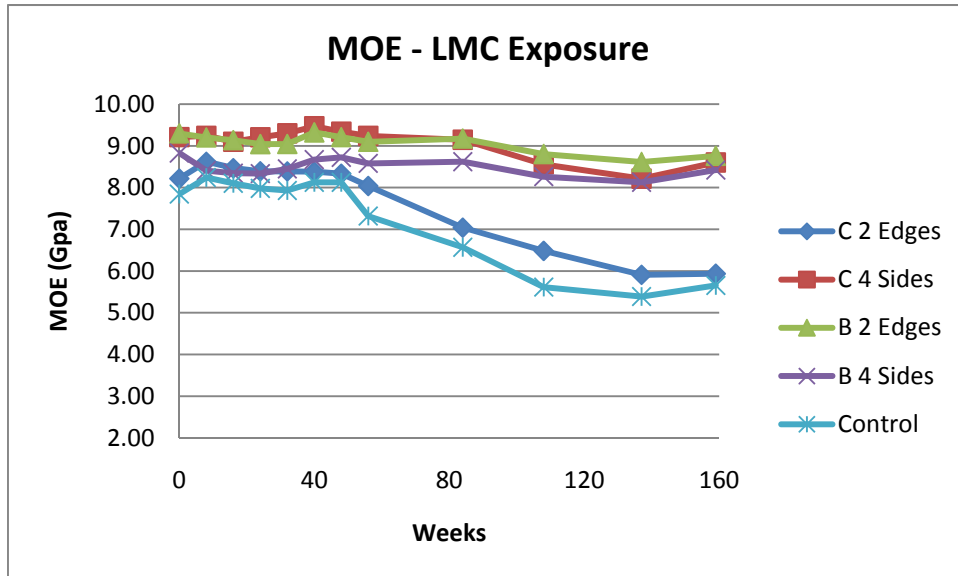
Figure 7 - The modulus of elasticity (MOE) in the low moisture content stack.

Figures 7 and 8 compare the MOE of LMC exposure stack treatment groups with the equivalent groups from the HMC exposure tanks. These show that the samples treated on two edges with copper naphthenate rapidly lost stiffness whereas the boron treated samples and those treated with copper naphthenate on four sides only changed very slowly.

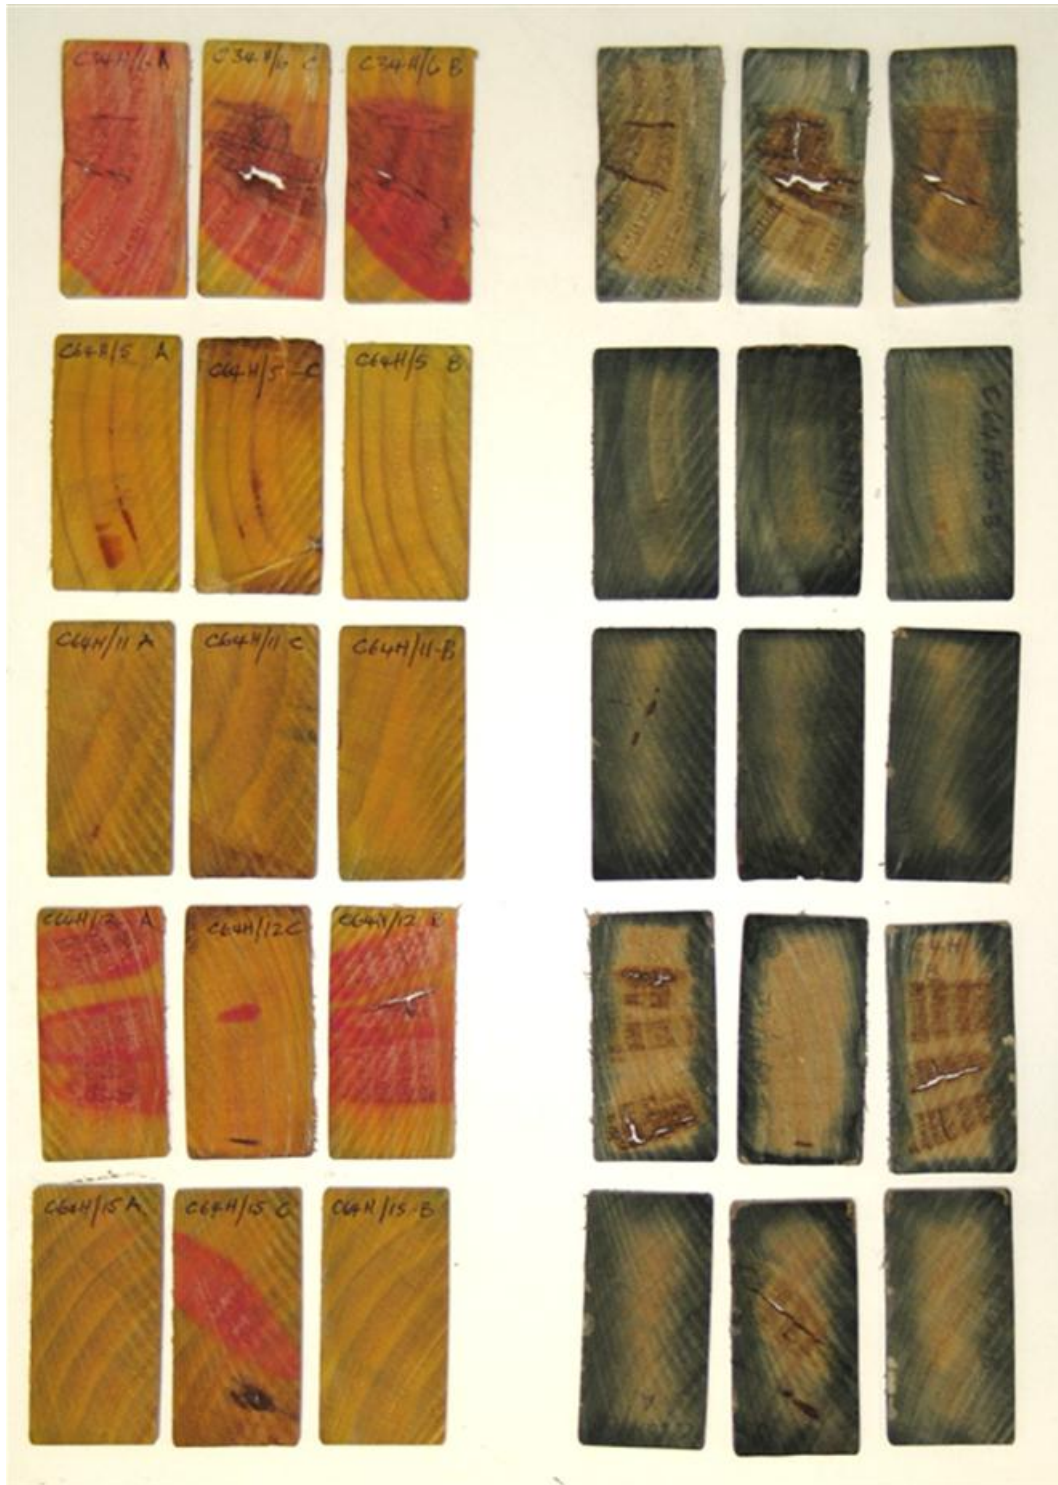
Figure 9 – Decay and preservative penetration in copper naphthenate treated samples (HMC samples treated on four sides in Table 6). The samples on the left have been sprayed with methyl orange reagent which turns a pink-red colour where there is active decay. The samples on the right are matched with the decay test samples and have been sprayed with rubeanic acid reagent which turns blue-black in the presence of copper. The three biscuits in each set are from the same sample, the central “C” sample from the original decay feeder block position, the “A” and “B” samples 150 mm from each end. There is limited, variable copper penetration and active decay in three of the samples.

Table 7 compares decay ratings and MOE loss from the start of the exposure period in samples that were spot tested in Figures 9-18. These show that there were well established pockets of decay present in the centre of the samples before significant MOE loss occurred. In samples where decay developed at either or both ends but not in the centre, such as in the second to bottom sample in Figure 9, there was very little loss of MOE.

In Figures 9-18 the distribution of copper in the copper naphthenate treated samples is relatively close to the surface and shows very little evidence of redistribution following treatment. The boron treated samples all show that the preservative has spread through the whole sample cross-section, even in samples that were below 30% moisture content. Given the limited copper penetration in the copper naphthenate treated samples it is likely that

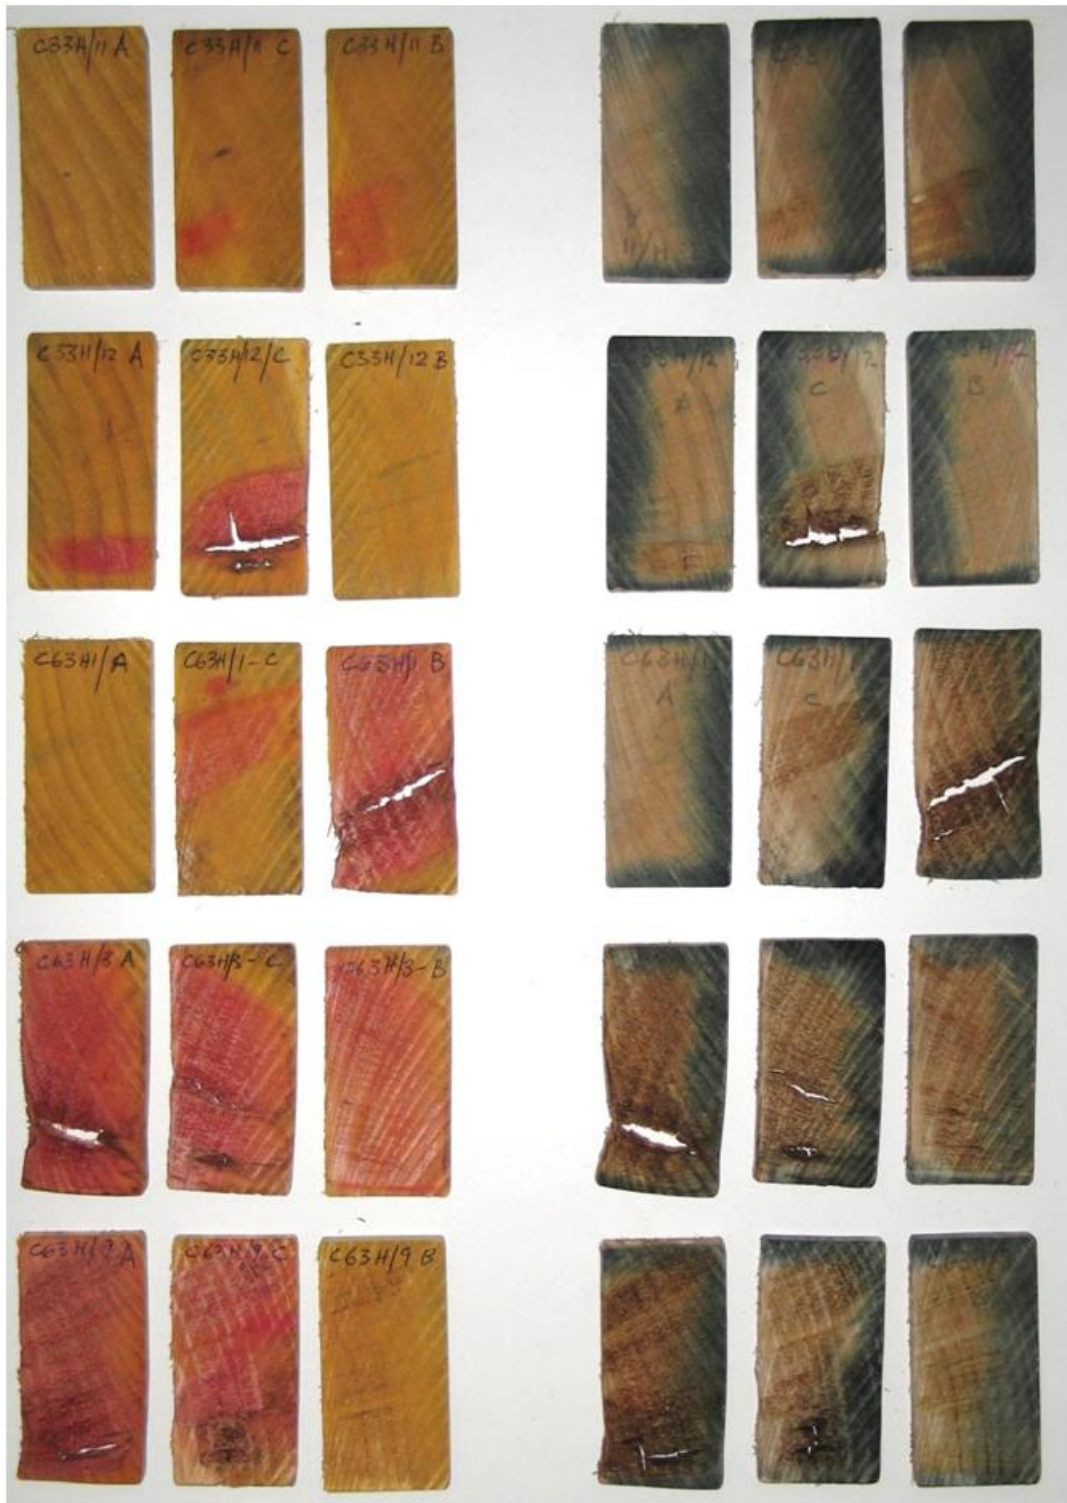
Figure 11 – Decay and preservative penetration in copper naphthenate treated samples (HMC tanks treated on one face and two edges). Preservative penetration is limited and all samples contain some decay extending into the treated areas.

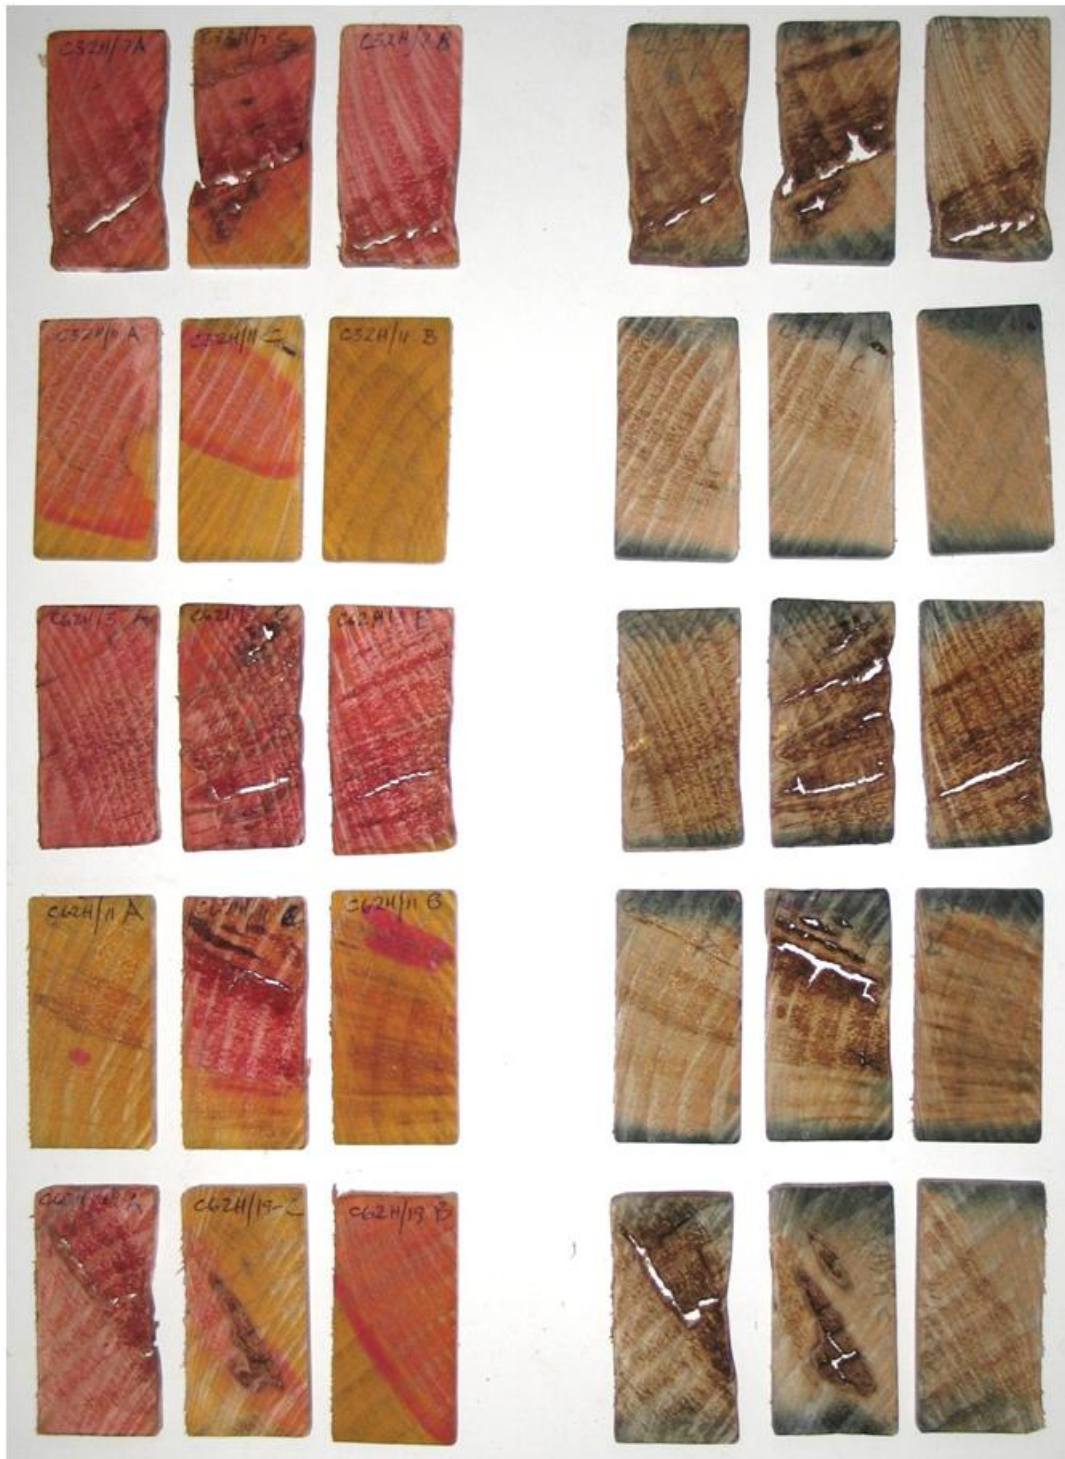
Figure 13 – Decay and preservative penetration in copper naphthenate treated samples (HMC tank treated on two edges). All samples contain extensive decay although in the second from top sample it was mainly at one end. There was limited preservative penetration and decay was active up to and through the treated area.

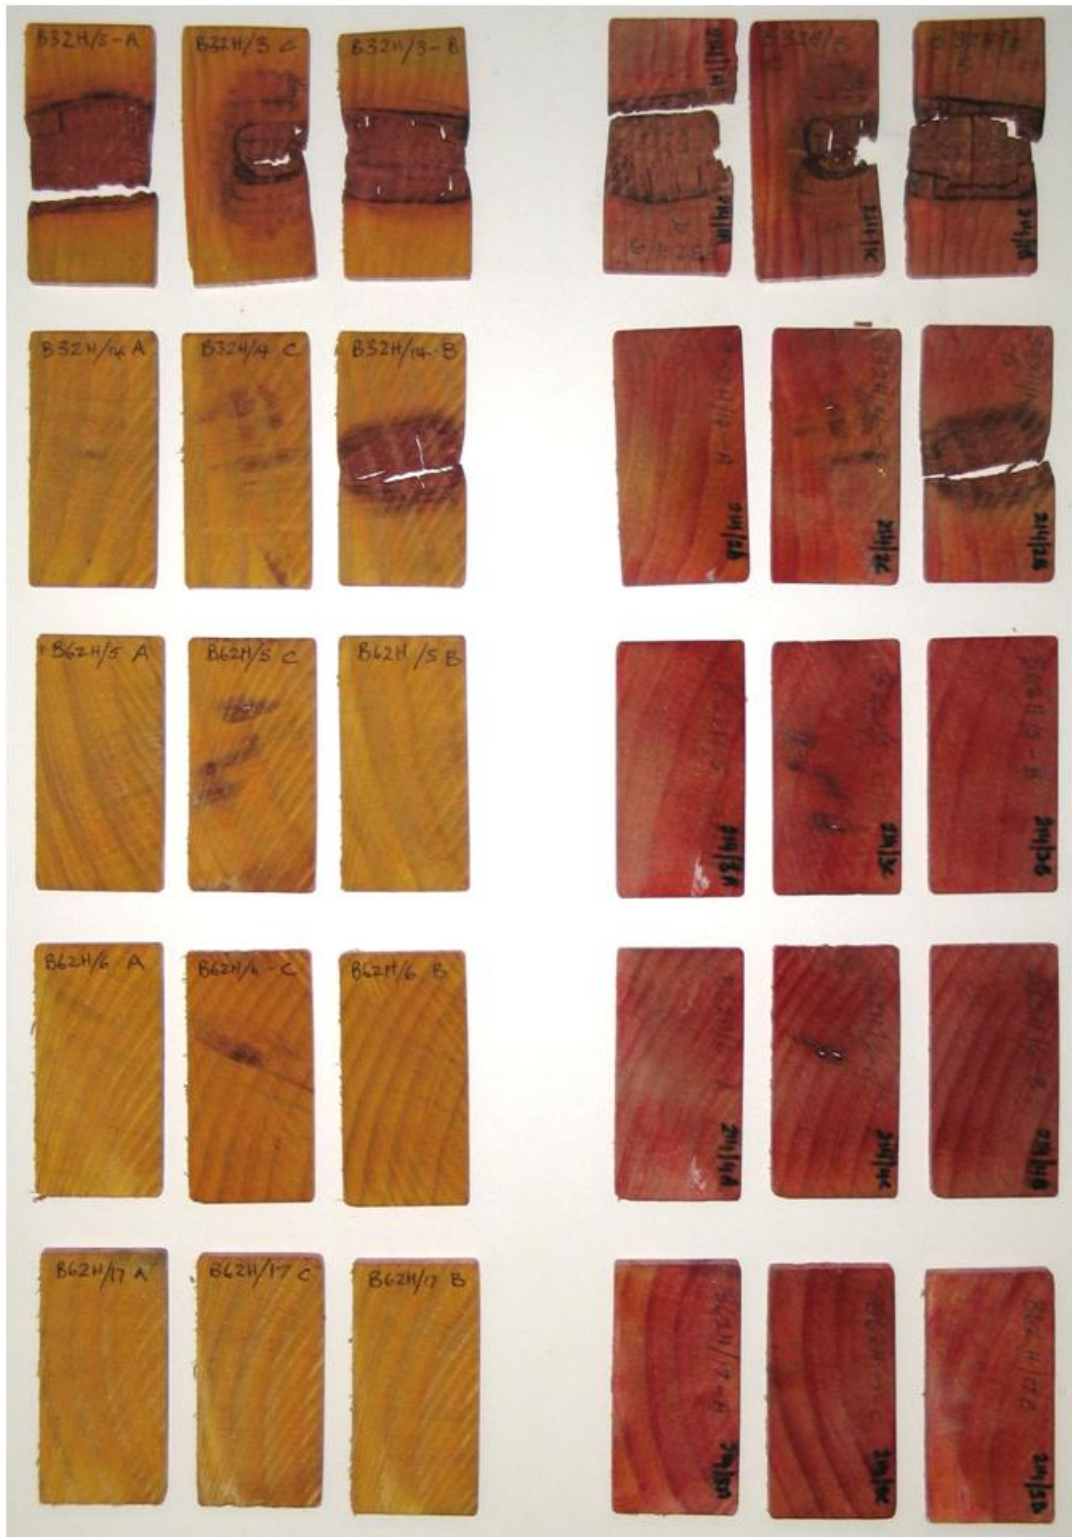
Figure 14 – Decay and preservative penetration in boron treated samples (HMC tank treated on two edges). All samples contain some decay although in the three lower samples it appeared to be from the original feeder block and was inactive. The reagent test colour suggests that the boron had spread through the sample from the two edges that it had originally been applied to.

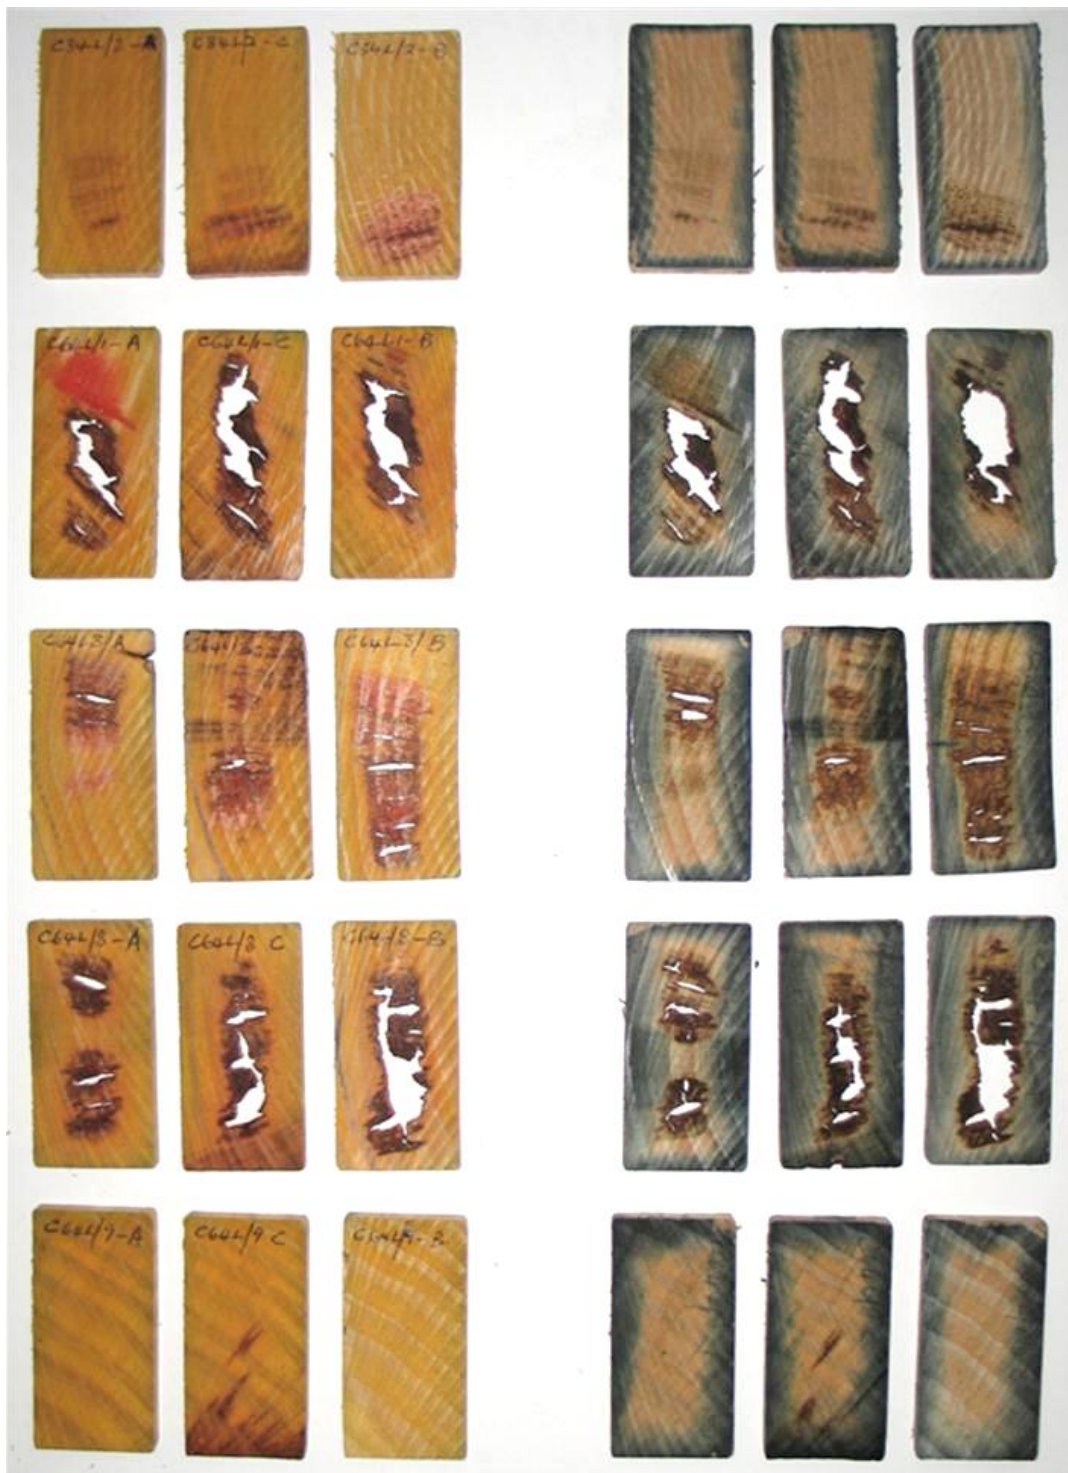
Figure 15 – Decay and preservative penetration in copper naphthenate treated samples (LMC samples treated on four sides in Table 4). There is limited copper penetration and there was active decay through the centre of the top four samples. Decay in the bottom sample was limited to the central section on one edge and had spread slightly from the area where the original decay feeder block had been attached.

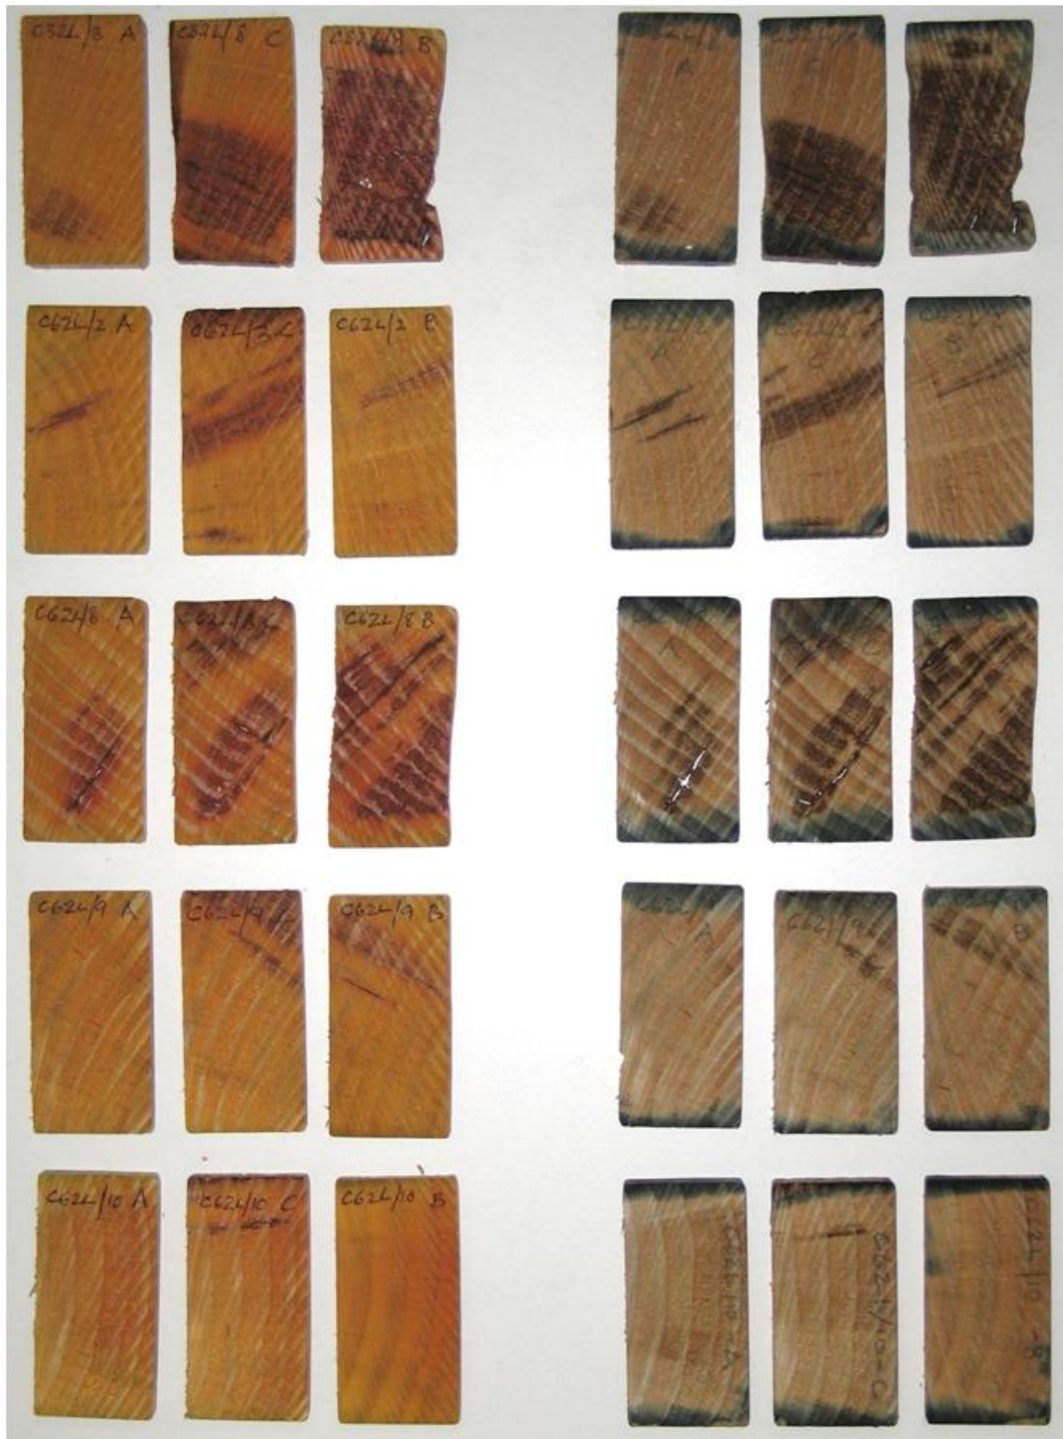
Figure 17 – Decay and preservative penetration in copper naphthenate treated samples (LMC stack treated on two edges). All samples contain some decay although the decay in the bottom two samples was from the original feeder block and appeared inactive. There was limited preservative penetration and decay was active up to the treated area.

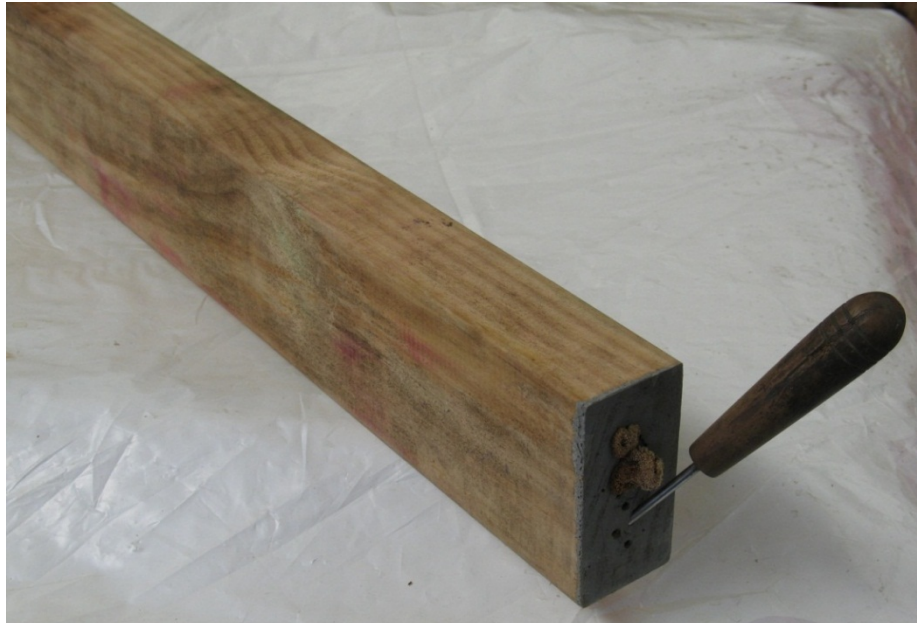
Figure 19 – LMC sample C64L/5 treated with copper naphthenate on four sides after 157 weeks exposure. This was in layer 5 near one side of the stack and would have not been wet by condensation drips hence its moisture content would have been between 25% and 30% for the duration of the trial. There were decay fruiting bodies at one end and decay extending full length of the sample through the centre. There was no decay on the exterior of the sample except what appeared to be an inactive area at the point where the original decay feeder block had been attached before treatment.

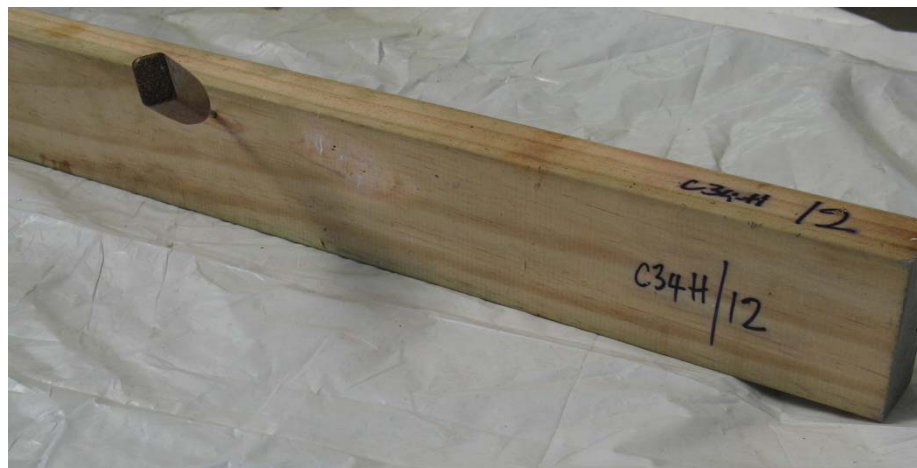
Figure 20 – HMC sample C34H/12 treated with copper naphthenate on four sides after 159 weeks exposure. Decay, probably originating from the pre-treatment decay feeder block has broken through the preservative treated envelope and is beginning to spread along the sample surface.

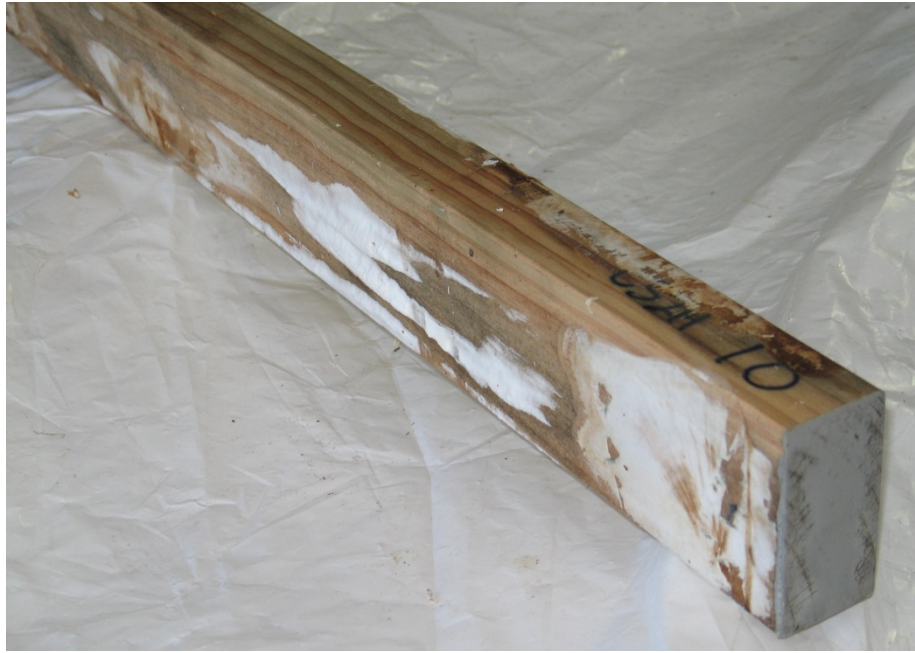
Figure 21 – HMC sample C32H/10 treated with copper naphthenate on two edges after 159 weeks exposure. Decay has spread along the length of the sample including over the treated edges. It was severe in patches and the sample rating was 6 (30-50% of the cross section decayed). MOE had declined by 11% during the exposure period.

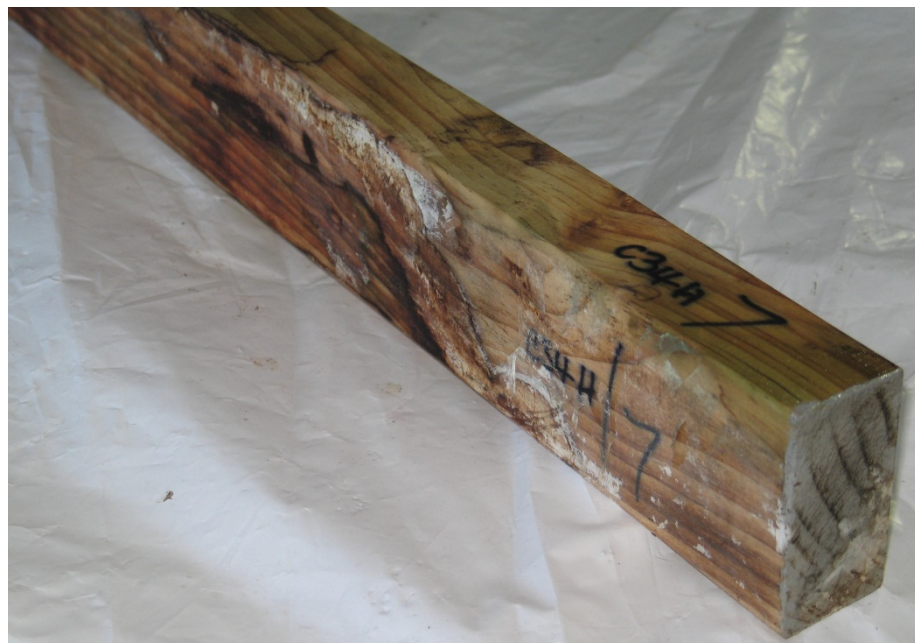
Figure 22 – HMC sample C34H/7 treated with copper naphthenate on four sides after 159 weeks exposure. Decay had spread along the length of the sample and it failed during deflection testing at the 159-week assessment.

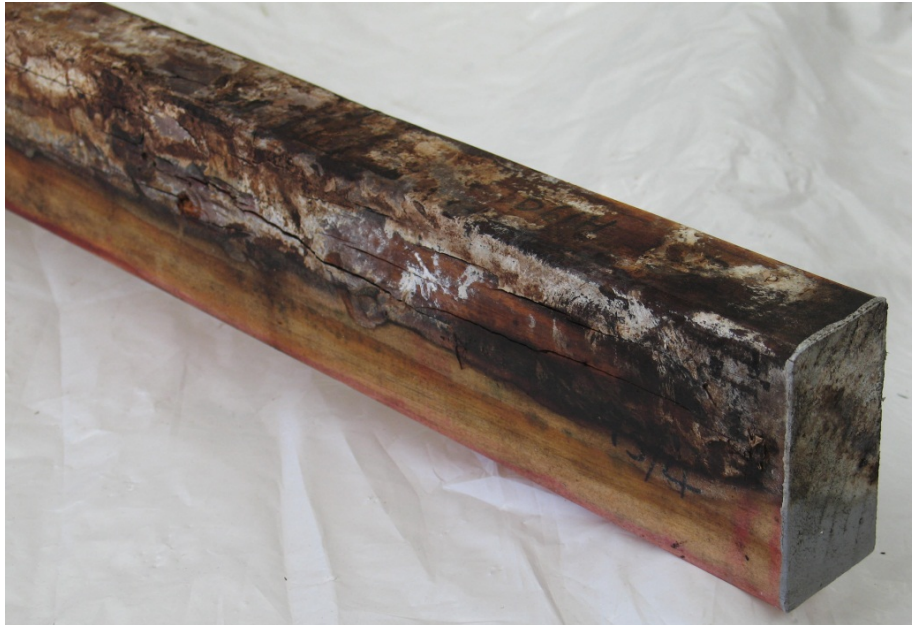
Figure 23 – HMC sample B61H/12 treated with boron on one edge after 159 weeks exposure. There was severe decay throughout the sample, away from the treated edge. This was typical of many of the samples in the group that were treated with boron on one edge only.

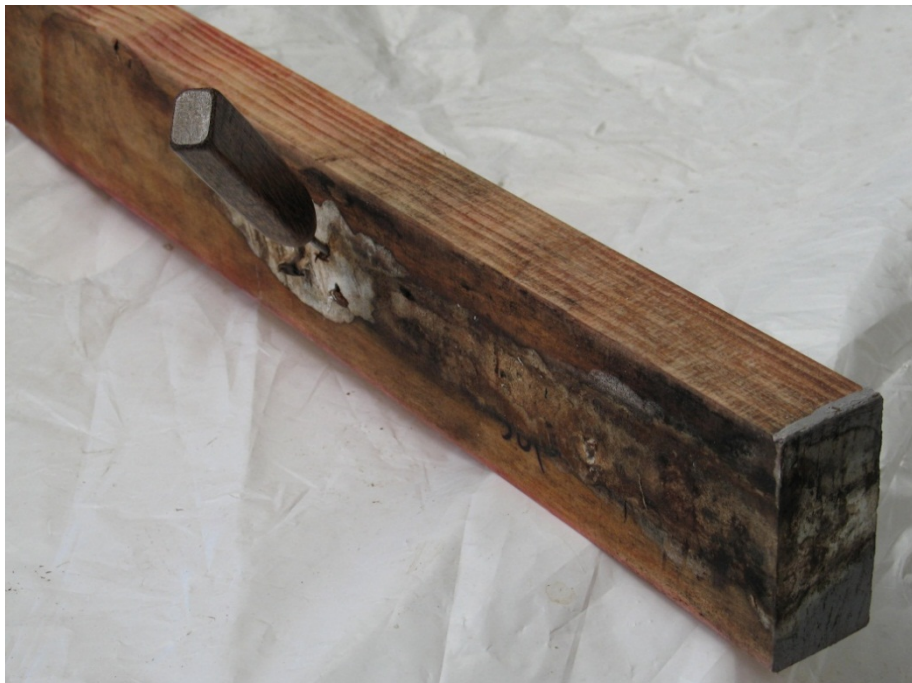
Figure 24 – HMC sample B32H/13 treated with boron on two edges after 159 weeks exposure. There was a strip of severe decay through the centre of the sample but this had not spread to the treated edges. This sample was in the top layer of the tank and it is likely that boron loss would have been greater than for samples lower in the tank. MOE for this sample had reduced by 23% over the exposure period due to this decay (rated 6, 30-50% of the cross section).

Samples treated with boron on two or more sides had less decay and showed fewer MOE changes than the equivalent copper naphthenate treated samples. Even where there was major decay through the length of the sample, e.g., the top sample in Figure 14, there was no serious loss of MOE. Decay in these samples was generally restricted to a strip through the centre away from the boron treated edges and the wood either side of this remained intact. The samples were tested for deflection as a plank, hence the decay would have had little effect on deflection.
