Maunganui Road Traffic Calming Road Safety Audit - Golf Road to Hinau Street

Prepared for Tauranga City Council

Prepared by Beca Limited

19 December 2018

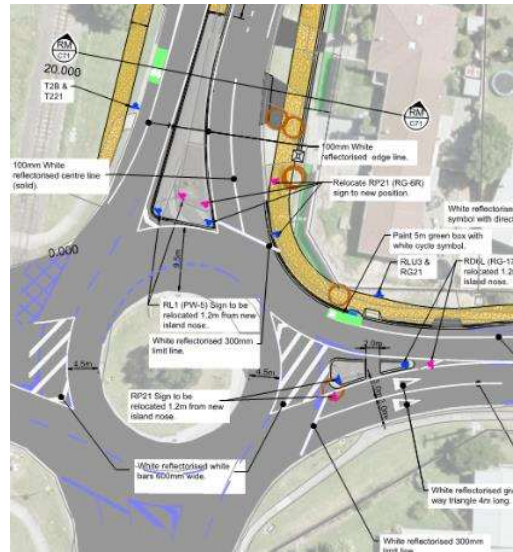
Figure 3: Change in approach lanes to roundabout

The SAT noted that the changes to traffic movements within the Maunganui Road / Golf Road intersection will be largely facilitated by line marking. However, some approach lane movements & markings will appear the same to drivers as they approach. As this proposal includes restricting some to left turn only, this has the potential to result in drivers making late lane changes or simply driving over the new line marking. This is shown below by the proposed hatching area.

The identified risk here is when drivers expect others to follow the new line marking (i.e. turn left) and enter the roundabout only to collide with a vehicle that continues straight.

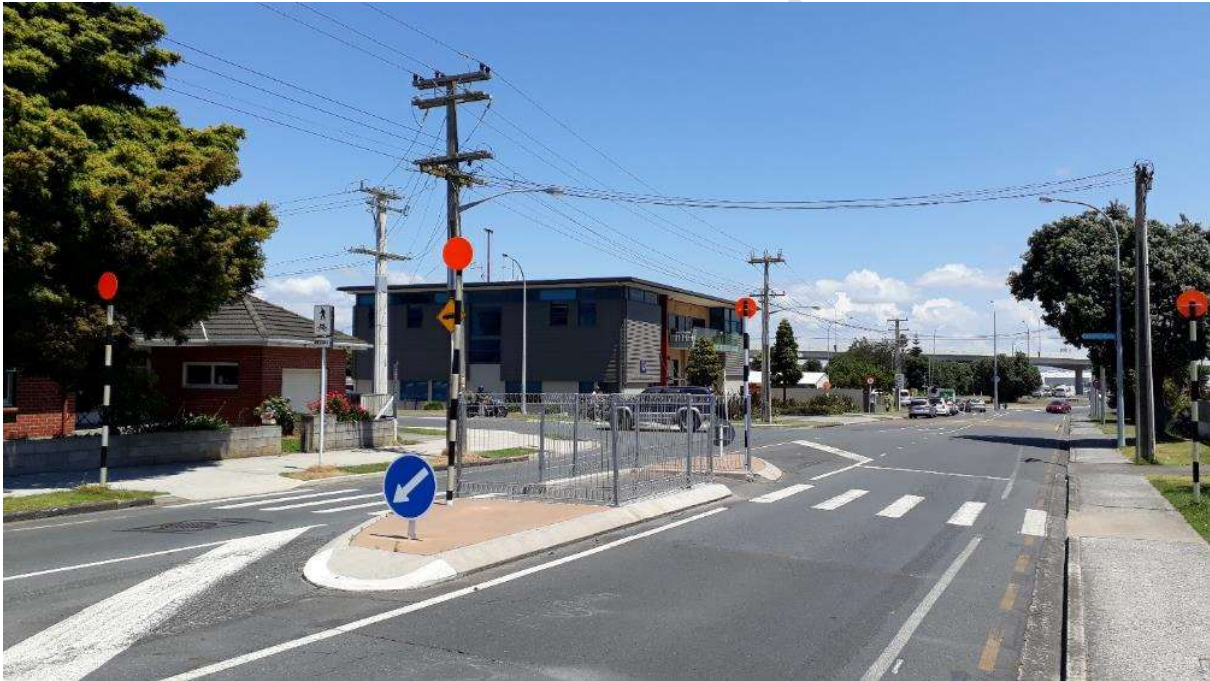
Figure 4: Golf Road pedestrian crossing

The SAT identified that the southern end of the project, left a shared path on both sides of Golf Road connected by a pedestrian crossing with a pedestrian cage and chicane. A cyclist using this shared path would need to dismount and navigate the crossing before continuing on the adjacent shared path through Links Ave or northbound on Golf Road.

The SAT felt that this break in the path may likely result in cyclists crossing Golf Road away from the crossing, which may distract a driver from an actual user of the pedestrian crossing or vice versa.

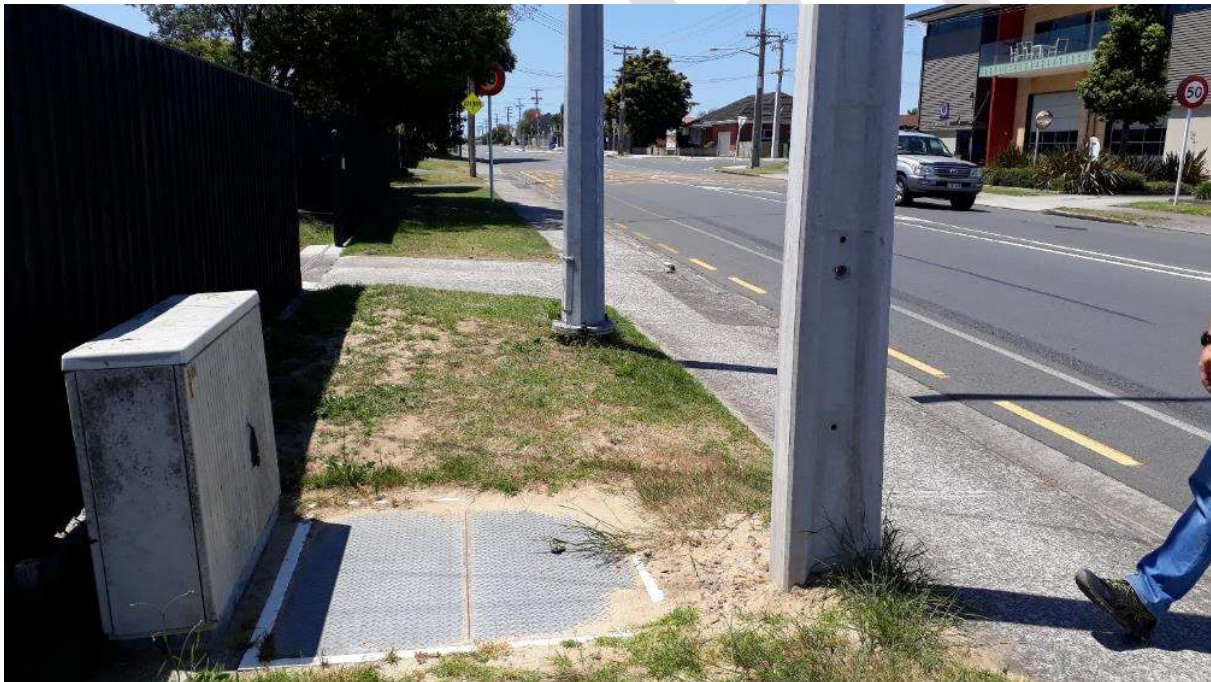
Figure 5: Recently Installed Power Pole

The SAT identified a new power pole not included on the design drawings, which is within the proposed path extent.

Review the ability for this pole to be relocated and relocate if possible.

Designers Comment: The designer agrees with the SAT team recommendations. The relocation of the power pole has been included in the schedule.

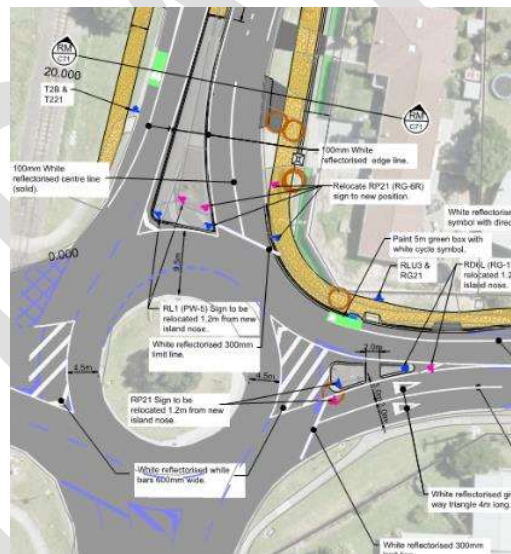
Figure 6: Change required to approach lane markings

Arrow markings shown on both approaches to Maunganui Road need to be provided/corrected as they are a change over the existing and the line marking plans provided do not reflect this.

Update drawings with new lane arrows.

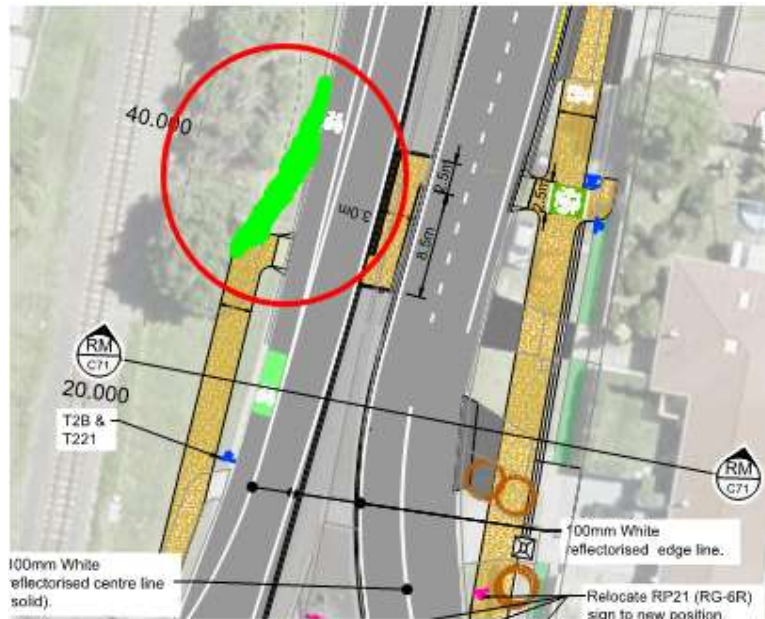
Figure 7: Example of more favourable cycle drop kerb

The SAT noted that any cyclist on the Hewlett’s Road shared path wanting to use the northbound cycle lane or Maunganui Road, need to use the proposed drop kerb. This is likely to be an awkward angle causing a slow movement speed for cyclists. A cyclist that is wanting to do this could surprise drivers, causing sudden reactions.

Provide a more suitable drop-kerb connection for cyclists connecting from the Hewletts Road shared path.

Designers Comment: The designer agrees with the SAT recommendations, this will be discussed with TCC.

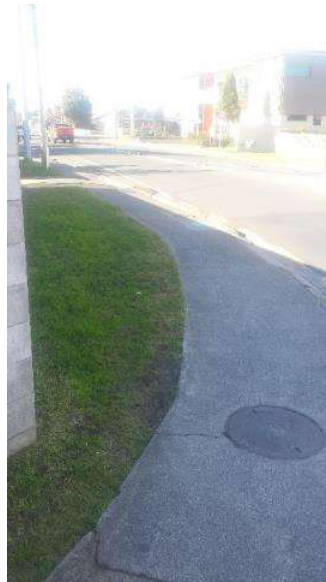
Figure 8: Blind Corner Approach (Maunganui to Golf)

At the Maunganui / Golf intersection where the path is located close to the adjacent property boundary, the fence obstructs sight distance around the curve. There is a high potential for two users to approach on either side of this curve and collide on the corner.

The blind corner is also located on the exit lane of the roundabout, potentially increasing the risk if a collision were to occur and a user were to fall into the road way.

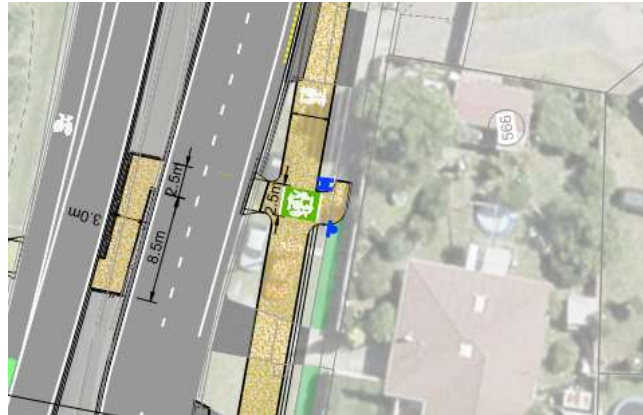
Figure 9: Shared Path to Exclusive Path

The SAT felt that where the shared path transitions into the cycle only path section, there is no specific change in environment that would guide users into the appropriate location. This is likely to result in more pedestrians using the cycle path and conflicting with cycle users.

Adjust the end locations of the shared path to ensure that priority for each path is clear to all users, supported by the appropriate signage.

Designers Comment: The designer agrees, and we recommend that the dedicated cycle route sign be relocated in advance of the conflict point at approx. CH60

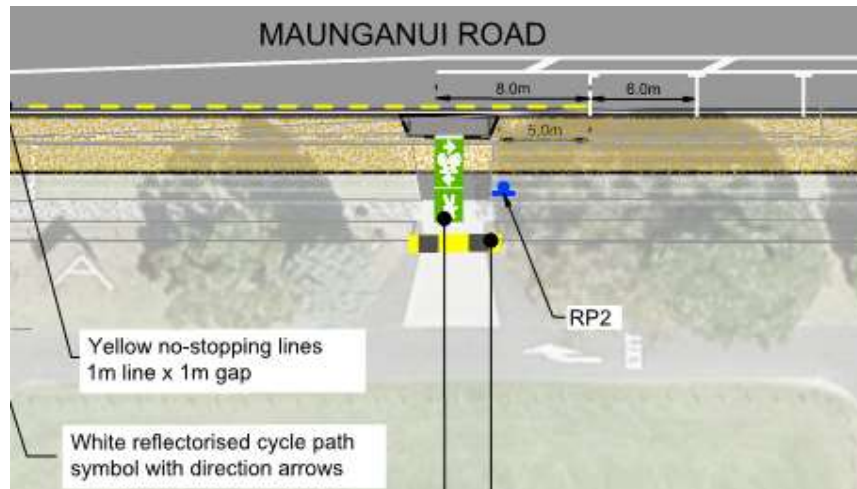
Figure 10: Give-way sign at path crossing

The RP-2 is shown at the school driveway to be located between the footpath and cycle path, may confuse drivers as to which path they give way to.

Reinforce the give way markings by relocating the yellow & black lines between the footpath and cycle path or ensure that the cycle path and footpath are clearly separated – unlike the above where the markings are directly adjacent to one another.

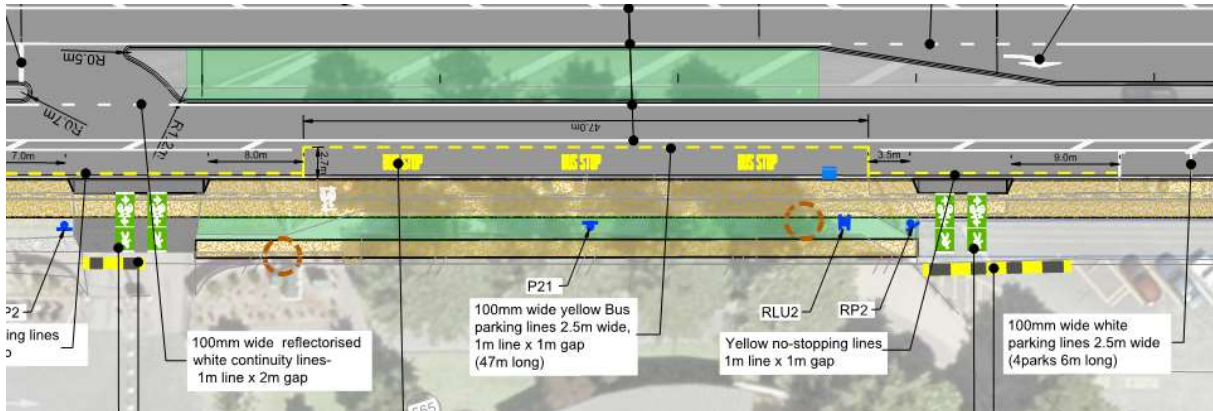
Figure 11: Cycle Path Through Bus Stop

The cycle path is in direct conflict with the bus stop area, which is likely to be an area of significant conflict during school start/end times. School students are expected to be waiting on this path, increasing the likelihood of a collision and this is an area where pedestrians step off the bus straight into the path of cyclists.

Combine the cycle path and footpath through this area, providing a designated waiting and alighting area for passengers.

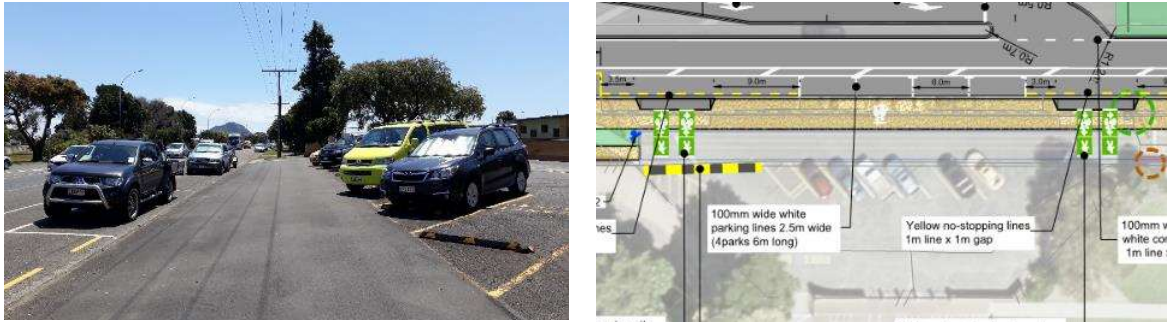
Figure 12: Possible New Informal Parking Area

The provision of the widening for the cycle path section is shown to significantly increase the size of the drop off area in front of the school. The existing parking area appears to be able to spill over into the cycle lane section, which will be a notable conflict with path users.

Provide greater delineation of the cycle path through this location, and designate parking areas with additional measures (such as raised kerbing or bollards) to discourage parking in the cycle lane.

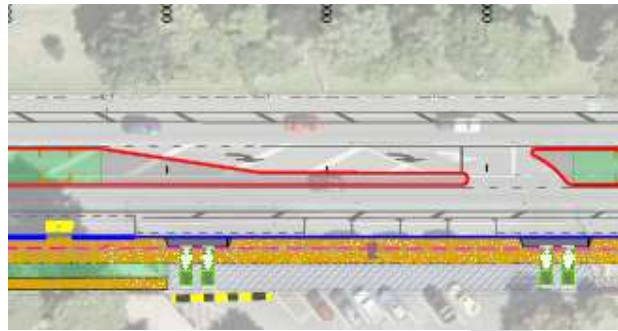
Figure 13: Potential U-Turn Location

The SAT felt that the implementation of a solid median will increase the number of U-turns at right turn bays. This should be checked by the designer, particularly if a parked car is present in the nearest parking space, potentially making it a three-point turn and increasing the time a driver is turning in the traffic lane.

Review the impacts of U-turns on traffic flow and parking.

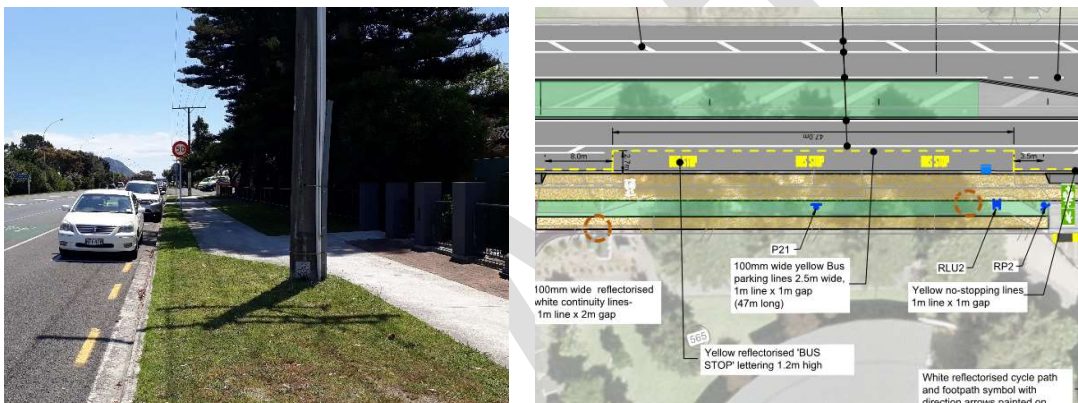
Figure 14: New Path Against Property Boundary

With the paths located in and through busy areas, the SAT queried where there are entrances to the school how this will safely operate when large numbers of school students enter and exit the school. This is particularly of concern where the path is being shifted to be closer to the boundary than currently.

The SAT recommend that the facilities through this section are reviewed in tandem with item 3.13 with further consideration for sight lines into the school in an attempt to mitigate occasions where path users conflict with those exiting the school.

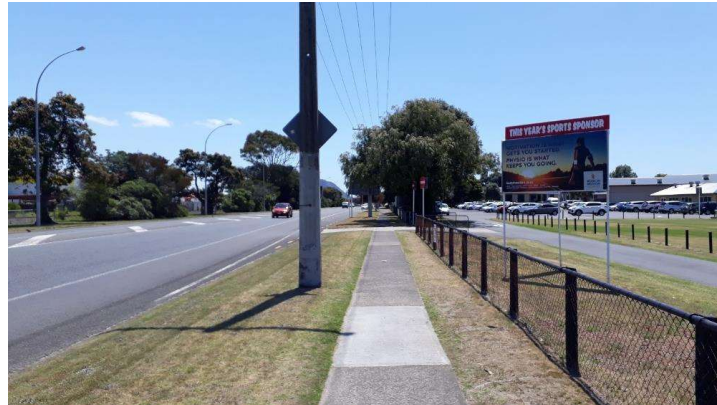
Figure 15: Existing Path Width

The existing footpath on the eastern side of Maunganui Road was noted to be particularly thin throughout its length and is proposed to be retained for this project. This width is only sufficient for one user, two pedestrians crossing requires one to walk off the path. Added to this there is a swale next to the path in some locations.

Widen the footpath to 1.8m with on-road cycle lane or consider combining the cycle path and pedestrian path into one shared path. It is likely that this combination would allow more flexibility to deal with other issues identified within the RSA such as the bus stop conflicts.

Designers Comment: The designer agrees with this recommendation and that the shared path should be consistent throughout the project. There is however issues with combining the footpath and cycle path due to volume of cyclists and pedestrians from the College. We would recommend widening the footpath to 1.8m.

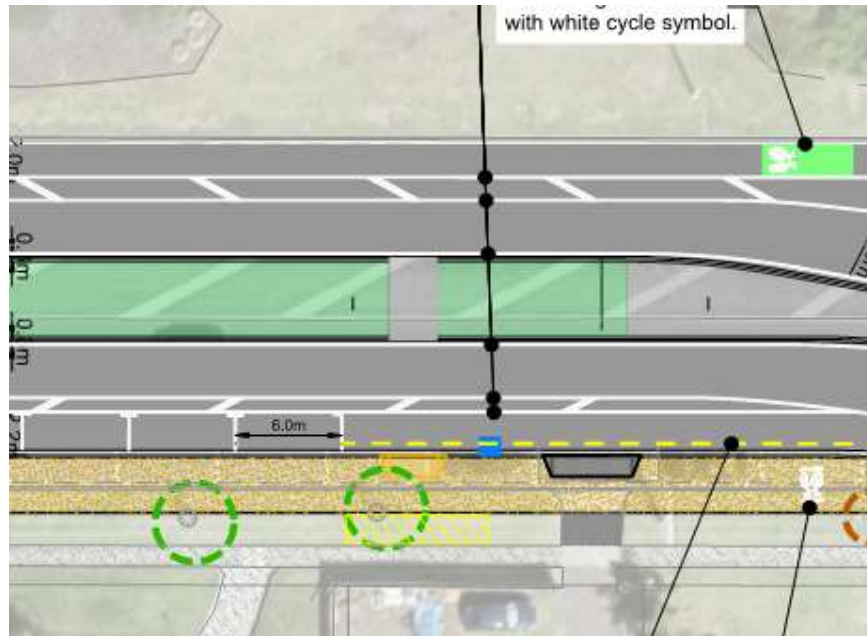
Figure 17: Proposed Cycle Crossing Point

At the Tui Street intersection, the crossing does not provide a safe waiting location for those wanting to cross. A cyclist would need to wait in the cycle lane, potentially conflicting with other cyclists, or wait next to the traffic lane in an unprotected location.

Provide a safe waiting area for cyclists crossing at Tui Street (e.g. hook turn facility with hand rail).

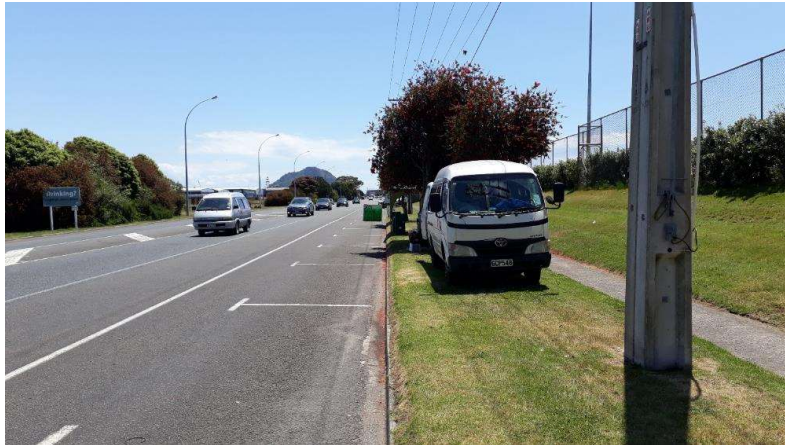
Figure 18: Informal Berm/Path Usage

During the site visit, the SAT observed an informal yet established produce seller parking within the verge. This space would no longer be easily available for this use, either resulting in them remaining on site or shifting the use to another location.

There is a risk that this activity would continue to operate in this location (i.e. parking on the cycle path) or relocate to a less safe location if the current location were no longer available. Consult with users or investigate alternative measures.

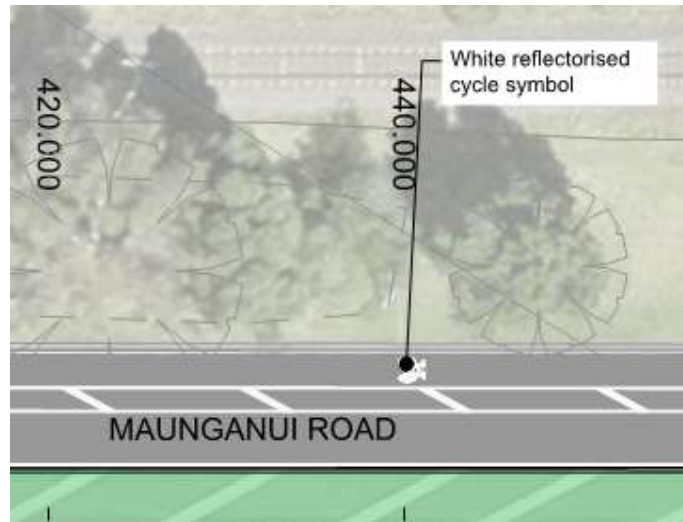
Figure 19: Delineation of Cycle Lane

The cycle lane on the western side of Maunganui Road will need to be clearly delineated so that drivers are discouraged from driving within the lane and so cyclists are safe from errant vehicles. Physical protection is typically favourable for cyclists rather than just line marking.

Ensure that on-road cycle lanes are clearly delineated to prevent vehicles for driving in the new median area. Consider physical separation e.g. armadillos or bolt on kerbing.

Designers Comment: The designer considers physical protection to be a hazard to the cyclists. However safe hit posts could be considered.

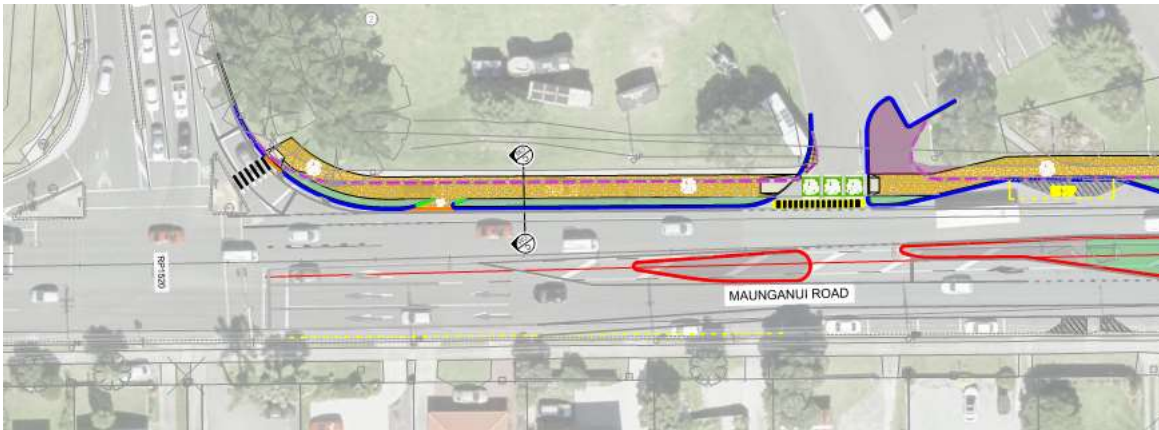
Figure 20: Short Stacking Lanes Approaching Hull Road

The provision of a new right turn facility into Blake Park and median will prevent informal stacking for the right turn lane into Hull Road. This will reduce the level of service for the approach and is could result in increased red-light running and late lane changes approaching the intersection.

Review traffic modelling to check there is sufficient stacking space for the right turn. Extend the two-lane approach to the intersection in necessary by removing some parking spaces to provide greater functionality.

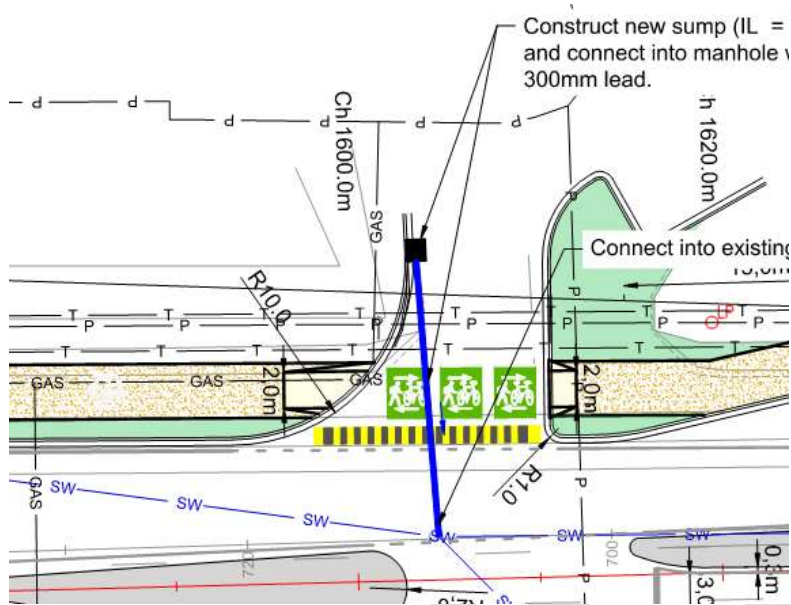
Figure 21: Effective Path Widths

The SAT noted that crossing widths decrease to 2.0m wide in some locations. This is likely to have a significant impact on the ability for multiple users to cross at the same time and has the potential to funnel users together and create conflicts between cyclists and pedestrians in particular.

Retain a consistent 3.0m path widths by widening kerb crossings and cut downs to 3.0m.

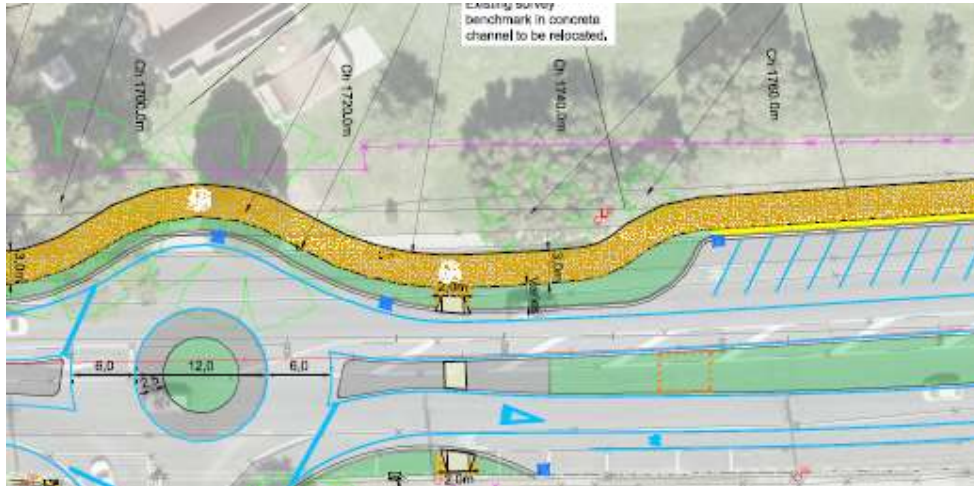
Figure 22: Limited On-Road Space for Cyclists

As cyclists may be on-road from Clyde Street or Tay Street there is also no provision for cyclists to leave the road, effectively giving these such cyclists no appropriate alternative.

Provide the appropriate width to avoid this conflict zone and the appropriate facilities to encourage cyclists to leave to road at likely locations.

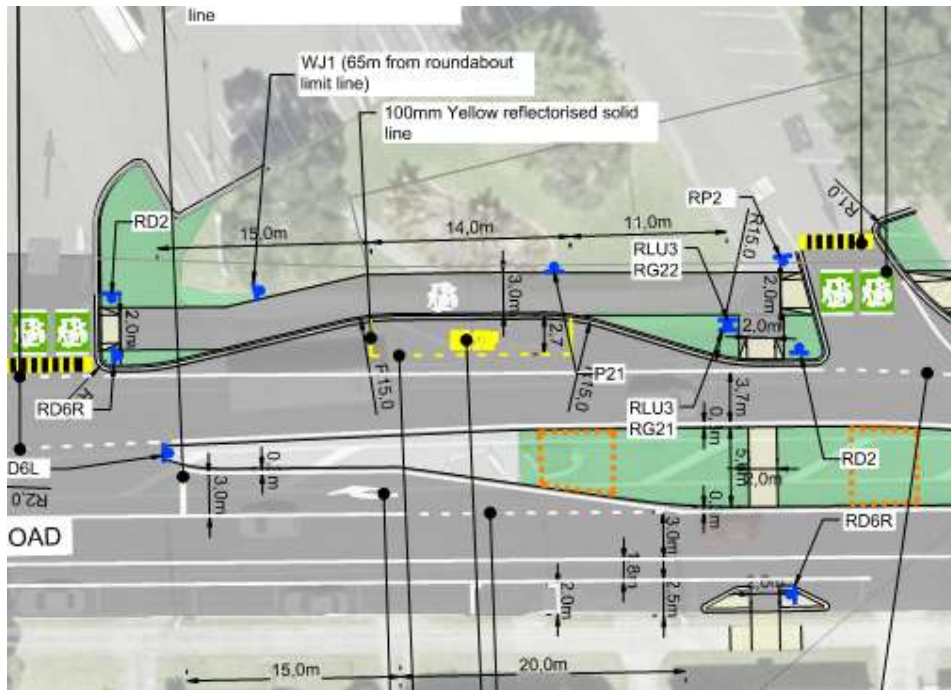
Figure 23: Potential Conflict with Shared Path and Bus Stop

Similar to issue 3.13, the SAT were concerned with the shared path and bus stop waiting area sharing the same space, in particular cyclists as on-road cyclists will be discouraged with the lack of on-road facility. It is likely that this will increase the risk of a passenger alighting a bus in front of a cyclist on the path.

Implement additional measures to slow approaching cyclists or implement a safer treatment in this location that separates the different users to mitigate this risk.

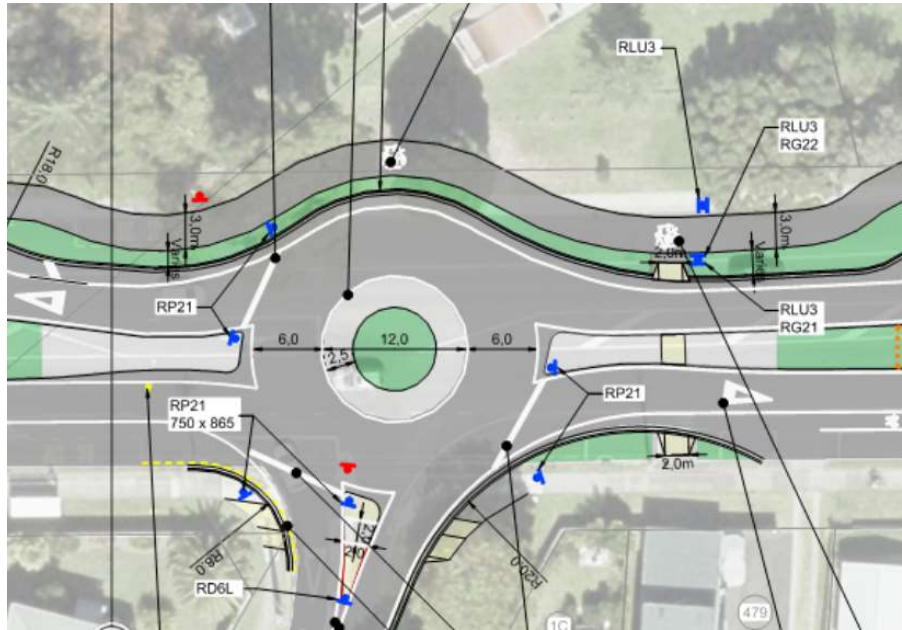
Figure 25: Limited Roundabout Deflection at Roundabouts

The SAT noted that the deflection at roundabouts in the southbound direction will not constrain vehicle speeds as effectively as the northbound direction, and at both intersections may offer very little deflection to drivers at all.

Increase roundabout deflection exiting the roundabout in the southbound direction.

Designers Comment: The designer agrees with the recommendations, however the deflection angle at the exit to the roundabout is achieved when considering the position of the edge line, the location of the kerb is however governed by the turning movement of the design vehicle.

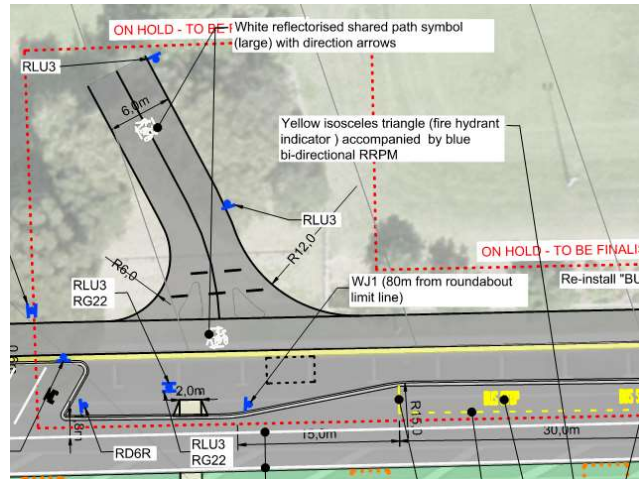
Figure 28: Totara Street Approach to Maunganui Road

At the connection with the Totara Street Cycleway, the SAT felt that this will need to be managed appropriately to ensure that users are aware of this intersection and slow accordingly. The risk is from cyclists missing the intersection and entering the road or colliding with other users on the path that are travelling along Maunganui Road. (appreciating the notation of hold status).

Implement the appropriate signage (such as give way markings and signage) and potential cycle calming measures to manage user speeds and provide an indication to users of the approaching intersection.

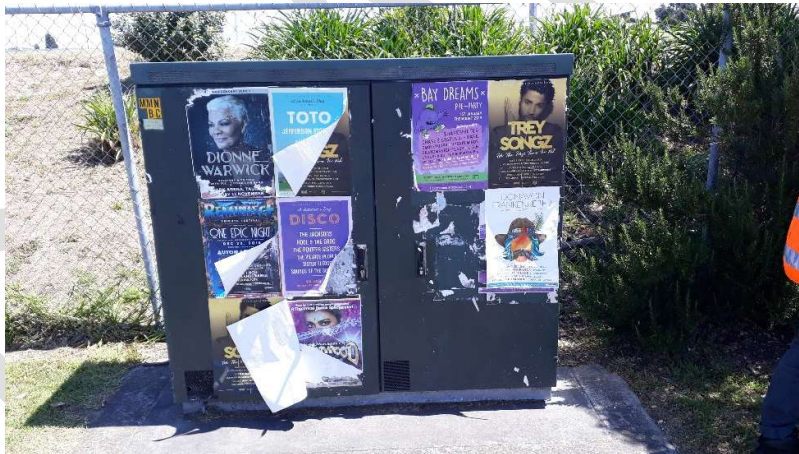
Figure 30: Existing Chorus Box to Remain

The SAT noted the existing Chorus Box opposite Tay Street, which if the project is constructed as shown will cause a sudden reduction in path width, which is a notable risk, particularly at night.

Adjust the path widths approaching the utility box to reduce the impact of the sudden change in width, relocate the box or provide more path width on the roundabout side of the path. In addition consider the lighting provided for this box to ensure that users are aware of it as they approach.

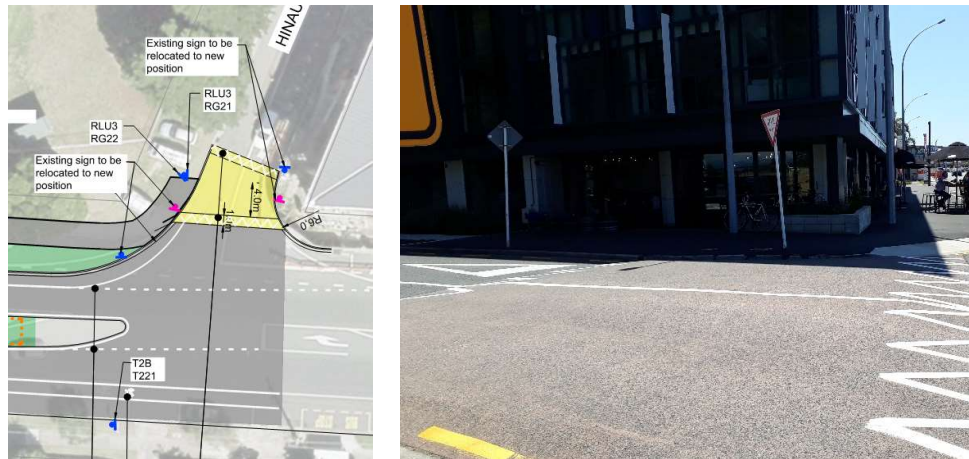
Figure 31: Hinau Street Approach Crossing

treatment, however as this is a continuation of the shared path, users may interpret this as a raised table crossing giving priority. Plans imply that this will be altered on site, however an appropriate design is recommended to ensure that all users are aware of the intentions here.

Considering the current use in this location, it is recommended that significant changes are made (i.e. the raised table to be specifically aligned with the path) to this location to encourage the correct priority treatment.

Designers Comment: The designer agrees with the SAT recommendations. The designers view is that the shared path should be terminated at this location due to the level of uncertainty as what the extended cycle network will look like. Final decision to be made by TCC.
