# Report: Scruttons Road LCSIA (2024)

Ref: 310203418

PREPARED FOR: Christchurch City Council

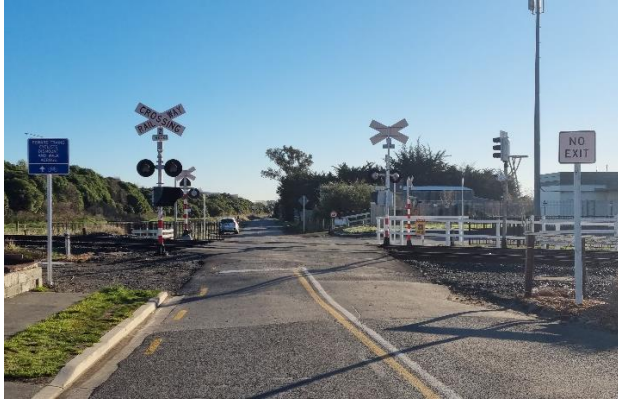
**Figure 4-3: Southern approach to level crossing from Scruttons Road**

The Scruttons Road level crossing is controlled by FLBs, with duplicated FLBs provided on the northern side of the level crossing and a single FLB on the southern side. The primary FLBs are angled to face traffic approaching from the north and south of Scruttons Road as seen in Figure 4-3 and Figure 4-4. Note that the bells are soft-tone bells as the level crossing is adjacent to residential housing. Two more recent FLB installations have occurred on the northern side that face the approaches of the MCR from the east and west.

The level crossing is skewed on an angle approx. 42° from the perpendicular (or 48° to the road).

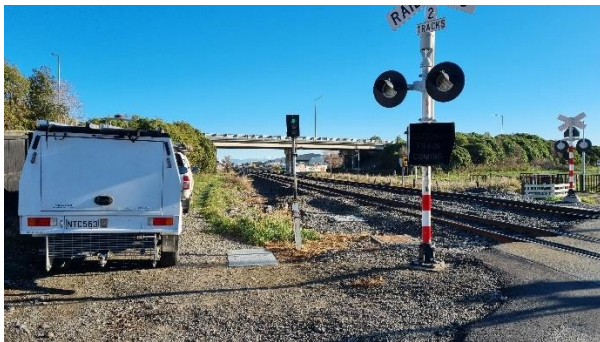
**Figure 4-5: FLB with 'RAILWAY' crossbuck sign and West track sightline on the southern approach**

Figure 4-5 shows the FLB with a WX6 crossbuck sign and the sightline western side from the southern approach. Figure 4-6 shows the sightline to the east from the southern approach. The vegetation and signal control boxes obstruct view from this position.

In Figure 4-5 a track signal (lit green) is visible and there is a replicated signal for the other track on the opposite side of the level crossing. KiwiRail staff noted that these signals needed to be changed, so that trains when stopped for a red signal, did not block Scruttons Road. There was no timeline provided on when this might occur, but the fact that stopped trains block Scruttons Road was not desirable to the staff present. The signals could be relocated such that the signal was before the level crossing and not after it, which would remove this issue.

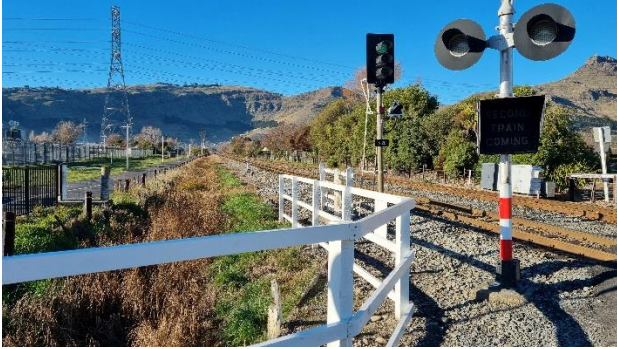
**Figure 4-7: FLB with "RAILWAY" crossbuck sign and east track sightline on the northern approach**

Figure 4-7 shows the FLB with a WX6 crossbuck sign (not pictured) and the sightline to the east from the northern approach. It can also be seen that track signals for the trains are located very close to the level crossing on this north-east quadrant. Road users, pedestrians and cyclists may get confused by the two conflicting signs. Out of shot to the left of the image, is a separate set of recently installed FLB facing directly at the westbound cyclists on the MCR.

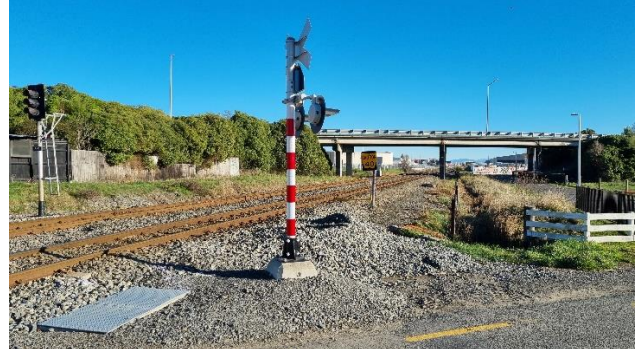
**Figure 4-8: FLB with "RAILWAY" crossbuck sign and west track sightline on the northern approach**

Figure 4-8 shows the FLB with a WX6 crossbuck sign and the sightline to the west from the northern approach. This FLB faces the cyclists approaching the level crossing from the western approach of the MCR.

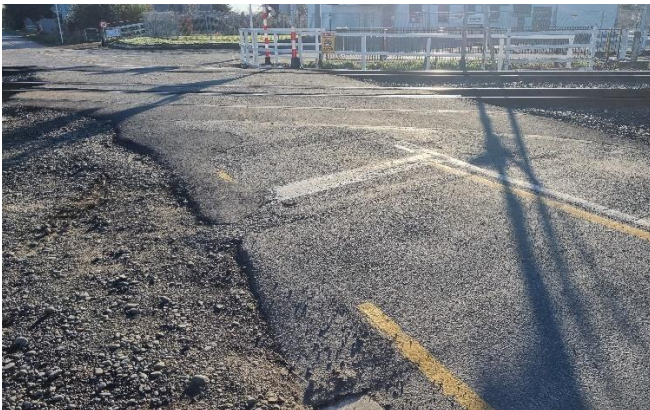
**Figure 4-9: Edge break and faded line markings**

Figure 4-9 shows the edges of the carriageway are breaking away and maintenance repairs on the road covering over the line marking, which is beginning to fade. Figure 4-10 shows the slight hump at the level crossing, which hides the opposing lane limit lines from view, but the centreline in the distance is still clearly visible. Of note is that the centrelines either side of the crossing panel are misaligned.

8. **Fading pavement markings.** Some of the pavement markings are fading and will need to be remarked in the near future.
9. **Pavement defects:** There are some minor pavement defects forming that if not addressed in a timely manner, will become a bigger issue if left unattended.

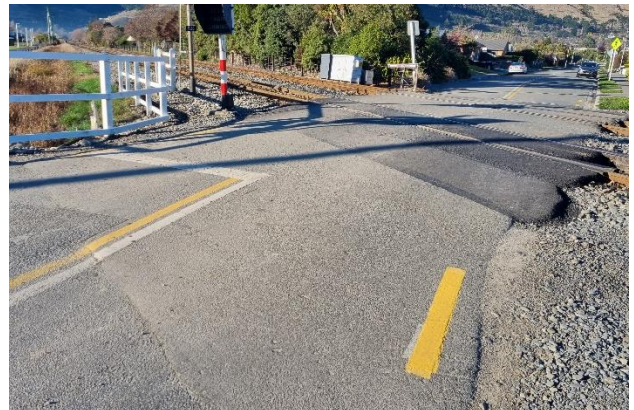
**Figure 4-10: Slight hump over level crossing**

6. **Deteriorating condition of crossing panel:** The crossing panel is starting to show signs of wear / deterioration, with the asphalt warping in places. This will need to be monitored so that a renewal can be timely programmed when required. Currently trip hazards are developing for pedestrians that walk over the road. There is also edge break occurring to the crossing panel that is further narrowing the road over the level crossing.

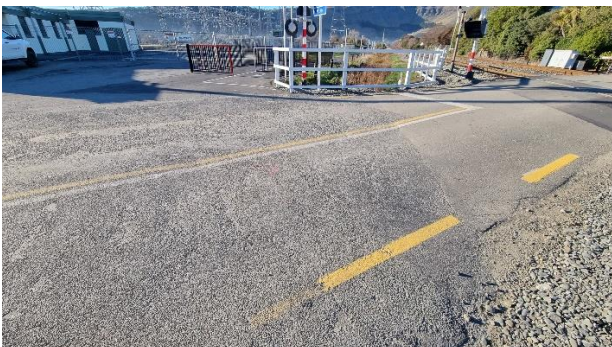
**Figure 4-11: Faded line markings, no parking lines**

There are no parking lines in three quadrants, except the southeast quadrant (nearest vegetation). Some of the pavement marking is starting to fade as seen in Figure 4-11. The track panel is in an average condition, with asphalt starting to warp by the EPflex rubber edging along the tracks, which by its very nature creates small flange gaps at this skewed level crossing, as seen in Figure 4-12.

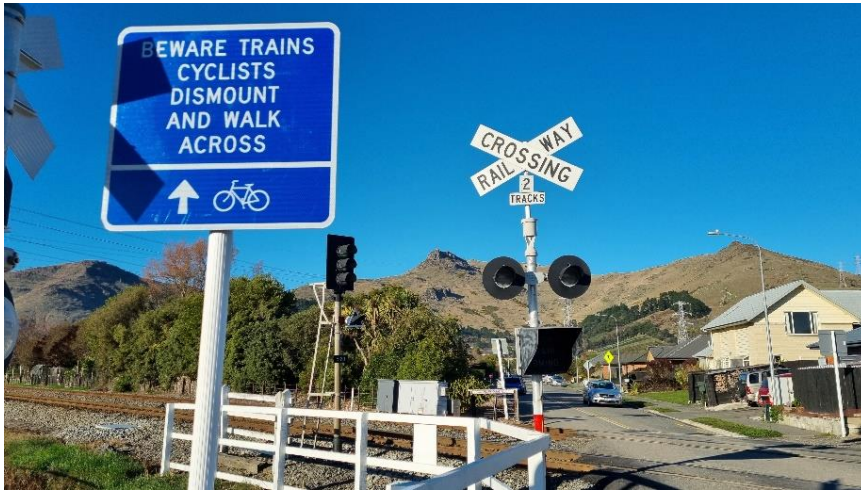
Figure 4-13: Signpost warning cyclists to dismount when crossing

Figure 4-13 shows a blue signpost on the eastern side of the road from the northern approach, which warns cyclists to beware of trains and dismount when travelling over the level crossing. Figure 4-14 shows the 'second train coming' active sign that turns on when a second train approaches in the opposite direction after the first train, warning users to wait longer. The '2 tracks' sign below the crossbuck also implies to users of the second train risk.

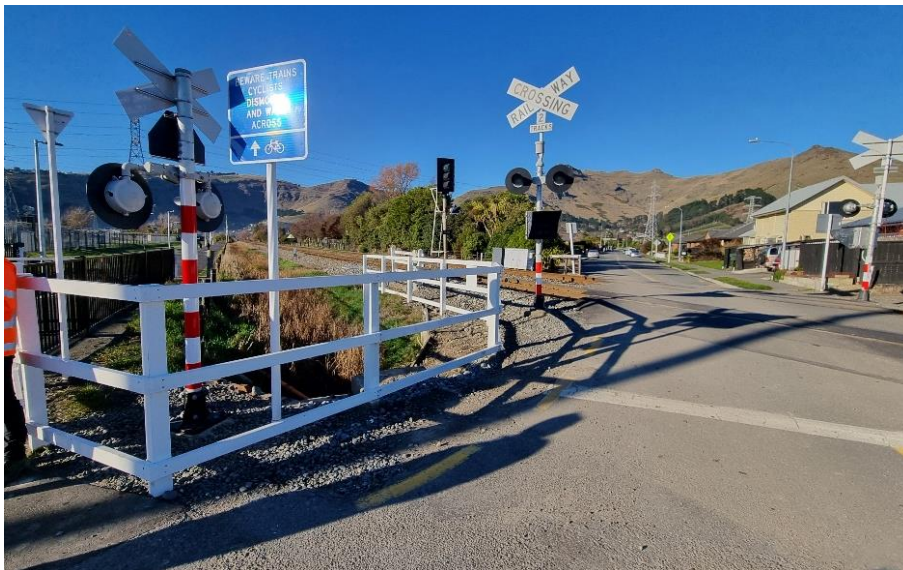
Figure 4-15: Fenced culvert, with set of FLB facing the eastern MCR approach

The culvert beside the level crossing from the northern approach is fenced off as seen in Figure 4-15. Also visible in Figure 4-15 is the recently installed FLB for the eastern approach of the MCR.

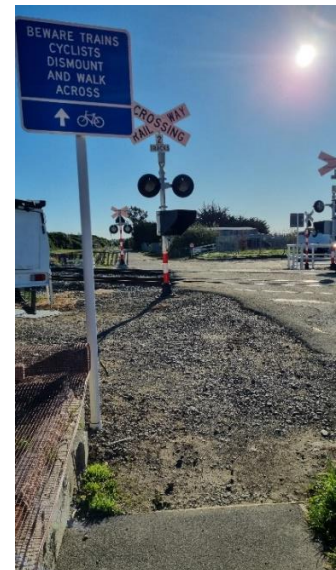
Figure 4-16: End of footpath

The footpaths and MCR approaches all stop prior to approaching the level crossing. Therefore, pedestrians and cyclists need to use the road crossing to travel over the rail corridor. Figure 4-16 shows the footpath on the south-west quadrant stopping just before the level crossing, continuing onto an unsealed section

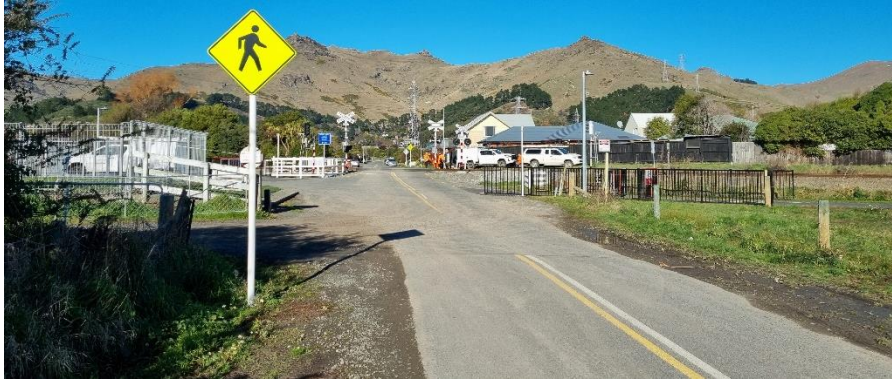
Figure 4-17: Pedestrian warning sign (north approach)

There are no advanced warning signs, including signposts or 'RAIL X' road markings, for the level crossing on the northern approach. The lack of sign on the northern approach, may be due to the road being a 'no exit'. However, there is a singular pedestrian warning sign on the left-hand side of the road as seen in Figure 4-17, which is replicated on the southern approach as well. It is not clear precisely what these signs are intended for, possibly related to the new cycleway, as the signs appear to be newly installed. Although, one would expect cyclist signs instead.

10. **Missing advanced warning signage and 'RAIL X' marking.** There are no advanced warning signs for the level crossing on the northern approach, and there is one WX1L sign on the southern approach. This may not be an issue due to the road being a 'no exit' and all road users will have approached from the south to cross initially and hence have had prior warning of the level crossing. Neither of the approaches have 'RAIL X' road markings.

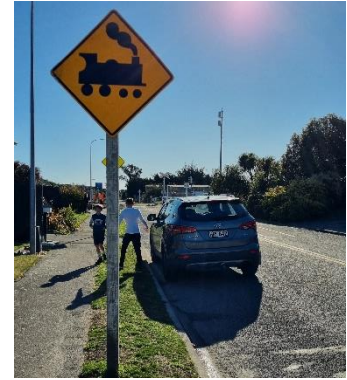
Figure 4-18: WX1L signpost

The southern approach to the crossing has a WX1L signpost on the left-hand side of the road, approximately 60m from the level crossing as seen in Figure 4-18. There are no 'RAIL X' road markings on this approach either.

Safety Recommendation	Level of Necessity
probably do not achieve the intended effect. Review for installing WX1L signs on both approaches, particularly the southern approach to the level crossing.

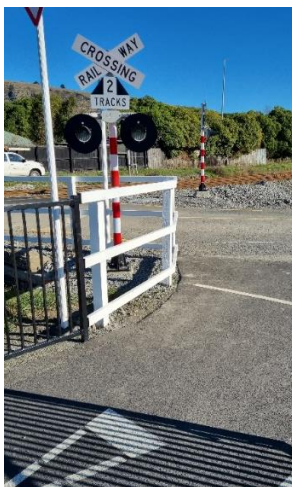
Figure 4-20: FLB northeast quadrant

Figure 4-20 shows the FLB in the northeast quadrant specifically to warn pedestrians and cyclists westbound that are coming off the MCR to cross the rail corridor at Scruttons Road. Figure 4-21 shows another FLB in the northwest quadrant to warn eastbound MCR users of approaching trains.
