**Absolutely Positively
Wellington City Council**

Thank you for your email dated 13 February 2026 to Te Kaunihera o Pōneke | Wellington City Council (the Council) requesting the following information in relation to the Mt Kaukau Viewing Platform under service request SR-1239957:

From: s7(2)(a) <[redacted]@frame.co.nz>
Sent: Monday, 8 December 2025 5:31 pm
To: Buzz Graham <[redacted]>
Cc: s7(2)(a) <[redacted]@frame.co.nz>; Adam Groenewegen <[redacted]>; s7(2)(a) <[redacted]@frame.co.nz>
Subject: Closure Recommendation: Kaukau Lookout Platform (20006501) - Preliminary Structural Inspection Findings

Mt Kaukau Lookout Platform (Asset #20006501) is a public viewing structure built and donated to Wellington City Council (WCC) by the Lions Club in 1972. Although the platform is not located on Council land, WCC is responsible for its ongoing maintenance. The most recent known structural reporting appears to have been undertaken by Spencer Holmes around 2020/21, and the asset is not currently included in Frame Group's Asset Condition Assessment database for Wellington's Parks and Reserves. Frame Group also has no record of previous inspections for this specific structure.

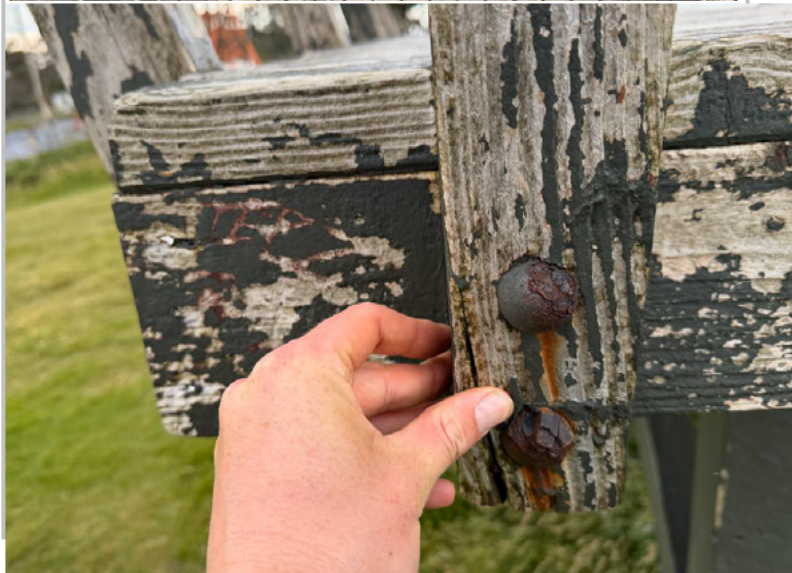
1. Barrier is significantly under-capacity i.e. approximately <15% current NZ Building Code (NZBC) required capacity for the barrier post bolts, and <50% for the timber barrier post capacity.
2. Barrier bolts are badly corroded and structurally inadequate (noted as ~15% of required capacity).
3. Barrier height is low at 940mm high (i.e. current NZBC requirement is 1100mm).
4. Seat arrangement is dangerous – it encourages people (especially children) to sit/lean against a weak barrier. Children can fall off the back of the seating/barrier area if climbing on the seat.
5. The structure has an effective fall height of ~>1.5 m making it a 'high-risk' viewing platform category structure as per HB SNZ 8630.
6. Bolted connections are generally corroded throughout the structure.

Based on these observations, I recommend that WCC close the Lookout to the public as soon as is practical.

To re-open the structure, a full barrier replacement to current NZBC requirements will likely be required (and removing the seat, and replacing corroded bolts throughout the structure). A Building Consent or Exemption may be required for this barrier replacement.

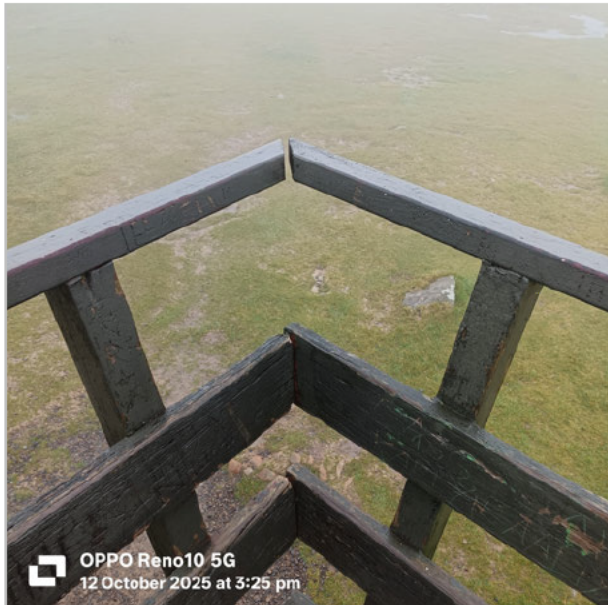
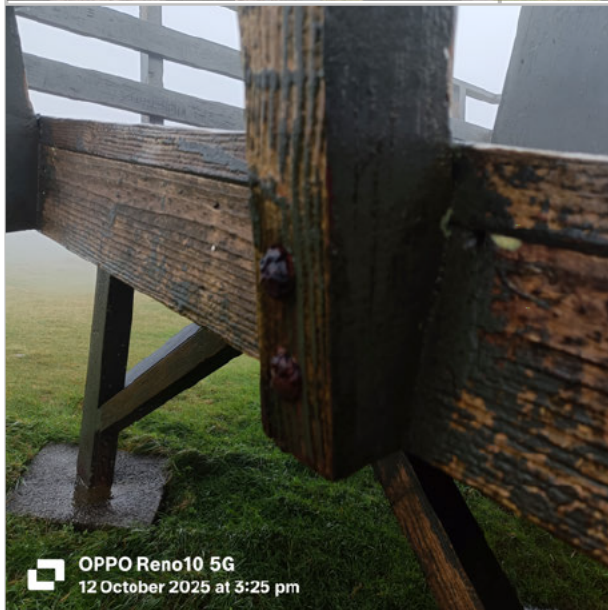
I can see from s7(2)(a) photos below that we do need to replace the rusted bolts and the mesh so I have already given that job to s7(2)(a) at Open Spaces Ltd to do asap.

“This platform has poorly connect handrails and rusted bolts. Some of the connections are nailed when they should be bolted and engineered. There is a real risk of them breaking.”

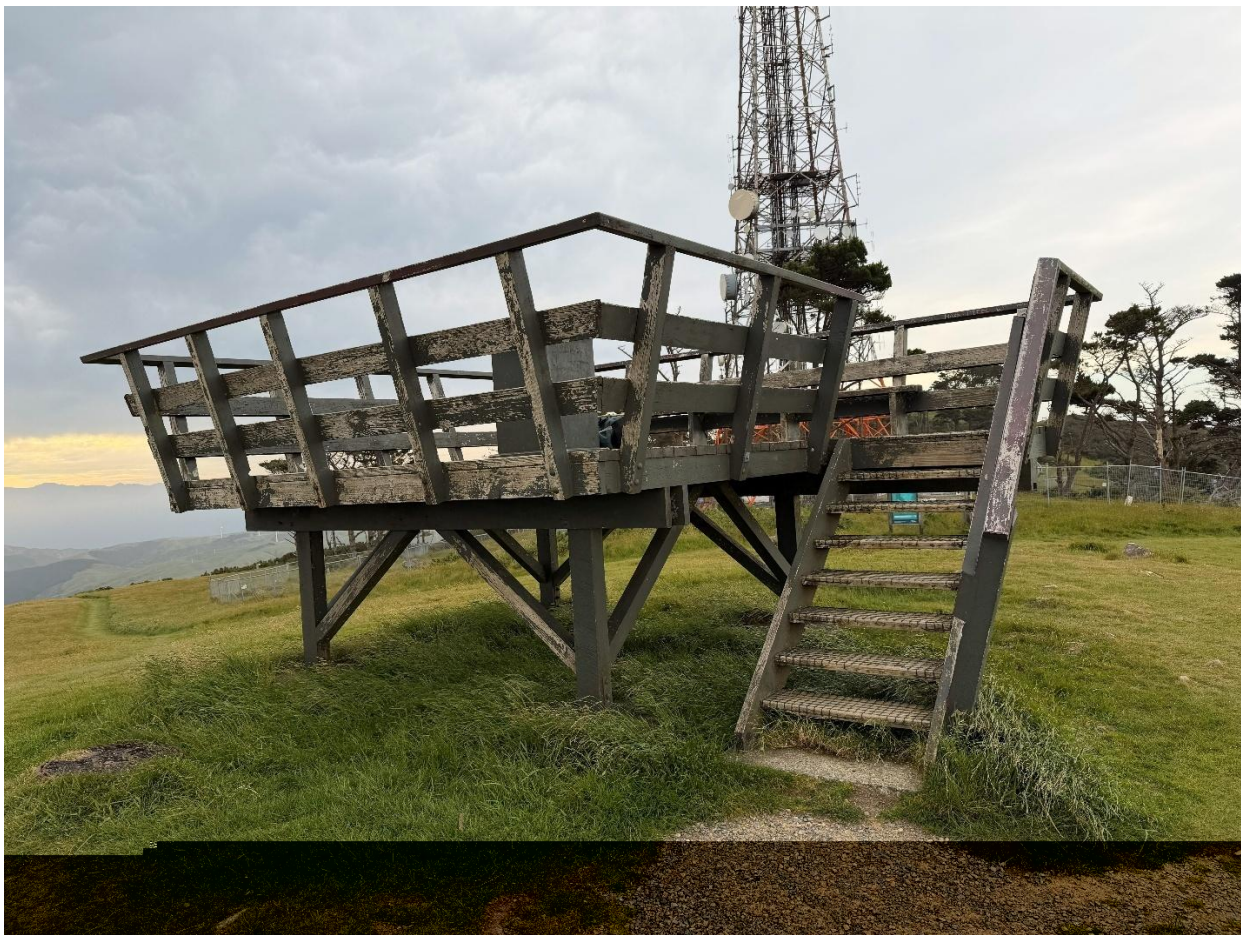
Figure 1 : Mt Kaukau Lookout Platform (Asset #20006501) - Photo taken by Frame Group on 5 Dec 2025.

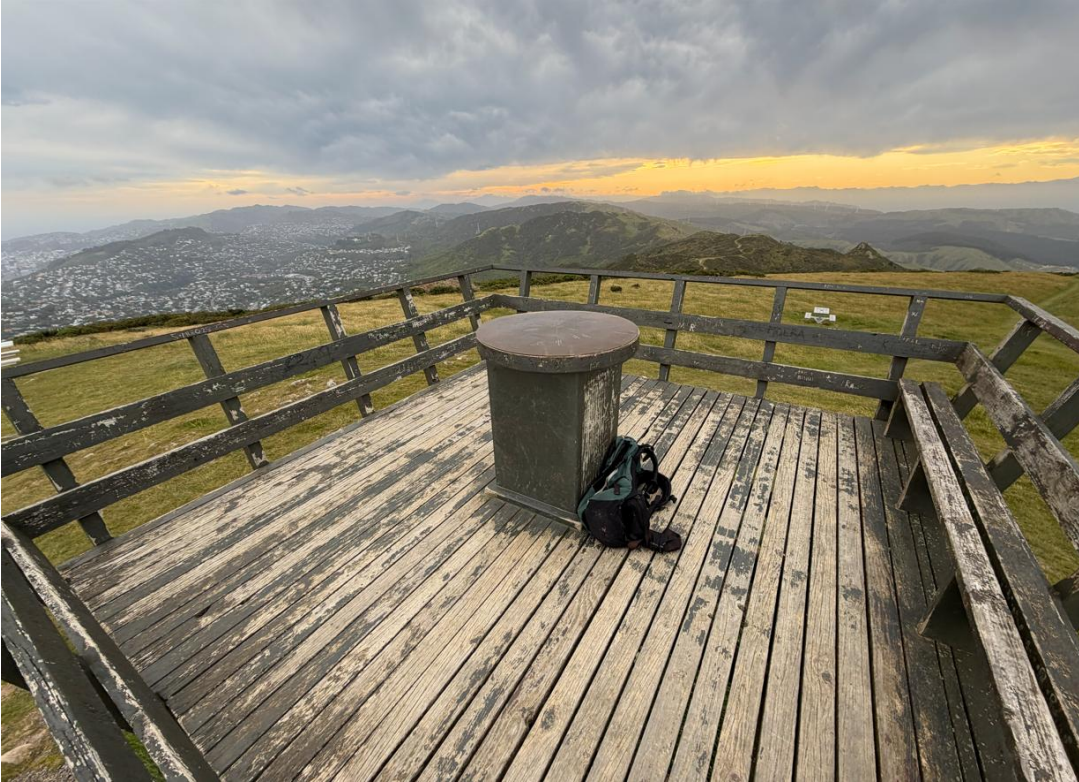
Figure 2 Mt Kaukau Lookout Platform (Asset #20006501) - Photo taken by Frame Group on 5 Dec 2025.

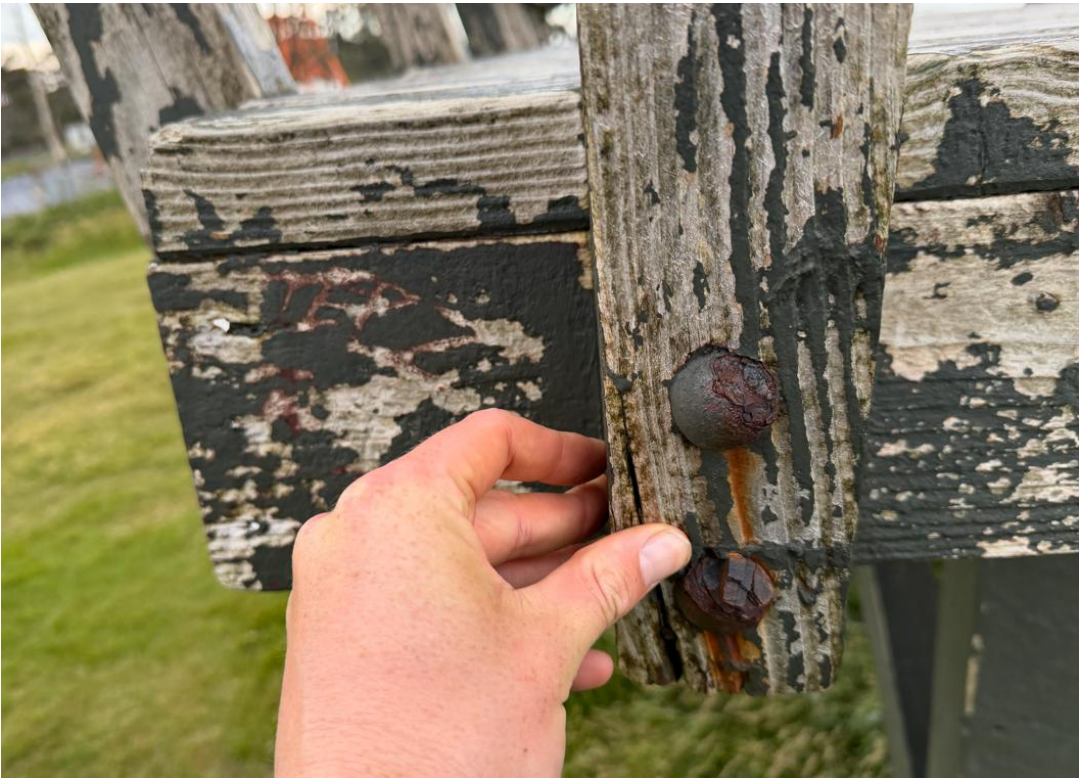
- barrier elements with very low structural capacity (estimated at <15% of current NZ Building Code (NZBC) requirements for post bolts and <50% for timber barrier posts);
- badly corroded and structurally inadequate barrier bolts, and a barrier height of only 940 mm compared to the current NZBC requirement of 1100 mm.;
- the existing seat arrangement was also assessed as hazardous, as it encourages sitting and leaning against a weak barrier and creates a fall risk for children climbing on the seat;
- given the effective fall height of greater than 1.5 m, the structure falls within the 'high-risk' viewing platform category under HB SNZ 8630; and

Figure 3 Corrosion and inadequate spacing at barrier post bolts - Photo taken by Frame Group on 5 Dec 2025.

To enable safe re-opening, it is anticipated that a full barrier replacement to current NZBC requirements will be required, including removal of the existing seat and replacement of corroded bolts throughout. A Building Consent or Exemption may also be required for these works.
