Resource Consent Application
Assessment of Environmental Effects
Discharge of Wastewater into Land

Te Pirangi Developments

Resource Consent Application Assessment of Environmental Effects

Discharge of Wastewater into Land

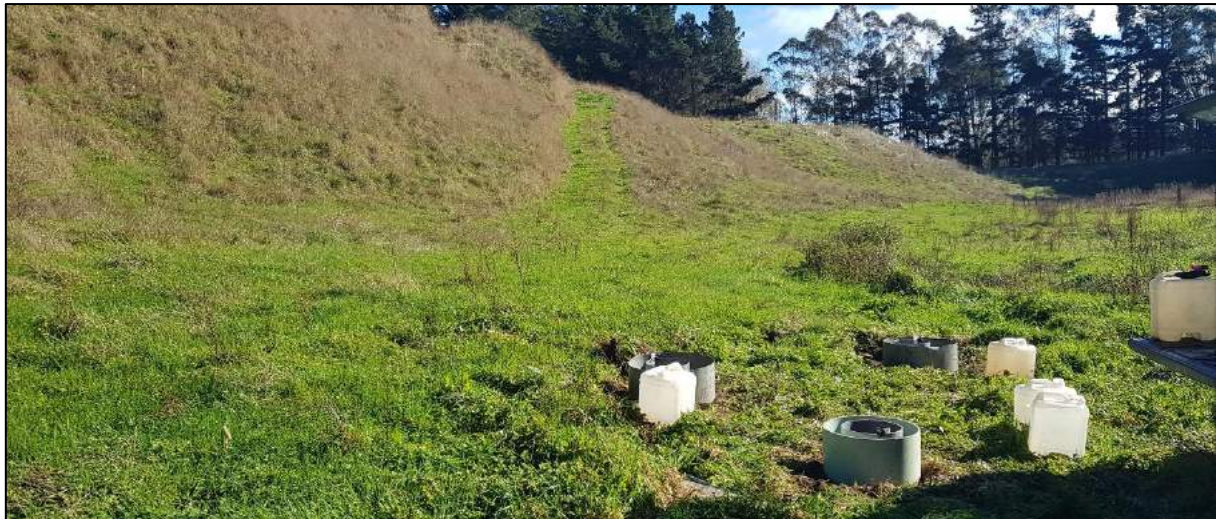
Figure 0.5: Photo Taken from Lot 14 and Looking North-West Towards Lots 16, 17 and 19.

Figure 0.5 shows the expected overland flow path along the foot of the terrace towards the north-west as discussed in Section 0.

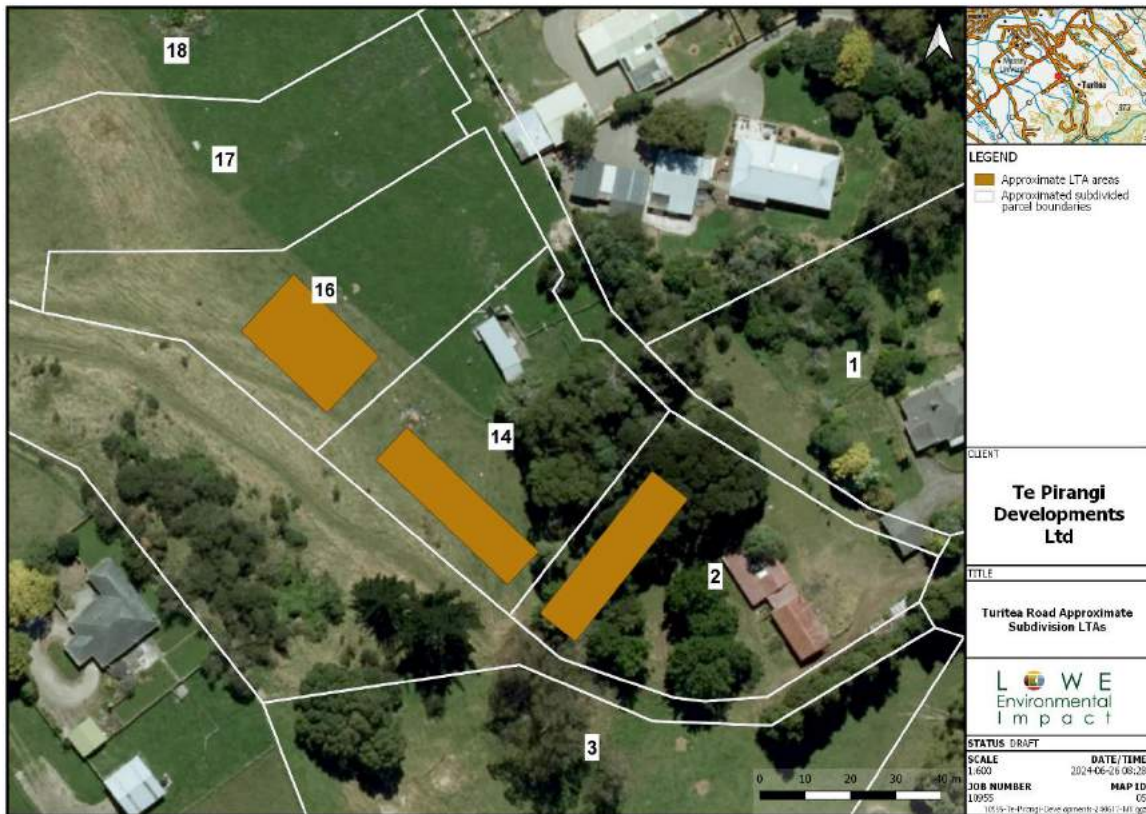
Figure 0.2: Proposed Land Treatment Areas for Lots 2, 14 and 16

The proposed land treatment areas are illustrated in Figure 0.2. These locations have been chosen to maximise land space for building platforms and ensure appropriate buffer distances to the waterway (>20 m), active groundwater bore (> 20 m), property boundaries (1.5 m), buildings (> 1.5 m) and from retaining wall and embankments (> 3.0 m) (under AS/NZS 1547), these are the minimum separation distances recommended in Table 2.2 of the Manual for On-Site Wastewater Systems Design and Management. There has been no buffer given for the Lot 2 bore (ID 346024) as this is understood to have been decommissioned.
