Appendix E

Laboratory Test Reports

W2HVlink Field Investigations

Geotechnical Interpretive Report

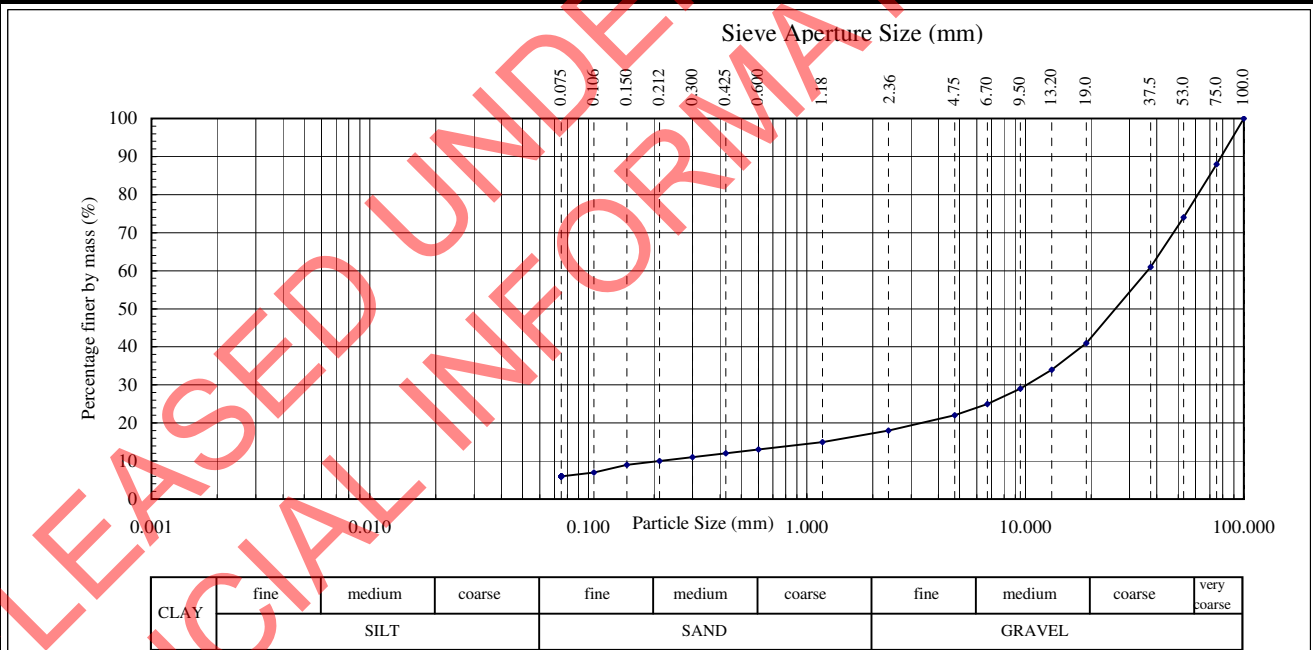
Project: **P2N Cycleway**
 Location: **Petone foreshore**
 Client: **NZTA**
 Contractor: **JAD Civil Design**
 Sampled by: **Aecom**
 Date sampled: **17.12.13**
 Sampling method: **Test pit**
 Sample source: **TP2 1.20m**
 Sample description: **GRAVEL: f-vc, brown, with sand**
 Sample condition: **As received**
 Solid density: **n/a** t/m³ **Assumed**
 Water content as rec'd: **7.2** % **whole**

Sieve Analysis					Hydrometer Analysis				
Sieve Size (mm)	Passing (%)	Sieve Size (mm)	Passing (%)	Sieve Size (mm)	Passing (%)	Particle Size (mm)	Passing (%)	Particle Size (mm)	Passing (%)
100.0	100	9.50	29	0.425	12				
75.0	88	6.70	25	0.300	11				
53.0	74	4.75	22	0.212	10				
37.5	61	2.36	18	0.150	9				
19.0	41	1.18	15	0.106	7				
13.20	34	0.600	13	0.075	6

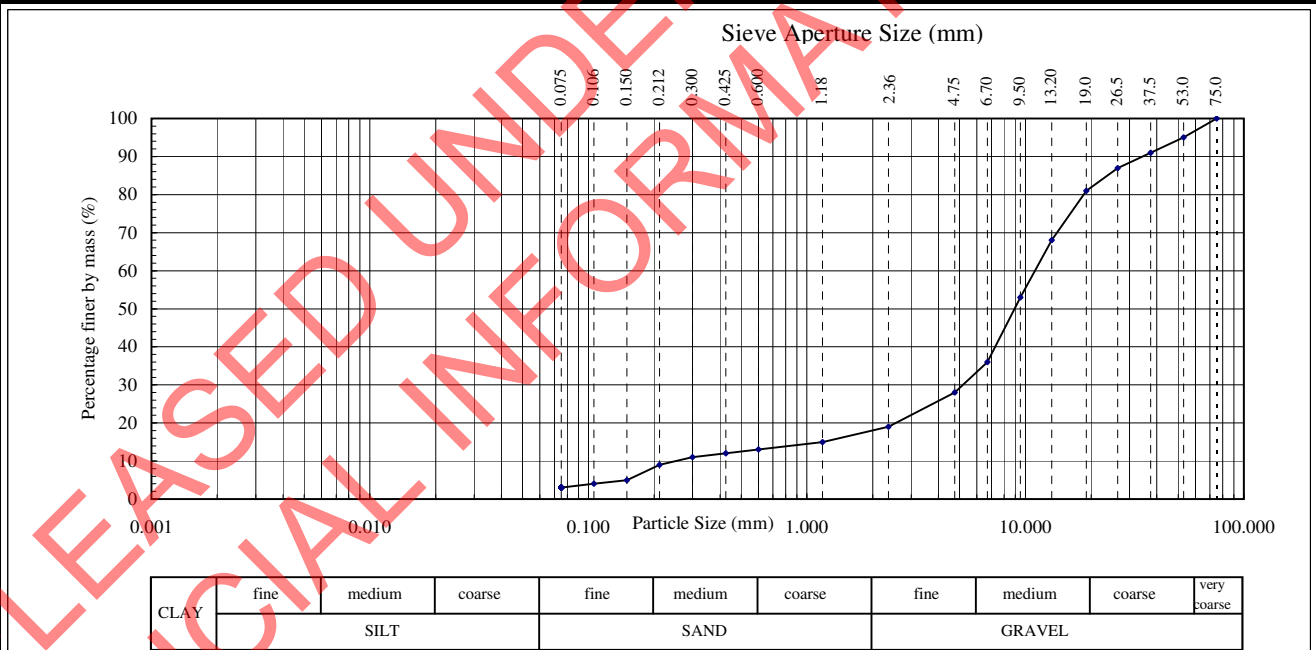
Project: **P2N Cycleway**
 Location: **Petone foreshore**
 Client: **NZTA**
 Contractor: **JAD Civil Design**
 Sampled by: **Aecom**
 Date sampled: **17.12.13**
 Sampling method: **Test pit**
 Sample source: **TP2 1.80m**
 Sample description: **Gravel: f-vc, grey, with sand**
 Sample condition: **As received**
 Solid density: **n/a** t/m³ **Assumed**
 Water content as rec'd: **11.4** % **whole**

Sieve Analysis						Hydrometer Analysis			
Sieve Size (mm)	Passing (%)	Sieve Size (mm)	Passing (%)	Sieve Size (mm)	Passing (%)	Particle Size (mm)	Passing (%)	Particle Size (mm)	Passing (%)
75.0	100	9.50	53	0.425	12				
53.0	95	6.70	36	0.300	11				
37.5	91	4.75	28	0.212	9				
26.5	87	2.36	19	0.150	5				
19.0	81	1.18	15	0.106	4				
13.20	68	0.600	13	0.075	3

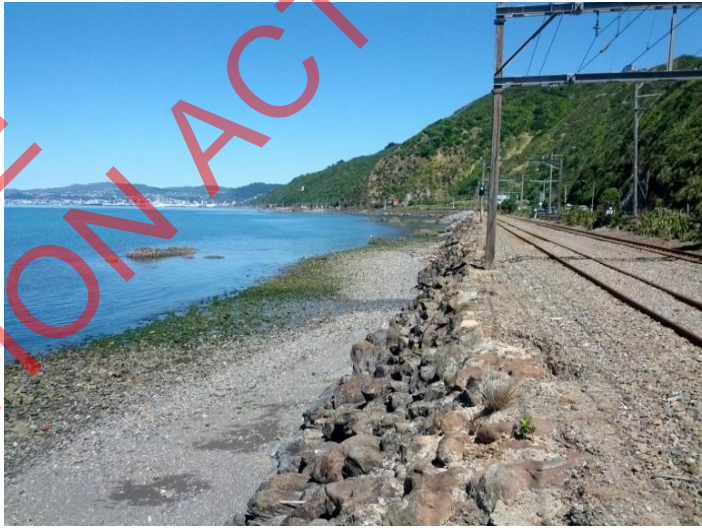
Area ID No.	Chainage		length (m)	Observations	Photo
	start	end			
Area 1	3690	3730	40	0.2-0.3m rock elements in unreinforced concrete matrix

existing railway embankment slope 45-55 deg	
				Beach gently sloping. Cobbles and coarse gravel	
				exposed beach area approx 10m	
				Rock armour reutilisation: 0 elements	
Area 2	3730	3800	70	0.3-0.5m rock elements in unreinforced concrete matrix

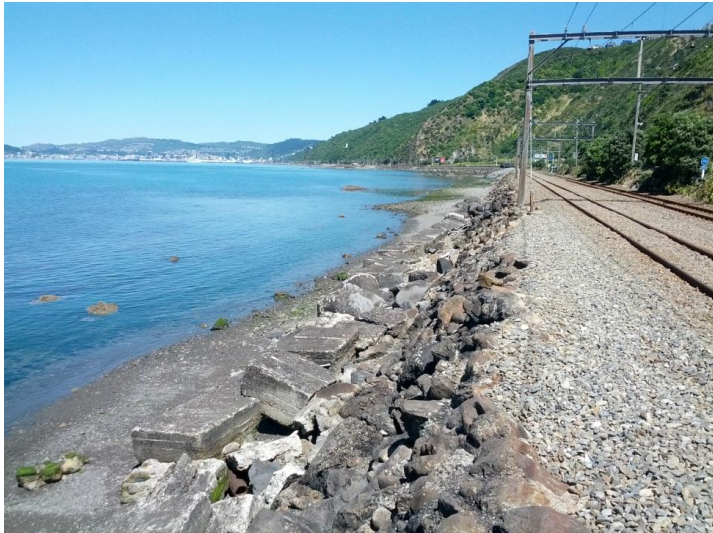
existing railway embankment slope 45-55 deg	
				Beach gently sloping. Coarse gravel	
				exposed beach area approx 5m	
				Rock armour reutilisation: 0 elements	
				Concrete blocks sizing 1.5x0.7mx0.6m at embankment toe (2 rows). Concrete includes cobble size elements and appear to be unreinforced. Some of the blocks are heavily eroded

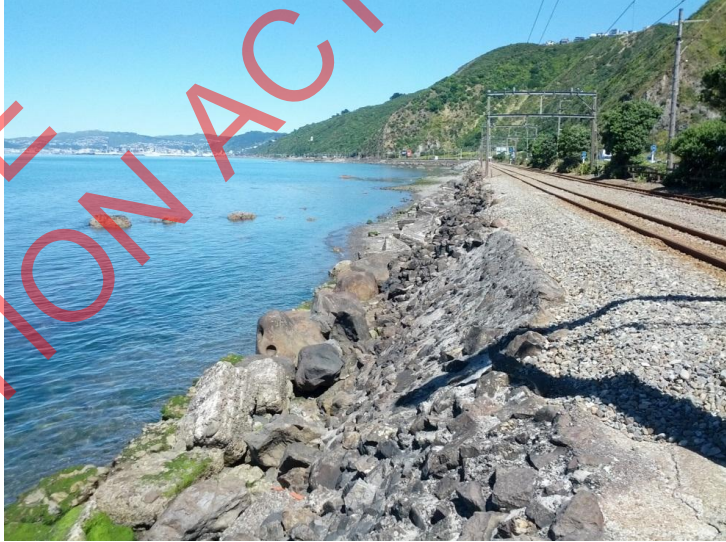
Area ID No.	Chainage		length (m)	Observations	Photo
	start	end			
Area 3	3800	3840	40	0.2-0.3m rock elements in unreinforced concrete matrix

Additional rock armour elemnts at toe. Sizing 400-1000mm	
				existing railway embankment slope 45-55 deg	
				Beach gently sloping. Cobbles and coarse gravel	
				no exposed beach area	
				Rock armour reutilisation: 10 elements	
Area 4	3840	3960	120	Additional rock armour protection on existing slope. Sizing 300-1200mm

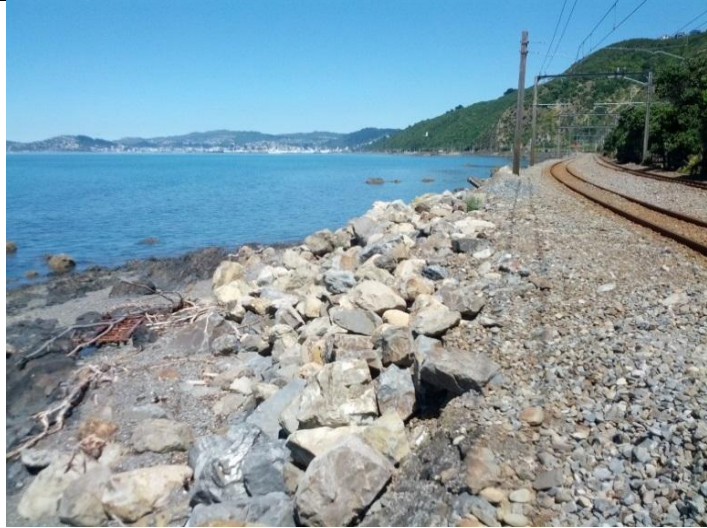
rock outcrops on beach and in shallow waters	
				Overall embankment slope angle 30 deg	
				Beach gently sloping. Coarse gravel	
				Exposed beach area up to 15m	
				Rock armour reutilisation: 40 elements

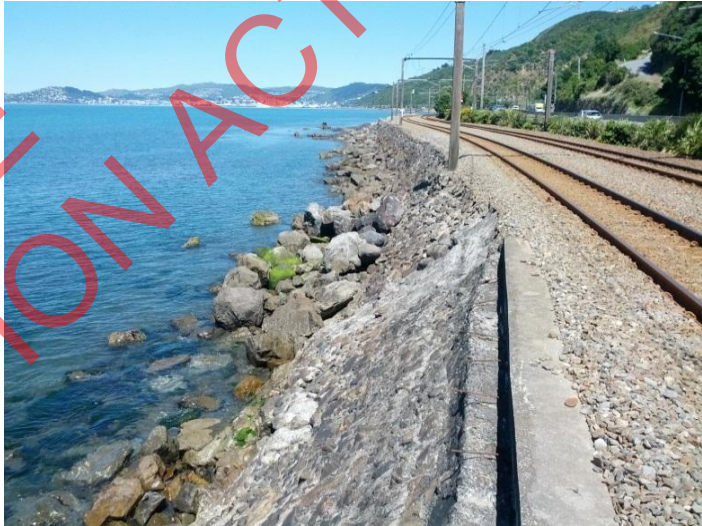
Area ID No.	Chainage		length (m)	Observations	Photo
	start	end			
Area 5	3960	4095	135	0.2-0.3m rock elements in unreinforced concrete matrix

slope angle 50/55deg	
				Additional rock armour elements at toe. Sizing 350-1100mm	
				Unreinforced masonry wall and RC beam on top of on a 15m section	
				no exposed beach area	
				Rock armour reutilisation: 15 elements	
				stormwater outlet diameter 800mm at chainage 3880	
Area 6	4095	4185	90	0.2-0.3m rock elements in unreinforced concrete matrix

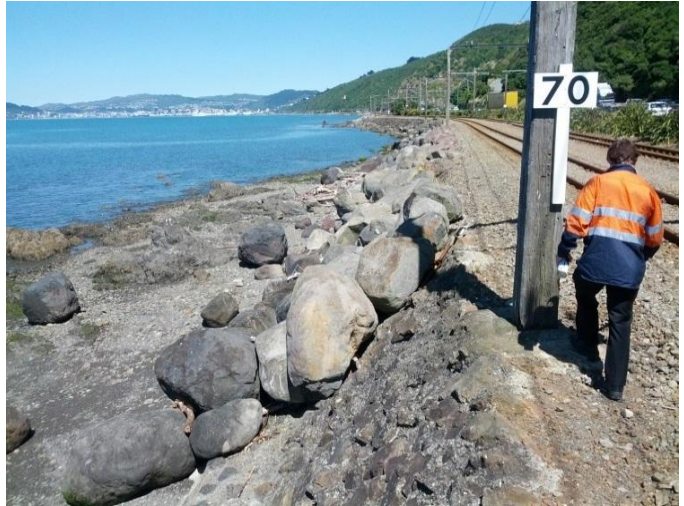
slope angle 50/55deg	
				Additional rock armour elements at toe and on embankment slope. Sizing 250-1300mm	
				Exposed beach area 5 to 8m	
				Rock armour reutilisation: 15 elements

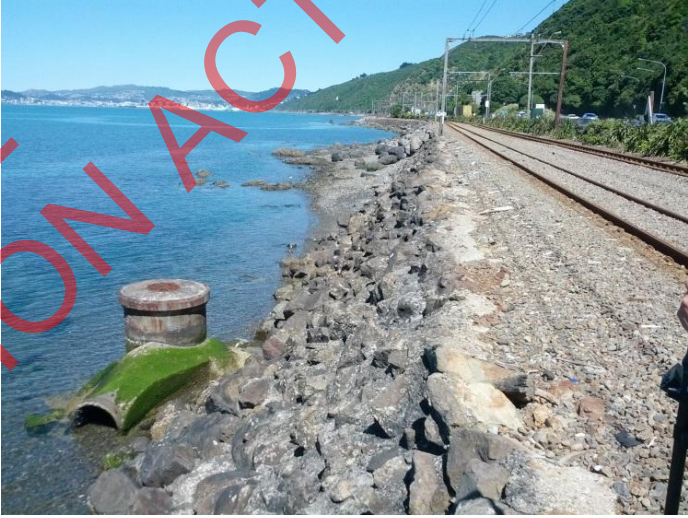
Area ID No.	Chainage		length (m)	Observations	Photo
	start	end			
Area 7	4185	4230	45	0.2-0.3m rock elements in unreinforced concrete matrix

slope angle 40/45 deg	
				No exposed beach area	
				Storwater outlet (diameter 600mm) and manhole at chainage 4200	
				Storwater outlet (diameter 600mm) and manhole at chainage 4300	
				Rock armour reutilisation: 0 elements	
Area 8	4230	4350	120	rock armour and construction debris form the coastal protection

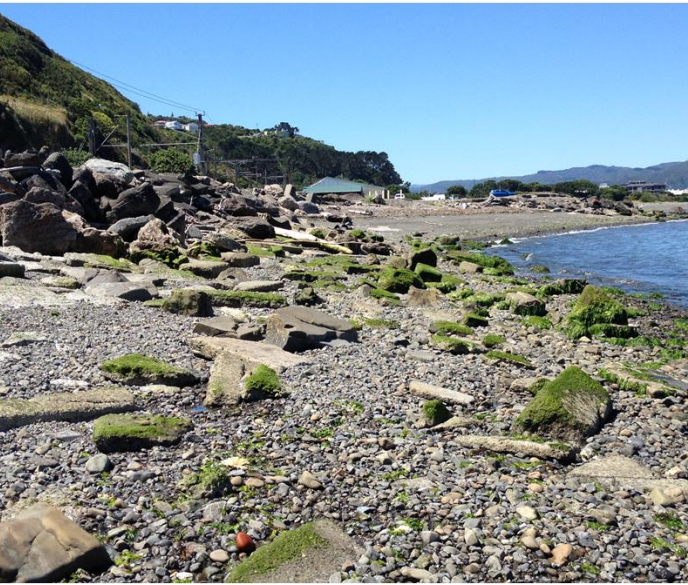
Overall embankment slope angle 30 deg	
				Reclaimed area on seaside of railway tracks 1 to 4m	
				Exposed beach area 3 to 20m	
				Beach is rock blocks, concret blocks and filled with cobbles and coarse gravel	
				Rock armour reutilisation: 20 elements

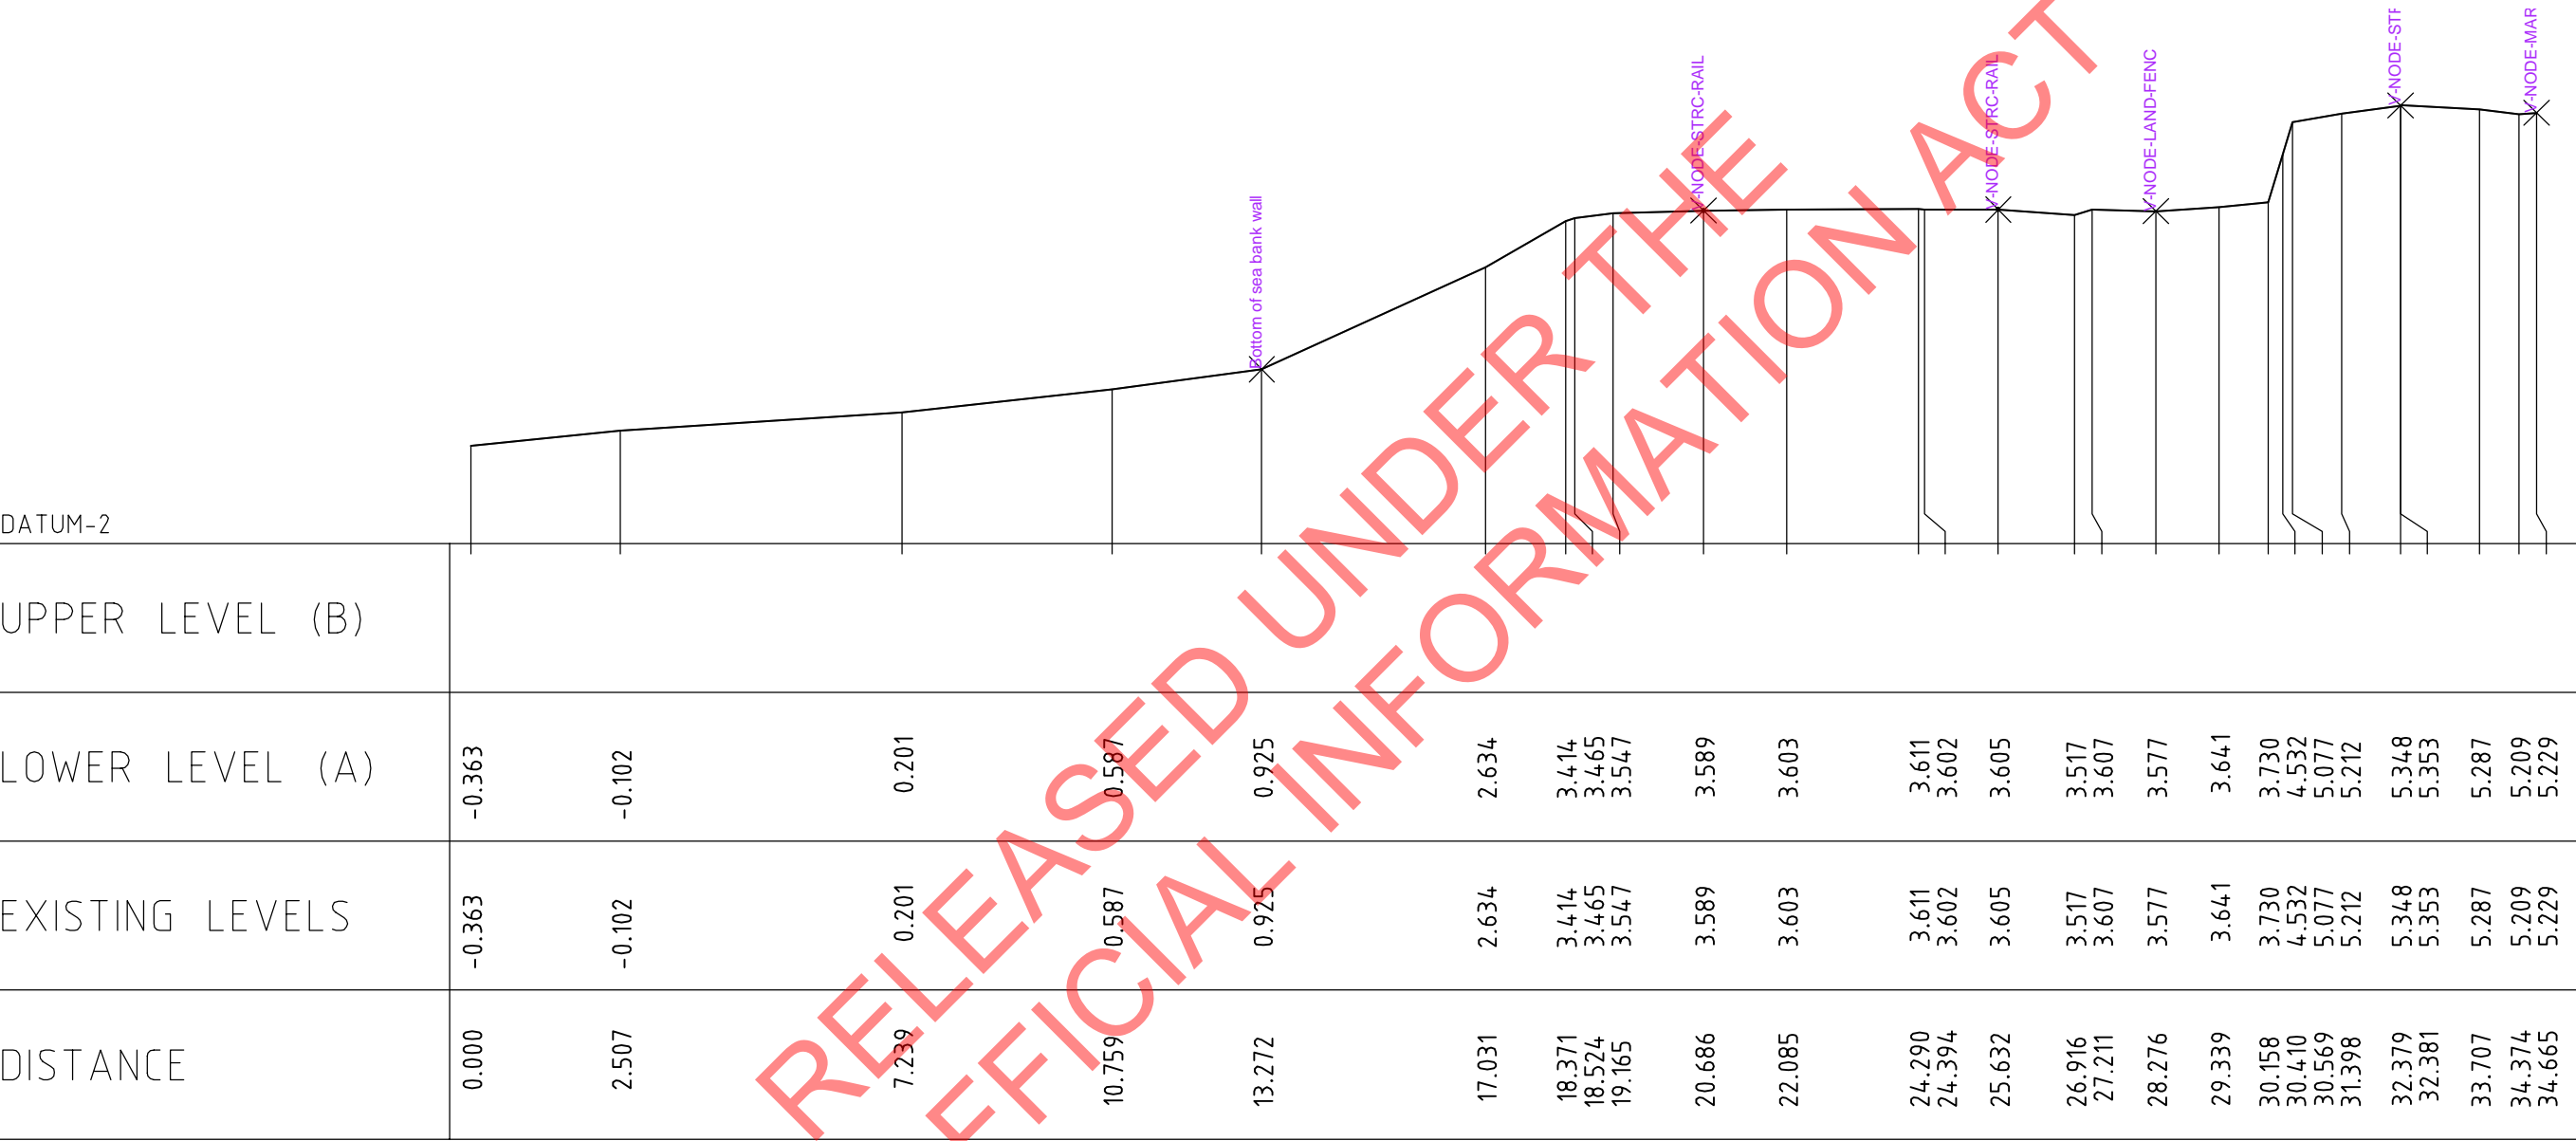
CROSS-SECTION CS2

HORIZONTAL - 1 : 100

VERTICAL - 1 : 100

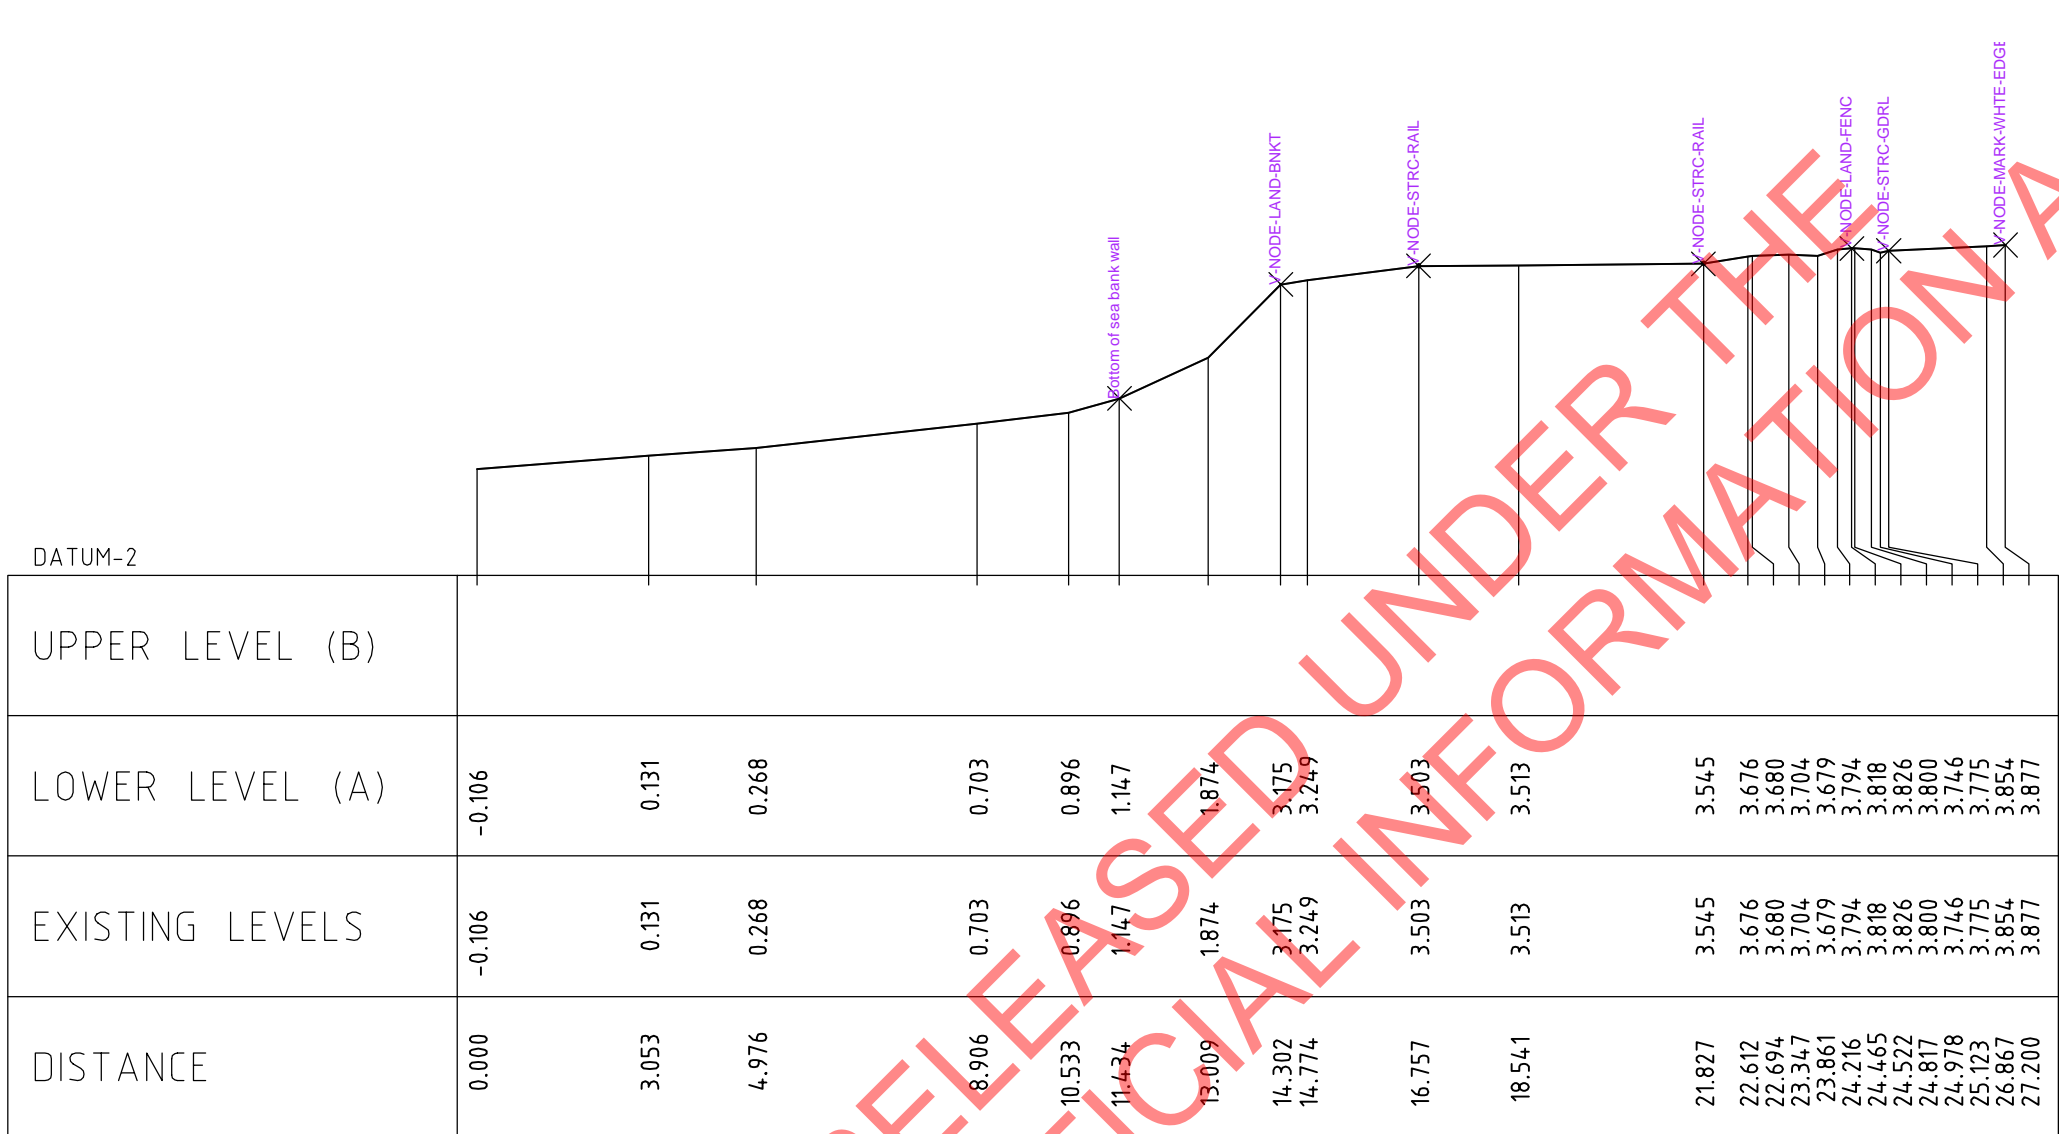
CROSS-SECTION CS5

HORIZONTAL - 1 : 100

VERTICAL - 1 : 100

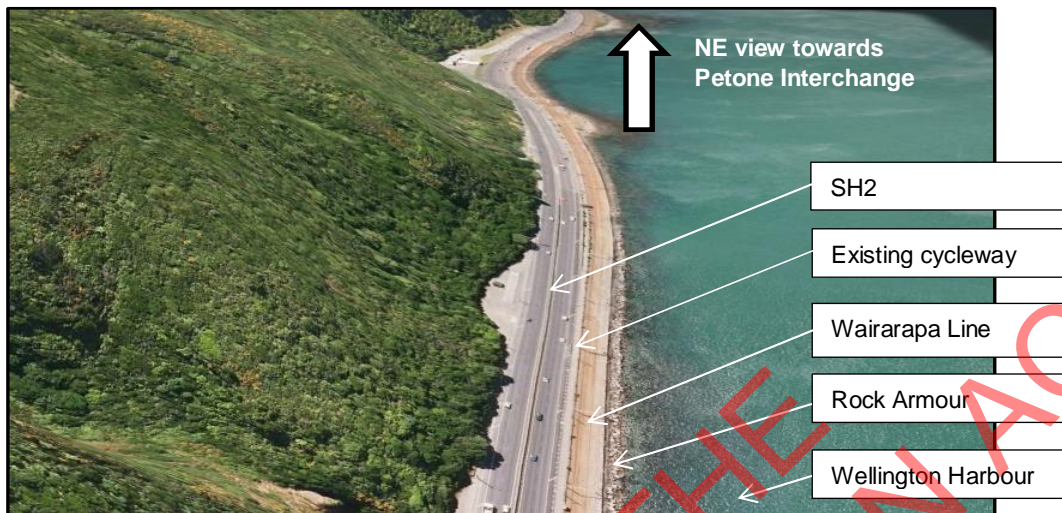
Figure 1 View of the Existing Transport Corridor (Courtesy of Google Earth® imagery)

The corridor is approximately 40m wide developing from the toe of the existing hills to the existing shoreline on the sea side of the railway line. Locally the corridor width extends up to 100m as the hill toe moves away from the current shoreline. The topography of the transport corridor is relatively flat. Reclamation was carried out to adapt the natural shoreline to the geometric requirements of motorway and railway alignments. The railway line is set directly behind the crest of the existing reclamation embankment with little to no available residual space on the sea side. Along the study area the edge of existing reclamation elevation varies between 3 and 4m above mean sea level. Existing rock armour and seawall currently protect the railway embankment from wave action from the Wellington Harbour.

Figure 1 provides an aerial oblique view of the transport corridor in an area where the cycleway currently exists.

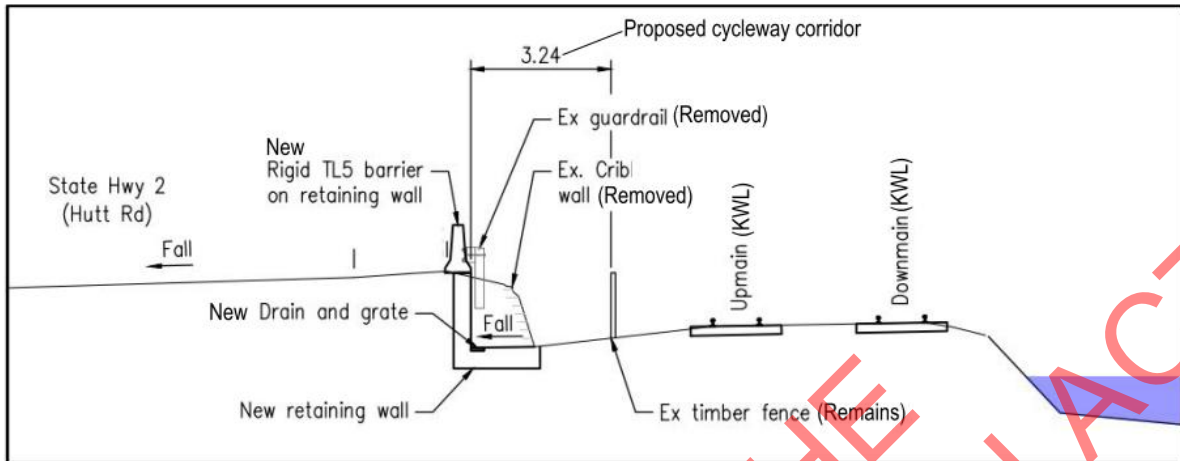
- Construction of new retaining walls closer to the road as illustrated in Figure 3 to accommodate the path widening works. The maximum height of the walls is 1.5m, with typical heights less than 1.0m as indicated in Table 1 along with the indicative length of the proposed retaining wall sections. In-between these sections widening of the existing path does not require retaining structure as the levels of SH2 and the existing path are similar.

Figure 3 Schematic Layout of Retaining Wall Arrangement for Option 1 (locations detailed in Table 1)

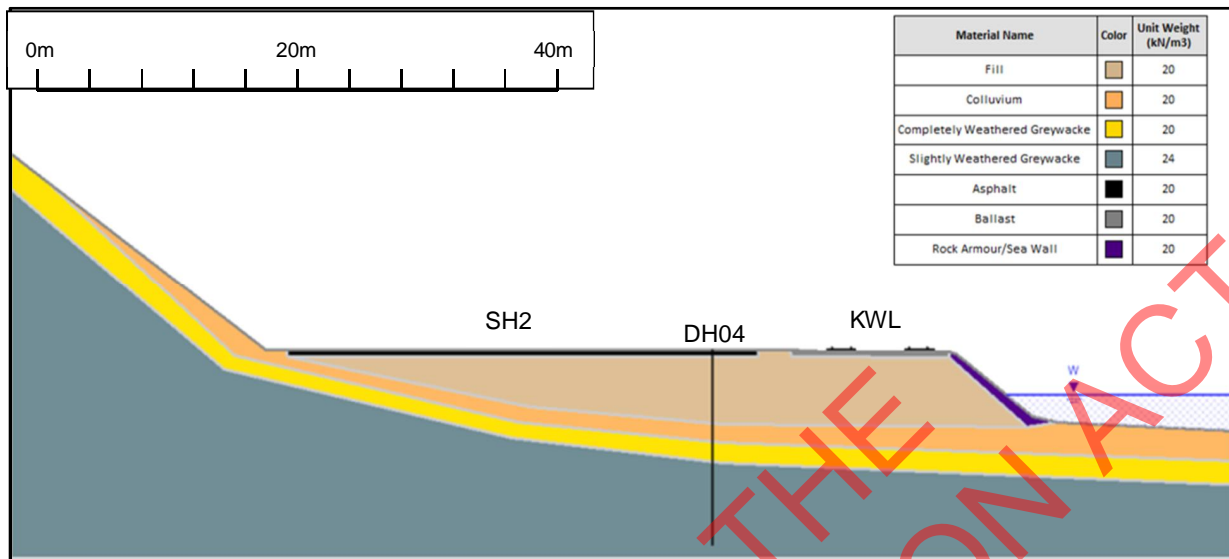
Groundwater was observed between 2.2 and 2.5m depth in TP01 and TP03 respectively.

Figure 7 Schematic Representations of Ground Conditions (chainage 3,800 approx)

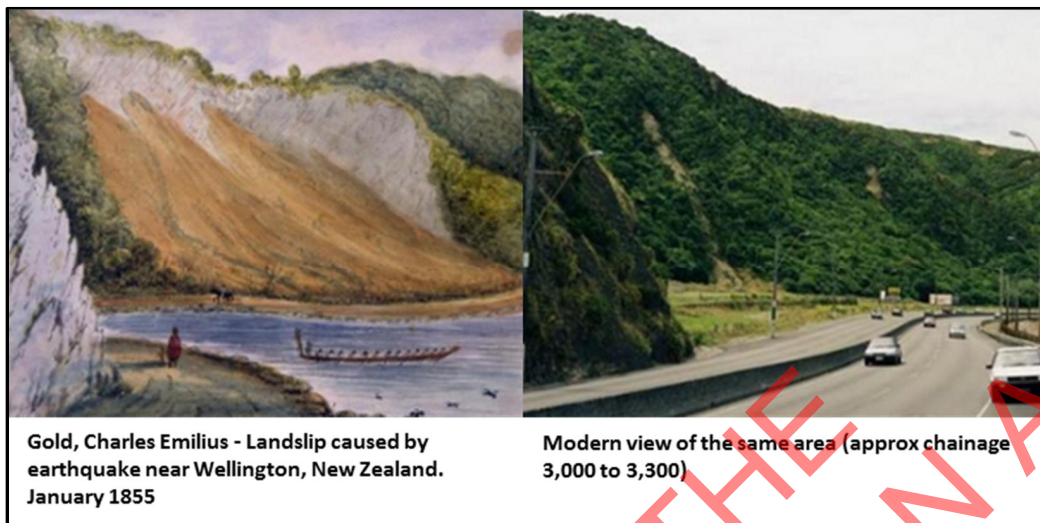
Evidence of previous instability can be observed in the steep hills north-west of SH2. This may include small scale failures (slips and landslides) triggered by intense rainfall episodes to full size slope failure following strong earthquakes such as the January 23, 1855 magnitude 8.2 Wairarapa earthquake. A 1855 painting and a photograph of the same area today shown in Figure 8 illustrates the size of such an event.

Gold, Charles Emilius - Landslip caused by earthquake near Wellington, New Zealand. January 1855

Modern view of the same area (approx chainage 3,000 to 3,300)

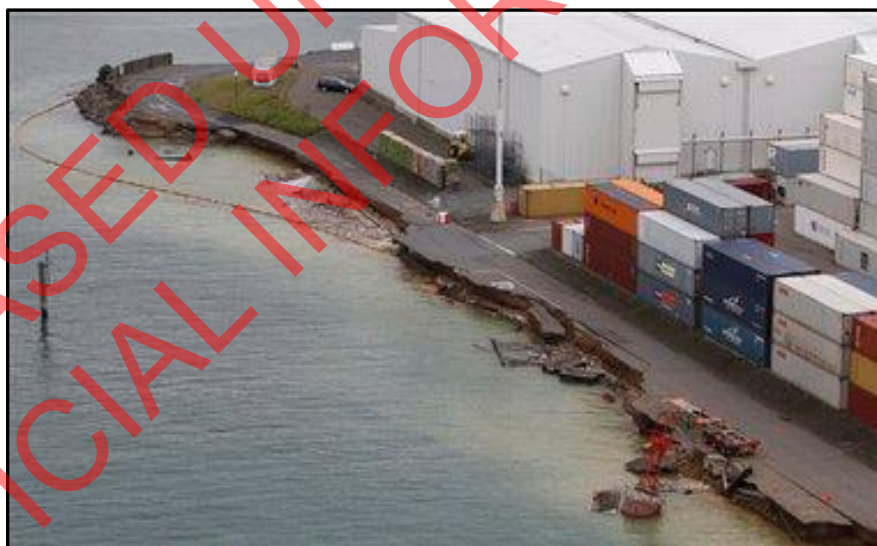
Due to their proximity to a water body and presence of a free face, reclaimed areas can be exposed to liquefaction and lateral spreading hazard. Instability of reclaimed land alongside Wellington Centerport (4km south of the study area) was observed following the July 21 2013 magnitude 6.5 Seddon earthquake. The existing coastal protection and part of the reclaimed area was lost to sea as shown in Figure 9. There are different factors affecting the susceptibility of reclaimed land to liquefaction-induced instability and among those the most significant are the material type and compaction of the reclamation fill along with the geotechnical properties of the foundation soil and the groundwater level.

Figure 9 Effects of Liquefaction and Lateral Spreading on Reclaimed Land

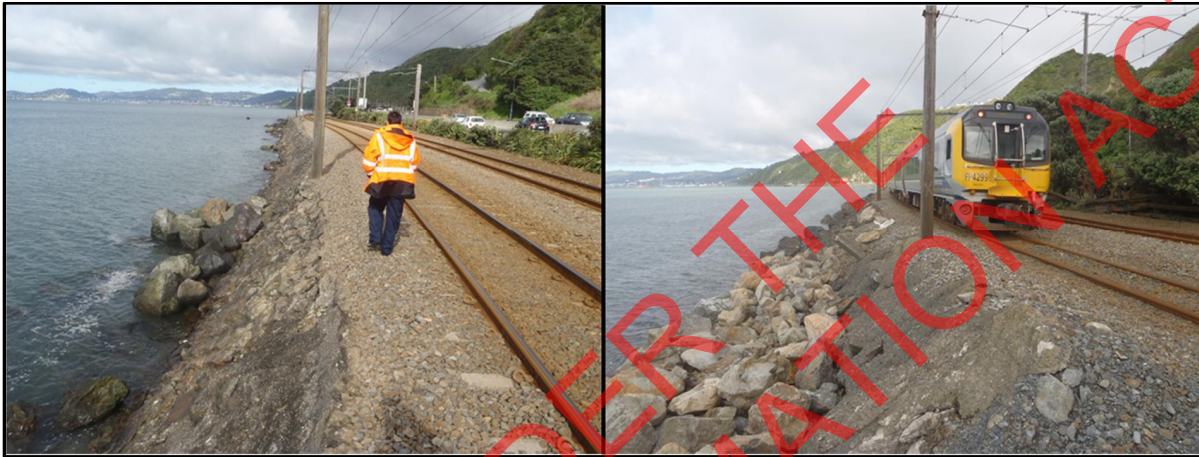
Currently various types and sizes of engineered coastal defence measures exist on the shoreline. They are related to the history of reclamation, storm-related damage and consequent repairs. The existing defence measures vary from relatively small size concrete-bond rock elements to large size boulders of different origin and concrete elements from demolition sites. The site walkover carried out on 5&6 February (observations and notes provided in Appendix G) provides a visual assessment of existing coastal defence measures in the area proposed for reclamation of both options 1&3 (from chainage 3,500 to 4,300 approximately). Photographs of the typical observed measures are shown in Figure 11.

Figure 11 Existing Coastal Protection Measures

The existing reclamation embankment profile typically includes a steep (35/45°) slope profile extending directly onto the seafloor from the side of the existing railway tracks as shown in Figure 11. The crest of the existing reclamation embankment is at elevation 3.0m (WVD53) which is approximately 2.8m above Mean Sea Level. In some areas additional rock armouring has been added following instability of the existing slope. These maintenance works are ongoing and the latest was completed in January 2014 under Kiwirail supervision.

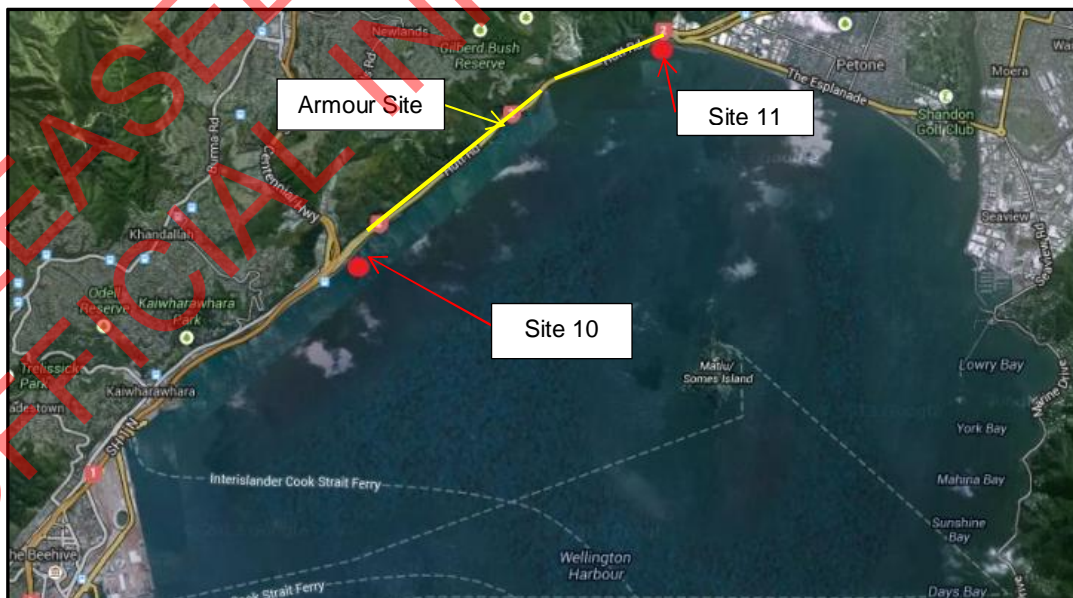
Waves in Wellington Harbour are dominantly controlled by wind conditions due to protection from sea swells. Wave heights were calculated by the National Institute of Water and Atmospheric Research (NIWA) via the SWAN model (Reference 9) for different sites around Wellington Harbour. Two of those sites are located in the study area (approximate locations are shown in Figure 12). Wind and tidal data were combined to create a numerical prediction model for wave height. For detailed statistically significant wave data, continuous monitoring buoys would need to be placed in the harbour.

Figure 12 Location of Prediction Model for SWH

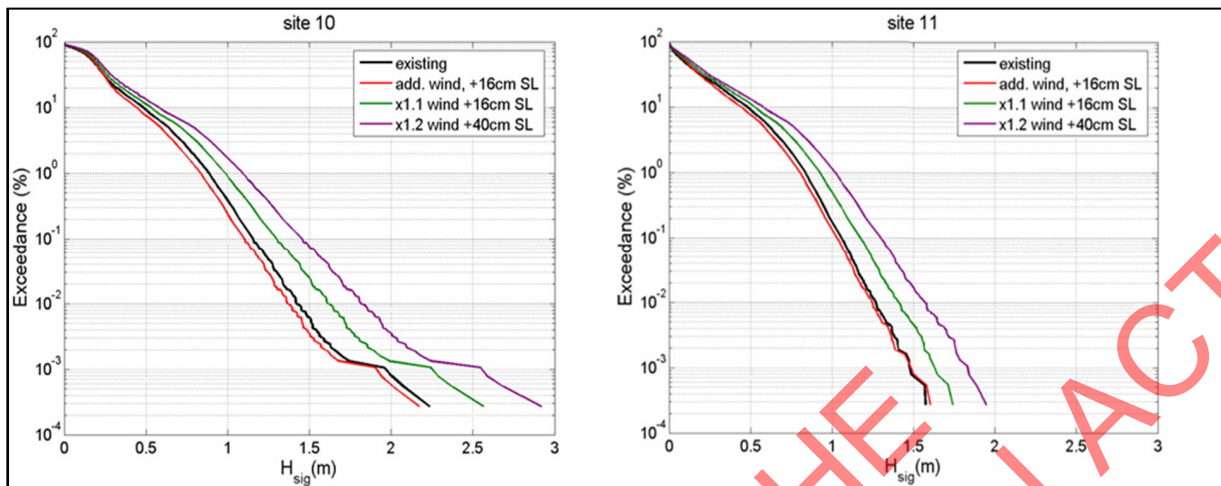
The SWAN model provides graphs of wave height against the exceedance probability (Figure 13). The main difference between the two locations is the water depth, with 16.8m at Site 10 (Ngauranga) and 3.8m at Site 11 (Petone). The graphs in Figure 13 illustrate the predicted wave height for existing conditions and for three different climate change (sea level rise and wind intensity) scenarios.

Figure 13 Graph of the Significant Wave Height vs Exceedance (from NIWA study)

The predicted wave heights from the model are indicated in Table 13 against different return periods. These values do not consider the effects of climate change over these periods with predicted sea level and wind intensity rise likely to have significant effects on the wave height prediction and therefore the proposed rock armour properties. The worst case scenario in the NIWA report indicates a predicted wave height approximately 30% greater than the existing conditions.

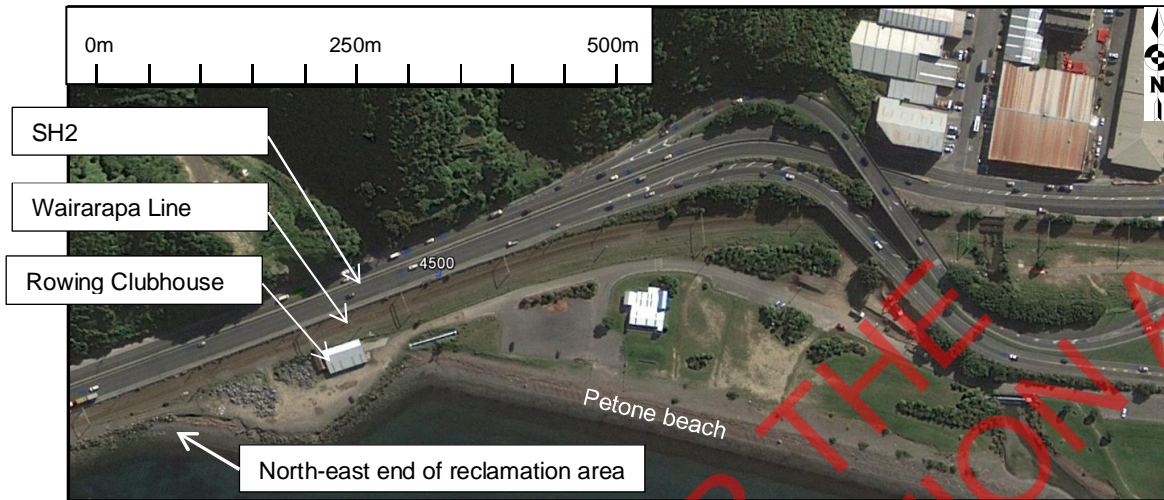
For both options 1&3 on the Petone (north-east) end an existing sealed accessway from The Petone Esplanade leads to the Petone Rowing Clubhouse. A gate marks the limit of the KiwiRail-owned land. Upgrading works to the accessway are required for access of construction equipment.

Figure 15 Access from Petone End for Options 1&3 Reclamation
